INSPECTION REPORT  
113 Ivy Hollow Ln  
Mooreville NC 28117

INSPECTION DATE  
📅 12/18/2023  
🕒 5:00:44 PM

Inspection Date: 12/18/2023  
Report ID: 112923AP1

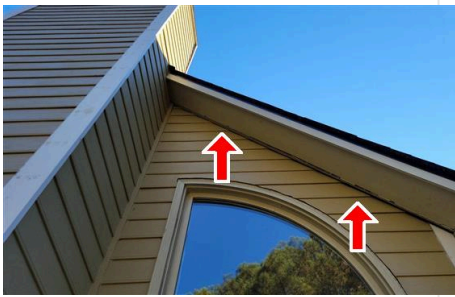
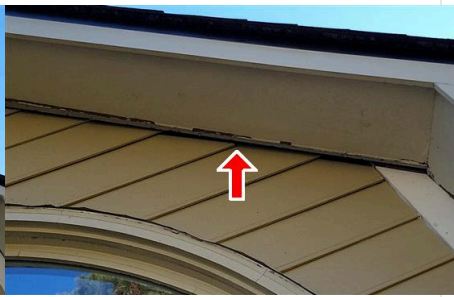
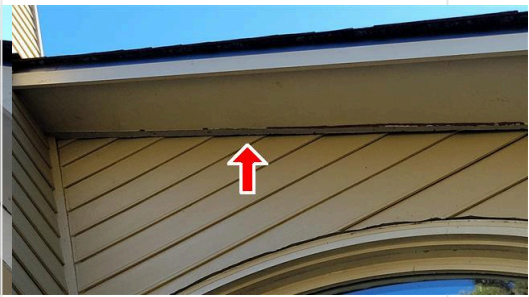
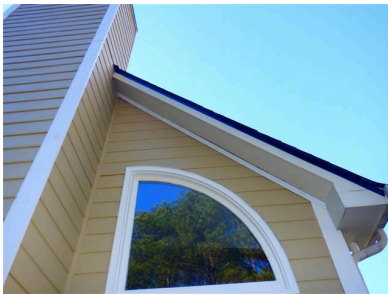
1. The Wood trim at the rear of home is missing. Deterioration can eventually occur if not corrected. Repairs are needed.

Re-inspected 12/18/2023 **The repairs appear to be satisfactory**. It is recommended that you obtain a copy of the repair contract from the sellers (s). Our company does not guarantee repairs from service providers. We only re-inspect to determine whether or not repairs were performed.

A qualified person should repair or replace as needed.

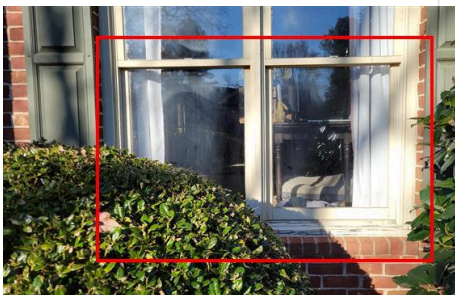
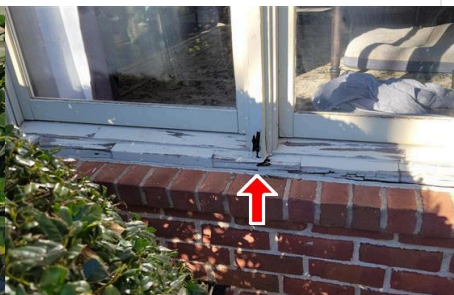
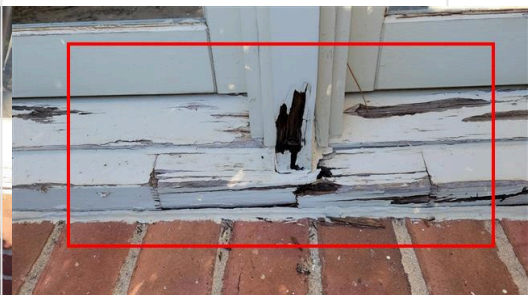
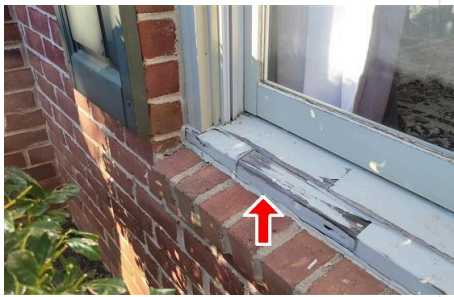
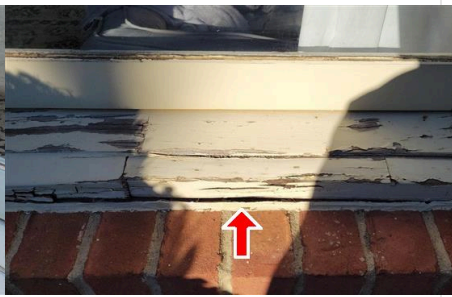
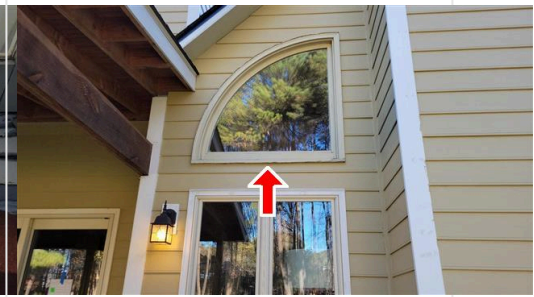
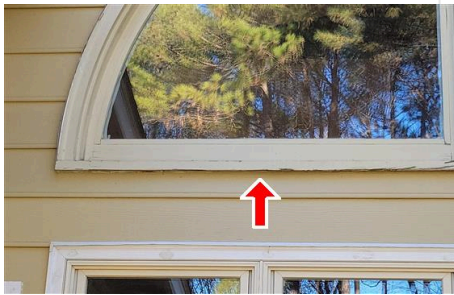
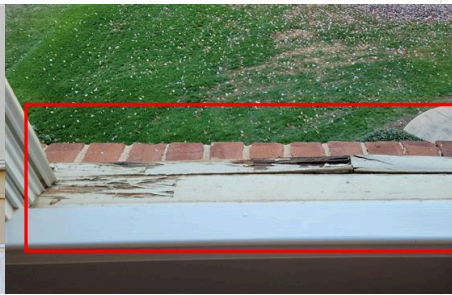
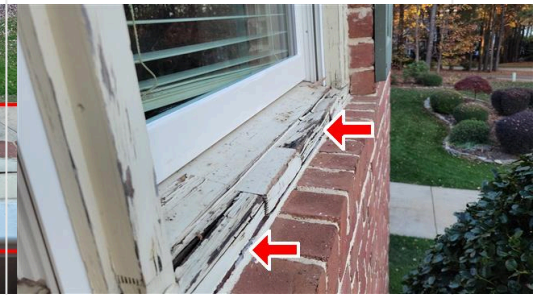
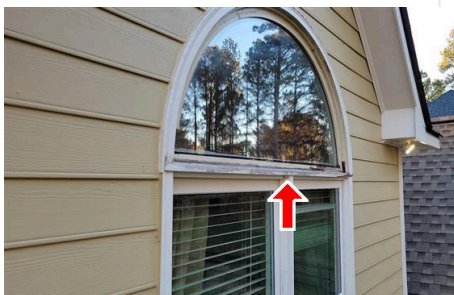
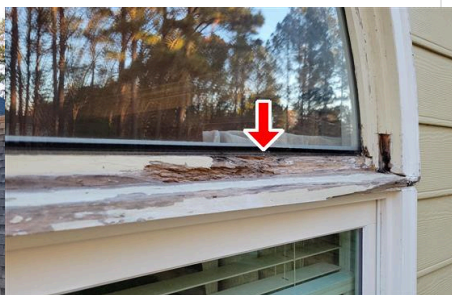
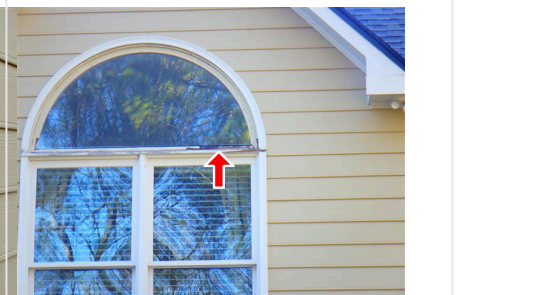
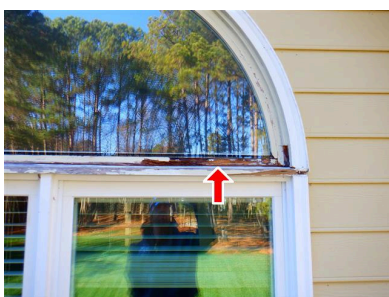
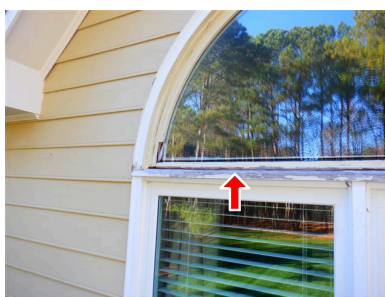
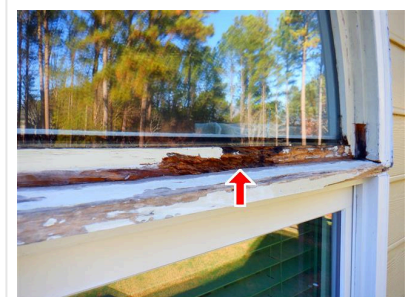
1. The some windows are deteriorated at rear of home. Because of the extent of deterioration it is possible for some framing in wall to be deteriorated. Further investigation and repairs are needed. A qualified contractor should inspect and repair as needed.

Re-inspected 12/18/2023 The repairs do NOT appear to be adequate. The repair is either incomplete or has not been done according to standard workmanlike practice. It is recommended after a proper repair is performed that you obtain a copy of the repair contract from the seller(s). Our company does not guarantee repairs from contractors. We only re-inspect to determine whether or not repairs were performed.

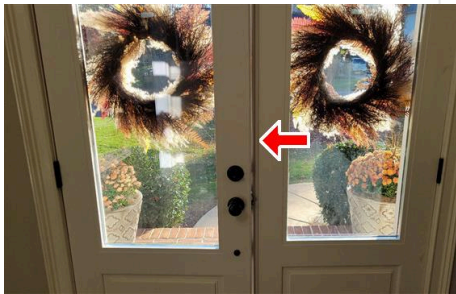
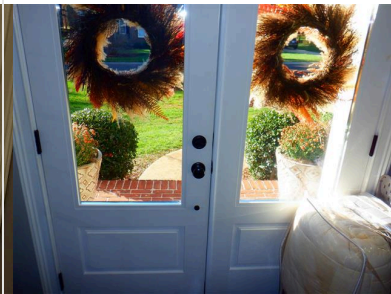
1. The main entry door rubs the other door when closing. As a result the door will not close properly. Further investigation and repairs are needed.

Re-inspected 12/18/2023 **The repairs appear to be satisfactory.** It is recommended that you obtain a copy

A qualified person should repair or replace as needed.

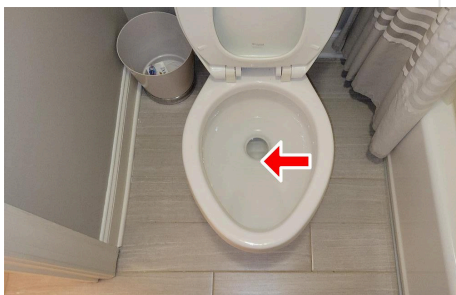
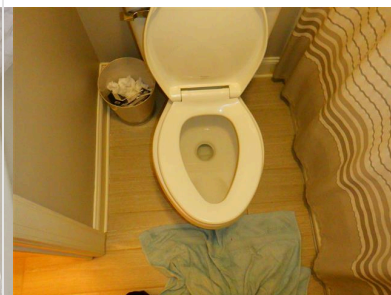
1. The toilet is loose at floor at the bath. Repairs may involve re-setting the toilet on a new wax seal. Repairs are needed.

Re-inspected 12/18/2023 **The repairs appear to be satisfactory.** It is recommended that you obtain a copy of the repair contract from the sellers (s). Our company does not guarantee repairs from service providers. We only re-inspect to determine whether or not repairs were performed.

I recommend a qualified licensed plumber repair or correct as needed.

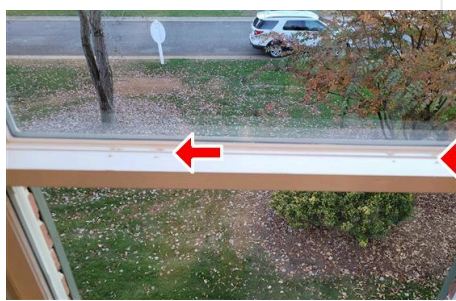
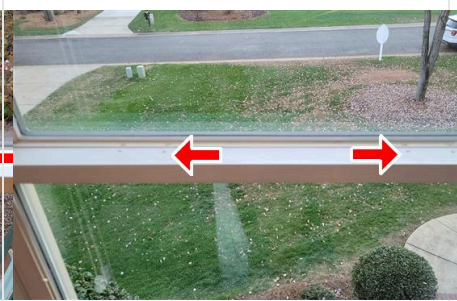
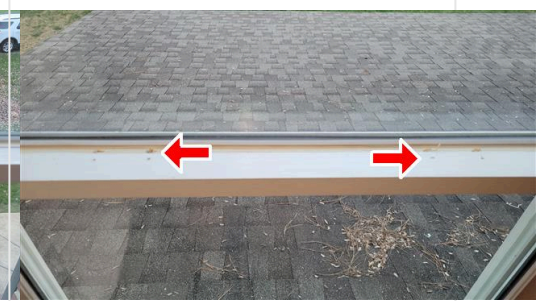
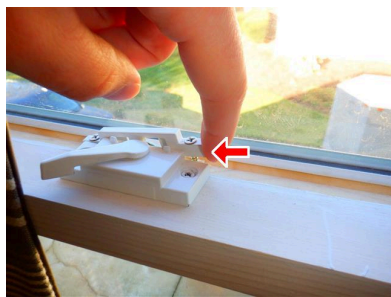
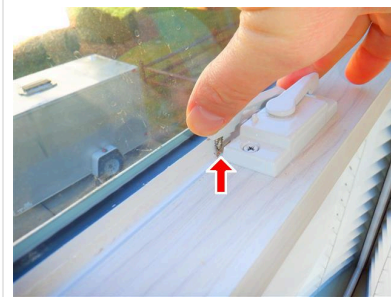
1. Numerous windows is damaged at lock hardware at the throughout the home. As a result you can not lock the window. Repairs are needed.

Re-inspected 12/18/2023 The repairs do NOT appear to be adequate. The repair is either incomplete or has not been done according to standard workmanlike practice. It is recommended after a proper repair is performed that you obtain a copy of the repair contract from the seller(s). Our company does not guarantee repairs from contractors. We only re-inspect to determine whether or not repairs were performed.

A qualified person should repair or replace as needed.

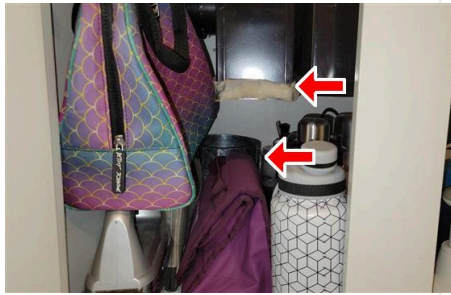
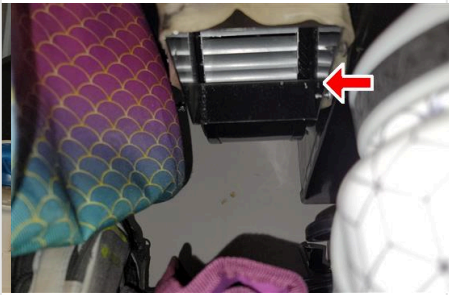
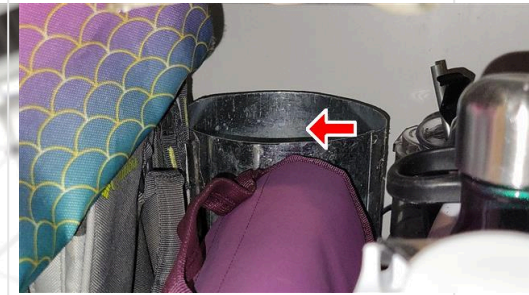
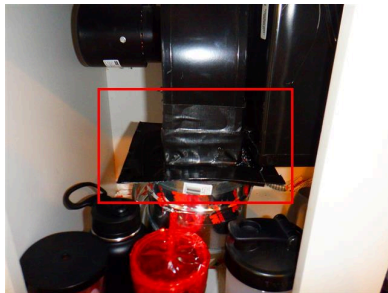
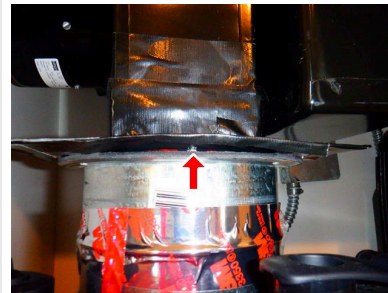
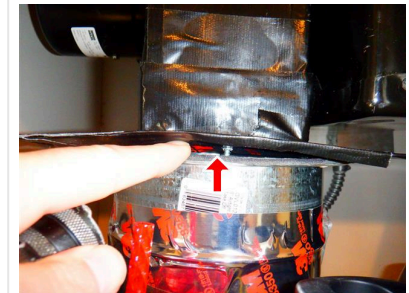
1. The downdraft fan vents into the cabinet and should vent to the outside. This is a fire hazard. I recommend repair or replace as needed.

Re-inspected 12/18/2023 The repairs do NOT appear to be adequate. The repair is either incomplete or has not been done according to standard workmanlike practice. It is recommended after a proper repair is performed that you obtain a copy of the repair contract from the seller(s). Our company does not guarantee repairs from contractors. We only re-inspect to determine whether or not repairs were performed.

I recommend contacting appliance repair company.

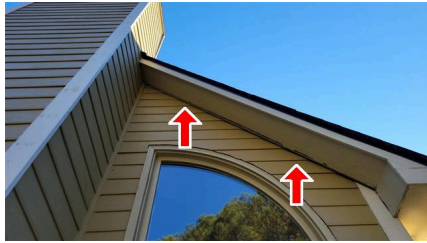
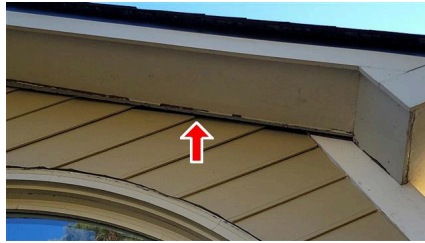
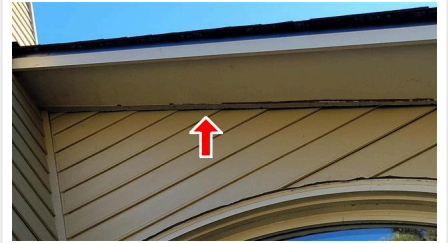
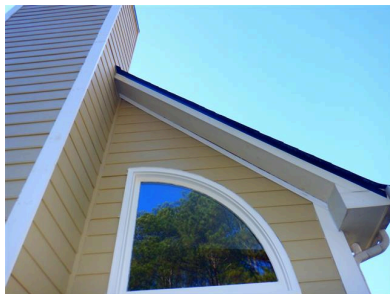
1. The Wood trim at the rear of home is missing. Deterioration can eventually occur if not corrected.

Repairs are needed.

Re-inspected 12/18/2023 **The repairs appear to be satisfactory.** It is recommended that you obtain a copy of the repair contract from the sellers (s). Our company does not guarantee repairs from service providers. We only re-inspect to determine whether or not repairs were performed.

A qualified person should repair or replace as needed.

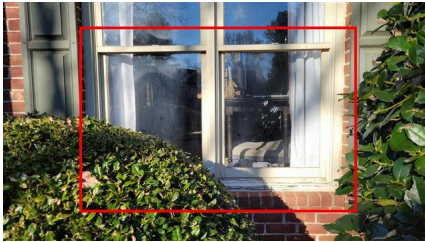
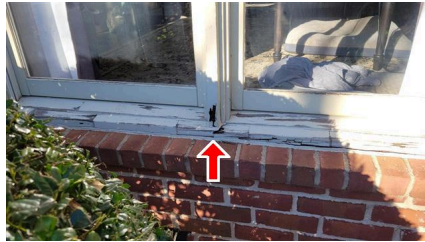
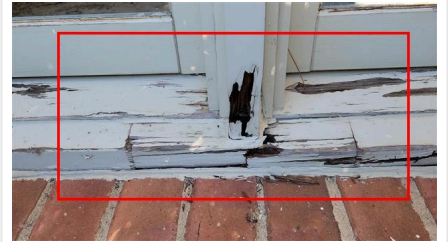
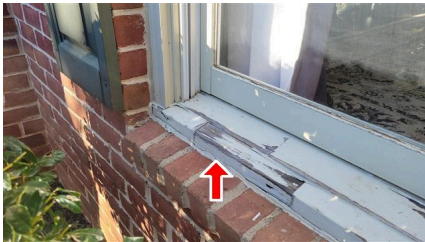
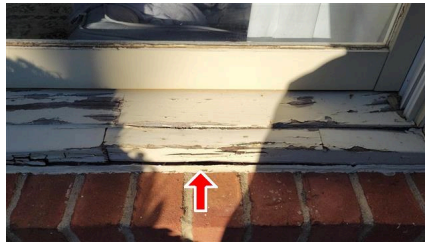
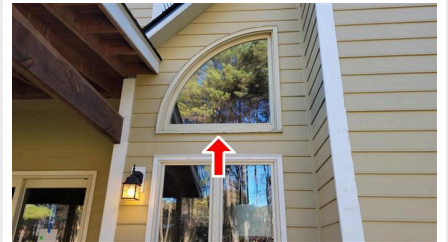
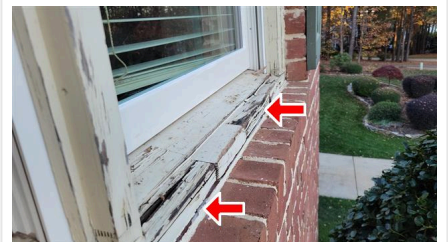
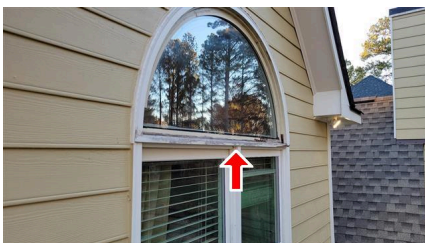
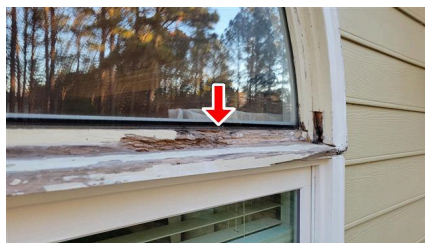
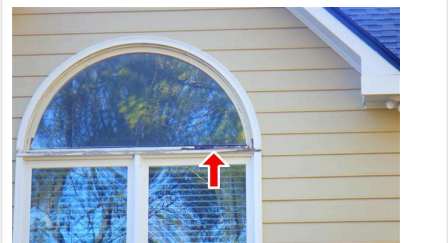
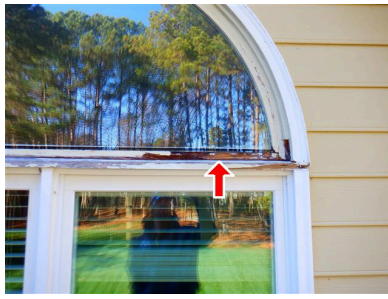
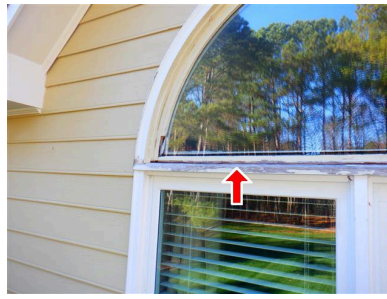
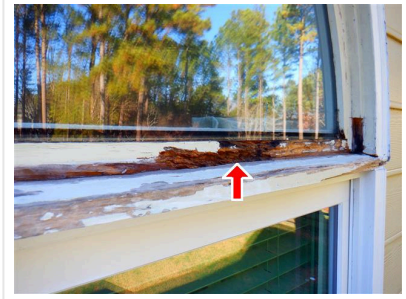
1. The some windows are deteriorated at rear of home. Because of the extent of deterioration it is possible for some framing in wall to be deteriorated. Further investigation and repairs are needed. A qualified contractor should inspect and repair as needed.

Re-inspected 12/18/2023 The repairs do NOT appear to be adequate. The repair is either incomplete or has not been done according to standard workmanlike practice. It is recommended after a proper repair is performed that you obtain a copy of the repair contract from the seller(s). Our company does not guarantee repairs from contractors. We only re-inspect to determine whether or not repairs were performed.

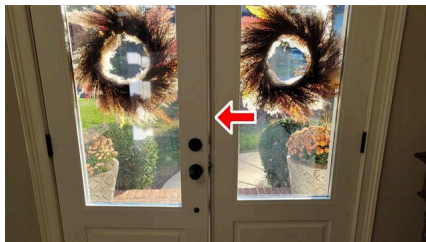
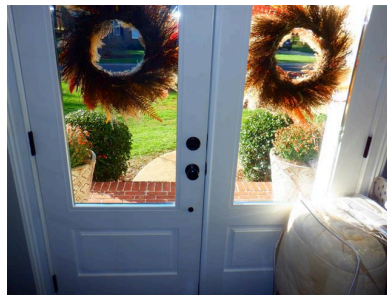
1. The main entry door rubs the other door when closing. As a result the door will not close properly. Further investigation and repairs are needed.

Re-inspected 12/18/2023 **The repairs appear to be satisfactory.** It is recommended that you obtain a copy of the repair contract from the sellers (s). Our company does not guarantee repairs from service providers. We only re-inspect to determine whether or not repairs were performed.

A qualified person should repair or replace as needed.

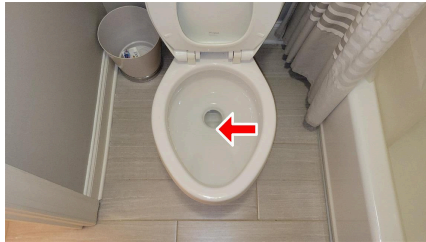
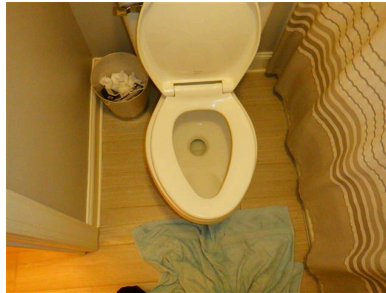
1. The toilet is loose at floor at the bath. Repairs may involve re-setting the toilet on a new wax seal. Repairs are needed.

Re-inspected 12/18/2023 **The repairs appear to be satisfactory.** It is recommended that you obtain a copy of the repair contract from the sellers (s). Our company does not guarantee repairs from service providers. We only re-inspect to determine whether or not repairs were performed.

I recommend a qualified licensed plumber repair or correct as needed.

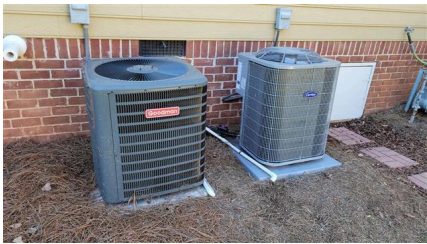
Complimentary photo of the AC units

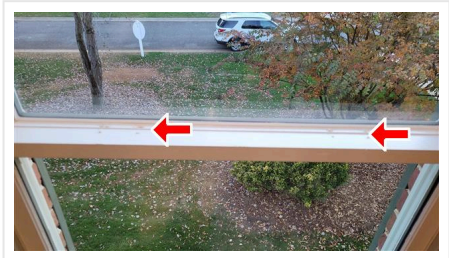
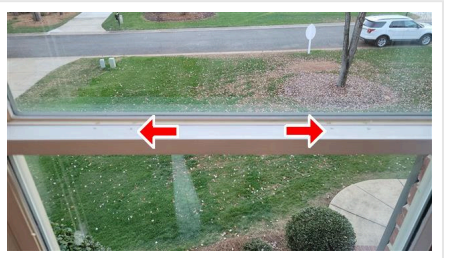
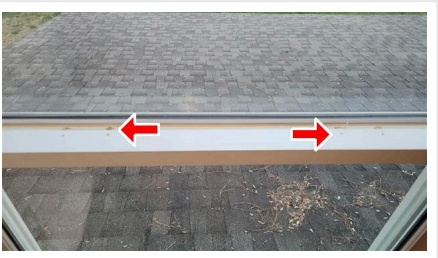
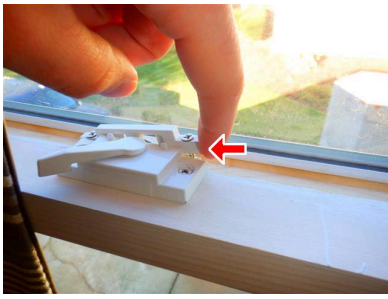
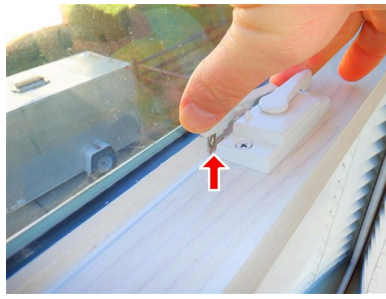
1. Numerous windows is damaged at lock hardware at the throughout the home. As a result you can not lock the window. Repairs are needed.

Re-inspected 12/18/2023 The repairs do NOT appear to be adequate. The repair is either incomplete or has not been done according to standard workmanlike practice. It is recommended after a proper repair is performed that you obtain a copy of the repair contract from the seller(s). Our company does not guarantee repairs from contractors. We only re-inspect to determine whether or not repairs were performed.

A qualified person should repair or replace as needed.

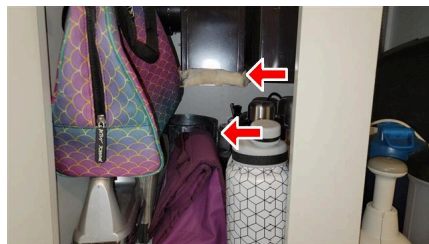
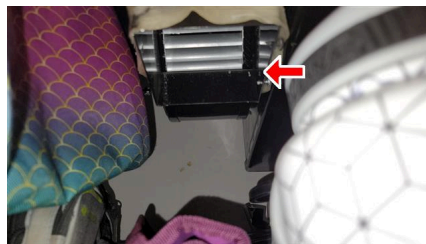
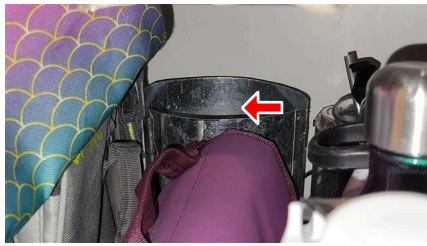
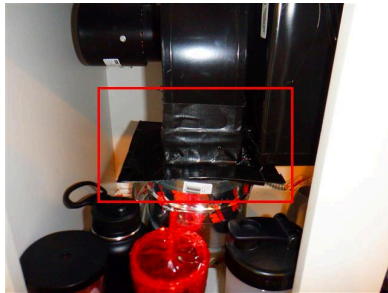
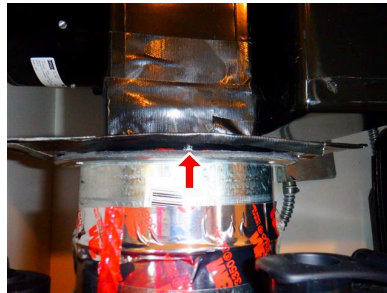
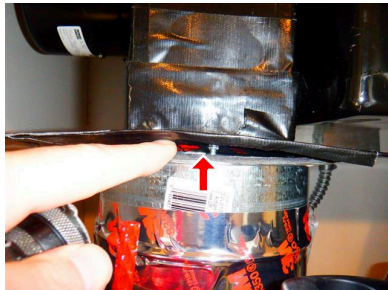
1. The downdraft fan vents into the cabinet and should vent to the outside. This is a fire hazard. I recommend repair or replace as needed.

Re-inspected 12/18/2023 The repairs do NOT appear to be adequate. The repair is either incomplete or has not been done according to standard workmanlike practice. It is recommended after a proper repair is performed that you obtain a copy of the repair contract from the seller(s). Our company does not guarantee repairs from contractors. We only re-inspect to determine whether or not repairs were performed.

I recommend contacting appliance repair company.
