# Summary Only

**Property Address:**  
1022 Kenilworth Ct NW  
Concord NC

**Carolinas Home Inspections, LLC**  
**Bill Boan NC HILB 2981**  
**108 Bridgeport Dr**  
**Mooresville, NC 28117**

## SUMMARY

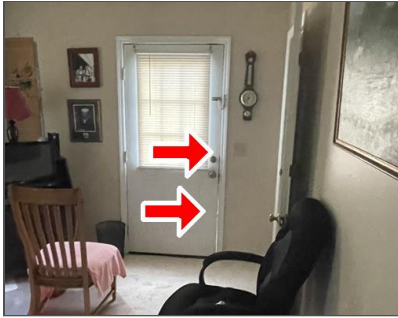
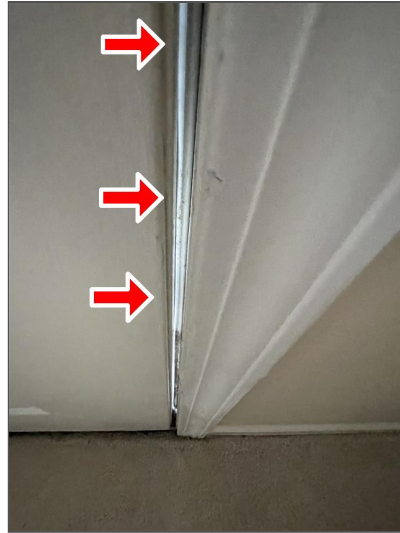
At rear basement exterior door, daylight was visible at the weatherstripping on the side of the door. This can produce drafts. The weatherstripping needs to be "enlarged" at this side of the door to prevent drafts. Recommend repair.

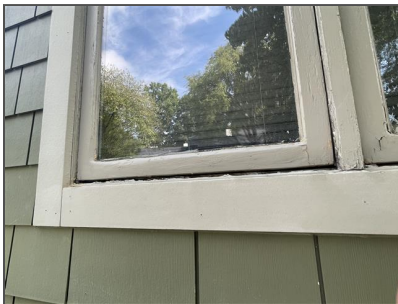
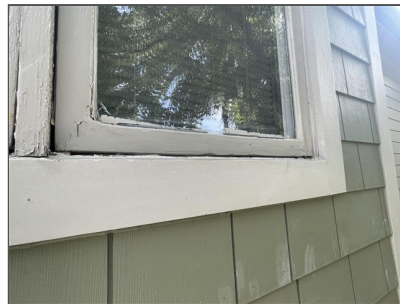
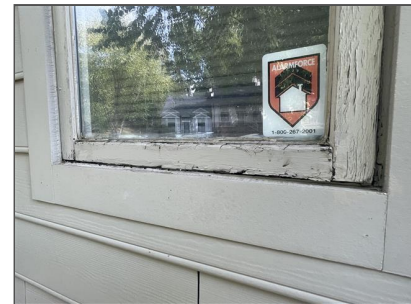
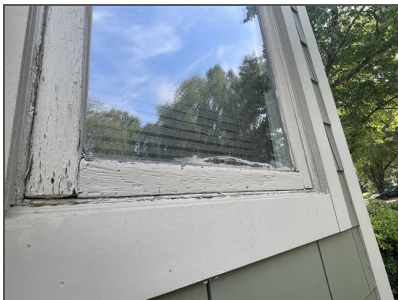
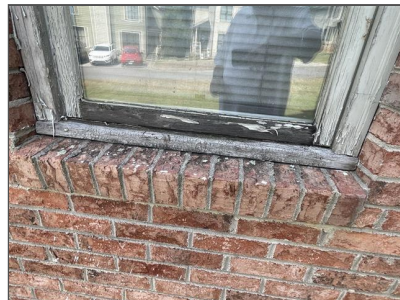
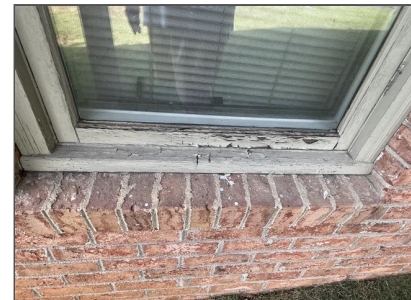
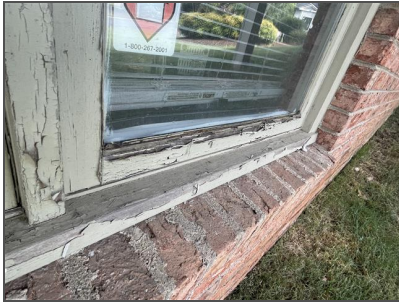
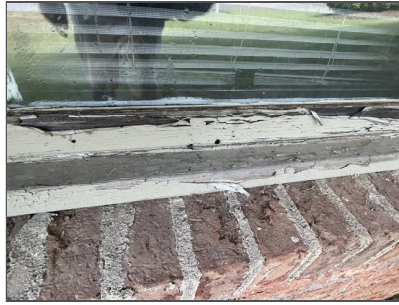
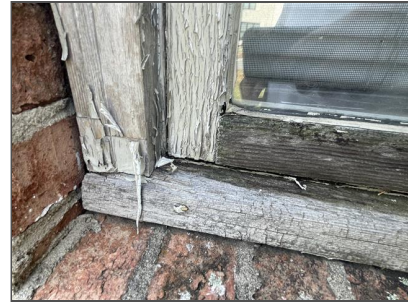
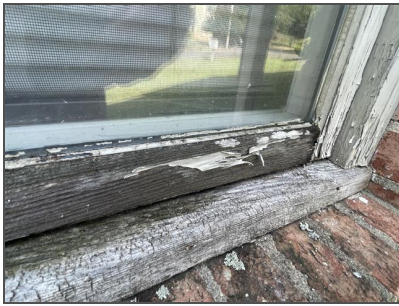
Many of exterior casement window bottom stiles are in need of repair or are near to rotting. Some have been repaired with wood hardener, many have not. I operated some of the windows from the inside, but there were some I did not operate due to fear that operating them may further damage the bottom stiles. Repair or replacement of windows is needed.

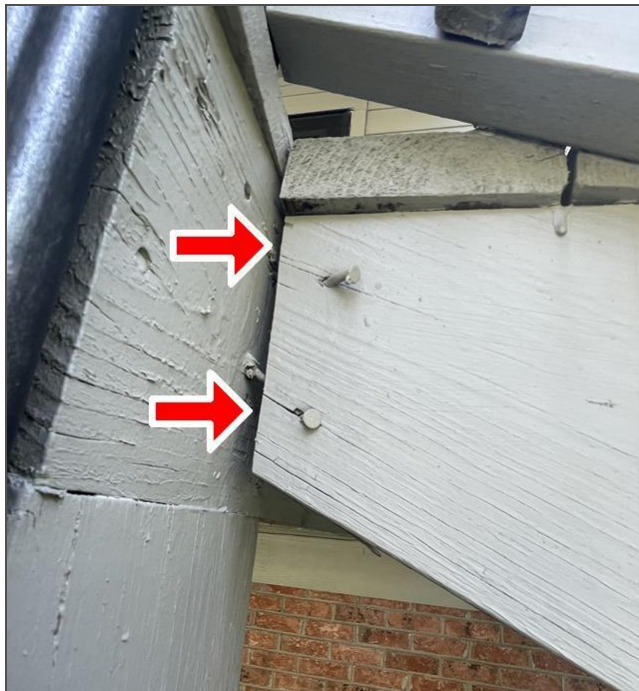
A) - where the stairs stringers attach to the deck structure at the top of the stairs, the stringers are pulling away where they are nailed to the side of the deck structure. These stair stringers should have joist hangers or mechanical steel plates added to ensure the stairs stringers do not pull away from the deck structure.

2.3 Item 2 (Picture) stair stinger connection to side of deck

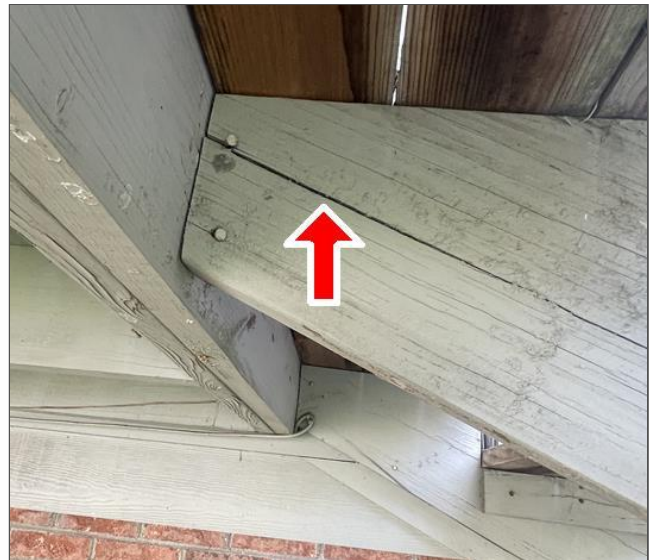
B) - the middle stair stringer is cracked near where it connects to the side of the deck. A joist hanger (mentioned above) will help to prevent this from further cracking)

2.3 Item 3 (Picture) middle stair stringer cracked

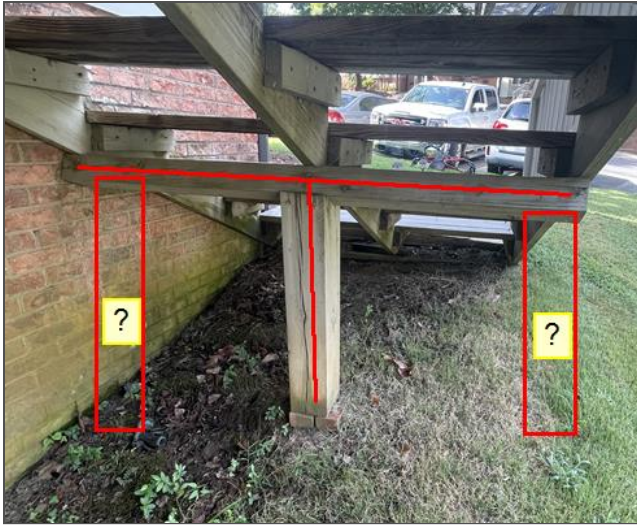
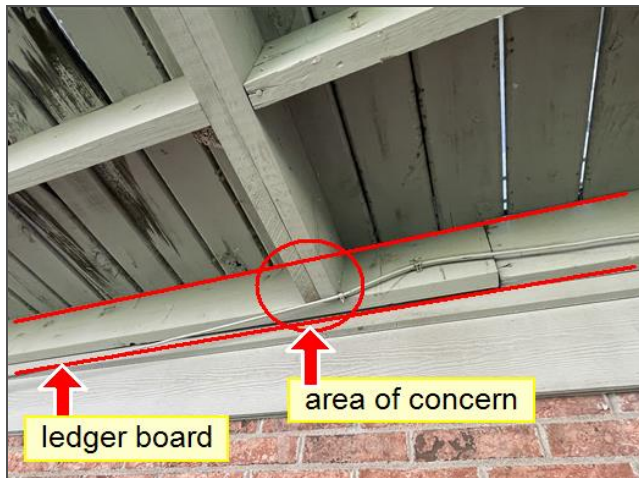
(2) At the side deck structure, the deck structure was built using methods approved at the time of the build. It is likely that most all condo units have the same building method to each deck. I noted no rotten boards or structure issues which require "immediate" attention. However, there are some safety features which could be added to ensure long-term structural stability for occupant safety.

E) - at the deck ledger board which runs parallel to the exterior wall of unit, the ledger board was applied over the siding, and there is no indication that this ledger board was properly fastened to the exterior frame of the wall using bolts. Due to this, the area of the ledger board where the double joists are located (shown in picture 9) may not be fully supported. Even if joists hangers are applied at the double joists (at red circle in picture), the ledger board which "carries the weight" of the double joists does not appear to be bolted to the house (only nailed). Further evaluation should be done at this area

You will need to address this with the HOA, which may (or may not) agree with my safety suggestions. ..

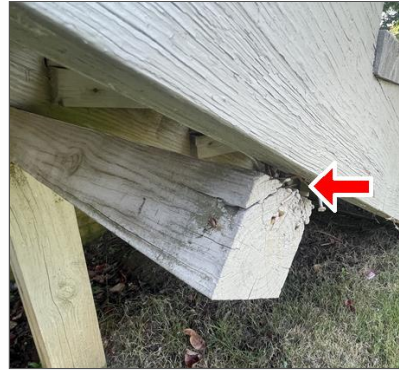
C) - under the deck stairs, there is a singular post with a 4x4 placed laterally on top of it. This is to provide vertical and horizontal stability to each of the stair stringers to prevent the stairs from shaking while transversing them.. There are no side posts under the lateral 4x4 (i.e, there is no support on open side of stairs if the side stair stringer needs it)

2.3 Item 5 (Picture) end of lateral 4x4 not touching the stairs stringer (no support)

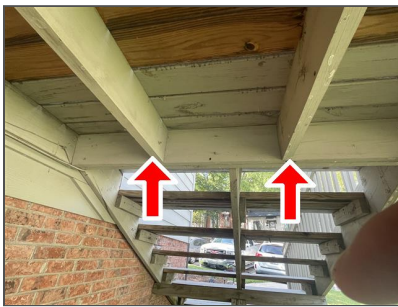
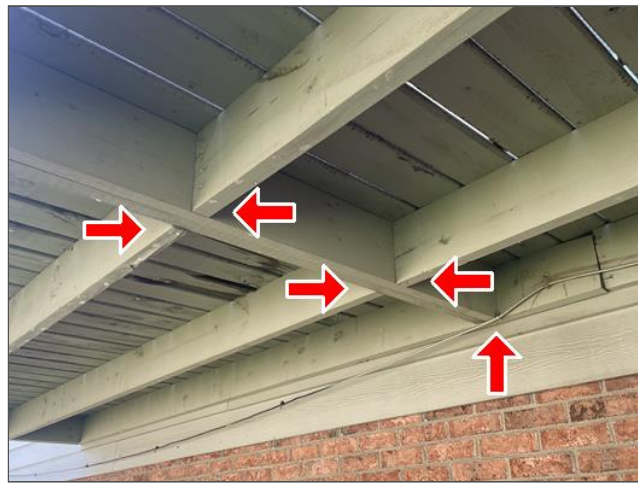
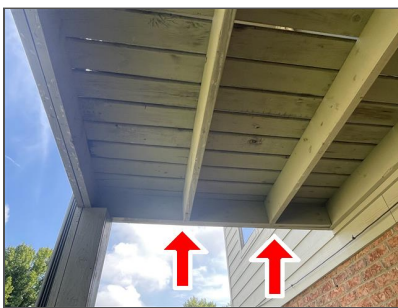
D) - all deck joists should have joist hangers applied for safety

2.3 Item 6 (Picture) joist hangers would help to provide a higher level of structural safety

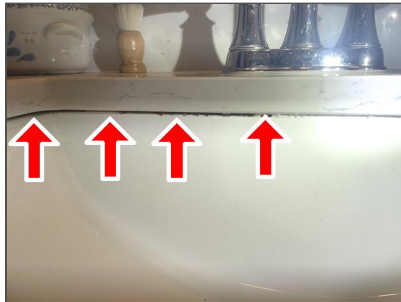
5.1 Item 1 (Picture)

(1) At master bath sink, the sink bowl needs to have caulking applied in certain areas where the sink bowl intersects the underside of the countertop. There appears to be "void" (gap) in various areas.

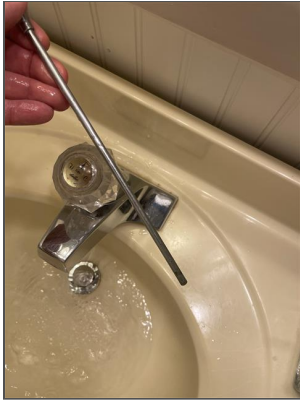
5.1 Item 2 (Picture)

(2) The basement vanity sink drain stop rod is not connected to the drain stop. Recommend repair.

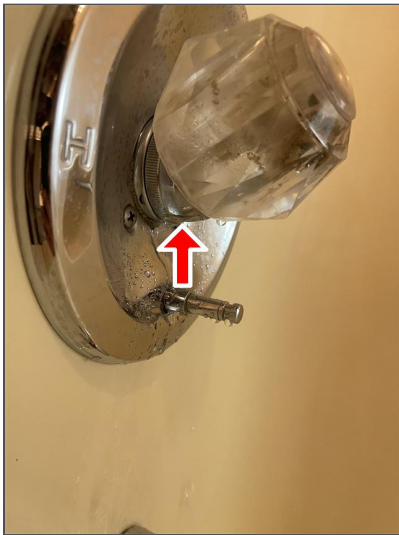
5.1 Item 3 (Picture)

(3) At basement bath, there was a minor leak coming from the valve handle to the bathtub. It stopped shortly after it started. This appears to be intermittent. Repair or replace if desired.

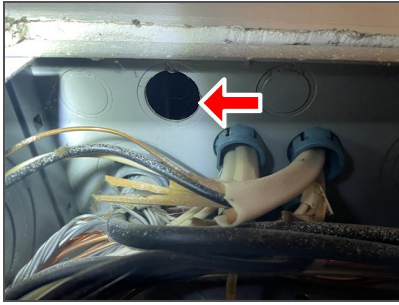
Inside the electrical panel, the knock-out hole at the top of the panel needs to be covered with knock-out plate, and at the bottom of the panel, the service entrance cables from the meter need to have a bushing installed (the bushing is meant to protect the electrical cable insulation from chaffing against the metal of the box). Recommend repair by electrician if/when they are on site for other issues noted in this section.

6.1 Item 1 (Picture) hole at top

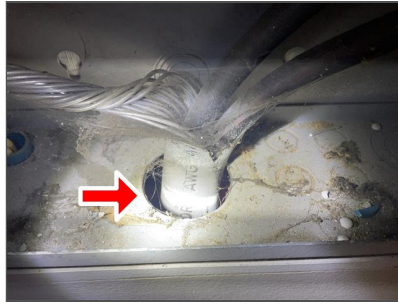
6.1 Item 2 (Picture) bushing  
needed at service entrance  
cables at bottom of panel

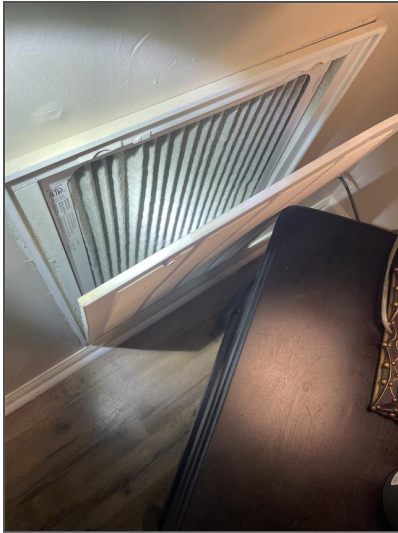
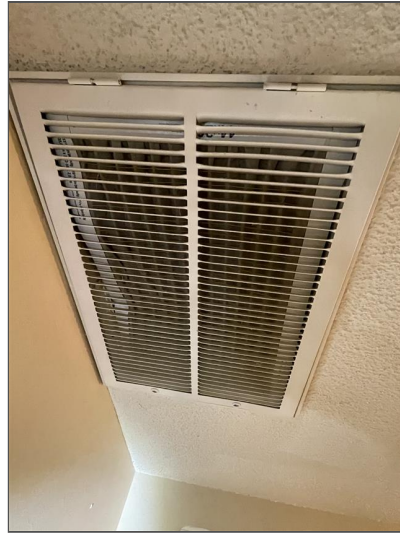
(1) All air filters need replacement (1 on main floor and 1 at basement ceiling)

7.3 Item 1 (Picture) main floor

7.3 Item 2 (Picture) basement ceiling

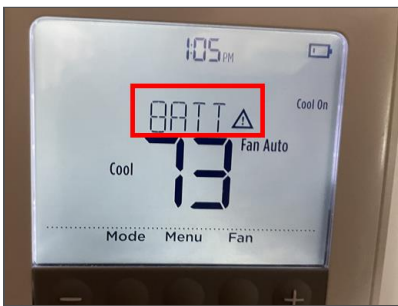
7.3 Item 3 (Picture)

(2) Battery needs to be replaced in the digital thermostat.

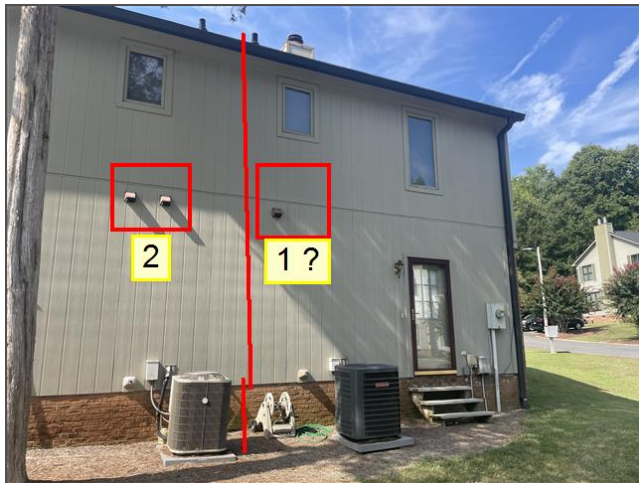
8.3 Item 1 (Picture)

At basement bathroom, it is an interior bathroom (no window) and does not have an exhaust fan installed. This is unusual, as bathrooms which include a shower (but no window) typically have been required to have fans for decades. There could be several reasons for this. 1) This issue may go back to the original build, and it was just never installed. 2) There may be a fan pipe in the ceiling, but the light in the bathroom did not have a fan installed. If this is the case, the light can simply be switched out for a fan/light, BUT there was only 1 vent termination noted at the rear of home, and the adjacent unit appears to have 2 vents at the exterior. The vent termination at the exterior rear wall may have been covered up with newer siding, and the termination vent at the rear wall would need to be relocated to properly vent to the exterior. (Seller stated that there was no fan when they bought it)

8.3 Item 2 (Picture) light in basement bath - no fan noted

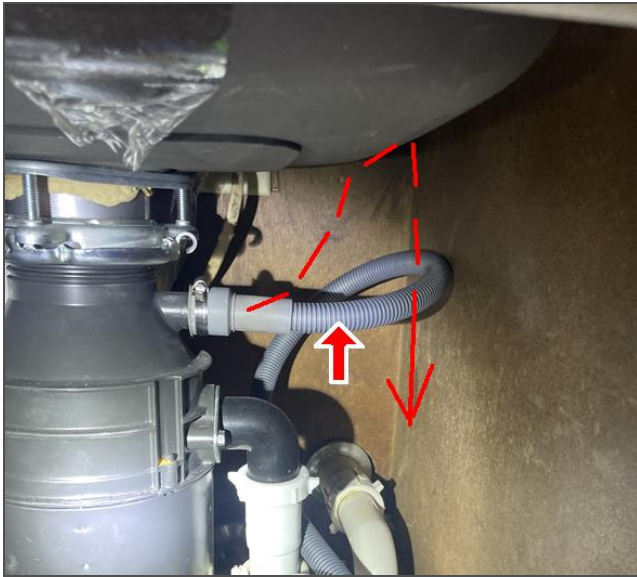
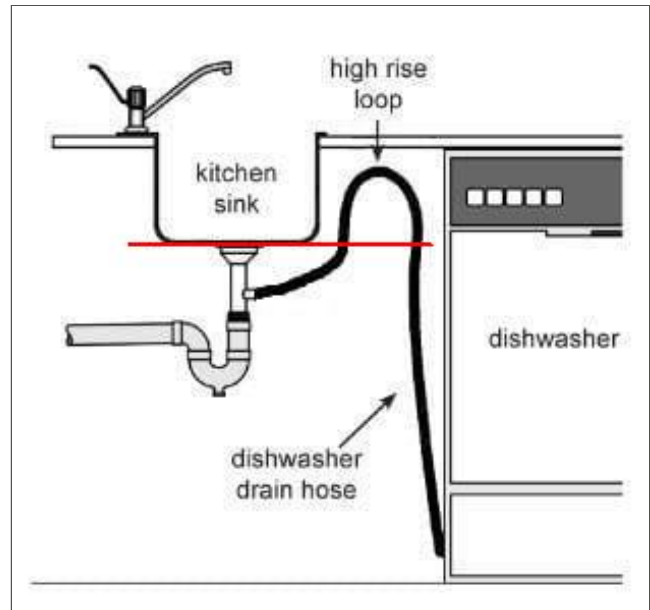
The dishwasher drain hose under the sink which attaches to the disposal needs to be elevated to a height just above the bottom of the sink and attached to the backside cabinet wall with a metal strap. This is called a "high loop" and it prevents water from the disposal from draining back into the dishwasher basin. This is a minor repair.

The dishwasher drain hose was not installed as to create a trap under sink.(known as a "high loop" ) The high loop prevents grey water and debris from disposal from running back to the dishwasher drain basin. Grey water which sits in the dishwasher basin can create mildew and foul smells inside the dishwasher. Repair recommended.
