# INSPECTION

1135 Brook Path Trail  
Denver Street NC 28037  
City St Zip

5-23-25

# WELL HEAD INSPECTION REPORT

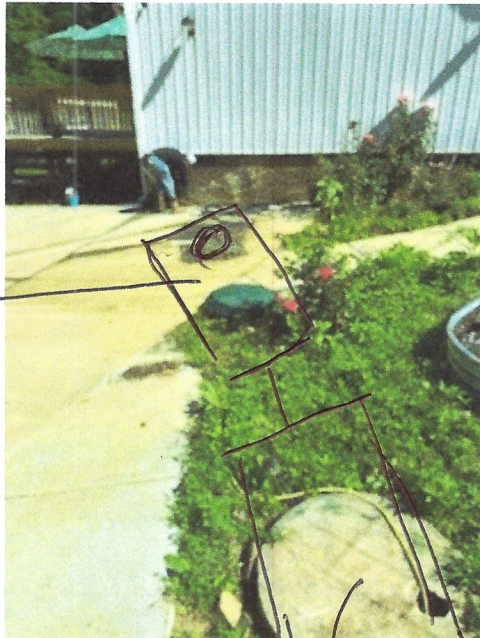
Septic Tank  
Location

Concrete drive was built over septic tank

This system is working but has many issues. #1 Concrete Drive over tank. #2- Non Code wiring of septic pump - Using Drop cord. #3 Pump tank Riser is Not Code. #4- Should install Riser on Inlet side of Septic tank. #5- Repair high water Alarm.

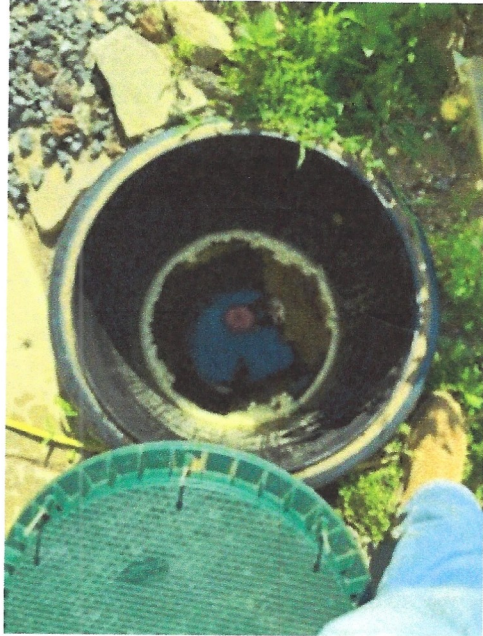
pump tank

☒ Other: Concrete riser with 4" hole

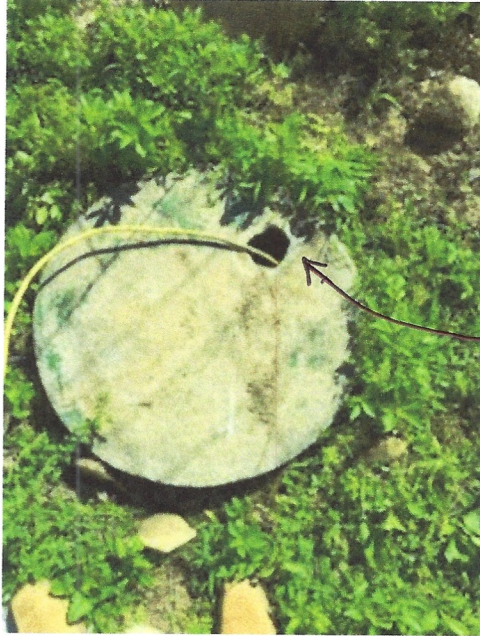
Outlet side of septic tank with a  
pvc outlet Tee and Filter

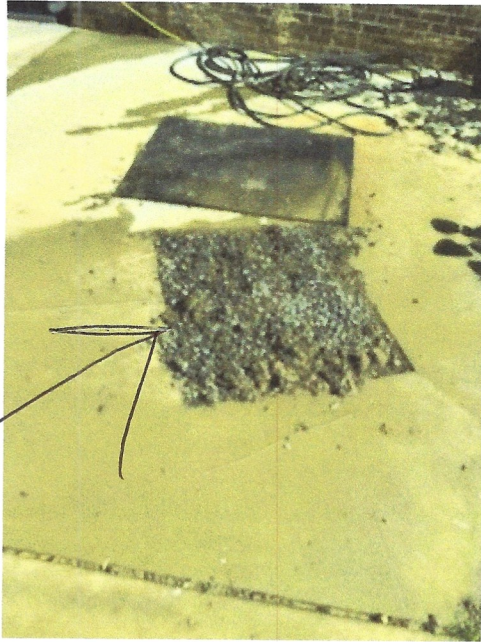
Pump wired to house with plug

4" hole with  
Drop cord entering  
pump tank

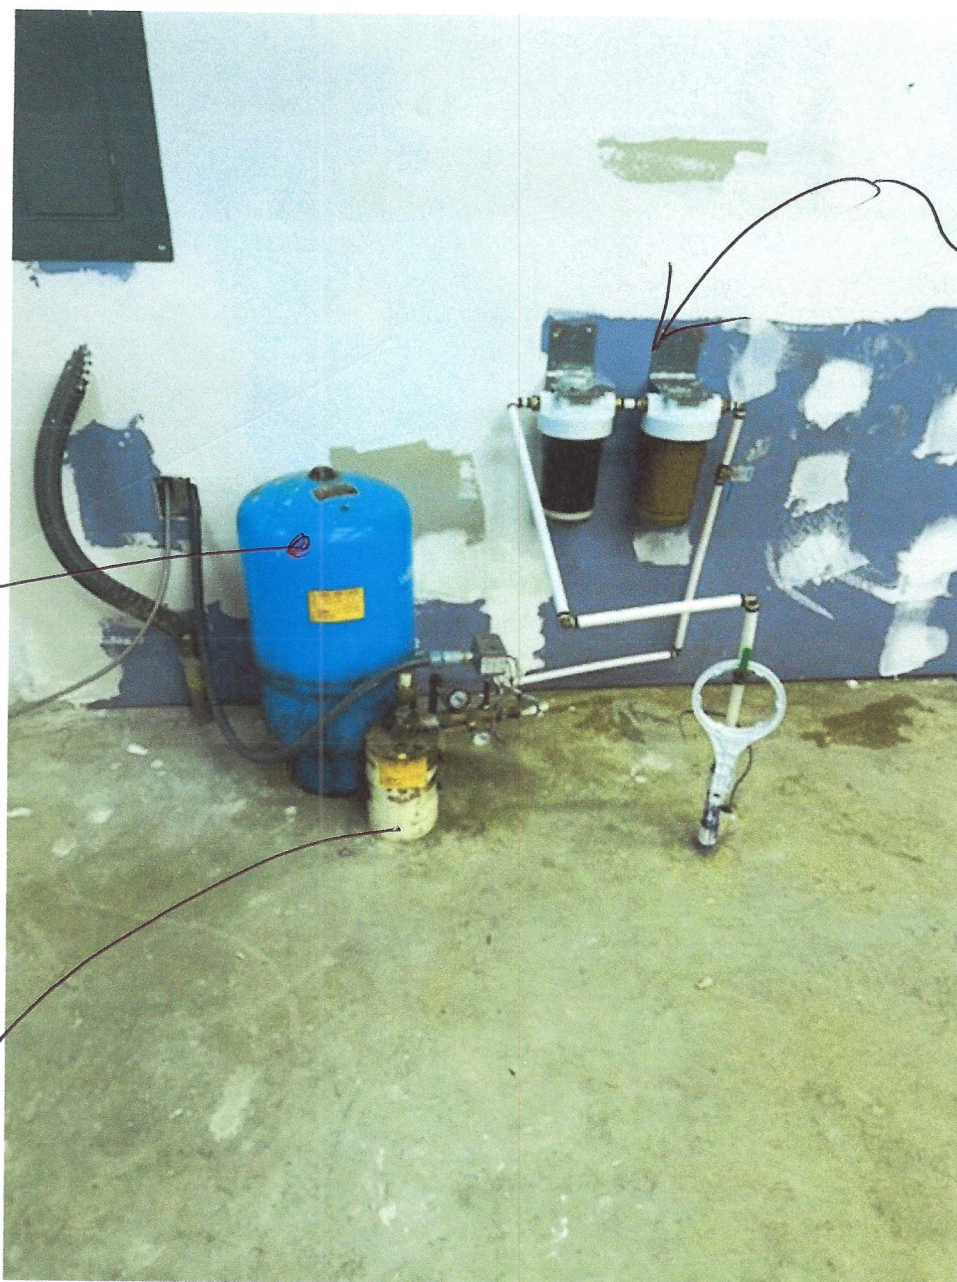
| Comments or Repairs Needed: <i>The well is functioning properly - A garage has been built over the existing well - Code is a 25' setback from a well and any structure. This well does not meet code unless</i> | | | | | | | | | | | | | | | |

Bladder  
Tank

Cartridge  
Filters

6 1/4" Drilled Well
