RE: Inspection Report for 113 Ivy Hollow Ln Mooresville NC 28117

Inspection Date/Time: **04-28-2023 / 8:26 AM**

System Type: LCPM-2/8

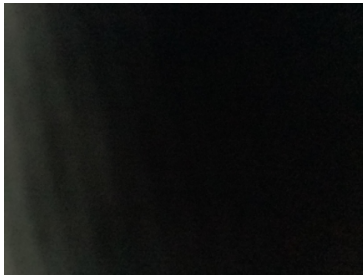
Beginning inspection with dirty filter

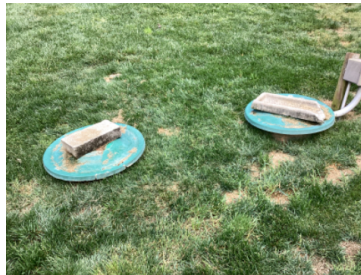
Ending Inspection

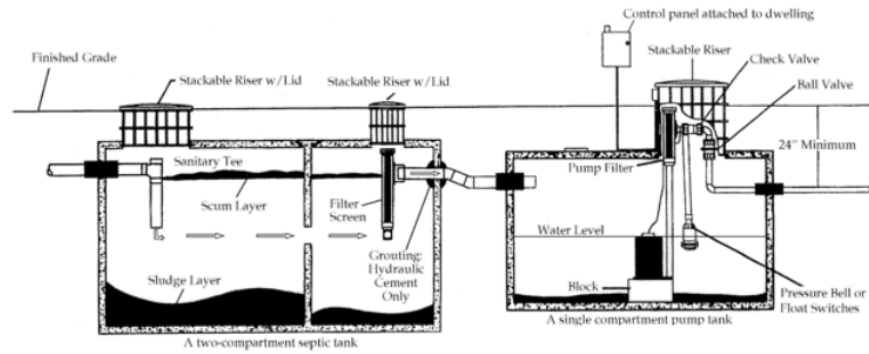
System not evaluated due to no response from homeowner

Inlet Sludge Level and Clean Filter

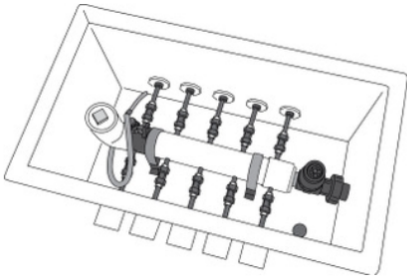
Pressure Manifold Assembly

| Inspection Results: | No action needed | | Is the vault is in good condition? | Marginal |
| | | | Are the valves and pipes in good condition? | Marginal |

Notes:  
Monitoring manifold lid. Vault was full of rain water at today's inspection so we could not see if the valve was still leaking. Will monitor for now
