INSPECTION REPORT  
726 Sunnywood Rd  
York SC 29745

INSPECTION DATE  
📅 9/18/2025  
Home Inspection  
Carolina

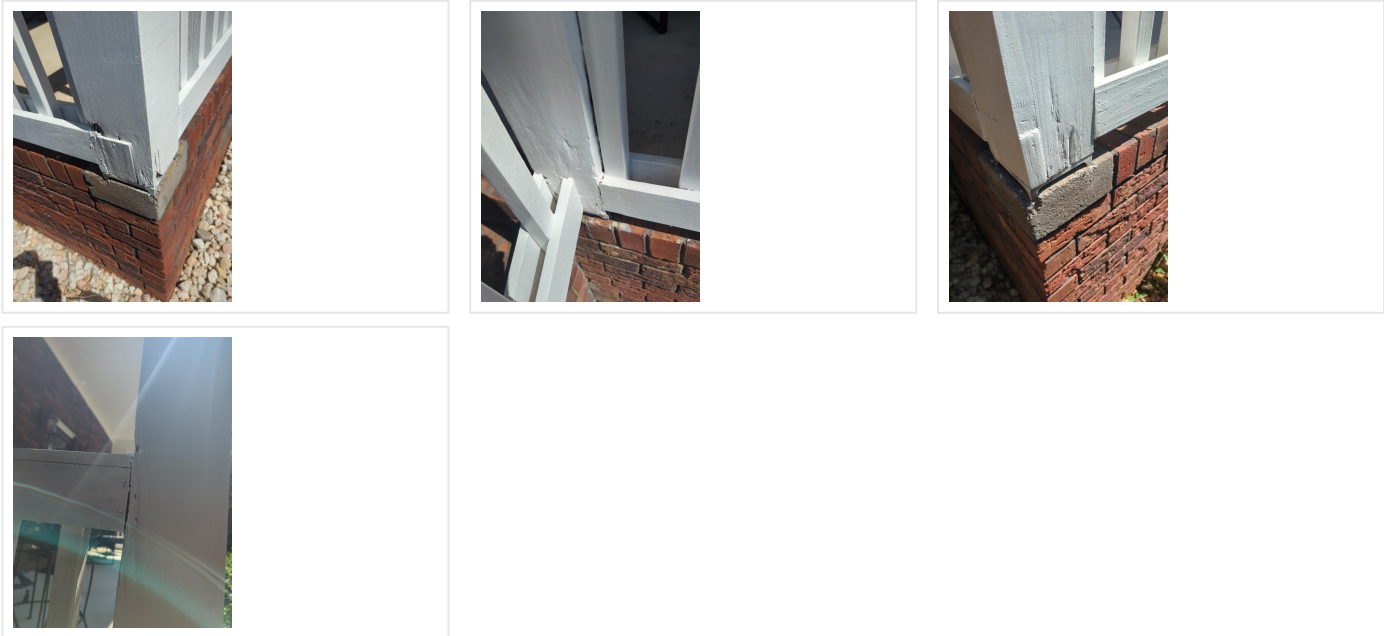
(1) **There are several posts on the front porch that are rotted.** Repair/replacement is needed to prevent further damage and to ensure the roof structure is properly supported.

Consult with a qualified licensed contractor to evaluate the area(s) of concern and make any additional repairs as deemed necessary during their evaluation.

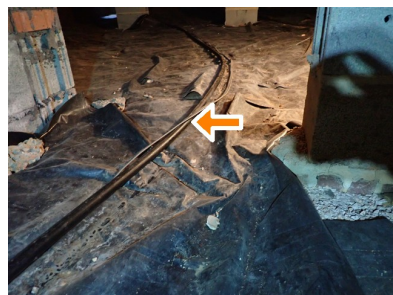
**(3) The water supply pipes are not supported properly in the crawl space and need corrections to prevent possible damage to the water lines.**

Consult with a qualified licensed contractor to fully understand the extent of the repairs needed and determine if corrective actions are required.

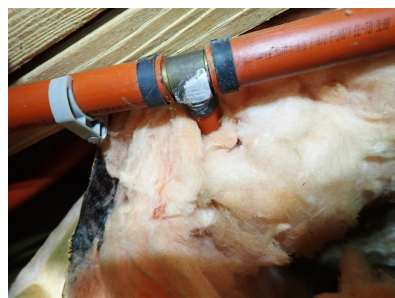
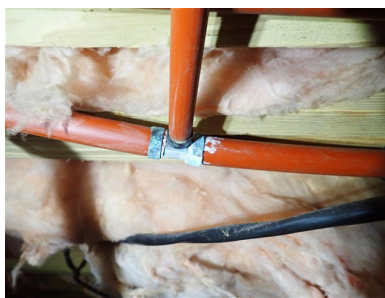
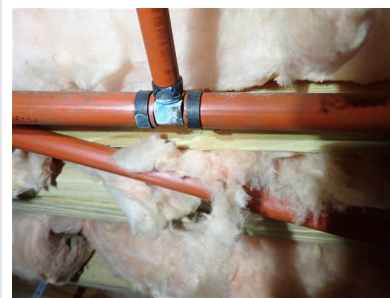
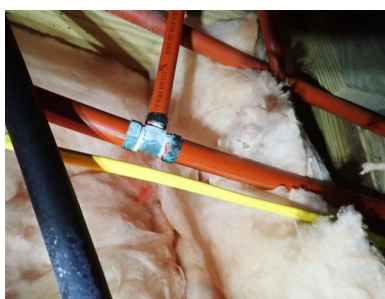
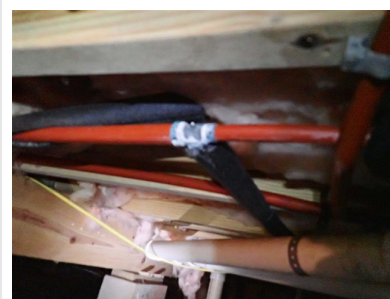
(4) The visible plumbing lines in this home are plastic PEX with brass metal fittings. Evidence of fitting deterioration was noted during the inspection in a few/several locations. The deterioration could be the result of a known problem referred to as “dezincification”. Dezincification occurs when brass fittings that are considered a high-zinc copper alloy are exposed to water and the zinc is leached from the fitting or component leaving the fitting in a weakened state. This process also leads to a build-up inside the fitting, restricting water flow and ultimately leaving the plumbing system prone to breakage and leaking. A licensed plumbing contractor should be consulted for a complete evaluation of the plumbing system to determine the general condition of the plumbing distribution and supply lines, the significance of this concern, and make necessary repairs.

Consult with a qualified licensed contractor to fully understand the extent of the repairs needed and determine if corrective actions are required.

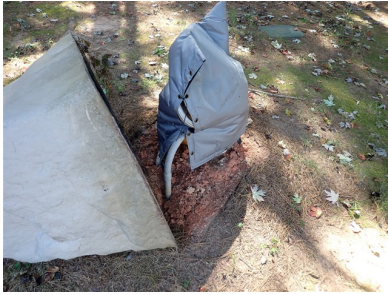
The property has a well. The well and functioning system of the well, is outside the scope of a home inspection. It is recommended that you have a qualified licensed contractor inspect the well and pump house and a water test to evaluate the quality of the water.

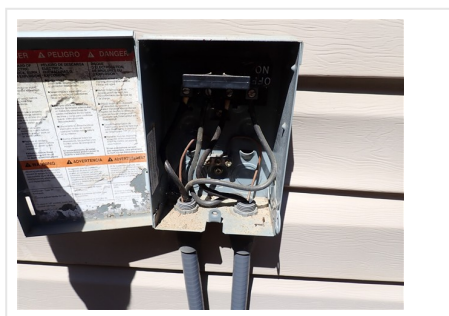
**The interior cover for the HVAC disconnect panel is missing and needs to be replaced for safety.**

Consult a qualified licensed contractor to assess the areas of concern and perform any additional repairs deemed necessary during their evaluation.

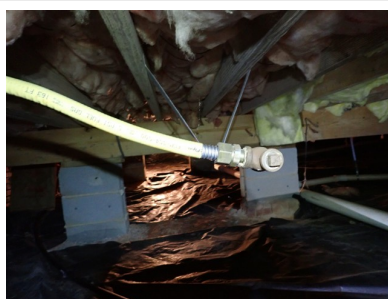
**b. There is CSST (corrugated stainless steel tubing) noted within the crawl space that was found to have the stainless steel areas exposed near the fittings.** The exposed stainless steel needs to be sealed or covered with the proper and/or approved tape to prevent corrosion and/or rusting.

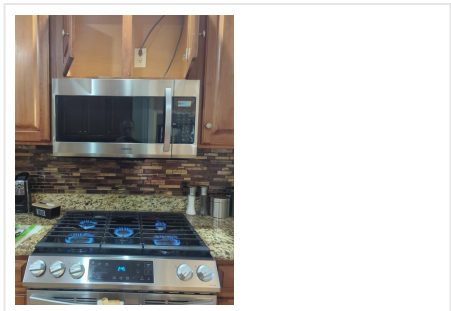
**The microwave installed has an internal vent installed with a gas cooktop/range installed below it.** It is never a good idea to have a re-circulating exhaust fan, especially when you have a gas cooktop/range below it. There may be affects of long term exposure to even low levels of CO levels. Though not required, many manufacturers require external venting with gas appliances. Manufacturer requirements supersede all residential code. Have the seller provide information from the manufacturer stating that it is ok for this type of gas appliance to vent indoors to ensure safety.

Consult with a qualified licensed contractor to evaluate the area(s) of concern and make any additional repairs as deemed necessary during their evaluation.

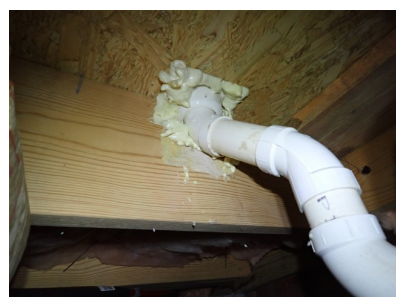
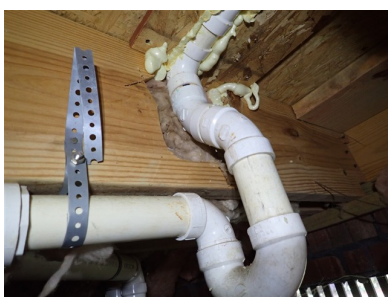
(1) **A cut or modifications were observed at the floor joist under the primary bathroom for the plumbing waste line.** The modifications made may have compromised the structural integrity of the floor joist. Additional support may be required depending on the extent of the cut to prevent structural movement..

Consult with a qualified licensed contractor to evaluate the area(s) of concern and make any additional repairs as deemed necessary during their evaluation.

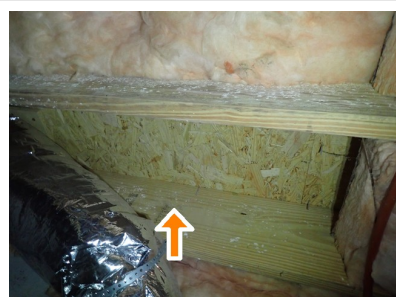
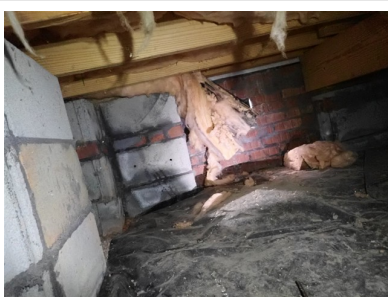
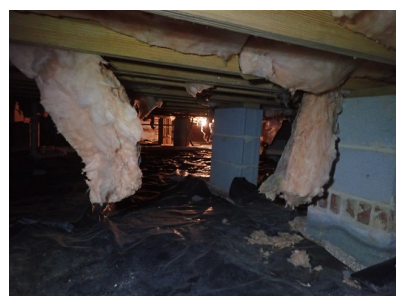
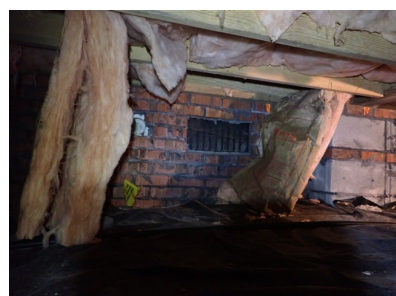
(2) **Insulation was noted to be missing, falling, fallen and/or is drooping within the crawl space area.** The insulation needs to be re-installed and/or supported properly. Note: Where it has touched the ground and become damaged needs to be replaced. Not all areas of concern are pictured.

Consult with a qualified licensed contractor to evaluate the area(s) of concern and make any additional repairs as deemed necessary during their evaluation.

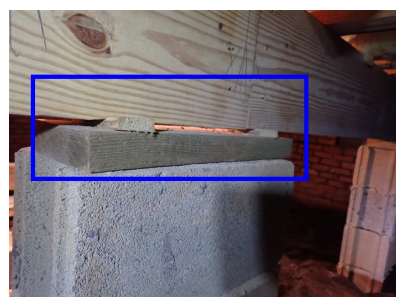
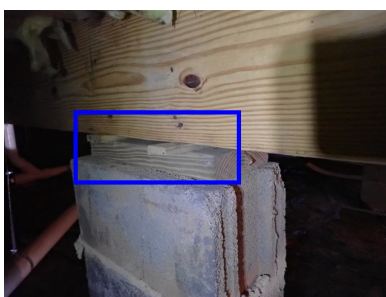
(3) The girders are currently shimmed with "wedge shims" and should be properly shimmed to properly support the girders, as "wedge shims" are known to be unstable. Not all areas of concern are pictured.

Consult with a qualified licensed contractor to evaluate the area(s) of concern and make any additional repairs as deemed necessary during their evaluation.

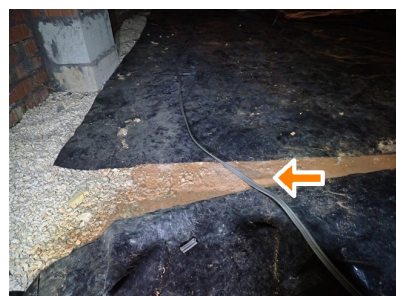
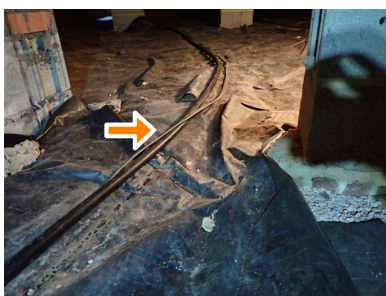
(4) There is an electrical wire lying on the ground in the crawl space at the rear side. The wiring needs to be properly secured along the bottom of the floor joists to prevent a possible hazard.

Consult with a qualified licensed contractor to evaluate the area(s) of concern and make any additional repairs as deemed necessary during their evaluation.

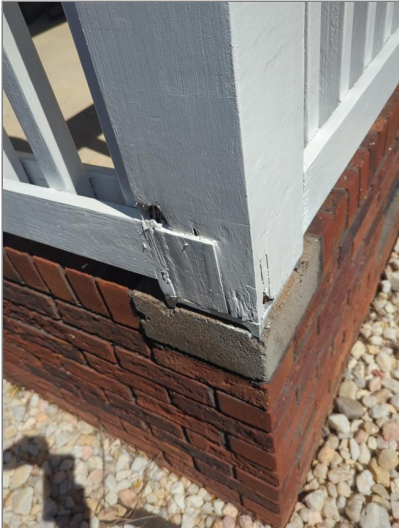
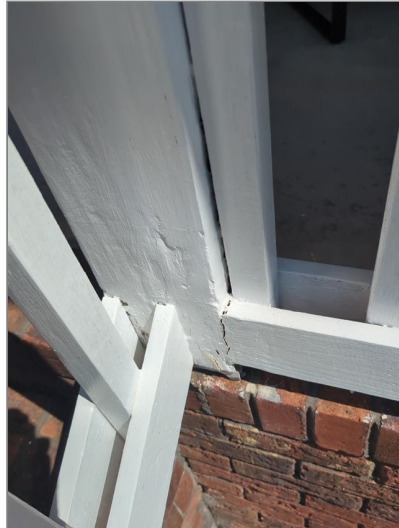
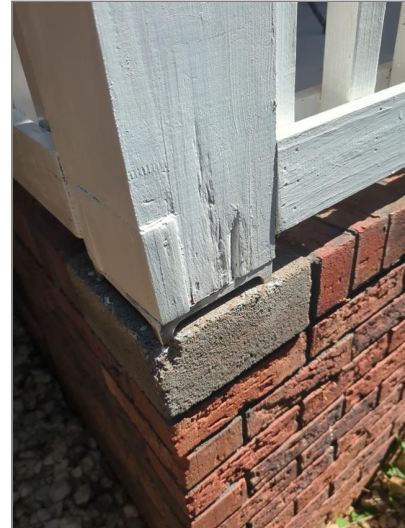
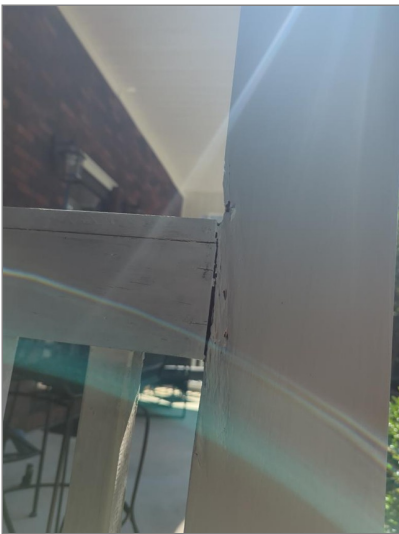
1. (1) **There are several posts on the front porch that are rotted.** Repair/replacement is needed to prevent further damage and to ensure the roof structure is properly supported.

Consult with a qualified licensed contractor to evaluate the area(s) of concern and make any additional repairs as deemed necessary during their evaluation.

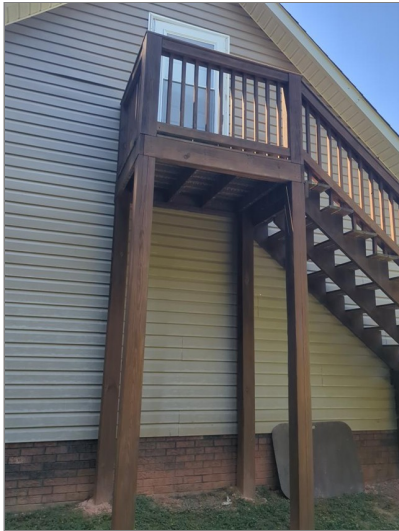
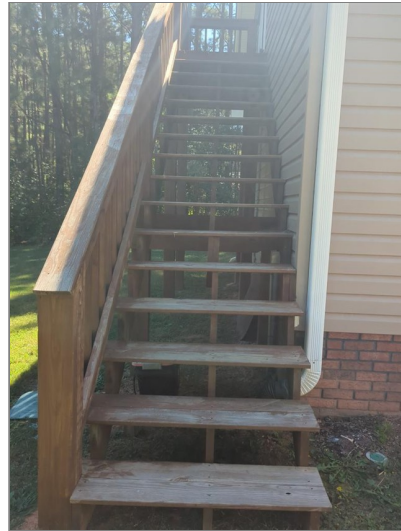
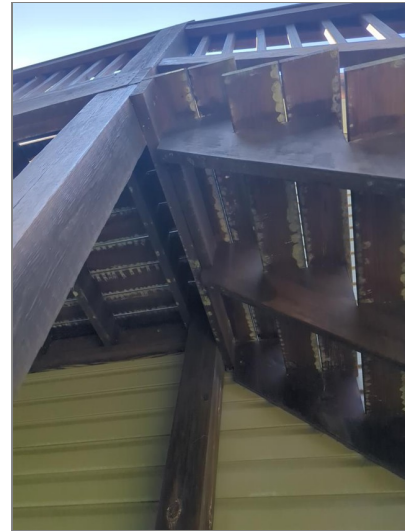
**a, Due to the height of the deck, cross bracing is needed.** Cross bracing provides stability and support to deck preventing possible movement or swaying.

**c. The stair stringers are not secured by any ledger or joist hanger.** A ledger or joist hanger gives the joist additional support, also preventing it from twisting or moving. A ledger or joist hanger needs to be installed to provide proper support and stability.

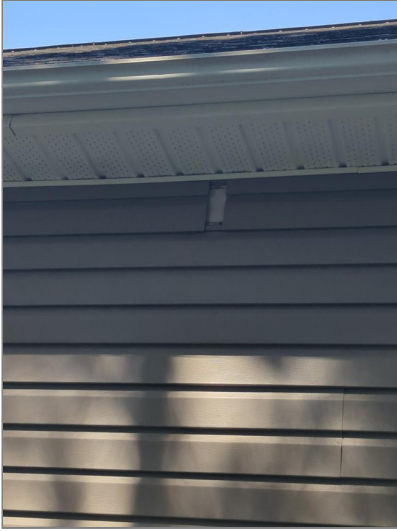
Right side of garage

**There is a gap in the siding on the right side of the garage.** Repair is needed to prevent wind and water damage.

Consult with a qualified licensed contractor to evaluate the area(s) of concern and make any additional repairs as deemed necessary during their evaluation.

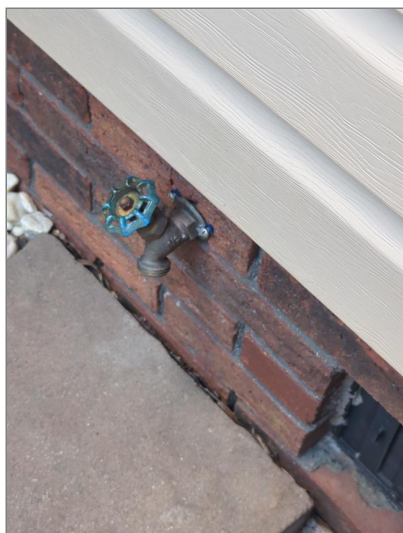
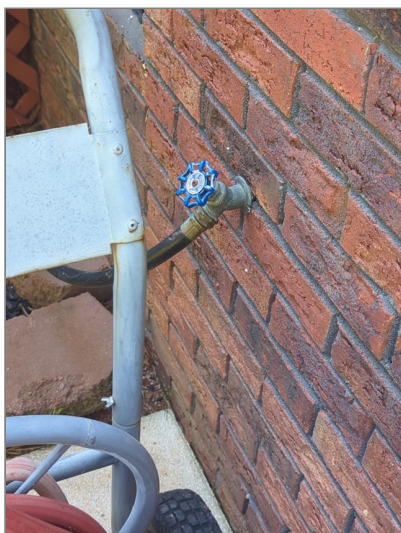
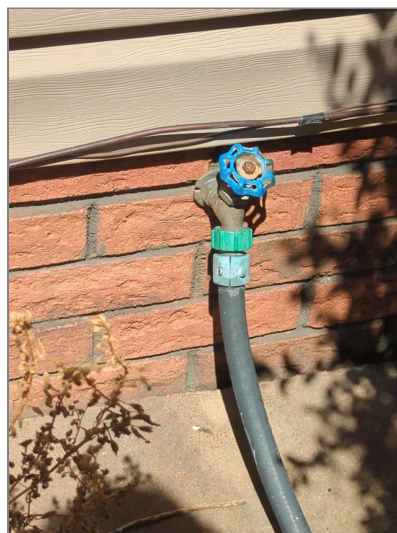
6. (1) **There are not any anti-backflow preventer valves installed at the exterior hose faucets.** Backflow preventer valves are required to prevent cross-contamination between water supply sources.

Consult with a qualified licensed contractor to fully understand the extent of the repairs needed and determine if corrective actions are required.

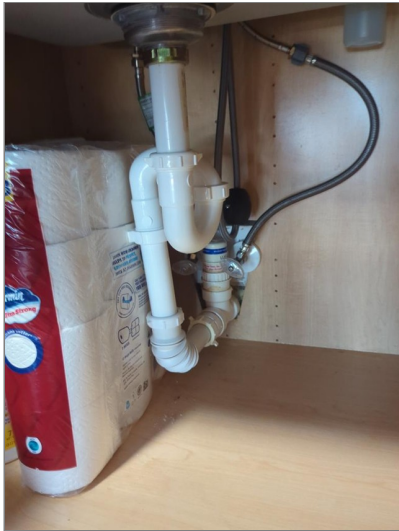
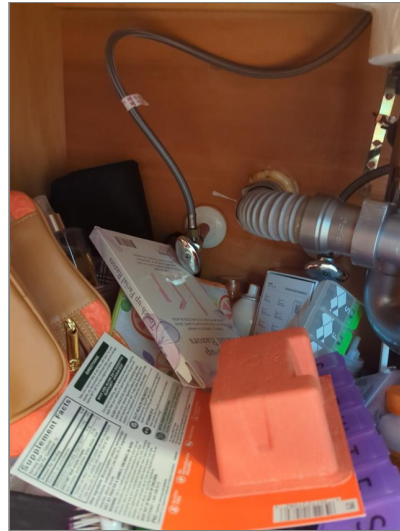
primary bathroom

**a. The drain line utilizes a flexible style pipe under the media room sink and primary sinks.** Although the line appeared to be clear at the time of inspection, these lines tend to clog easily. Continue to monitor and make any future repairs as necessary.

**b. There was an improper drain trap that needs to be corrected and/or repaired properly under the media room sink.** The drain trap is designed to hold water to prevent sewage gases from coming up the pipe and entering the home. The current "S" trap design under the sink will pull water out of the trap when draining, allowing sewage gases to enter the home.

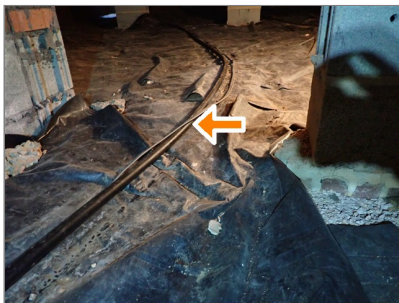
9. (4) The visible plumbing lines in this home are plastic PEX with brass metal fittings. Evidence of fitting deterioration was noted during the inspection in a few/several locations. The deterioration could be the result of a known problem referred to as "dezincification". Dezincification occurs when brass fittings that are considered a high-zinc copper alloy are exposed to water and the zinc is leached from the fitting or component leaving the fitting in a weakened state. This process also leads to a build-up inside the fitting, restricting water flow and ultimately leaving the plumbing system prone to breakage and leaking. A licensed plumbing contractor should be consulted for a complete evaluation of the plumbing system to determine the general condition of the plumbing distribution and supply lines, the significance of this concern, and make necessary repairs.

Consult with a qualified licensed contractor to fully understand the extent of the repairs needed and determine if corrective actions are required.

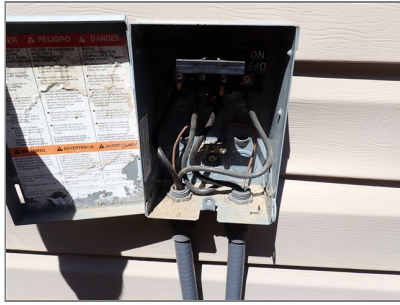
12. **The interior cover for the HVAC disconnect panel is missing and needs to be replaced for safety.**

Consult a qualified licensed contractor to assess the areas of concern and perform any additional repairs deemed necessary during their evaluation.

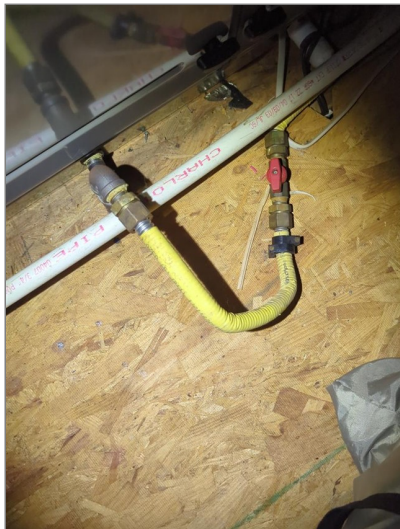
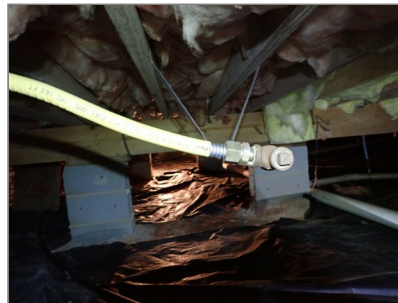
- a. **The gas piping in this house includes corrugated stainless steel tubing (CSST). There is not an electrical bonding connection between the gas piping system and the electrical system**, other than connections at the gas appliances that utilize the grounding conductors for the appliances. The lack of strong electrical bonding may increase the potential for lightning strikes to cause arcing at the CSST gas piping that may result in perforation of the piping, gas leaks, and fires.

- b. **There is CSST (corrugated stainless steel tubing) noted within the crawl space that was found to have the stainless steel areas exposed near the fittings.** The exposed stainless steel needs to be sealed or covered with the proper and/or approved tape to prevent corrosion and/or rusting.

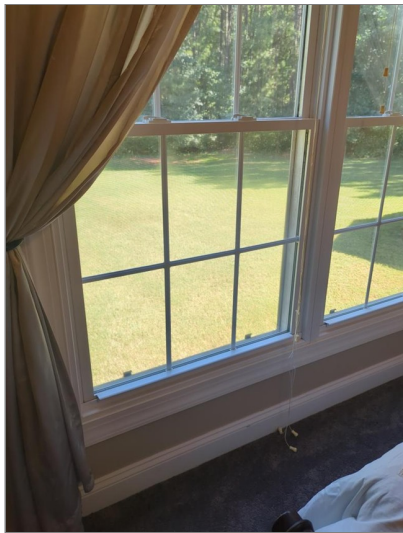
Right rear bedroom

16. (1) **The following window and/or sashes were found to have a bad or broken thermal seal.** When a bad or broken thermal seal is found, it is possible there may be more that cannot be found at the time of inspection. Because of this it is recommended that all windows be evaluated to prevent heating and air loss. right rear bedroom

Consult with a qualified licensed contractor to evaluate the area(s) of concern and make any additional repairs as deemed necessary during their evaluation.

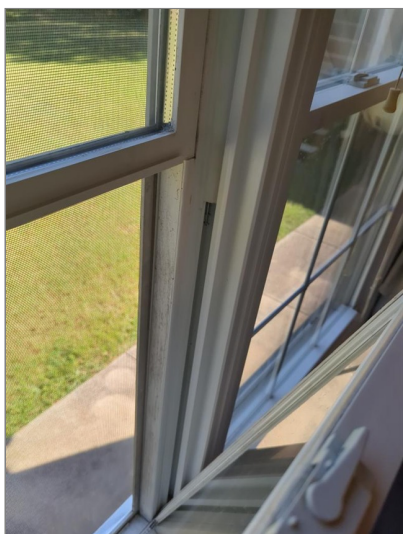
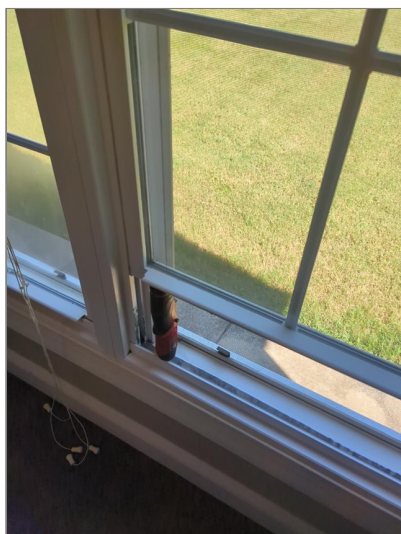
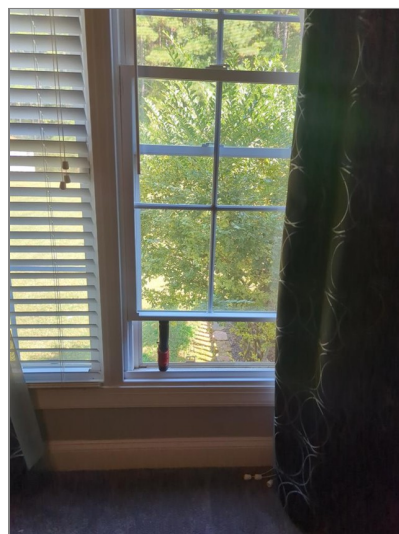
17. (2) **The following window(s) have a bad reverse tension spring(s) or weights.** This prevents the window from staying up when opening. If the spring or rope is bad, the window will slide back down when operating. Corrections and/or repairs are needed so the windows will stay up or function properly: right rear bedroom, primary bedroom, family room

Consult with a qualified licensed contractor to evaluate the area(s) of concern and make any additional repairs as deemed necessary during their evaluation.

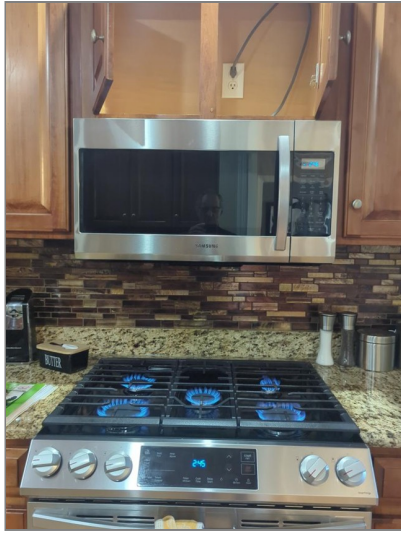
19. **The microwave installed has an internal vent installed with a gas cooktop/range installed below it.** It is never a good idea to have a re-circulating exhaust fan, especially when you have a gas cooktop/range below it. There may be affects of long term exposure to even low levels of CO levels. Though not required, many manufacturers require external venting with gas appliances. Manufacturer requirements supersede all residential code. Have the seller provide information from the manufacturer stating that it is ok for this type of gas appliance to vent indoors to ensure safety.

Consult with a qualified licensed contractor to evaluate the area(s) of concern and make any additional repairs as deemed necessary during their evaluation.

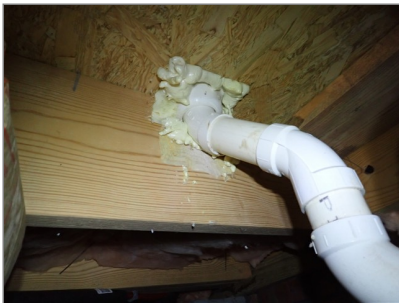
20. (1) **A cut or modifications were observed at the floor joist under the primary bathroom for the plumbing waste line.** The modifications made may have compromised the structural integrity of the floor joist. Additional support may be required depending on the extent of the cut to prevent structural movement..

Consult with a qualified licensed contractor to evaluate the area(s) of concern and make any additional repairs as deemed necessary during their evaluation.

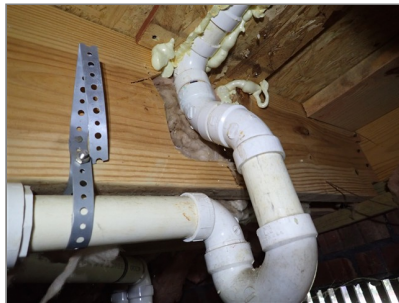
21. (2) **Insulation was noted to be missing, falling, fallen and/or is drooping within the crawl space area.** The insulation needs to be re-installed and/or supported properly. Note: Where it has touched the ground and become damaged needs to be replaced. Not all areas of concern are pictured.

Consult with a qualified licensed contractor to evaluate the area(s) of concern and make any additional repairs as deemed necessary during their evaluation.

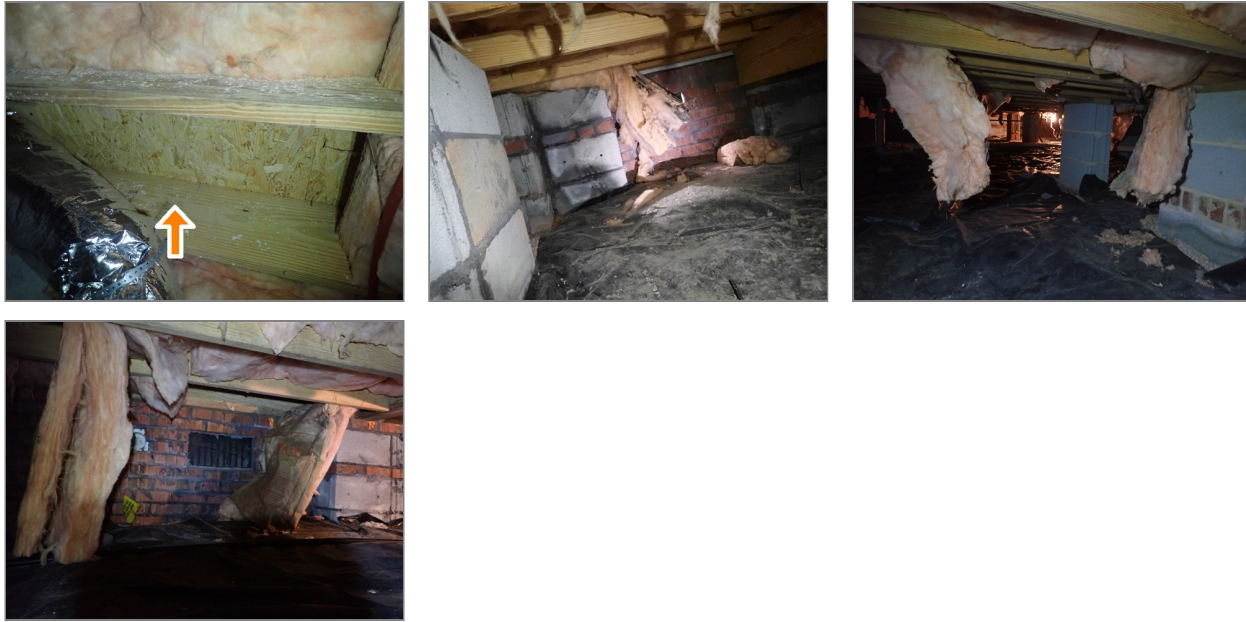
22. (3) The girders are currently shimmed with "wedge shims" and should be properly shimmed to properly support the girders, as "wedge shims" are known to be unstable. Not all areas of concern are pictured.

Consult with a qualified licensed contractor to evaluate the area(s) of concern and make any additional repairs as deemed necessary during their evaluation.
