INSPECTION REPORT  
107 S Gibbs Rd  
 Mooresville NC 28117

INSPECTED BY  
Alex Parr 3692  
Above Parr Home  
Inspections

INSPECTION DATE  
📅 6/23/2023  
🕒 09:00:00 AM

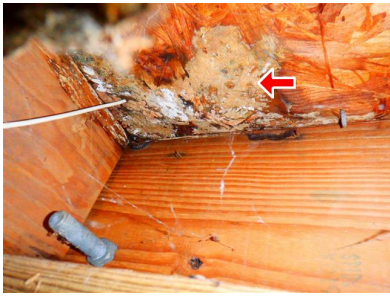
1.0 Item 1 (Picture)

1. Discoloration in some type of fungal growth (wood destroying fungus) is present in the structure at several areas including but not limited to the crawl space and or interior spaces. This type of substance commonly results in the building and finish type materials becoming weakened and or compromised. Evidence suggests that this condition is from a past or present elevated moisture conditions. The extent of the damage cannot be determined until the moisture issue is corrected. We did not inspect, test or determine if this type of substance is or is not a health hazard as this is above the scope of a home inspection. We recommend contacting a licensed expert for testing, investigation and or correction as deemed appropriate

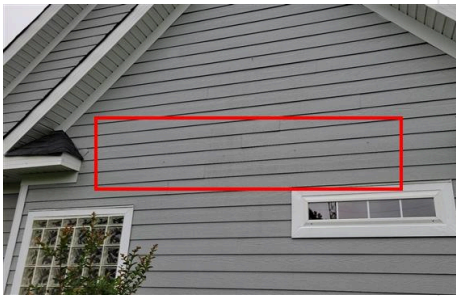
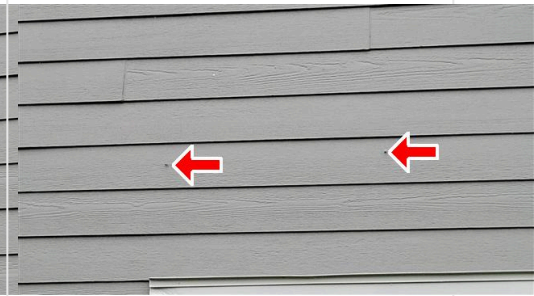
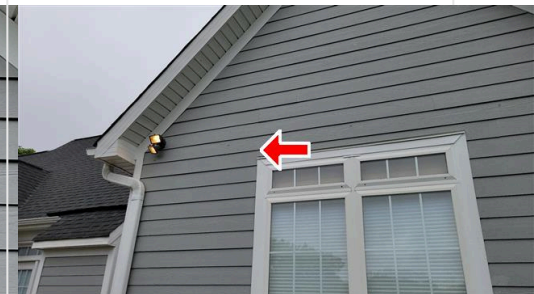
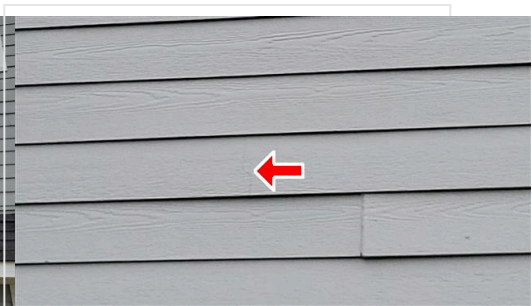
1. The cement board at the exterior in areas is damaged. Deterioration can eventually occur if not corrected. Repairs are needed.

A qualified person should repair or replace as needed.

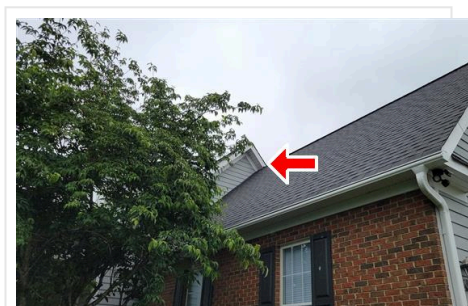
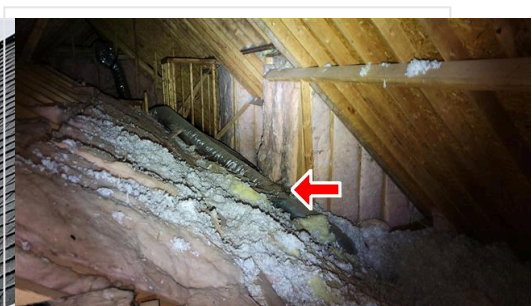
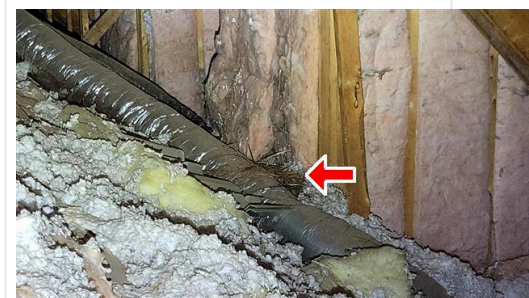
1. The wood fascia at the front of home is damaged from what appears a pest. Further deterioration may occur if not repaired. Rodents, reptiles or insects could enter into attic. Further investigation and repairs are needed.

A qualified person should repair or replace as needed.

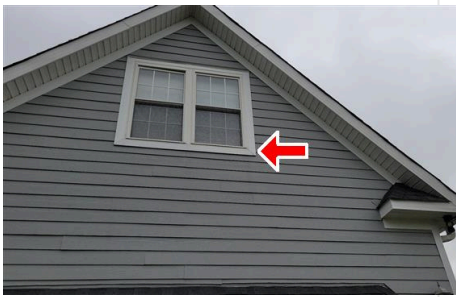
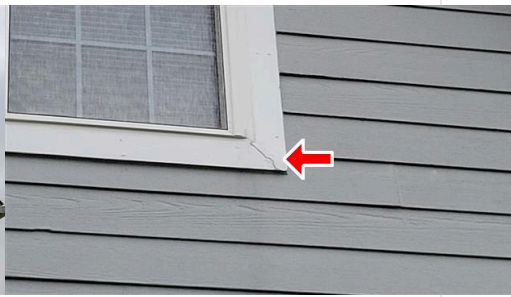
1. The wood trim deteriorated at some windows. Further deterioration may occur if not repaired. Further investigation and repairs are needed.

A qualified person should repair or replace as needed.

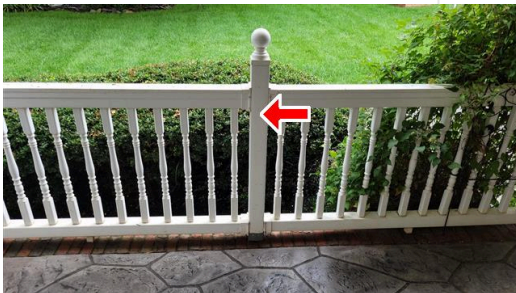
3.4 Item 1 (Picture)

1. The guardrails on covered porch at the front of home are loose. An injury could occur if not corrected.

A repair or replacement is needed.

A qualified contractor should repair or replace as needed.

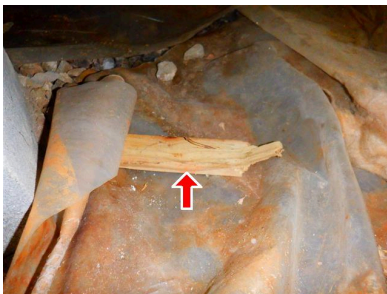
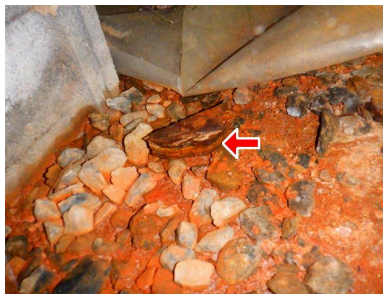
1. Wood debris is in contact with the crawl space floor in numerous areas. This can attract wood destroying organisms. Removal is needed.

A qualified contractor should inspect and repair as needed.

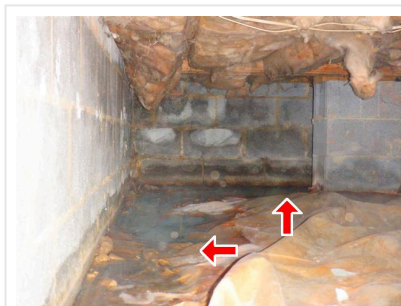
4.6 Item 1 (Picture)

1. Visible signs of water intrusion in the crawlspace are present from standing water on ground. Water intrusion if not corrected can lead to other problems including mold and cause excessive moisture to floor system that can lead to deterioration and increased repair cost. Further investigation and repairs are needed.

I recommend further investigation or correction by a qualified licensed contractor or water infiltration specialist.

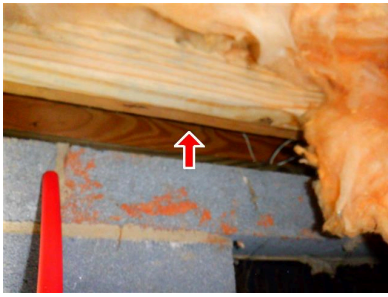
4.6 Item 6 (Picture)

1. Visible signs of water intrusion in the crawlspace (along rear of home) are present from water stains on floor. Water intrusion can cause deterioration and excessive moisture on building components if not corrected. Further investigation and repairs are needed.

I recommend further investigation or correction by a qualified licensed contractor or water infiltration specialist.

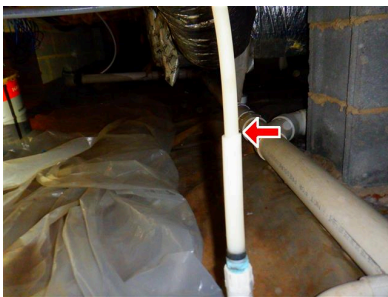
5.2 Item 1 (Picture)

1. The drain line for the water filtration system has been installed in properly. This can allow for cross contamination. This is a safety issue. Further investigation and repairs are needed..

A qualified licensed plumber should repair or correct as needed.

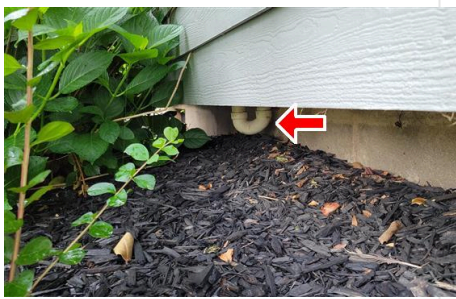
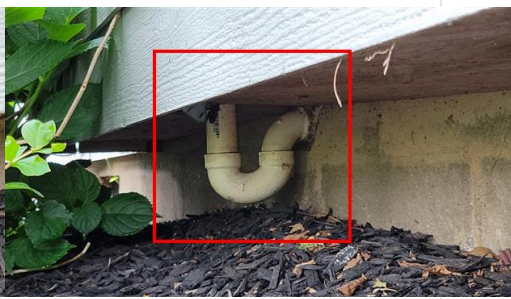
1. The plumbing waste line left side of the home is exposed to the elements. This may allow the waistline to freeze. Further investigation and repairs are needed..

A qualified licensed plumber should repair or correct as needed.

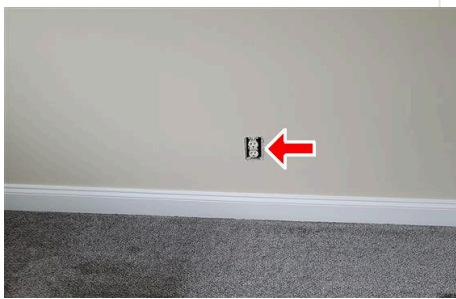
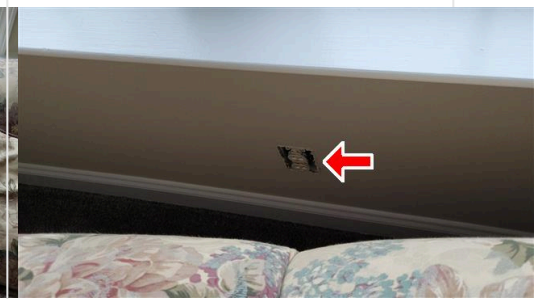
1. At least two outlets are missing cover-plate bonus room. This is a safety issue that needs to be corrected. I recommend repair as needed.

A qualified licensed electrical contractor should correct as needed.

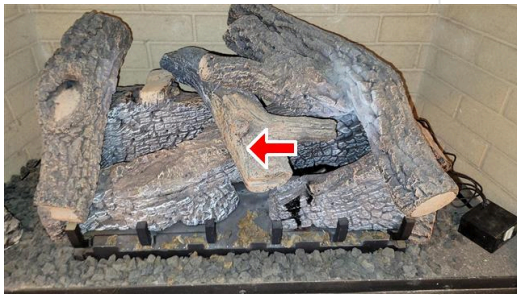
7.7 Item 1 (Picture)

1. The non-vented fire logs in the Living room is not operable (burner would not ignite). Repairs should be made so unit works properly. Repairs are needed.

A qualified licensed HVAC (Heat/Ventilation/Air conditioning Contractor) should inspect further and repair as needed.

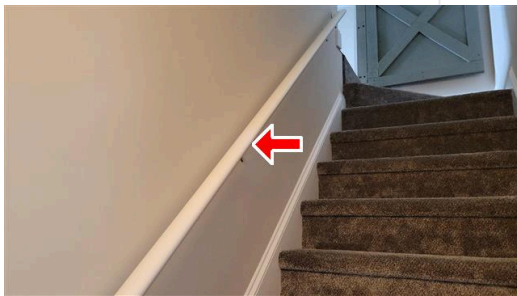
8.3 Item 1 (Picture)

1. The hand/guard rail for the upstairs are lower than 36 inches from floor. A fall or injury could occur if not corrected A repair or replacement is needed.

A qualified contractor should repair or replace as needed.

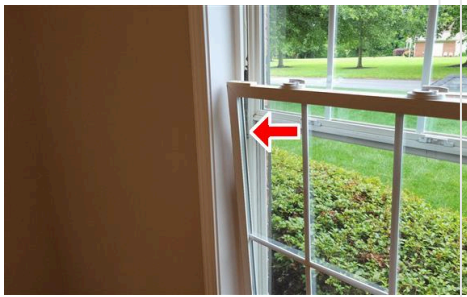
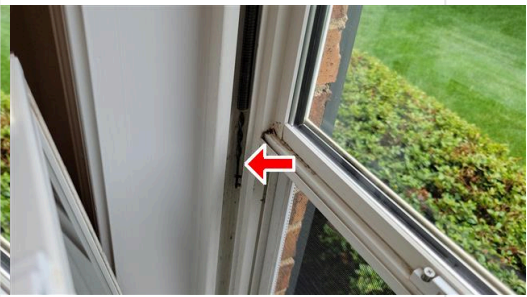
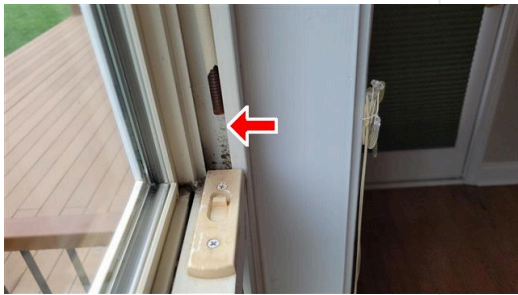
1. The windows at the throughout the home have damaged sash springs. This can allow the window to come down suddenly causing glass breakage and or injury. (Safety Issue) Repairs are needed.

A qualified person should repair or replace as needed.

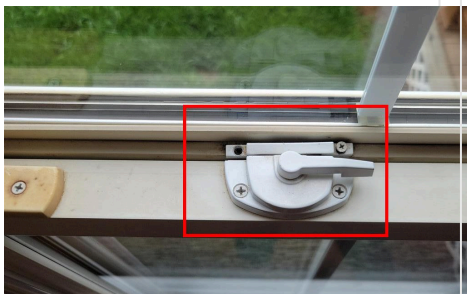
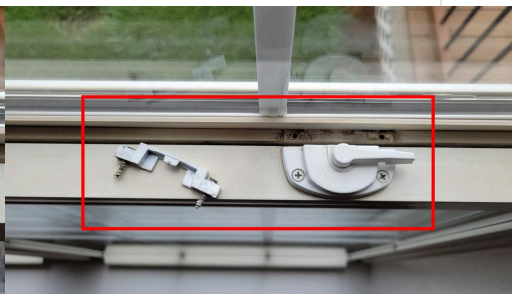
1. Two windows are damaged at lock hardware at the master bedroom. As a result you can not lock the window. Further investigation and repairs are needed.

A qualified person should repair or replace as needed.

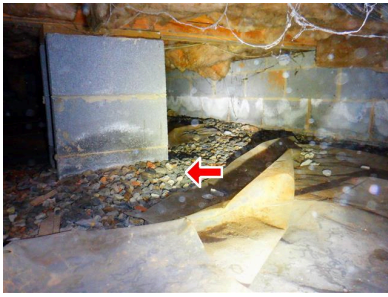
9.0 Item 1 (Picture)

1. The vapor barrier (plastic) on the crawlspace ground is missing in areas. A vapor barrier provides added protection to the floor system from moisture or dampness that can enter from ground. Repairs are needed.

A qualified person should repair or replace as needed.

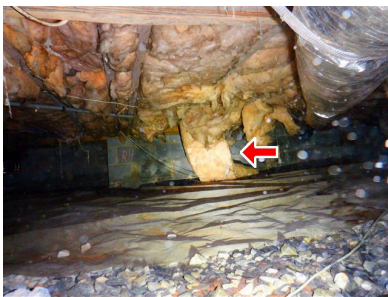
9.3 Item 1 (Picture)

1. The insulation is loose/fallen in the crawlspace. Heat loss can occur more on this home than one that is properly insulated. Repairs are needed..

A qualified person should repair or replace as needed.

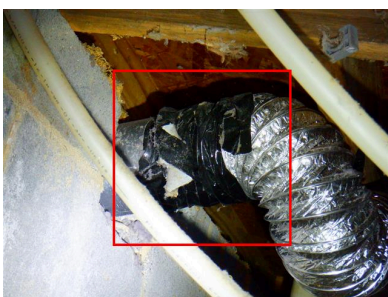
9.5 Item 1 (Picture)

1. The dryer vent piping is improperly put together with duct tape. "Duct tape is not UL rated for this application." Repairs are needed.

A qualified person should repair or replace as needed.

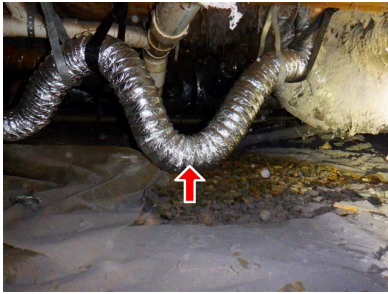
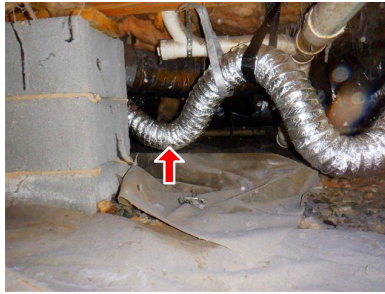
1. The dryer vent piping has large sags. This can cause an obstruction of lint that has a possibility to

create a fire hazard. Repairs are needed.

A qualified person should repair or replace as needed.

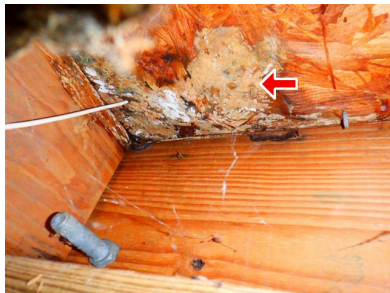
**1.0 Item 1 (Picture)**

1. Discoloration in some type of fungal growth (wood destroying fungus) is present in the structure at several areas including but not limited to the crawl space and or interior spaces. This type of substance commonly results in the building and finish type materials becoming weakened and or compromised. Evidence suggests that this condition is from a past or present elevated moisture conditions. The extent of the damage cannot be determined until the moisture issue is corrected. We did not inspect, test or determine if this type of substance is or is not a health hazard as this is above the scope of a home inspection. We recommend contacting a licensed expert for testing, investigation and or correction as deemed appropriate

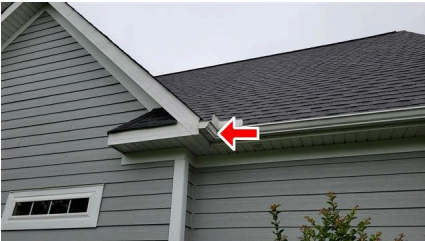
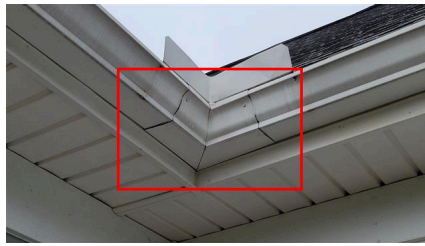
1. The gutter leaks at seam (s) at the left side of home (facing front). Erosion can continue or become worse if not corrected possibly leading to water intrusion. Repairs are needed.

A qualified person should repair or replace as needed.

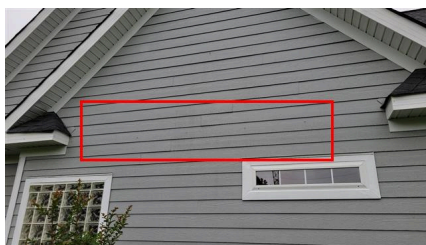
3.0 Item 1 (Picture)

1. The cement board at the exterior in areas is damaged. Deterioration can eventually occur if not corrected. Repairs are needed.

A qualified person should repair or replace as needed.

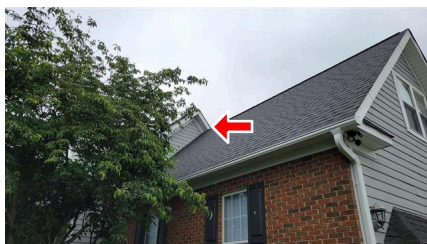
3.1 Item 1 (Picture)

1. The wood fascia at the front of home is damaged from what appears a pest. Further deterioration may occur if not repaired. Rodents, reptiles or insects could enter into attic. Further investigation and repairs are needed.

A qualified person should repair or replace as needed.

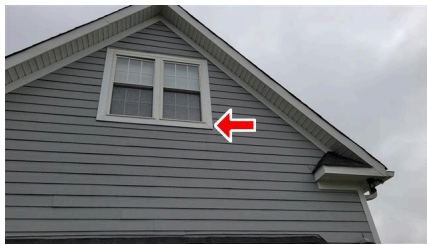
3.2 Item 1 (Picture)

1. The wood trim deteriorated at some windows. Further deterioration may occur if not repaired. Further investigation and repairs are needed.

A qualified person should repair or replace as needed.

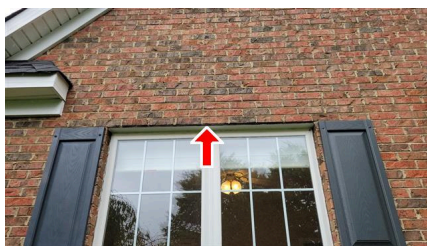
3.2 Item 3 (Picture)

1. The steel lintels around the exterior of the home are beginning to rust or have rust present. A lintel is a horizontal architectural member or steel beam support placed over a wall opening to carry the weight of the masonry placed over it. In most situation, the lintel above you windows and doors will be steel angle iron or I beam. Either due to age or improper rust proofing or weep chord and flashing placement during installation, lintels will begin to rust. Rusting lintels can expand to become much thicker than their original size. The expansive forces of rusting steel can shift entire multi-story elevations. If your lintels are currently rusting, a telltale sign of expansion is diagonal "step" pattern cracks, which can be found on either end of the window or door opening. Repairs are needed to prevent further damage to the structure. Further deterioration may occur if not repaired.

I recommend a qualified contractor inspect and repair as needed.

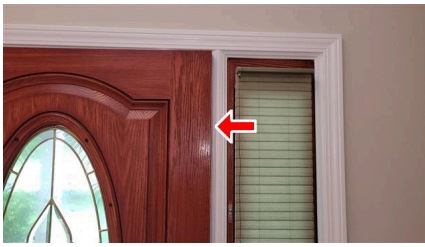
**3.3 Item 1 (Picture)**

1. The main entry door rubs at jamb when closing. As a result the door will not close properly. Repairs are needed.

A qualified person should repair or replace as needed.

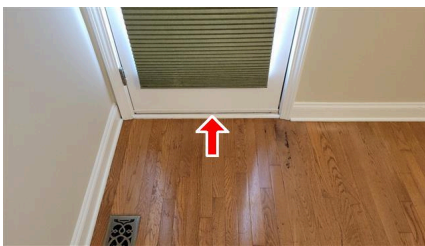
**3.3 Item 2 (Picture)**

1. The entry door rear of home rubs floor when opened. As a result the door will not close properly. Repairs are needed.

A qualified person should repair or replace as needed.

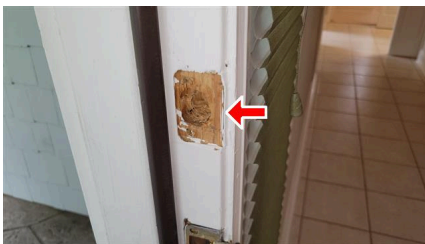
**3.3 Item 3 (Picture)**

1. The main entry door is missing strike plate. This is a maintenance issue and is for your information.

A qualified person should repair or replace as needed.

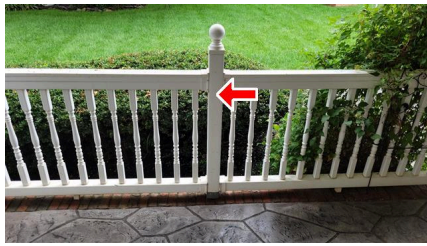
3.4 Item 1 (Picture)

1. The guardrails on covered porch at the front of home are loose. An injury could occur if not

corrected. A repair or replacement is needed.

A qualified contractor should repair or replace as needed.

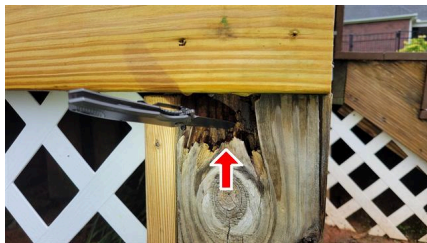
3.4 Item 2 (Picture)

1. The support post(s) on the deck at the rear of home is deteriorated. Further deterioration can occur if not repaired. Repairs are needed.

A qualified contractor should repair or replace as needed.

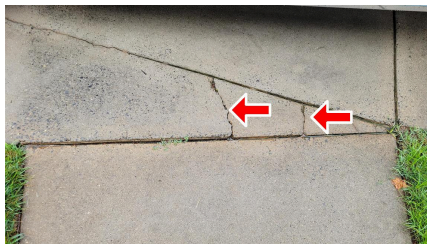
3.5 Item 1 (Picture)

1. The concrete driveway has cracks that should be sealed to prevent further damage, which is part of ongoing maintenance of a concrete driveway that will need to be performed on a regular basis. Repairs are recommended.

A qualified contractor should inspect and repair as needed.

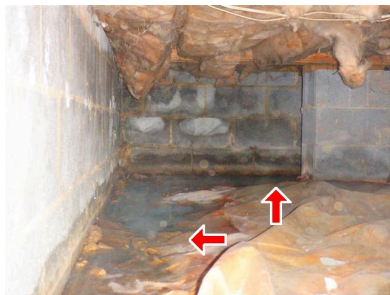
4.6 Item 1 (Picture)

1. Visible signs of water intrusion in the crawlspace are present from standing water on ground. Water intrusion if not corrected can lead to other problems including mold and cause excessive moisture to floor system that can lead to deterioration and increased repair cost. Further investigation and repairs are needed.

I recommend further investigation or correction by a qualified licensed contractor or water infiltration specialist.

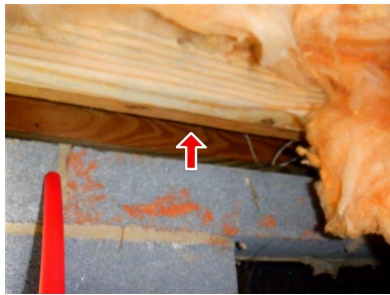
4.6 Item 6 (Picture)

1. Visible signs of water intrusion in the crawlspace (along rear of home) are present from water stains

on floor. Water intrusion can cause deterioration and excessive moisture on building components if not corrected. Further investigation and repairs are needed.

I recommend further investigation or correction by a qualified licensed contractor or water infiltration specialist.

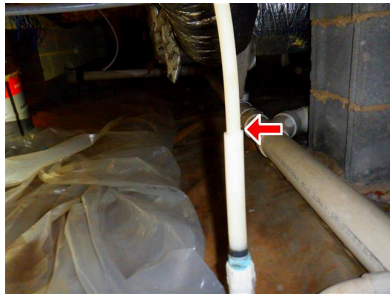
5.2 Item 1 (Picture)

1. The drain line for the water filtration system has been installed in properly. This can allow for cross contamination. This is a safety issue. Further investigation and repairs are needed..

A qualified licensed plumber should repair or correct as needed.

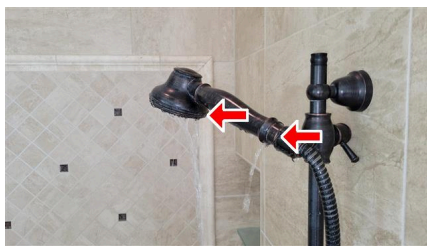
5.2 Item 3 (Picture)

1. The shower head leaks at the master bath. Repairs are needed.

A qualified licensed plumber should repair or correct as needed.

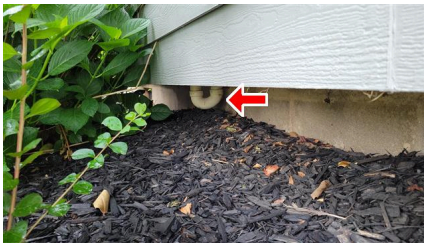
5.3 Item 1 (Picture)

1. The plumbing waste line left side of the home is exposed to the elements. This may allow the waistline to freeze. Further investigation and repairs are needed..

A qualified licensed plumber should repair or correct as needed.

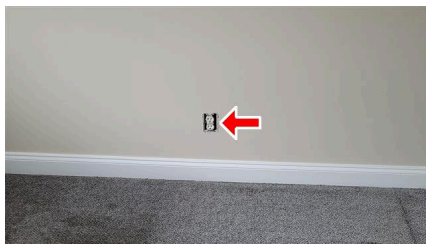
6.4 Item 1 (Picture)

1. At least two outlets are missing cover-plate bonus room. This is a safety issue that needs to be corrected. I recommend repair as needed.

A qualified licensed electrical contractor should correct as needed.

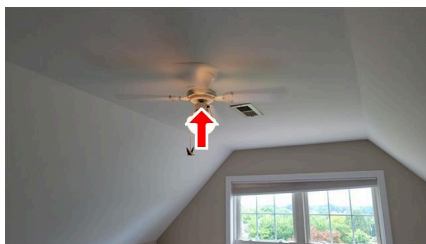
6.4 Item 4 (Picture)

1. The ceiling fan does work, but is noisy bonus room. This is for your information.

A qualified licensed electrical contractor should correct as needed.

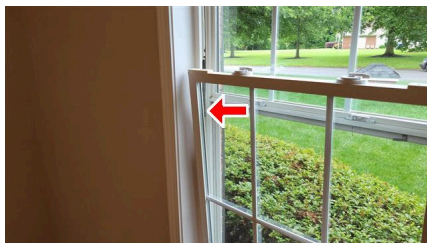
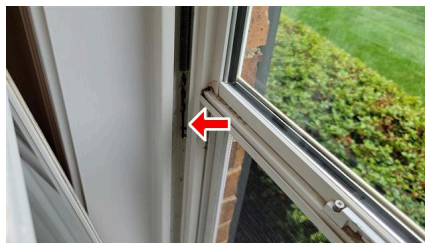
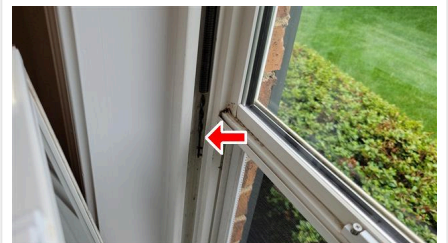
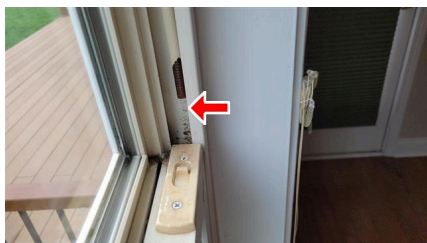
1. The windows at the throughout the home have damaged sash springs. This can allow the window to come down suddenly causing glass breakage and or injury. (Safety Issue) Repairs are needed.

A qualified person should repair or replace as needed.

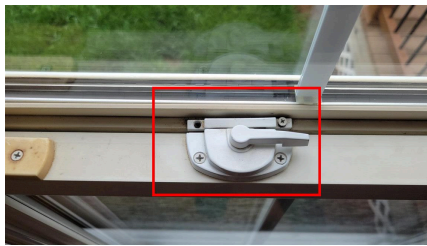
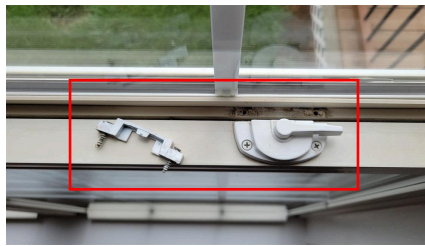
1. Two windows are damaged at lock hardware at the master bedroom. As a result you can not lock the window. Further investigation and repairs are needed.

A qualified person should repair or replace as needed.

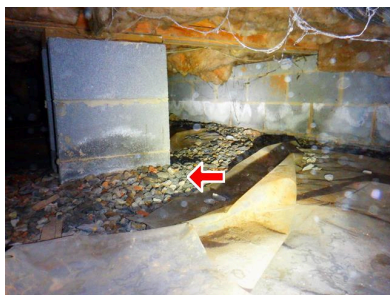
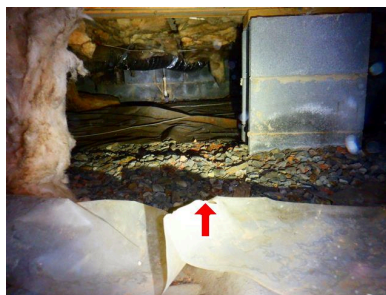
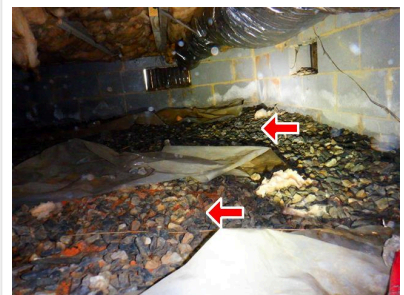
1. The vapor barrier (plastic) on the crawlspace ground is missing in areas. A vapor barrier provides added protection to the floor system from moisture or dampness that can enter from ground. Repairs are needed.

A qualified person should repair or replace as needed.

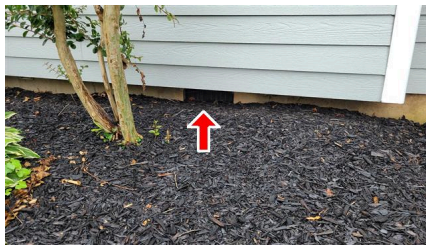
9.1 Item 1 (Picture)

1. The foundation vent(s) are below ground level at left side (facing front) which can allow water to enter crawlspace. A half-round window well should be installed. The dirt inside well should be replaced with approximately four inches of gravel. A couple of inches clearance between gravel and vent opening recommended. Repairs are needed.

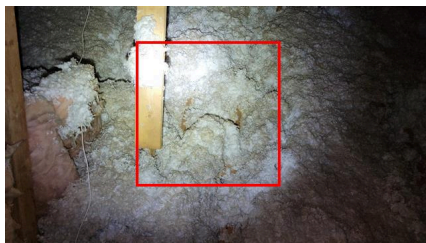
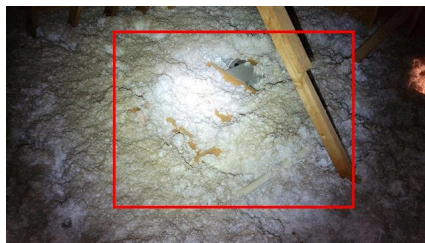
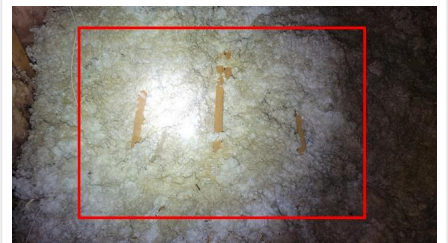
1. Fiberglass (loose-fill) insulation is is compressed in areas of the attic due to foot traffic or storage in attic. Heat loss can occur more on this home than one that is properly insulated. Repairs are recommended .

A qualified person should repair or replace as needed.

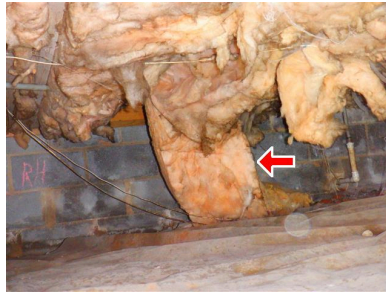
9.3 Item 2 (Picture)

1. The insulation is loose/fallen in the crawlspace. Heat loss can occur more on this home than one that is properly insulated. Repairs are needed..

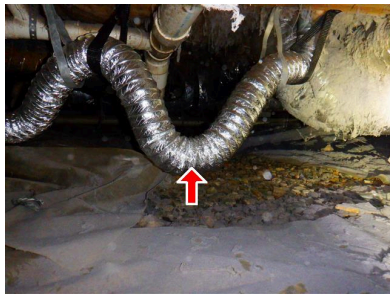
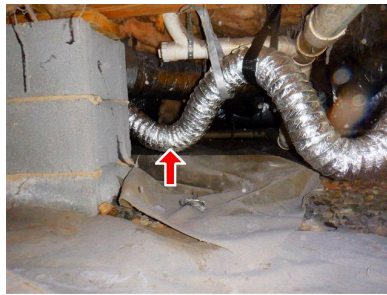
1. The dryer vent piping has large sags. This can cause an obstruction of lint that has a possibility to create a fire hazard. Repairs are needed.

A qualified person should repair or replace as needed.

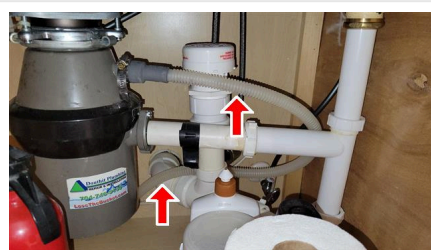
10.0 Item 1 (Picture)

1. The dishwasher drain hose needs to be looped above the level of the kitchen sink drain or an approved air gap installed to prevent back flow of waste water into the water supply. (food safety issue) This can allow waste for the sink to contaminate the dishwasher. This is a small repair.

A qualified licensed plumber should repair or correct as needed.
