INSPECTION REPORT  
119 Briar Ridge Cir  
Winston-Salem NC 27104

INSPECTION DATE  
📅 9/5/2024  
🕒 09:00:00 AM

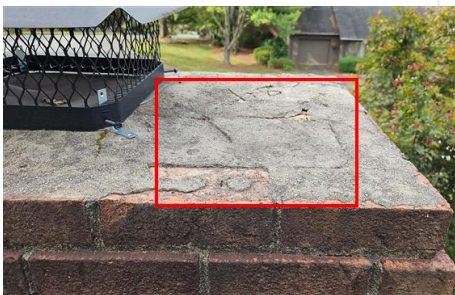
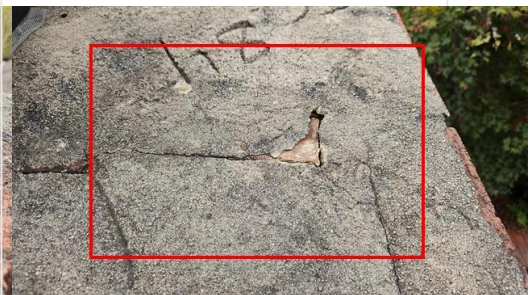
2.2 Item 1 (Picture)

1. The chimney crown appears to hold water and is deteriorate. This can cause deterioration of mortar, loose bricks, other structural problems and water intrusion to occur. Further investigation and repairs are needed.

I recommend a chimney sweep inspect and repairs what is deemed necessary.

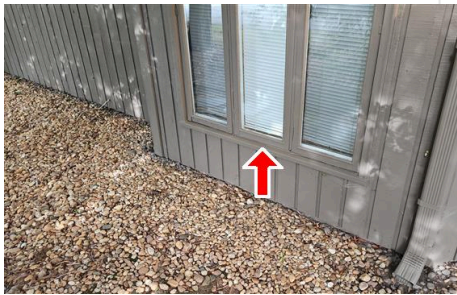
3.2 Item 1 (Picture)

1. The wood windows are deteriorated. Further deterioration may occur if not repaired. Further investigation and repairs are needed.

I recommend a qualified contractor inspect and repair as needed.

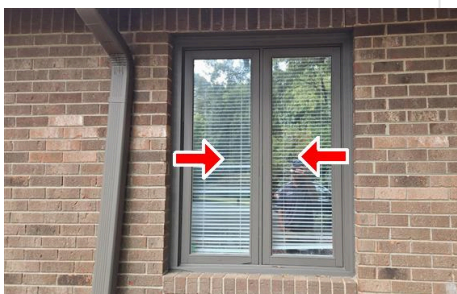
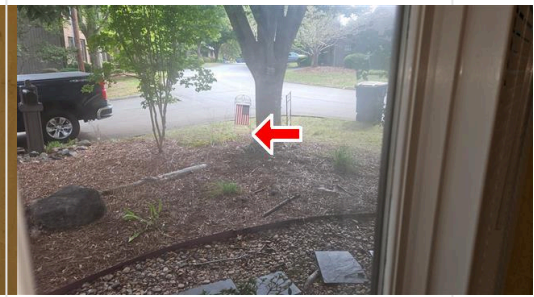
3.2 Item 6 (Picture)

1. Several windows have failed/compromised thermal seals/fogged window panes. This is indicated by the visible moisture, discoloration, calcium deposits and or crystallization visible between the glass window panes. A certified window technician should recheck all the windows throughout the home. Due to weather conditions many times compromised/failed windows cannot be identified at the time of inspection. Further investigation and repairs are needed.

We recommend contacting a properly licensed window technician/contractor regarding these conditions and have repairs made deemed appropriate

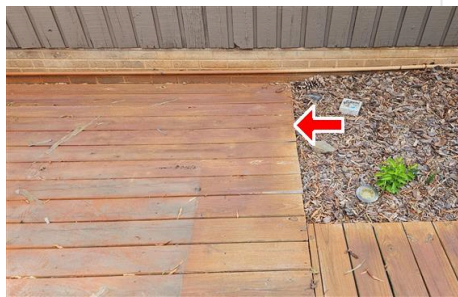
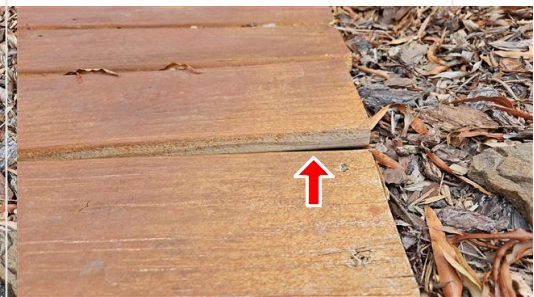
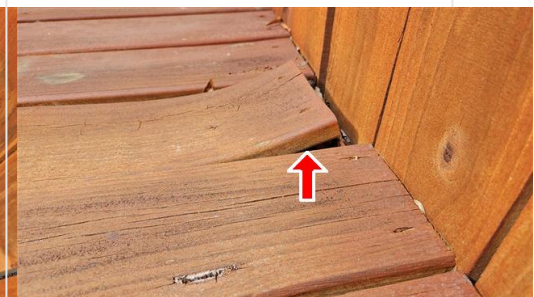
3.4 Item 1 (Picture)

1. The deck floor at the rear of home is loose and warped. A fall or injury can occur if not corrected.

Further investigation and repairs are needed.

A qualified contractor should repair or replace as needed.

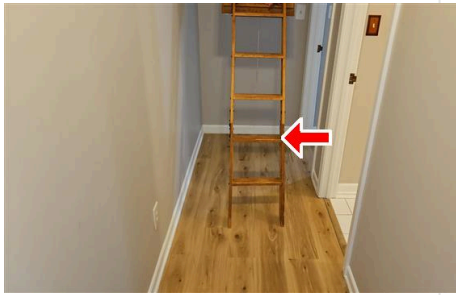
4.4 Item 1 (Picture)

1. The pull down stairs has missing hardware and is considered dangerous. Injury could result if not repaired. Repairs are needed.

A qualified person should repair or replace as needed.

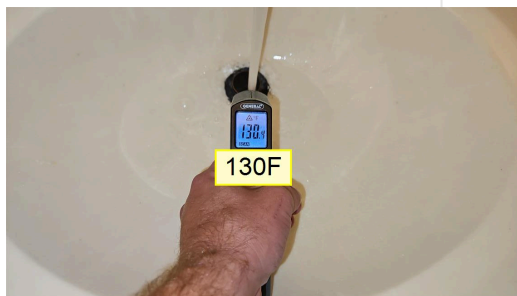
5.1 Item 1 (Picture)

1. The water heater is set over the recommended temperature. (Over 120) The risk is especially acute for infants, children, and the elderly. Water temperatures should never be set higher than 120 degrees.

This is a safety issue. Repairs are needed

A qualified contractor should inspect and repair as needed.

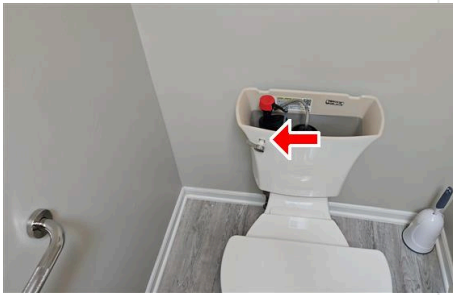
5.2 Item 1 (Picture)

1. The toilet handle is damaged at the master bath. Therefore the toilet does not function as intended. Further investigation and repairs are needed.

A qualified licensed plumber should repair or correct as needed.

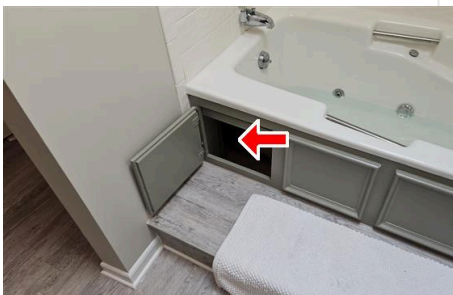
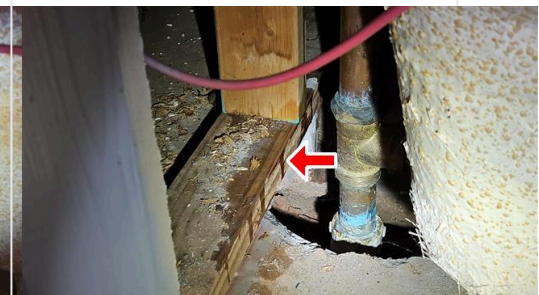
5.3 Item 1 (Picture)

1. There is a plumbing leak in between the master bathroom shower and bathtub. Repairs are needed to prevent water damage from occurring to the home. Further investigation and repairs are needed.

I recommend a qualified licensed plumber repair or correct as needed.

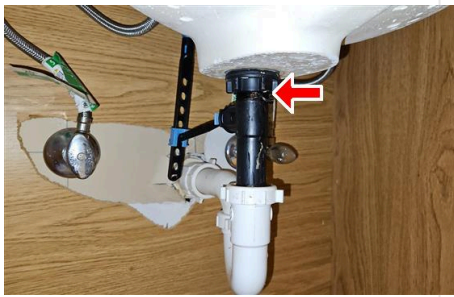
5.3 Item 6 (Picture)

1. The plumbing waste line is damaged at the guest bath sink. Repairs are needed to prevent water damage from occurring to the home. Further investigation and repairs are needed.

A qualified licensed plumber should repair or correct as needed.

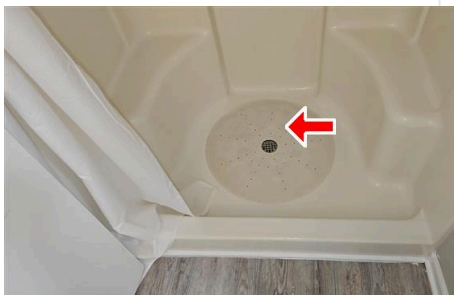
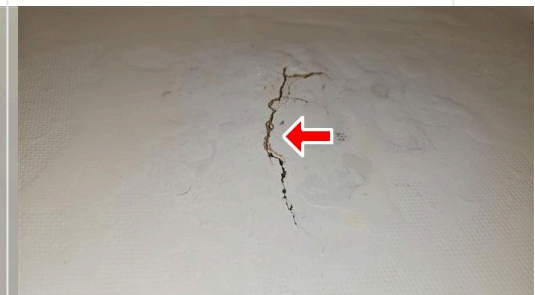
5.5 Item 1 (Picture)

1. The master and guest bath fiberglass shower/tub has chips and damage present. Damaged fiberglass tub have been known to leak. This can cause water damage to occur to the home. Further investigation and repairs are needed.

I recommend contacting a licensed plumber.

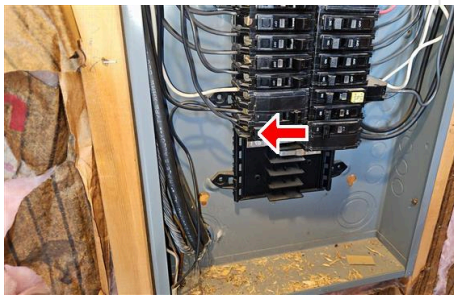
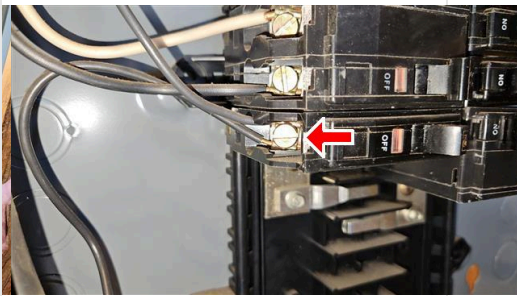
6.2 Item 1 (Picture)

1. Two wires were observed to be connected to one or more circuit breakers in the main panel. While often done, this is not permitted unless the device is so labeled. Double tapping often leads to overloaded circuits and loose connections that can overheat. Further investigation and repairs are needed.

A qualified licensed electrical contractor should correct as needed.

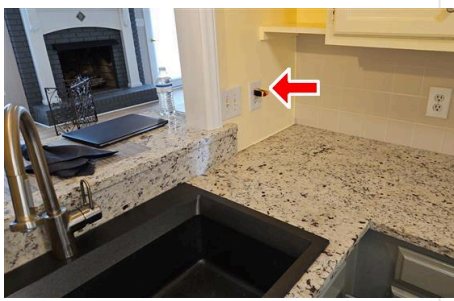
6.6 Item 1 (Picture)

1. The outlet at the kitchen are not GFIC protected. Electrical issues are considered a hazard until repaired. Further investigation and repairs are needed.

A qualified licensed electrical contractor should correct as needed.

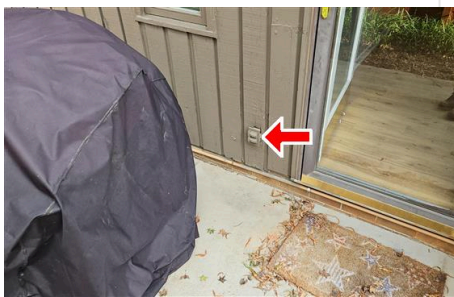
6.6 Item 3 (Picture)

1. One GFCI (Ground Fault Circuit Interrupter) outlet at the exterior is loose in the wall. Electrical issues are considered a hazard until repaired. Repairs are needed..

A qualified licensed electrical contractor should correct as needed.

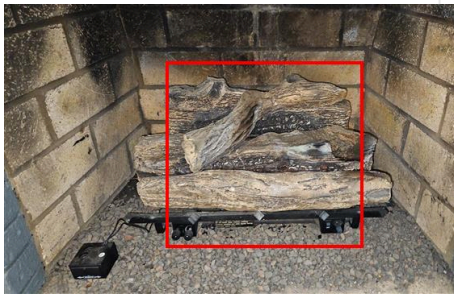
7.7 Item 1 (Picture)

1. The black soot build-up indicates that gas fire logs do not appear to be arranged or positioned according to manufacturer's specs. If logs are not positioned correctly, carbon monoxide can be produced. Repairs are needed.

A qualified licensed HVAC (Heat/Ventilation/Air conditioning Contractor) should inspect further and repair as needed.

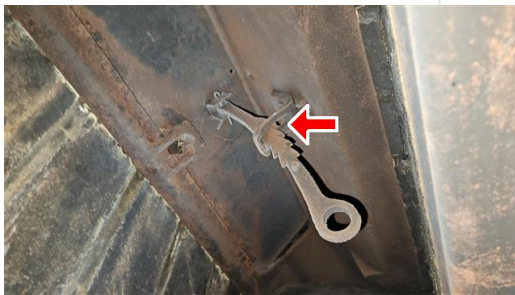
7.7 Item 3 (Picture)

1. The damper for vented fire logs at the Living room is missing a clamp or lock that forces lid to stay open (required for Vented Gas/LP logs). Without a clamp to force open the damper, it could shut and cause unsafe carbon dioxide to enter into living space. Repairs are needed.

A qualified licensed HVAC (Heat/Ventilation/Air conditioning Contractor) should inspect further and repair as needed.

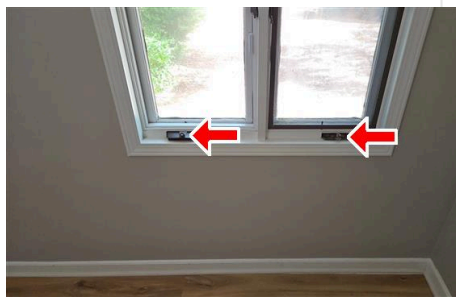
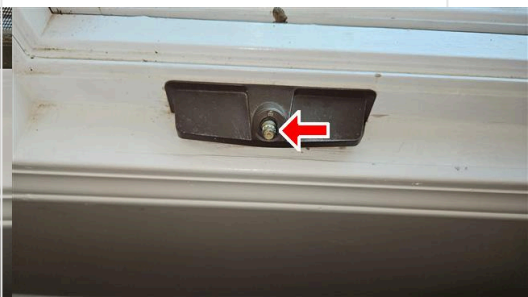
8.6 Item 1 (Picture)

1. Numerous casement windows are damaged or did not function as intended throughout the home. Further deterioration may occur if not repaired. Further investigation and repairs are needed.

A qualified person should repair or replace as needed.

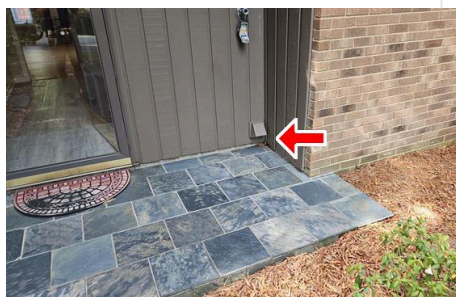
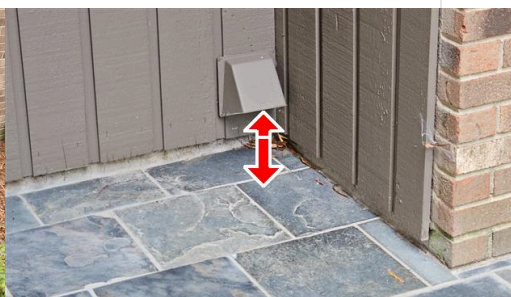
9.5 Item 1 (Picture)

1. The dryer vent hood at the front of home does not have the proper clearance from the grade/ground to function as intended. Dryer vent exhaust shall terminate not less than 12 inches above finish grade to prevent blockages. Current conditions should be considered a fire hazard until repaired. Repairs are needed.

A qualified person should repair or replace as needed.

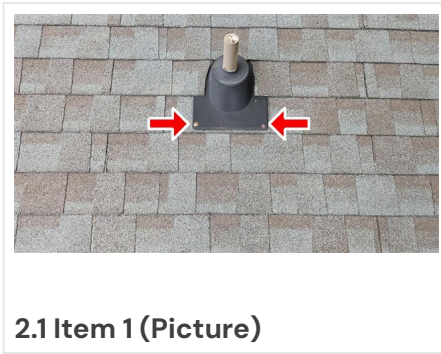
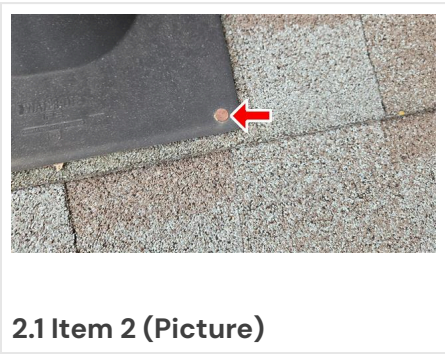
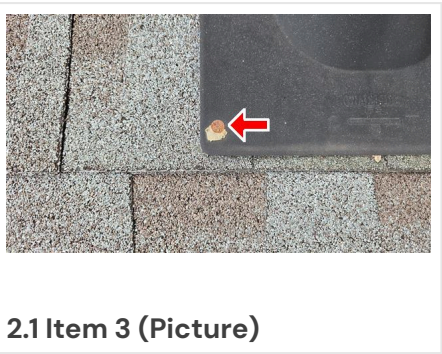
1. The nails for the plumbing vent boots need to be sealed to prevent water damage from occurring. Repairs are needed.

A qualified person should repair or replace as needed.

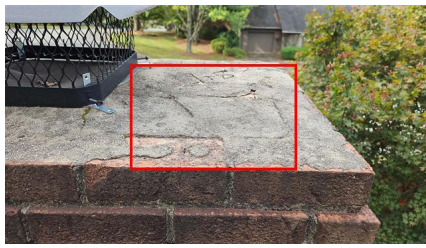
2.2 Item 1 (Picture)

1. The chimney crown appears to hold water and is deteriorate. This can cause deterioration of mortar, loose bricks, other structural problems and water intrusion to occur. Further investigation and repairs are needed.

I recommend a chimney sweep inspect and repairs what is deemed necessary.

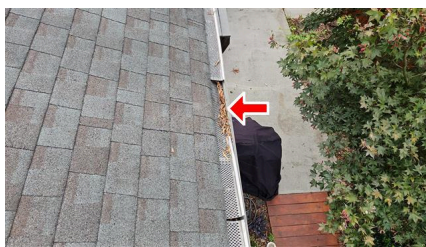
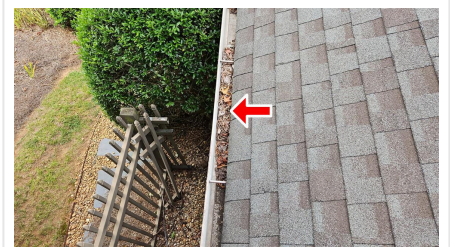
2.3 Item 1 (Picture)

1. The gutter needs cleaning of debris at the virtually all areas where gutters are installed. Gutters that drain poorly or clogged can lead to many costly problems such as deterioration of fascia, soffit or roof edge. It can also cause gutters to pull loose and lead to possible water intrusion. Repairs are needed.

A qualified person should repair or replace as needed.

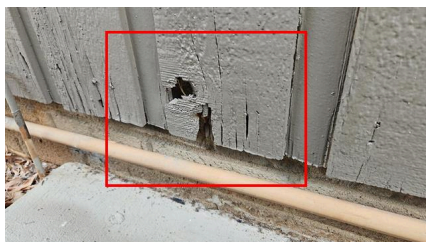
3.0 Item 1 (Picture)

1. The wood siding at the exterior in areas deteriorated. Further deterioration can occur if not corrected. Further investigation and repairs are needed.

A qualified person should repair or replace as needed.

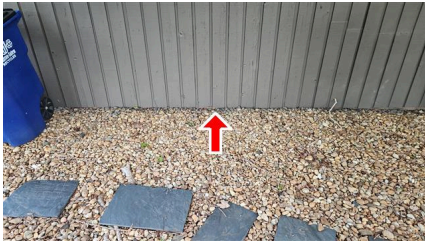
3.0 Item 4 (Picture)

1. Siding in contact with ground at left side (facing front). Because the siding is in contact with ground it is possible for framing to be deteriorated. We did not inspect behind this siding. Recommend a ground clearance of six to eight inches where possible. Repairs are needed.

A qualified person should repair or replace as needed.

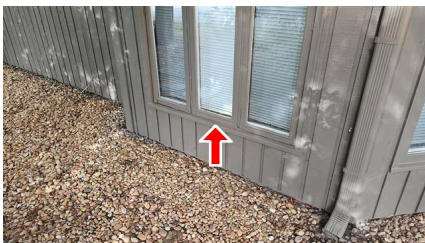
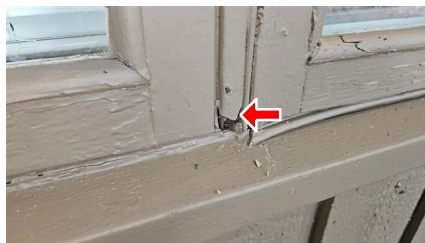
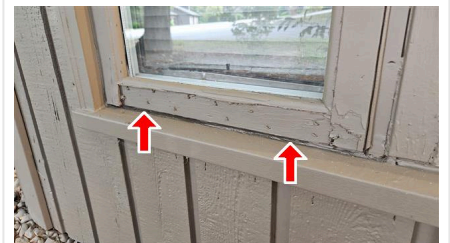
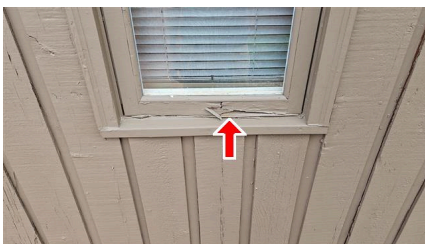
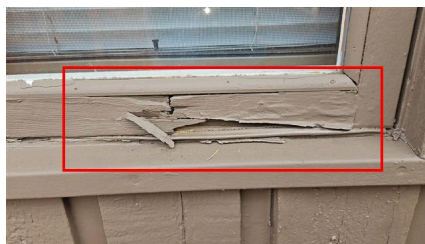
1. The wood windows are deteriorated. Further deterioration may occur if not repaired. Further investigation and repairs are needed.

I recommend a qualified contractor inspect and repair as needed.

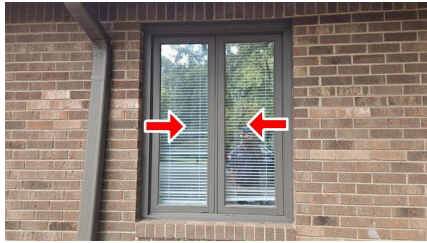
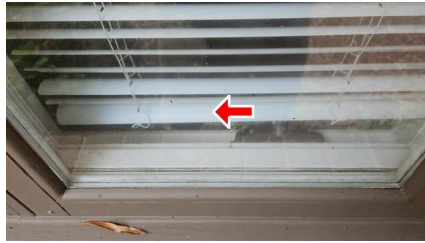
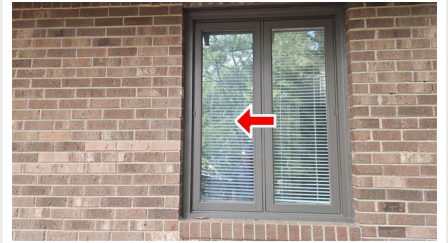
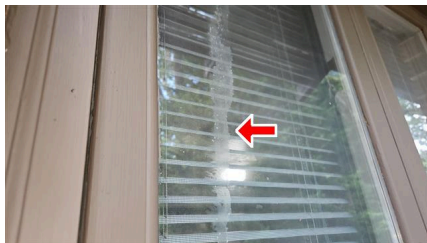
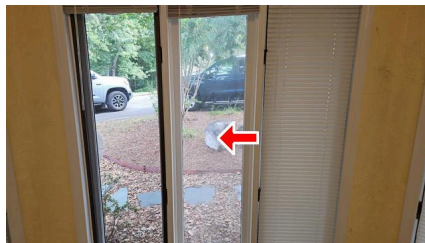
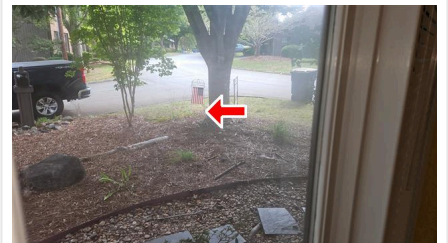
1. Several windows have failed/compromised thermal seals/fogged window panes. This is indicated by the visible moisture, discoloration, calcium deposits and or crystallization visible between the glass

window panes. A certified window technician should recheck all the windows throughout the home. Due to weather conditions many times compromised/failed windows cannot be identified at the time of inspection. Further investigation and repairs are needed.

We recommend contacting a properly licensed window technician/contractor regarding these conditions and have repairs made deemed appropriate

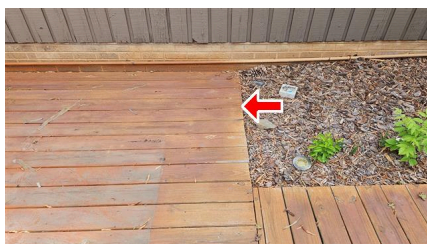
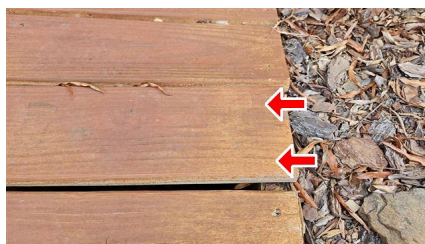
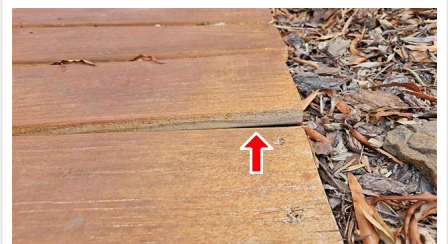
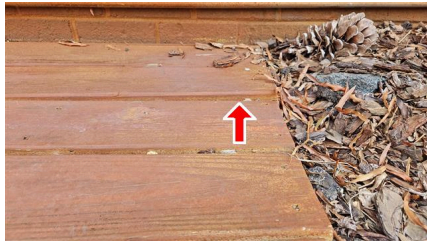
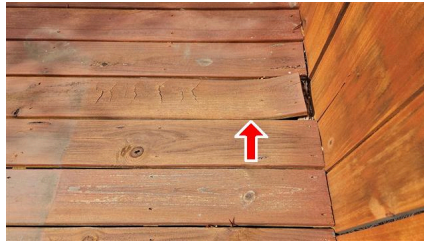
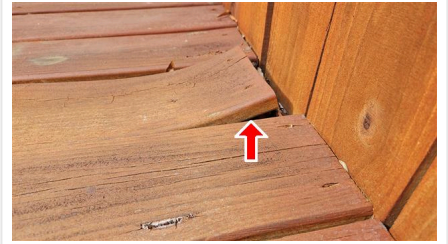
1. The deck floor at the rear of home is loose and warped. A fall or injury can occur if not corrected. Further investigation and repairs are needed.

A qualified contractor should repair or replace as needed.

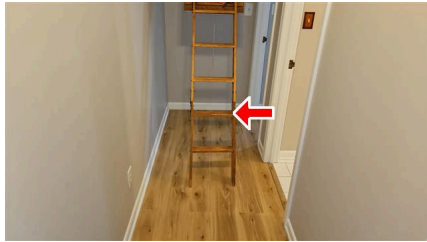
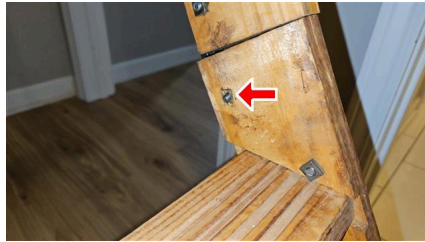
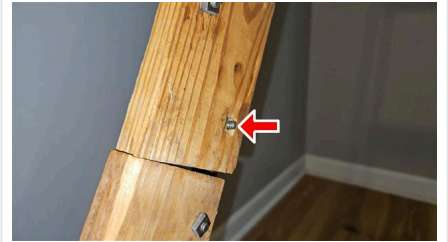
1. The pull down stairs has missing hardware and is considered dangerous. Injury could result if not repaired. Repairs are needed.

A qualified person should repair or replace as needed.

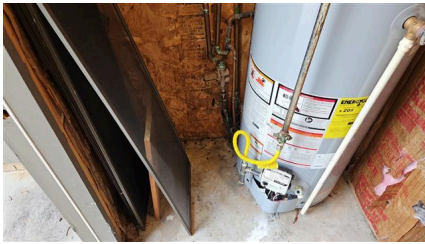
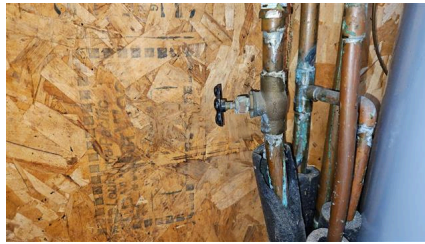
The main shut off is the black knob located at the utility room. This is for your information.

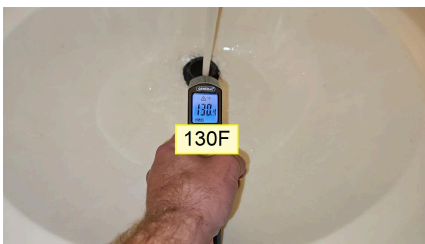
5.1 Item 1 (Picture)

1. The water heater is set over the recommended temperature. (Over 120) The risk is especially acute for infants, children, and the elderly. Water temperatures should never be set higher than 120 degrees. This is a safety issue. Repairs are needed

A qualified contractor should inspect and repair as needed.

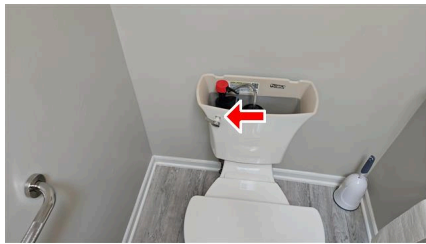
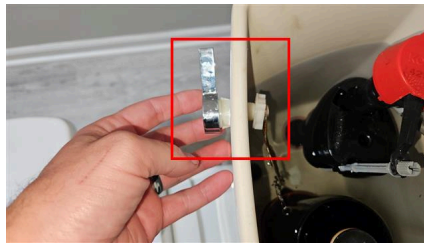
1. The toilet handle is damaged at the master bath. Therefore the toilet does not function as intended. Further investigation and repairs are needed.

A qualified licensed plumber should repair or correct as needed.

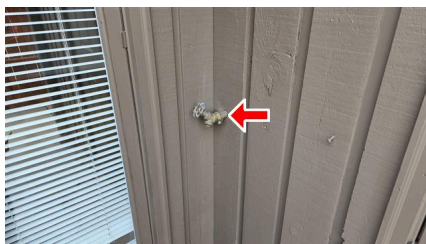
5.2 Item 3 (Picture)

1. The outside water faucet loose, and needs securing to wall at the rear of home. This can allow undue stress to occur on supply lines allowing leaks to occur. Repairs are needed.

A qualified licensed plumber should repair or correct as needed.

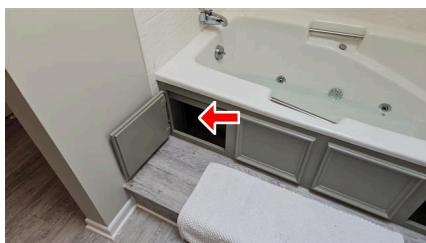
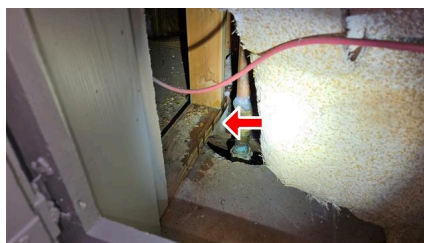
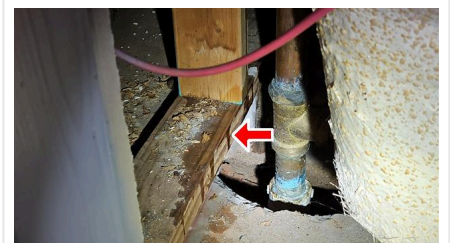
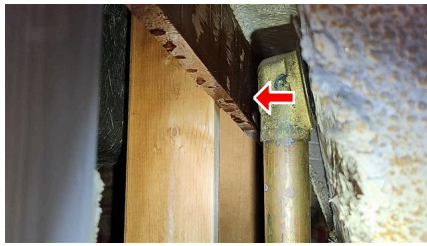
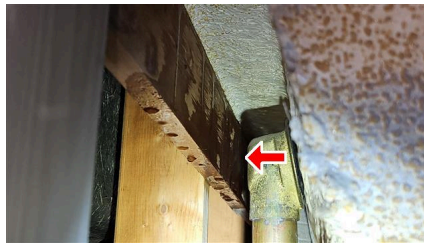
1. There is a plumbing leak in between the master bathroom shower and bathtub. Repairs are needed to prevent water damage from occurring to the home. Further investigation and repairs are needed.

I recommend a qualified licensed plumber repair or correct as needed.

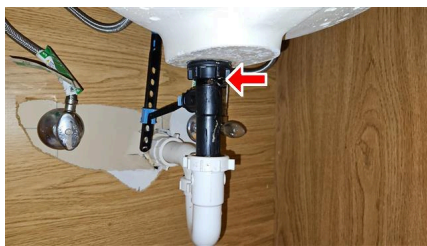
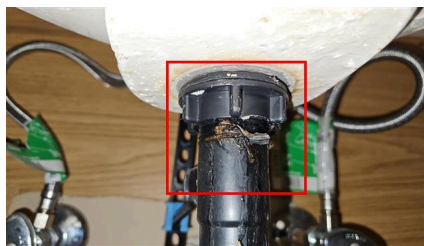
1. The plumbing waste line is damaged at the guest bath sink. Repairs are needed to prevent water damage from occurring to the home. Further investigation and repairs are needed.

A qualified licensed plumber should repair or correct as needed.

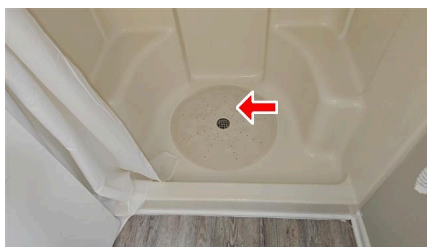
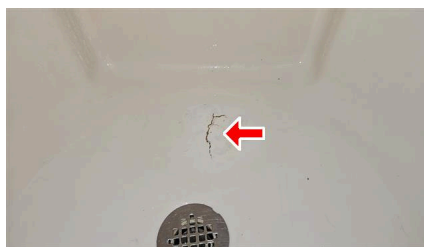
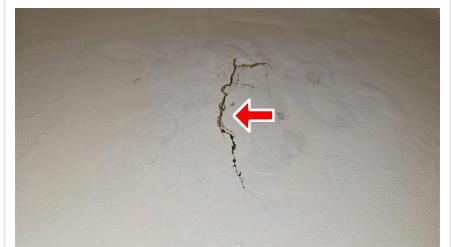
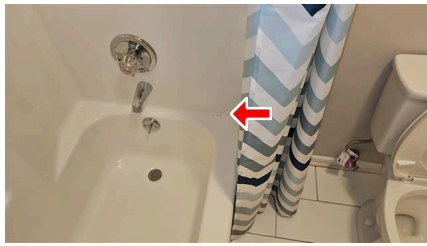
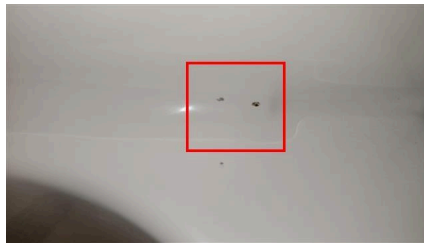
1. The master and guest bath fiberglass shower/tub has chips and damage present. Damaged fiberglass tub have been known to leak. This can cause water damage to occur to the home. Further investigation and repairs are needed.

I recommend contacting a licensed plumber.

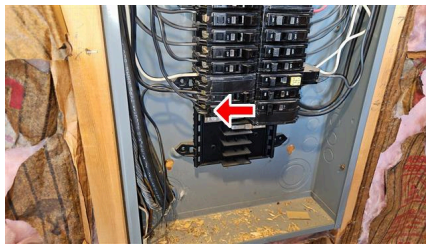
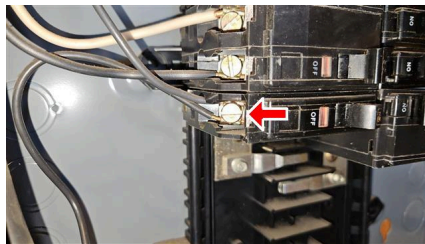
1. Two wires were observed to be connected to one or more circuit breakers in the main panel. While often done, this is not permitted unless the device is so labeled. Double tapping often leads to overloaded circuits and loose connections that can overheat. Further investigation and repairs are needed.

A qualified licensed electrical contractor should correct as needed.

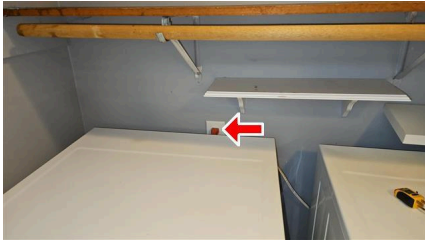
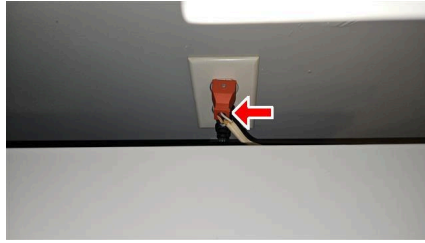
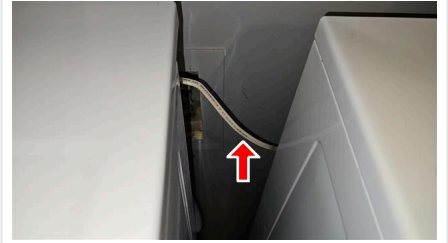
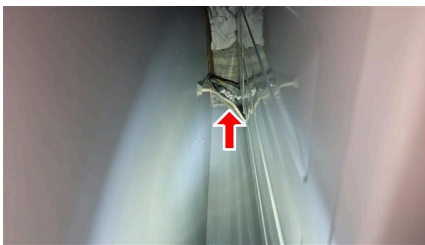
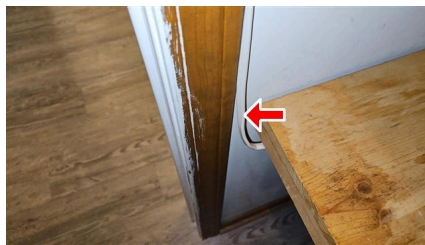
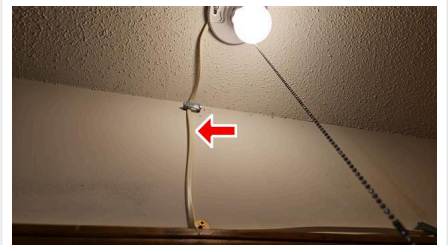
1. The light fixture is wired incorrectly at the entry coat closet. Electrical issues are considered a hazard until repaired. Further investigation and repairs are needed.

A qualified licensed electrical contractor should correct as needed.

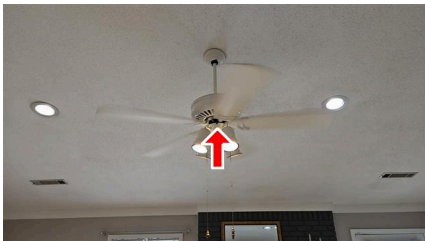
6.4 Item 7 (Picture)

1. The ceiling fan "wobbles" in the living room. Some fans that wobble cannot be corrected without replacement. Repairs are needed.

A qualified licensed electrical contractor should correct as needed.

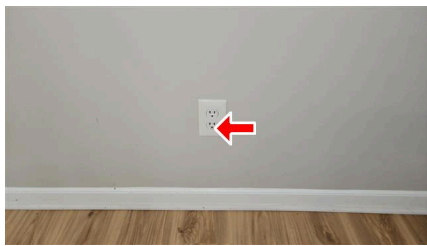
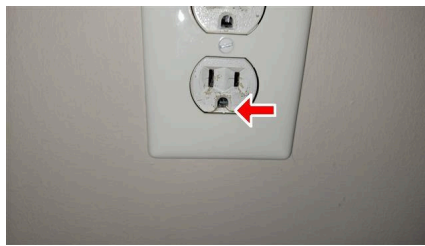
1. One or more "three-prong" outlet is broken or damaged in the living room. Electrical issues are considered a hazard until repaired. Repairs are needed.

A qualified licensed electrical contractor should correct as needed.

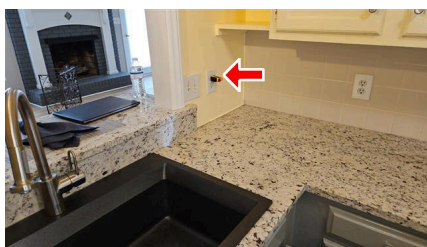
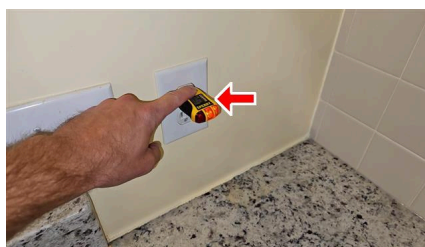
1. The outlet at the kitchen are not GFIC protected. Electrical issues are considered a hazard until repaired. Further investigation and repairs are needed.

A qualified licensed electrical contractor should correct as needed.

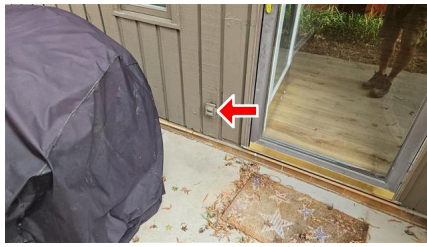
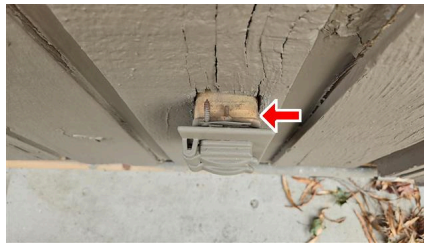
1. One GFCI (Ground Fault Circuit Interrupter) outlet at the exterior is loose in the wall. Electrical issues are considered a hazard until repaired. Repairs are needed..

A qualified licensed electrical contractor should correct as needed.

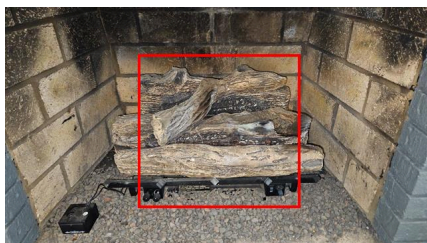
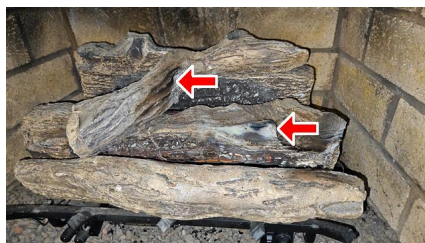
1. The black soot build-up indicates that gas fire logs do not appear to be arranged or positioned according to manufacturer's specs. If logs are not positioned correctly, carbon monoxide can be produced. Repairs are needed.

A qualified licensed HVAC (Heat/Ventilation/Air conditioning Contractor) should inspect further and repair as needed.

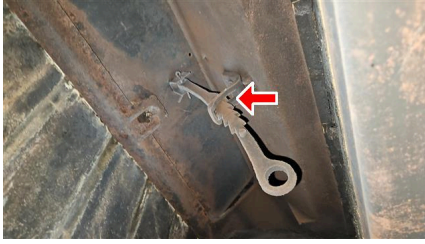
7.7 Item 3 (Picture)

1. The damper for vented fire logs at the Living room is missing a clamp or lock that forces lid to stay open (required for Vented Gas/LP logs). Without a clamp to force open the damper, it could shut and cause unsafe carbon dioxide to enter into living space. Repairs are needed.

A qualified licensed HVAC (Heat/Ventilation/Air conditioning Contractor) should inspect further and repair as needed.

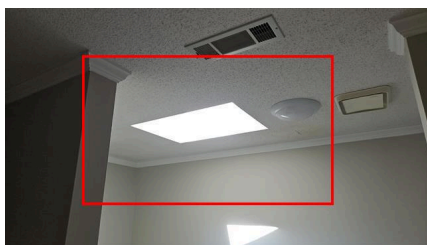
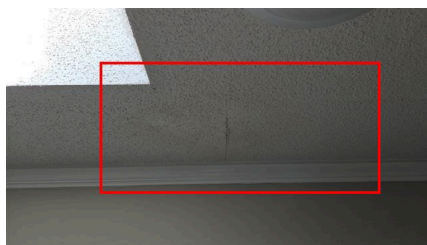
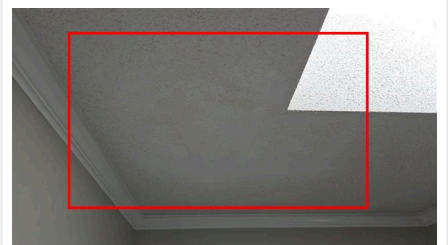
1. The drywall on the ceiling reveals a light stain which appears from a water leak. Stain appears old at the master bath. This damage is considered cosmetic. Further investigation may be needed.

A qualified person should repair or replace as needed.

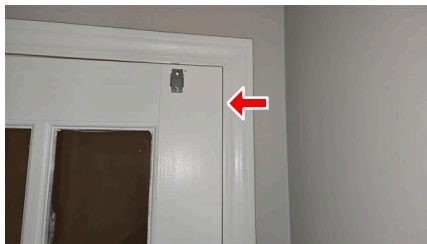
8.5 Item 1 (Picture)

1. The privacy door rubs at jamb when closing at the guest bedroom. As a result the door will not close properly. Repairs are needed.

A qualified person should repair or replace as needed.

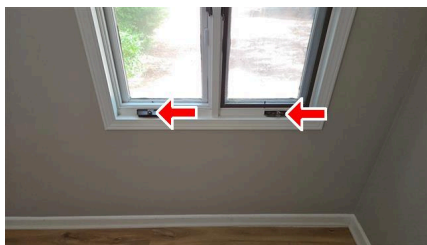
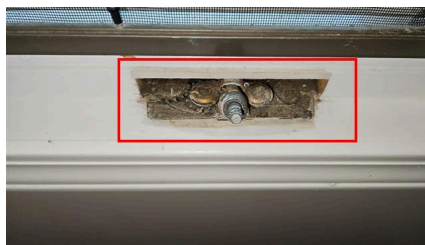
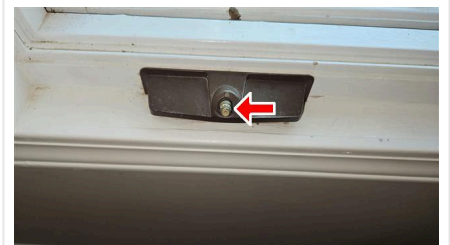
1. Numerous casement windows are damaged or did not function as intended throughout the home. Further deterioration may occur if not repaired. Further investigation and repairs are needed.

A qualified person should repair or replace as needed.

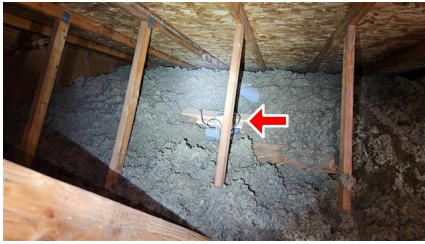
9.2 Item 1 (Picture)

1. Rock Wool (loose-fill) insulation is missing in areas in attic. Heat loss can occur more on this home than one that is properly insulated. Repairs are needed.

A qualified person should repair or replace as needed.

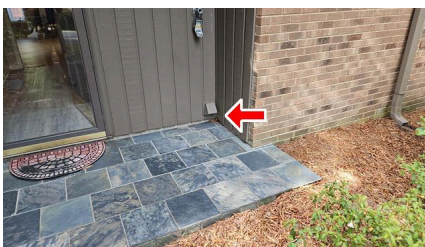
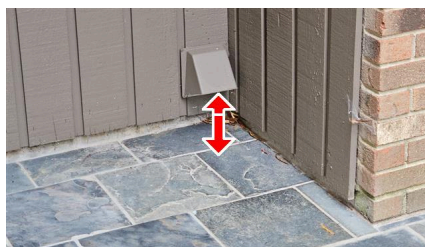
1. The dryer vent hood at the front of home does not have the proper clearance from the grade/ground to function as intended. Dryer vent exhaust shall terminate not less than 12 inches above finish grade to prevent blockages. Current conditions should be considered a fire hazard until repaired. Repairs are needed.

A qualified person should repair or replace as needed.

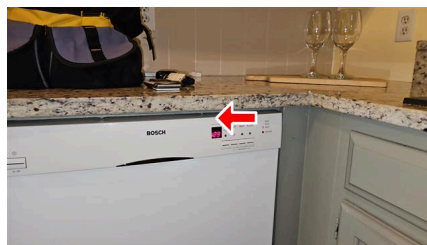
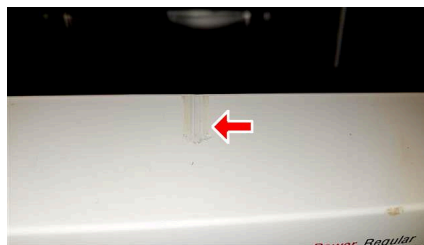
1. The dishwasher door is rubbing the mounting screw. Their deterioration could occur. Repairs are needed.

I recommend contacting appliance repair company.
