INSPECTION REPORT  
12133 Flatbush Dr  
Huntersville NC 28078

INSPECTED BY  
Alex Parr 3692  
Above Parr Home  
Inspections

INSPECTION DATE  
📅 4/19/2023  
🕒 02:00:00 PM

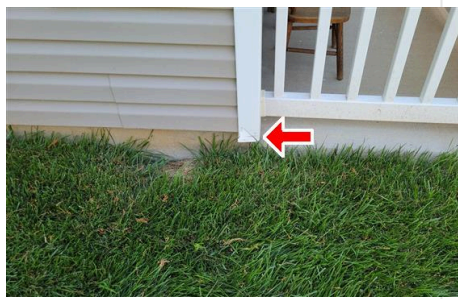
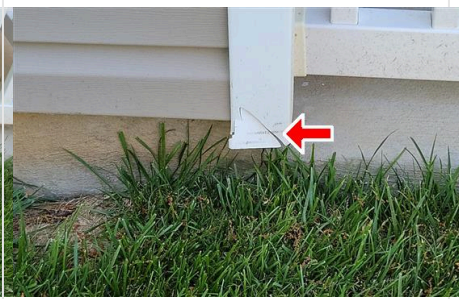
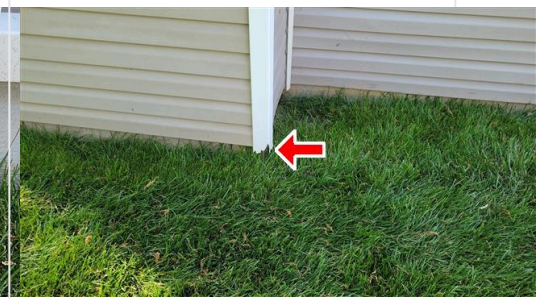
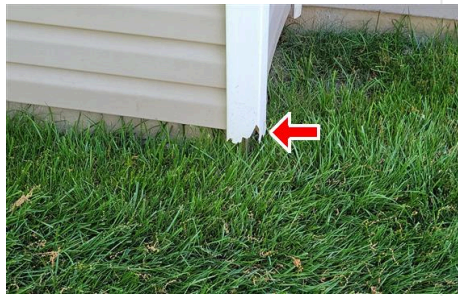
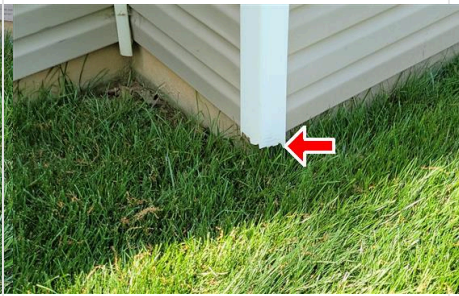
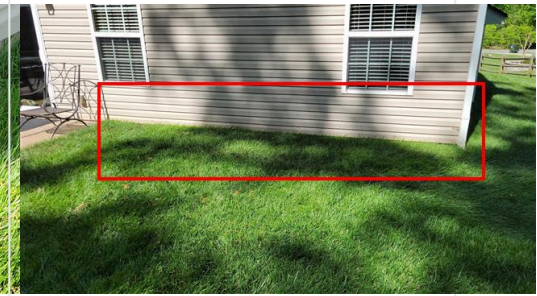
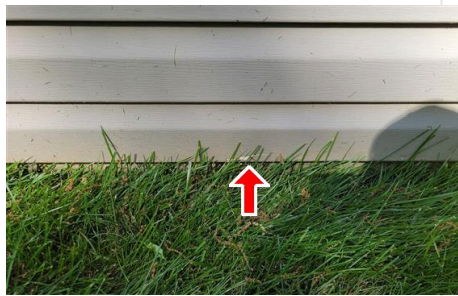
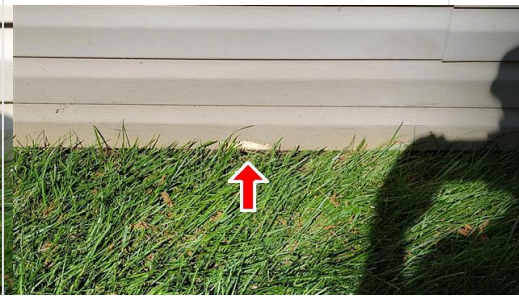
1. The Vinyl siding at the exterior in areas is damaged. Deterioration can eventually occur if not corrected. Repairs are needed.

A qualified person should repair or replace as needed.

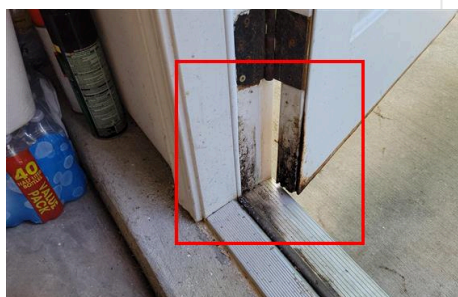
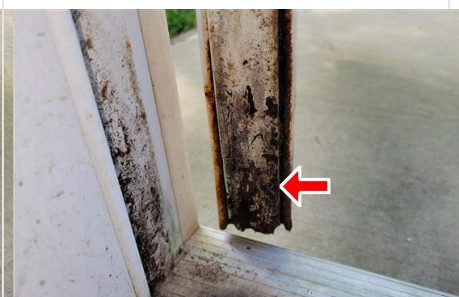
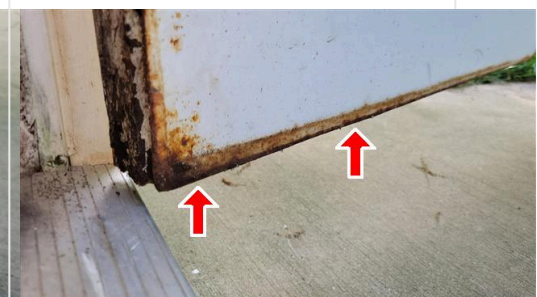
1. The side entry door is deteriorated and rusting. Further deterioration will occur. Further investigation and repairs are needed.

A qualified person should repair or replace as needed.

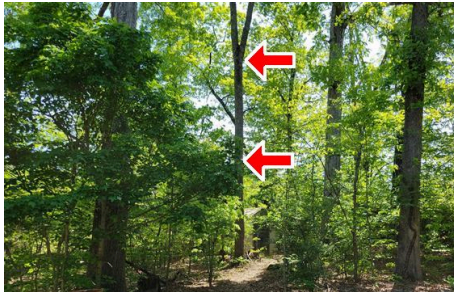
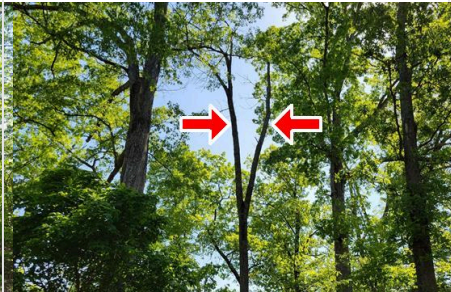
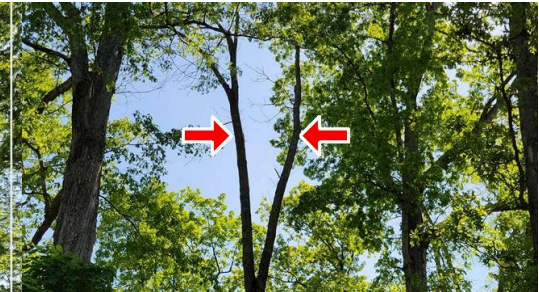
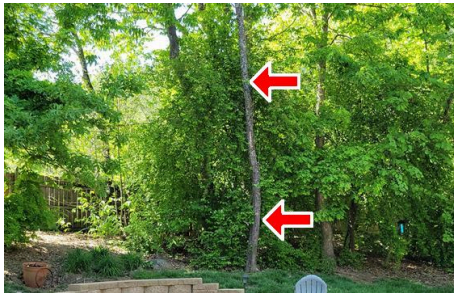
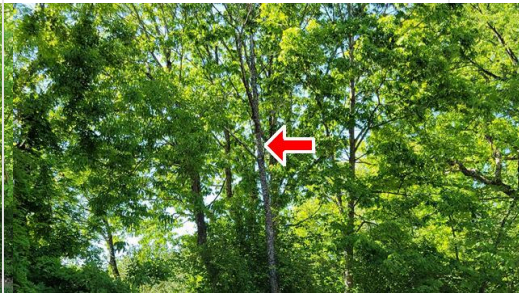
1. Several trees in the backyard are dead. This is a safety issue. The trees could injure people or damage the home. Further investigation is needed.

A qualified person should remove the trees.

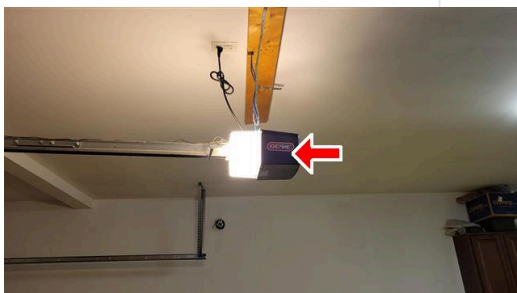
3.7 Item 1 (Picture)

1. The garage door operator safety reverse will not reverse properly when met with resistance. This is a safety issue. Further investigation and repairs are needed.

A qualified person should repair or replace as needed.

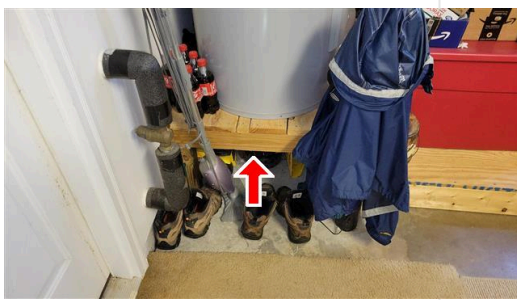
5.1 Item 1 (Picture)

1. The stand for the water heater is wood structure that does not appear to meet typical construction methods for a standard floor framing. Due to the unit's weight and safety related to a field water heater, water heater stands are typically required to be rated and labeled. Further investigation is needed.

A qualified contractor should inspect and repair as needed.

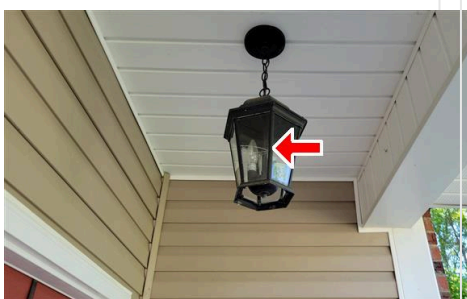
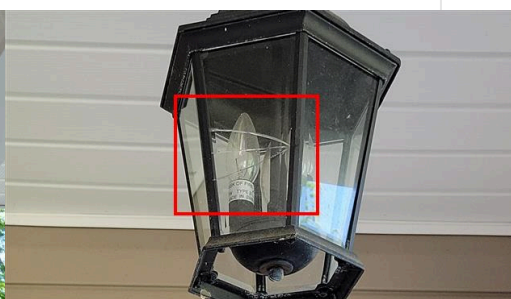
1. The light fixture glass is cracked or broken at the exterior. This is a safety issue that needs to be corrected. Repairs are needed..

A qualified licensed electrical contractor should correct as needed.

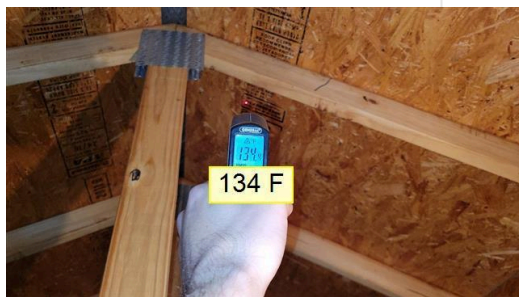
9.1 Item 1 (Picture)

1. Roof/attic area doesn't have enough ventilation. The temperature in the attic was 134F. The outside temperature was 81F. Improper/lack of ventilation will shorten the life expectancy of the roofing materials/shingles. Improper ventilation can also cause moisture problems/conditions/condensation inside the structure. Further investigation and repairs are needed.

A qualified contractor should inspect and repair as needed.

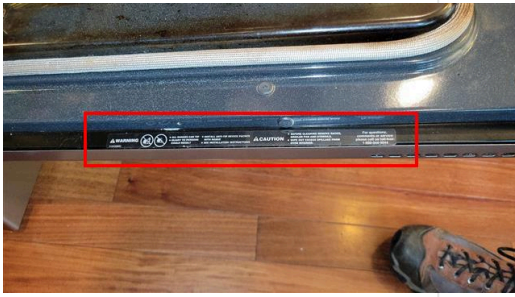
10.1 Item 1 (Picture)

1. The range/oven needs to be properly attached/anchored to the structure as to keep it from tipping over when the oven door is opened and/or oven racks are pulled out during use. This is a safety issue. Repairs are needed.

I recommend contacting appliance repair company.

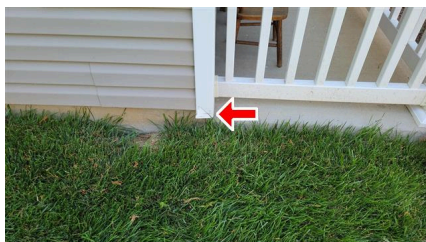
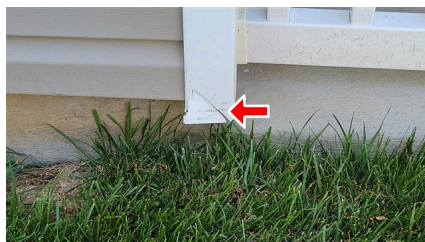
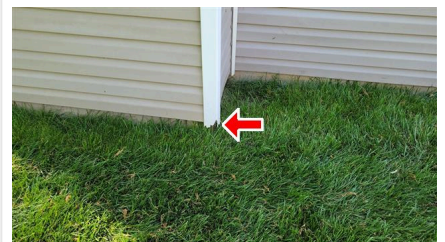
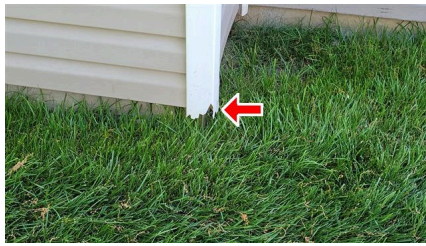
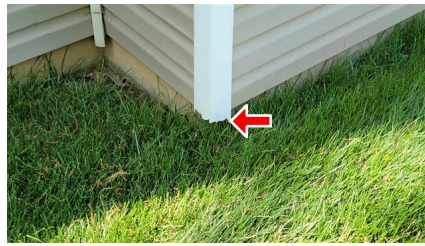
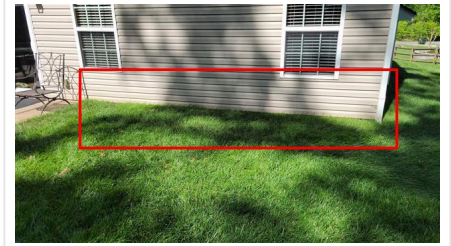
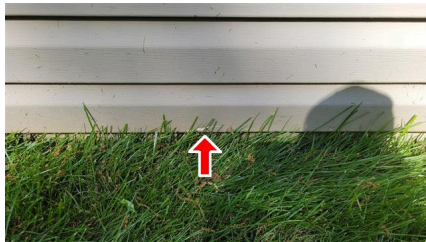
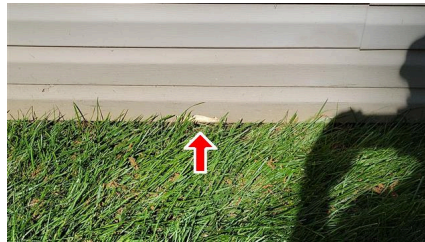
1. The Vinyl siding at the exterior in areas is damaged. Deterioration can eventually occur if not corrected. Repairs are needed.

A qualified person should repair or replace as needed.

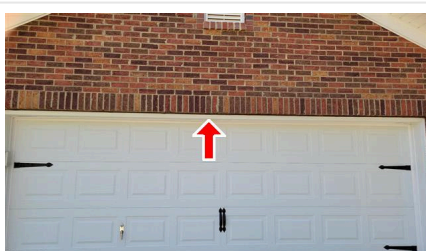
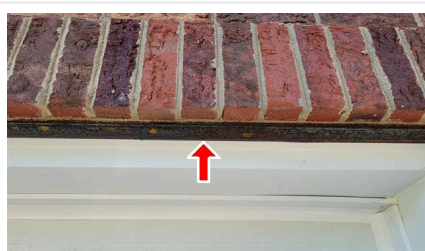
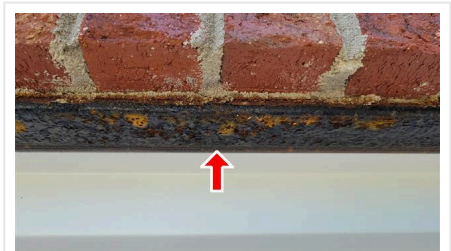
1. The steel lintels around the exterior of the home are beginning to rust or have rust present. A lintel is a horizontal architectural member or steel beam support placed over a wall opening to carry the weight of the masonry placed over it. In most situation, the lintel above you windows and doors will be steel angle iron or I beam. Either due to age or improper rust proofing or weep chord and flashing placement during installation, lintels will begin to rust. Rusting lintels can expand to become much thicker then their original size. The expansive forces of rusting steel can shift entire multi-story elevations. If your lintels are currently rusting, a telltale sign of expansion is diagonal "step" pattern cracks, which can be found on either end of the window or door opening. Repairs are needed to prevent further damage to the structure. Further deterioration may occur if not repaired.

I recommend a qualified contractor inspect and repair as needed.

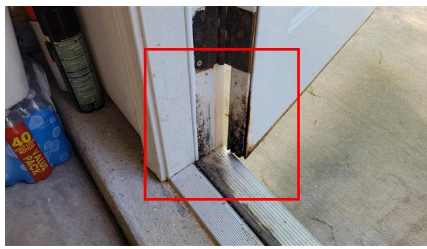
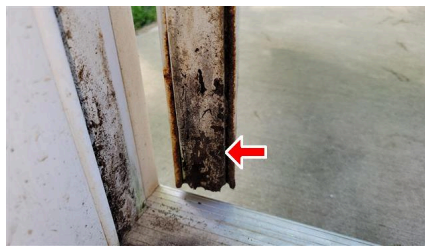
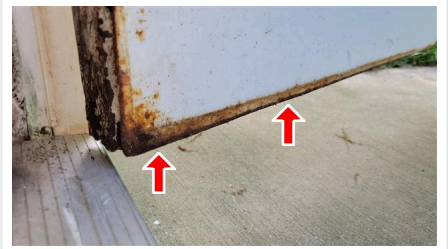
1. The side entry door is deteriorated and rusting. Further deterioration will occur. Further investigation and repairs are needed.

A qualified person should repair or replace as needed.

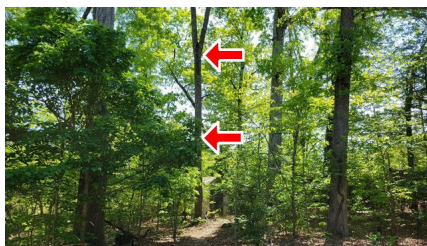
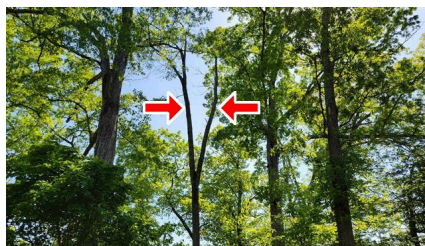
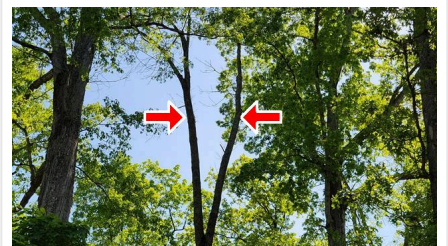
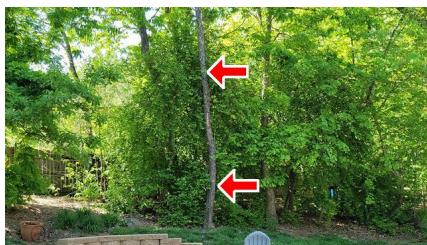
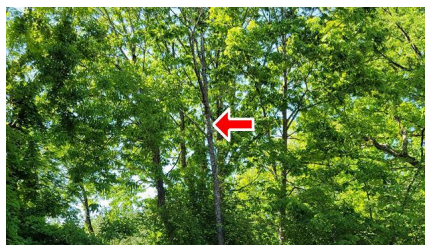
1. Several trees in the backyard are dead. This is a safety issue. The trees could injure people or damage the home. Further investigation is needed.

A qualified person should remove the trees.

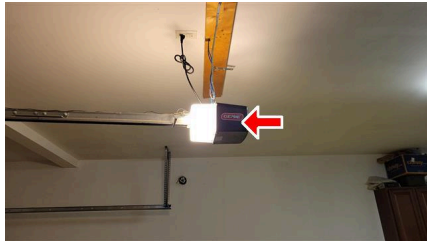
3.7 Item 1 (Picture)

1. The garage door operator safety reverse will not reverse properly when met with resistance. This is a safety issue. Further investigation and repairs are needed.

A qualified person should repair or replace as needed.

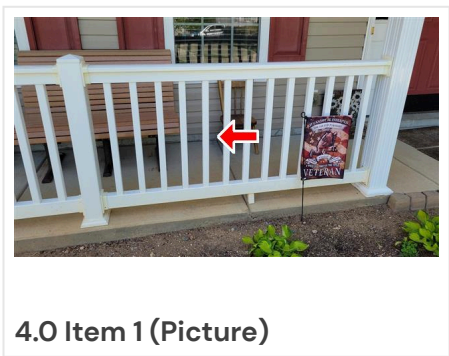
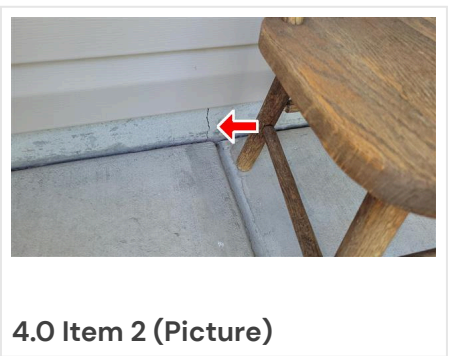
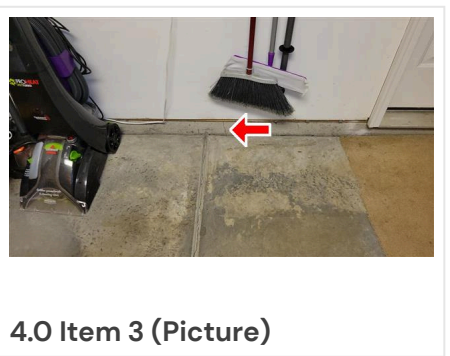
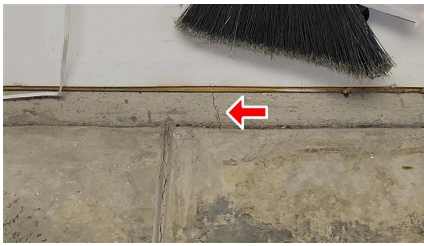
4.0 Item 4 (Picture)

1. The concrete slab at the exterior is cracked due to the natural shrinkage that occurs when concrete cools after it heats up and expands as it cures. The pad surface was even and no evidence of differential movement was noted. Repairs are recommended.

I recommended contacting a qualified handyman or qualified person regarding these conditions to seal the crack to prevent water penetration.

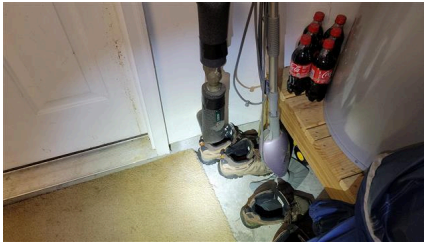
5.0 Item 1 (Picture)

The main shut off is the green lever located in the garage. This is for your information.

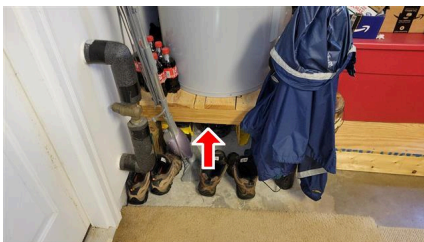
5.1 Item 1 (Picture)

1. The stand for the water heater is wood structure that does not appear to meet typical construction methods for a standard floor framing. Due to the unit's weight and safety related to a field water heater, water heater stands are typically required to be rated and labeled. Further investigation is needed.

A qualified contractor should inspect and repair as needed.

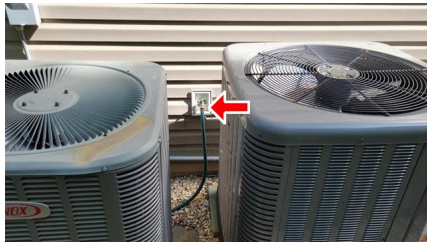
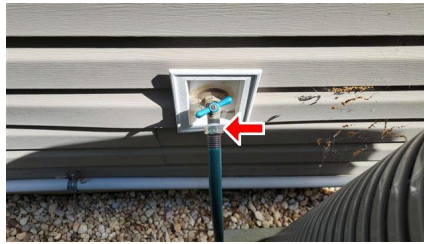
1. The hose bibs (outside water faucets) are missing anti-siphon device. An anti-siphon faucet prevents contaminated water from being back-washed into the main water supply. Cross contamination could occur if not corrected. This is a small repair.

I recommend contacting a licensed plumber.

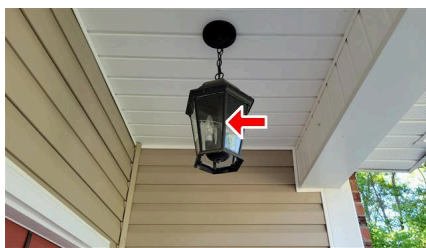
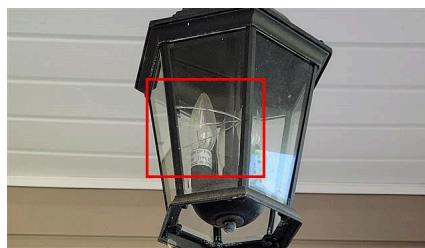
1. The light fixture glass is cracked or broken at the exterior. This is a safety issue that needs to be corrected. Repairs are needed..

A qualified licensed electrical contractor should correct as needed.

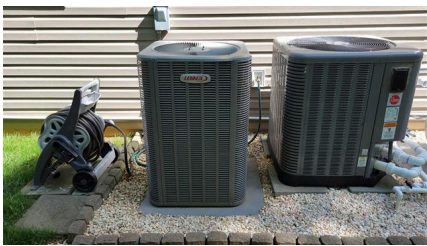
Complimentary photo of the heat pump

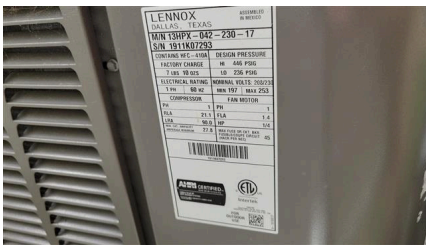
Complimentary photo of the heat pump

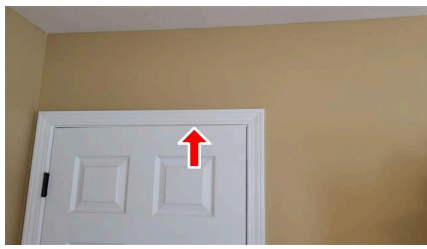
8.5 Item 1 (Picture)

1. The Privacy door rubs at top when closing at the guest Bedroom. As a result the door will not close properly. Repairs are needed.

A qualified person should repair or replace as needed.

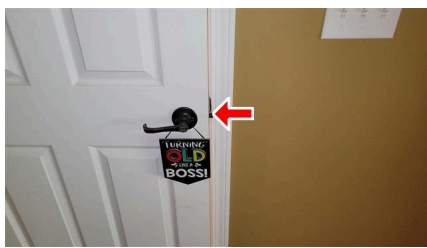
8.5 Item 2 (Picture)

1. The door at master Bedroom will not latch properly. Evidence suggest that the door needs strike and latch adjustment to shut properly. This is a small repair.

A qualified person should repair or replace as needed.

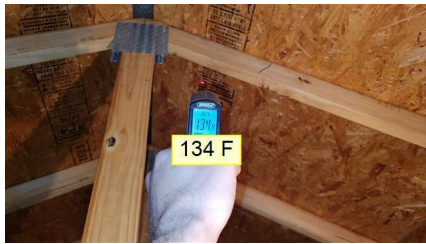
9.1 Item 1 (Picture)

1. Roof/attic area doesn't have enough ventilation. The temperature in the attic was 134F. The outside temperature was 81F. Improper/lack of ventilation will shorten the life expectancy of the roofing materials/shingles. Improper ventilation can also cause moisture problems/conditions/condensation inside the structure. Further investigation and repairs are needed.

A qualified contractor should inspect and repair as needed.

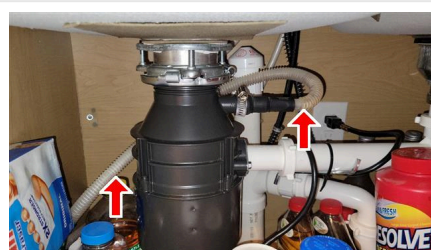
10.0 Item 1 (Picture)

1. The dishwasher drain hose needs to be looped above the level of the kitchen sink drain or an approved air gap installed to prevent back flow of waste water into the water supply. (food safety issue) This can allow waste for the sink to contaminate the dishwasher. This is a small repair.

A qualified licensed plumber should repair or correct as needed.

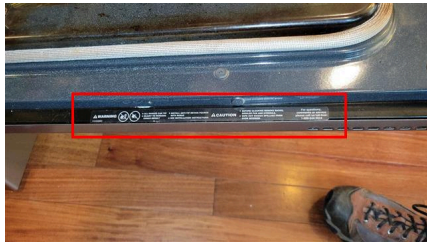
10.1 Item 1 (Picture)

1. The range/oven needs to be properly attached/anchored to the structure as to keep it from tipping over when the oven door is opened and/or oven racks are pulled out during use. This is a safety issue. Repairs are needed.

I recommend contacting appliance repair company.
