INSPECTION REPORT  
12430 Bravington Rd  
Huntersville NC 28078

INSPECTED BY  
Alex Parr 3692  
Above Parr Home  
Inspections

INSPECTION DATE  
📅 2/7/2024  
🕒 09:00:00 AM

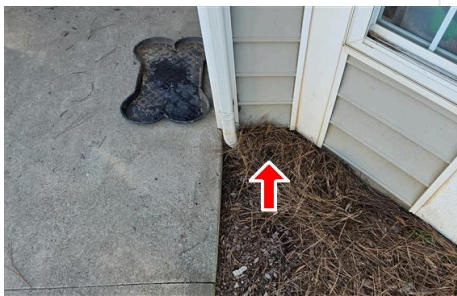
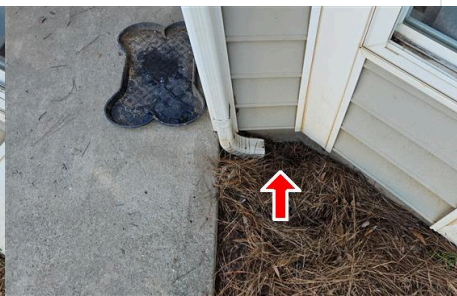
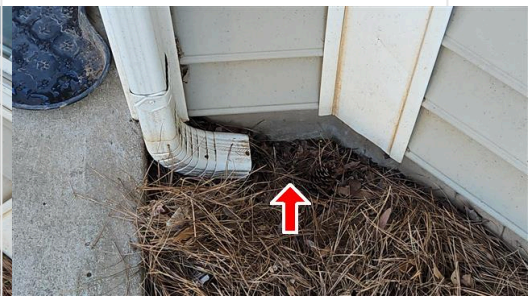
1. The downspout at the rear of the home terminates at the foundation. Erosion can continue or become

worse if not corrected possibly leading to water intrusion. Repairs are needed.  
A qualified person should repair or replace as needed.

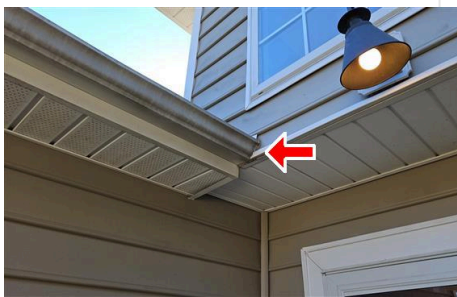
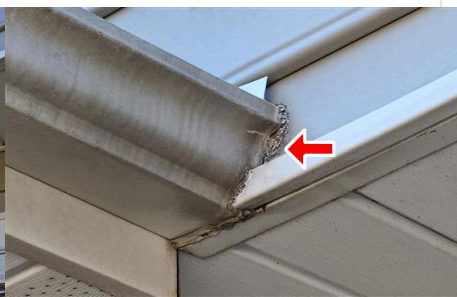
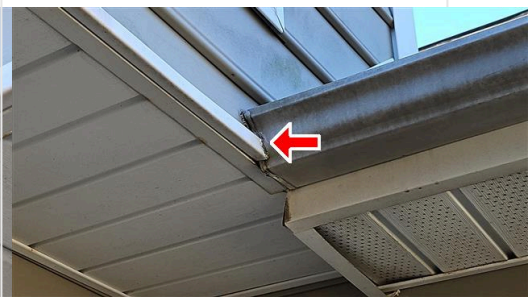
1. The gutters at the front of the home are installed improperly. Gutters that drain poorly or clogged can lead to many costly problems such as deterioration of fascia, soffit or roof edge. It can also cause gutters to pull loose and lead to possible water intrusion. Repairs are needed.

A qualified contractor should inspect and repair as needed.

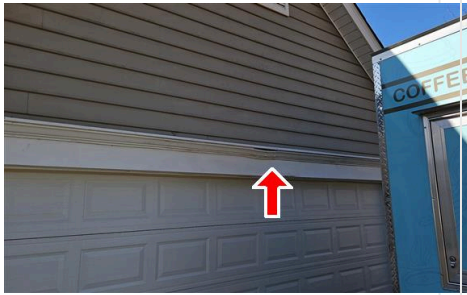
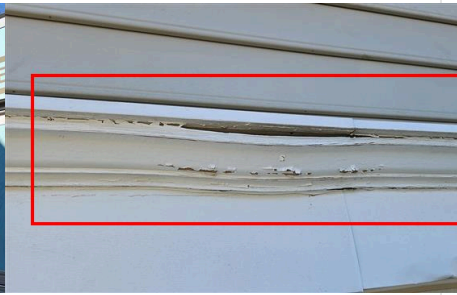
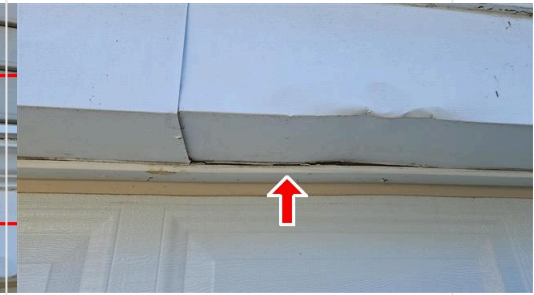
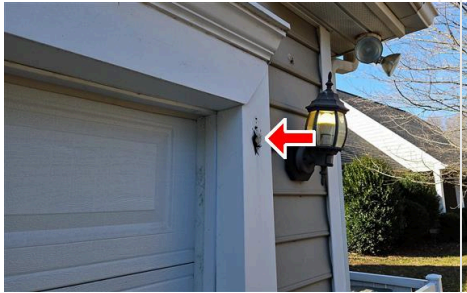
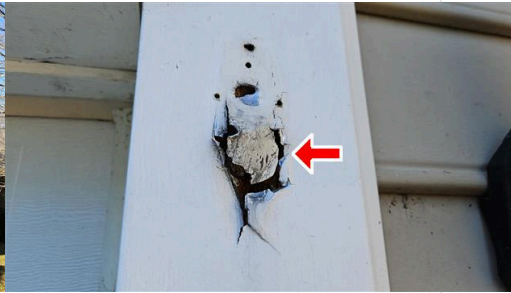
1. The wood trim at the front of home is deteriorated. Further deterioration can occur if not corrected. This could allow water damage to occur to the home. Further investigation and repairs are needed.

A qualified contractor should inspect and repair as needed.

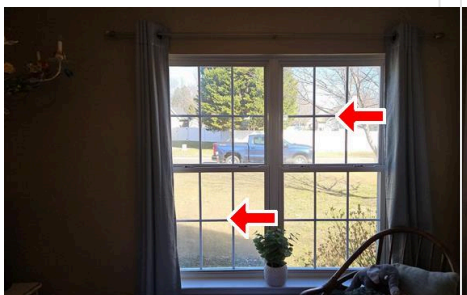
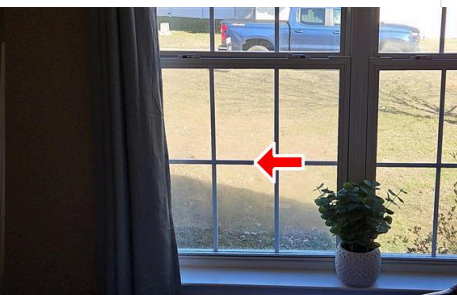
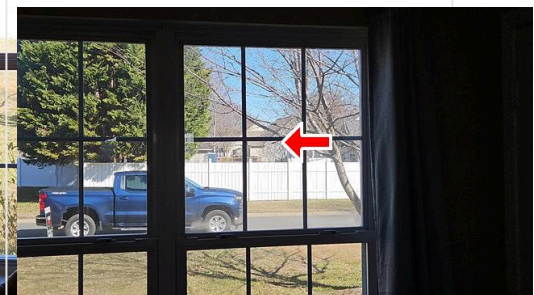
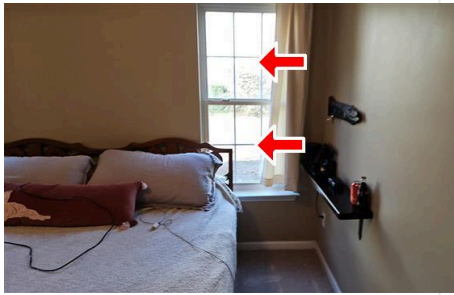
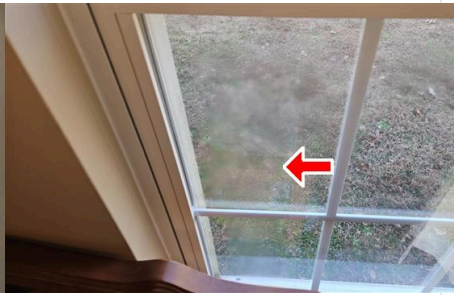
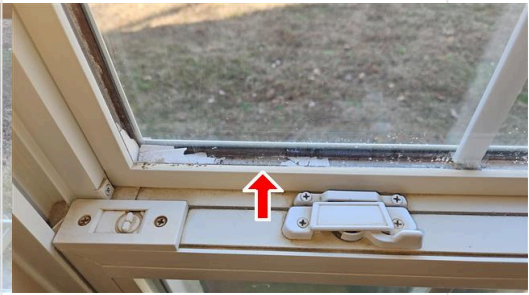
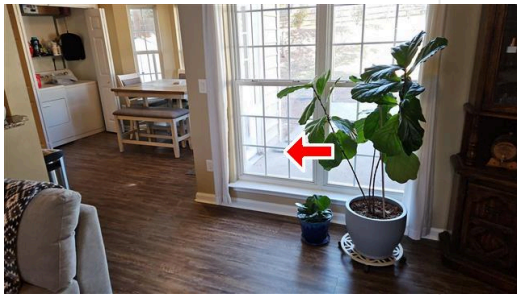
1. Several windows have failed/compromised thermal seals/fogged window panes. This is indicated by the visible moisture, discoloration, calcium deposits and or crystallization visible between the glass window panes. A certified window technician should recheck all the windows throughout the home. Due to weather conditions many times compromised/failed windows cannot be identified at the time of inspection. Further investigation and repairs are needed.

We recommend contacting a properly licensed window technician/contractor regarding these conditions and have repairs made deemed appropriate

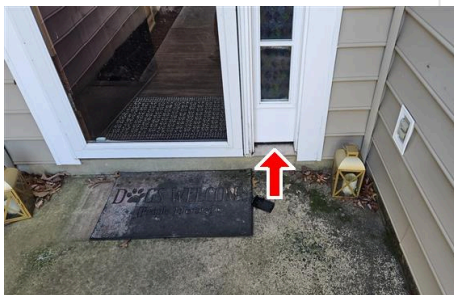
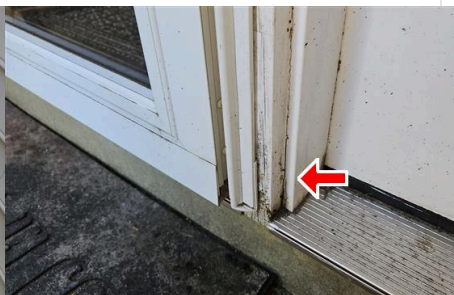
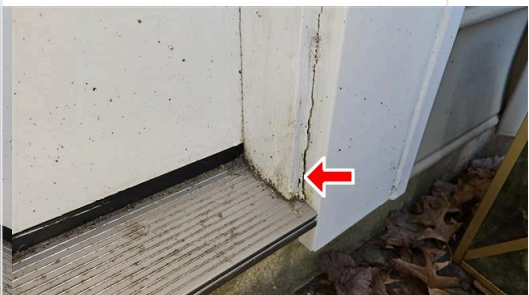
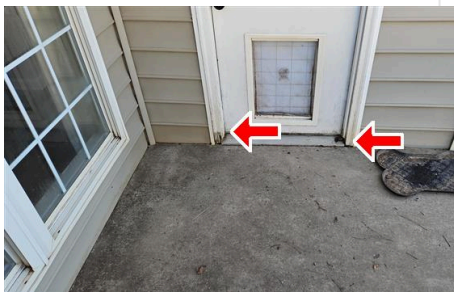
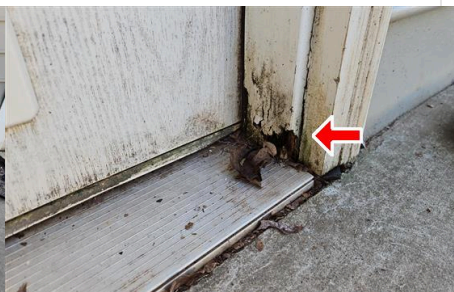
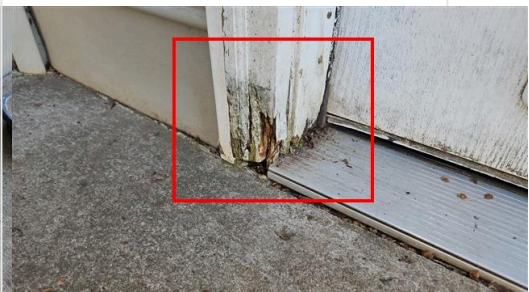
1. The main and rear entry doors are deteriorated at bottom of jamb (s). Further deterioration will occur if not repaired. A repair or replacement is needed.

A qualified contractor should inspect and repair as needed.

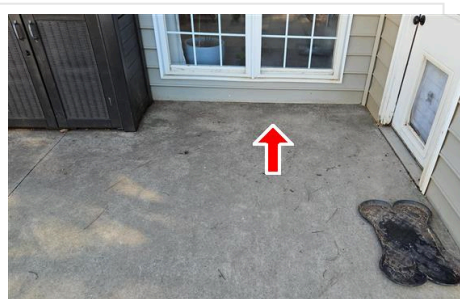
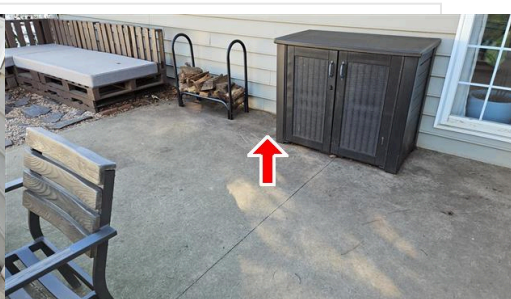
1. The concrete patio at the rear of home slopes toward foundation of home. Deterioration can occur if not repaired. Further investigation and repairs are needed.

A qualified contractor should inspect and repair as needed.

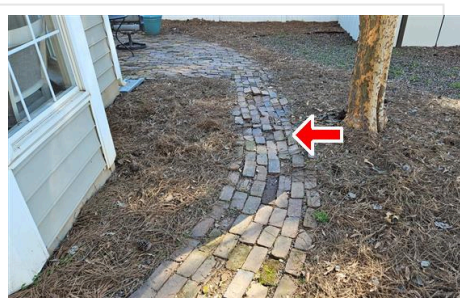
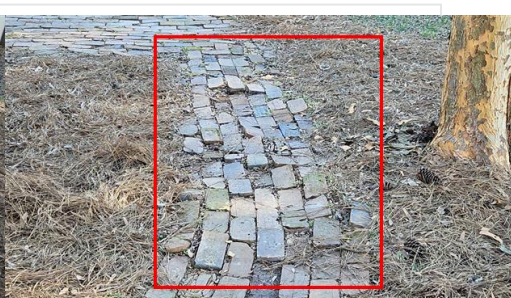
1. The brick walkway at the rear of home uneven, and can be a tripping hazard. Further deterioration can occur if not repaired. A fall or injury can occur if not corrected. Further investigation and repairs are needed.

A qualified person should repair or replace as needed.

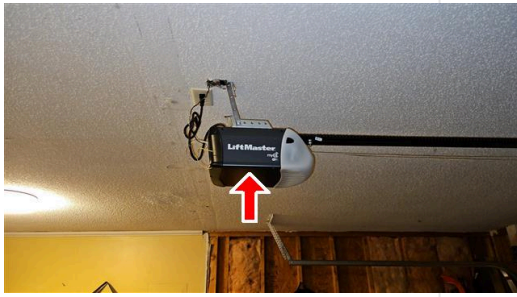
3.7 Item 1 (Picture)

1. The garage door operator safety reverse will not reverse properly when met with resistance. This is a safety issue. Further investigation and repairs are needed.

A qualified person should repair or replace as needed.

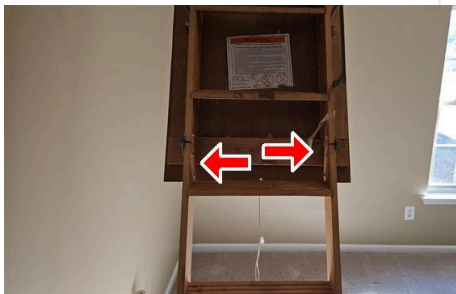
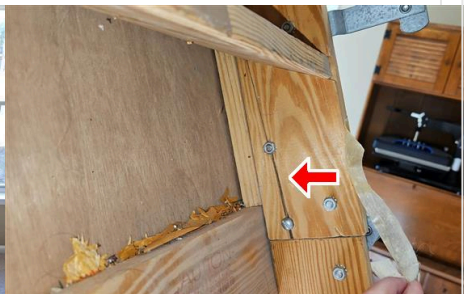
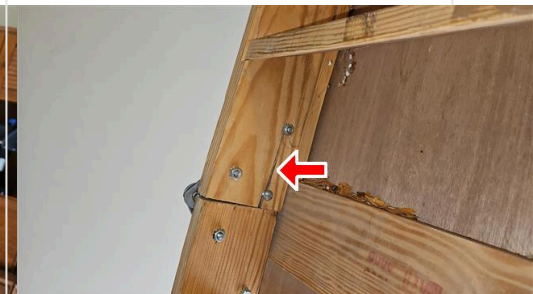
1. The attic stairs are split or damaged. Injury could result if not repaired. Repairs are needed. A qualified person should repair or replace as needed.

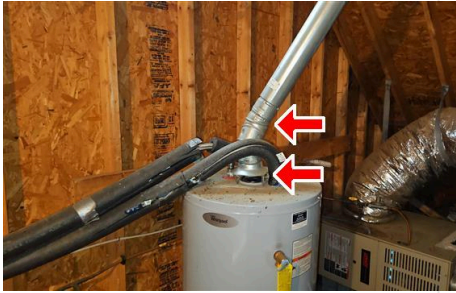
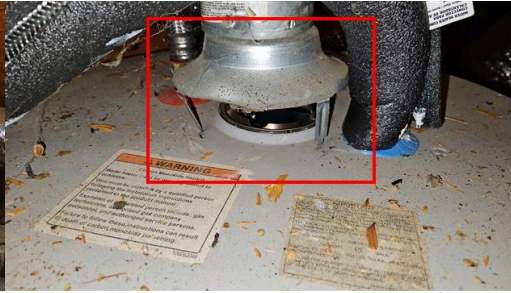
1. The draft hood connection to flue vent connector: provide at least 12" vertical inches of the flue vent between the draft hood outlet and the first elbow. This is a safety issue and should be repaired. Further investigation and repairs are needed.
2. The draft hood is not attached properly. A safety issue. Further investigation and repairs are needed.

A qualified licensed plumber should repair or correct as needed.

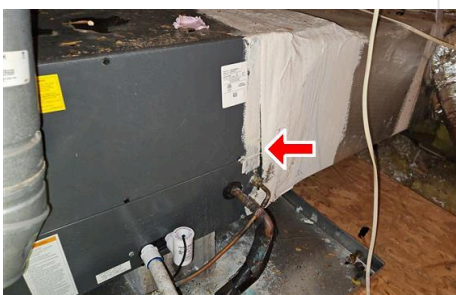
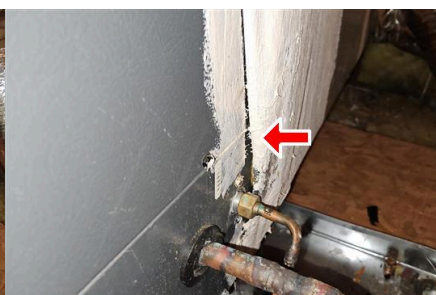
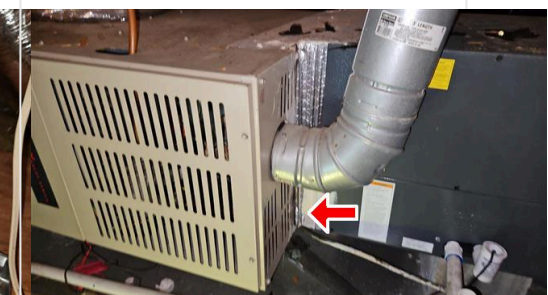
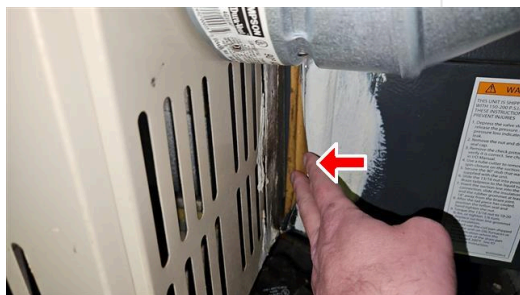
1. The ductwork and the AC/furnace are not sealed properly in the attic. Energy loss is occurring. Further investigation and repairs are needed..

I recommend further inspection by a licensed HVAC contractor.

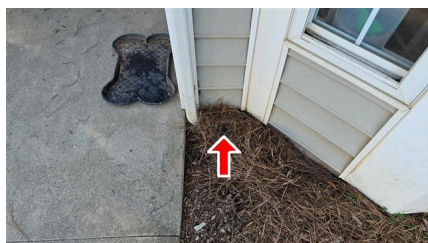
2.3 Item 1 (Picture)

1. The downspout at the rear of the home terminates at the foundation. Erosion can continue or become worse if not corrected possibly leading to water intrusion. Repairs are needed.

A qualified person should repair or replace as needed.

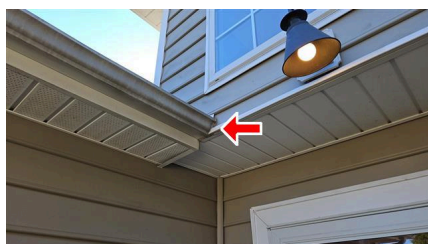
2.3 Item 4 (Picture)

1. The gutters at the front of the home are installed improperly. Gutters that drain poorly or clogged can lead to many costly problems such as deterioration of fascia, soffit or roof edge. It can also cause gutters to pull loose and lead to possible water intrusion. Repairs are needed.

A qualified contractor should inspect and repair as needed.

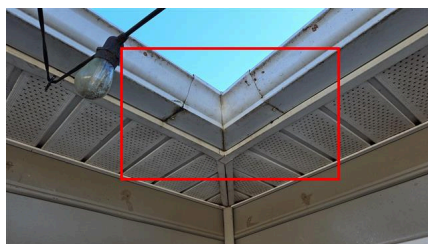
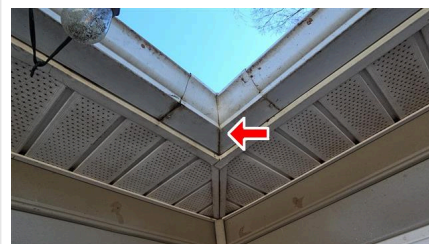
1. The gutter leaks at seam (s) at the rear of the home. Gutters that drain poorly or clogged can lead to many costly problems such as deterioration of fascia, soffit or roof edge. It can also cause gutters to pull loose and lead to possible water intrusion. Repairs are needed.

A qualified person should repair or replace as needed.

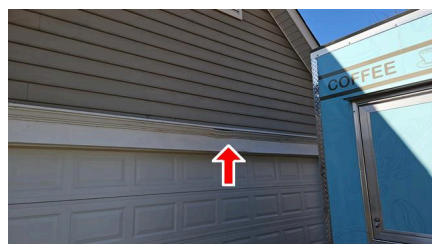
3.0 Item 1 (Picture)

1. The wood trim at the front of home is deteriorated. Further deterioration can occur if not corrected.

This could allow water damage to occur to the home. Further investigation and repairs are needed.

A qualified contractor should inspect and repair as needed.

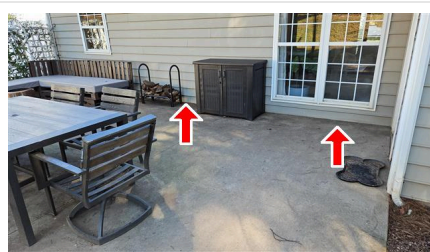
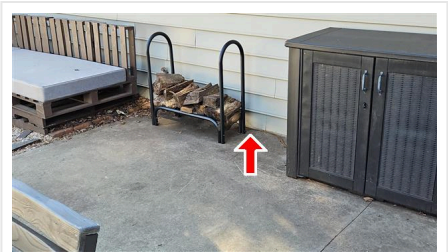
1. Siding in contact with ground at rear of home. Because the siding is in contact with ground it is possible for framing to be deteriorated. We did not inspect behind this siding. Recommend a ground clearance of six to eight inches where possible.

A qualified contractor should inspect and repair as needed.

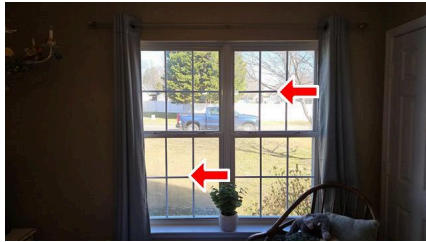
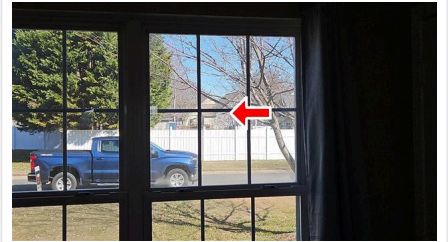
1. Several windows have failed/compromised thermal seals/fogged window panes. This is indicated by the visible moisture, discoloration, calcium deposits and or crystallization visible between the glass window panes. A certified window technician should recheck all the windows throughout the home. Due to weather conditions many times compromised/failed windows cannot be identified at the time of inspection. Further investigation and repairs are needed.

We recommend contacting a properly licensed window technician/contractor regarding these conditions and have repairs made deemed appropriate

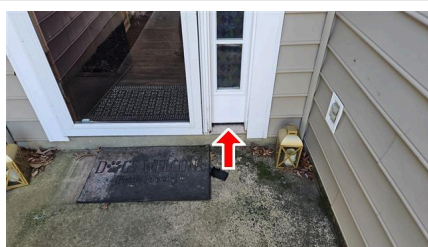
3.3 Item 1 (Picture)

1. The main and rear entry doors are deteriorated at bottom of jamb (s). Further deterioration will occur if not repaired. A repair or replacement is needed.

A qualified contractor should inspect and repair as needed.

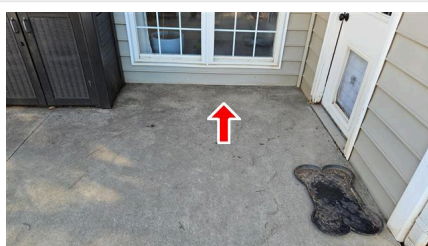
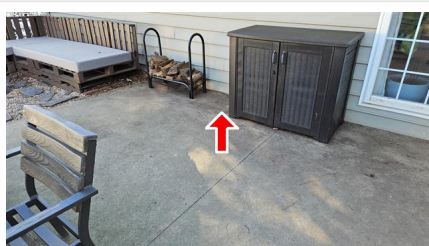
1. The concrete patio at the rear of home slopes toward foundation of home. Deterioration can occur if not repaired. Further investigation and repairs are needed.

A qualified contractor should inspect and repair as needed.

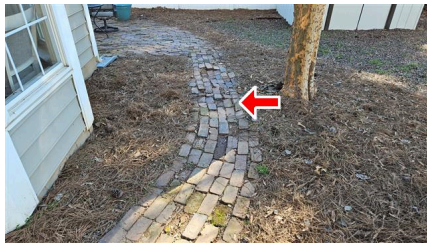
3.5 Item 1 (Picture)

1. The brick walkway at the rear of home uneven, and can be a tripping hazard. Further deterioration can occur if not repaired. A fall or injury can occur if not corrected. Further investigation and repairs

are needed.

A qualified person should repair or replace as needed.

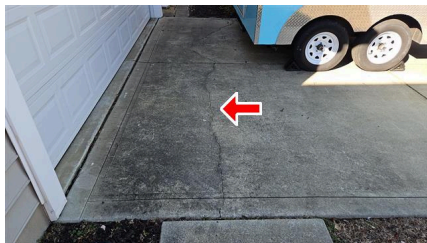
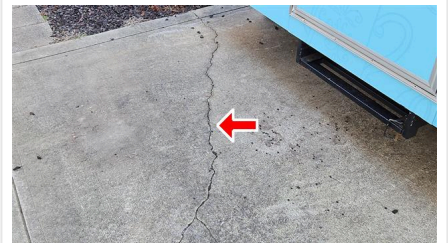
1. The concrete driveway has cracks that should be sealed to prevent further damage, which is part of ongoing maintenance of a concrete driveway that will need to be performed on a regular basis. Repairs are recommended.

A qualified contractor should inspect and repair as needed.

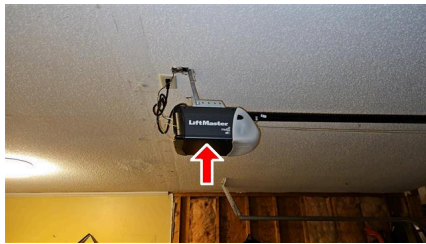
3.7 Item 1 (Picture)

1. The garage door operator safety reverse will not reverse properly when met with resistance. This is a safety issue. Further investigation and repairs are needed.

A qualified person should repair or replace as needed.

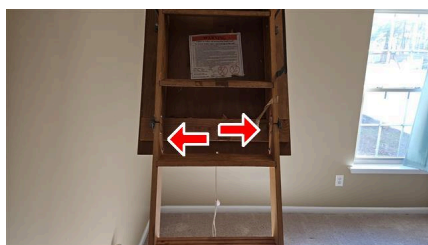
4.4 Item 1 (Picture)

1. The attic stairs are split or damaged. Injury could result if not repaired. Repairs are needed. A qualified person should repair or replace as needed.

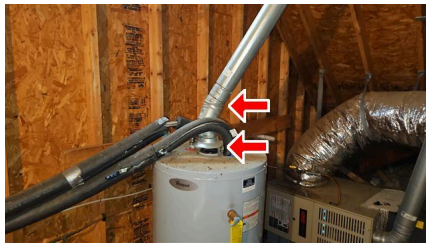
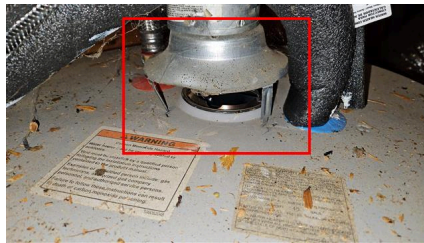
1. The draft hood connection to flue vent connector: provide at least 12" vertical inches of the flue vent between the draft hood outlet and the first elbow. This is a safety issue and should be repaired. Further investigation and repairs are needed.
2. The draft hood is not attached properly. A safety issue. Further investigation and repairs are needed.

A qualified licensed plumber should repair or correct as needed.

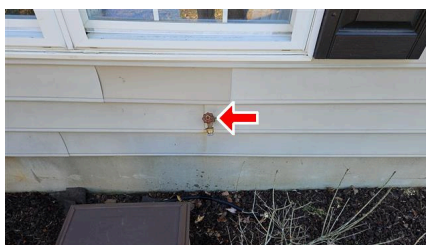
1. The outside water faucet loose, and needs securing to wall at the front of home. This can allow undue stress to occur on supply lines allowing leaks to occur. Repairs are needed..

A qualified licensed plumber should repair or correct as needed.

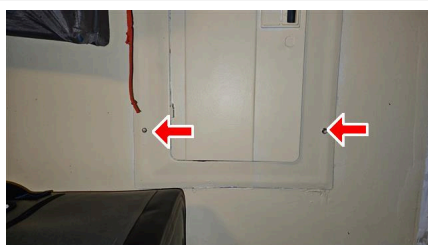
6.2 Item 1 (Picture)

1. The electrical panel cover main panel has been secure with sheet metal screw. This is considered unsafe as sheet metal screws are not rated for electrical panel use. The use of sheet metal screws with panel cover have been known to short hot wires, as the can pearce the branch wiring protective coverings. (Safety Issue) Repairs are needed.

A qualified licensed electrical contractor should correct as needed.

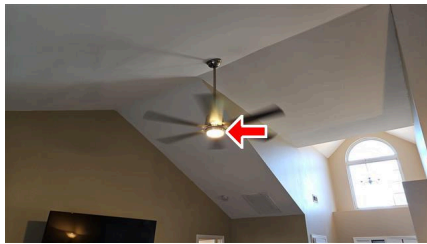
6.4 Item 1 (Picture)

1. The ceiling fan does work, but "wobbles" in the living room. Some fans that wobble cannot be corrected without replacement. Repairs are needed.

A qualified licensed electrical contractor should correct as needed.

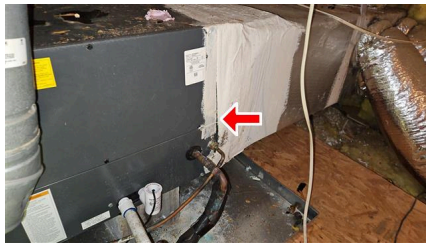
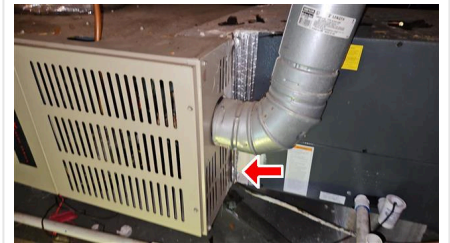
1. The ductwork and the AC/furnace are not sealed properly in the attic. Energy loss is occurring. Further investigation and repairs are needed..

I recommend further inspection by a licensed HVAC contractor.

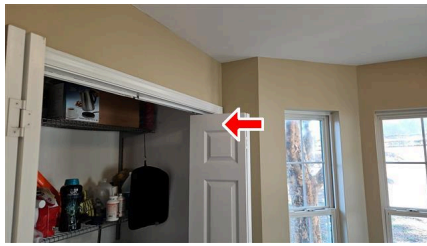
8.5 Item 1 (Picture)

1. The bifold door has damaged hardware for the laundry room. As a result the door will not close properly. Repairs are needed.

A qualified contractor should inspect and repair as needed.

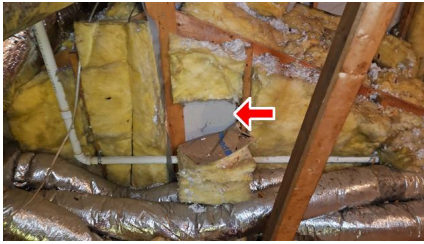
9.2 Item 1 (Picture)

1. Insulation in attic is missing in areas. Heat loss can occur more on this home than one that is properly insulated. Repairs are needed..

A qualified person should repair or replace as needed.
