INSPECTION REPORT  
127 Streamside Ests Dr  
Mooresville NC 28117

INSPECTION DATE  
📅 7/8/2024  
🕒 09:00:00 AM

Inspection Date: 7/8/2024  
Report ID: 070824AP5

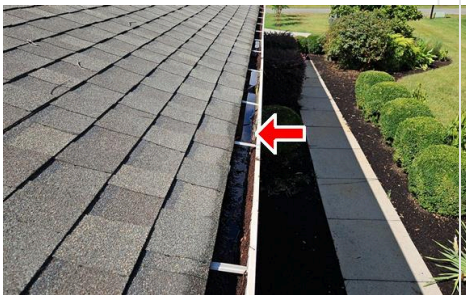
2.3 Item 1 (Picture)

1. The gutter is holding water due to leaves or debris at the front (right of main entry). Gutters that drain poorly or clogged can lead to many costly problems such as deterioration of fascia, soffit or roof edge. It can also cause gutters to pull loose and lead to possible water intrusion. Repairs are needed.

A qualified person should repair or replace as needed.

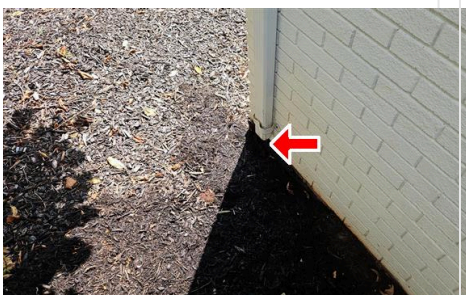
2.3 Item 3 (Picture)

1. The downspout missing part (S) at the front left corner of home. Erosion can continue or become worse if not corrected possibly leading to water intrusion. Repairs are needed.

A qualified person should repair or replace as needed.

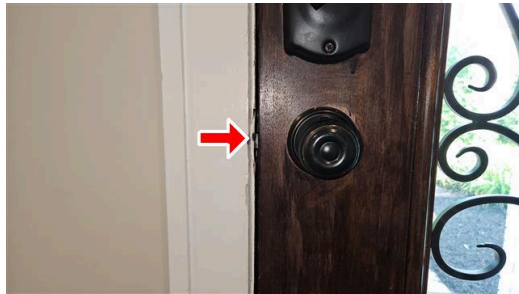
3.3 Item 1 (Picture)

1. The front door will not latch properly. Evidence suggest that the door needs strike and latch adjustment to shut properly. Repairs are needed.

A qualified person should repair or replace as needed.

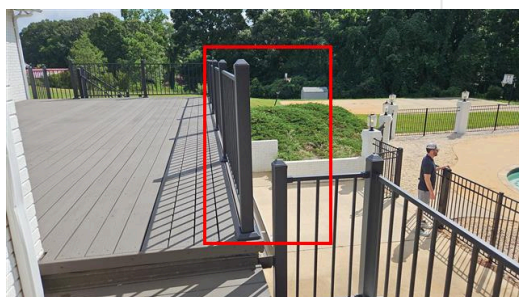
3.4 Item 1 (Picture)

1. The guardrail on steps at the rear of home are lower than 36 inches from deck floor. A fall or injury could occur if not corrected. A repair or replacement is needed.

A qualified contractor should repair or replace as needed.

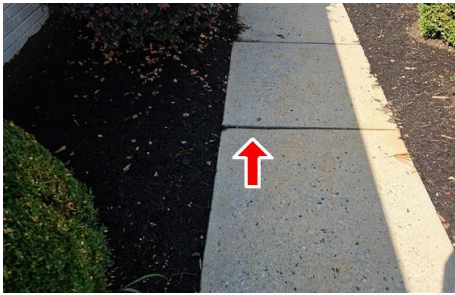
3.5 Item 1 (Picture)

1. The sidewalk at the front of home uneven, and can be a tripping hazard. Water can cause further deterioration if not repaired and sealed properly. A fall or injury can occur if not corrected. Repairs are needed.

A qualified person should repair or replace as needed.

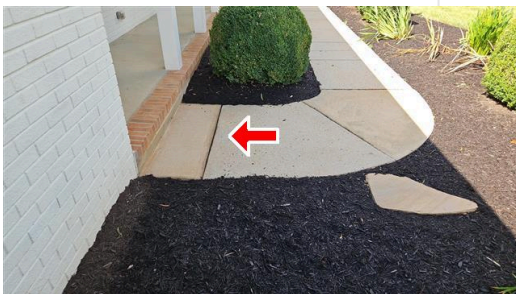
3.5 Item 3 (Picture)

1. The sidewalk at the front of home is sloped back towards the home. Water can cause further deterioration if not repaired and sealed properly. Further deterioration can occur if not repaired.

A qualified person should repair or replace as needed.

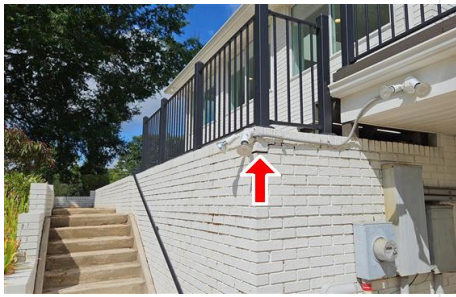
4.0 Item 1 (Picture)

1. The brick at the rear of home has cracks present with outward displacement/ movement present. The wall(s) may need reinforcement. Further investigation and repairs are needed.

A qualified licensed general contractor should inspect further and repair as needed.

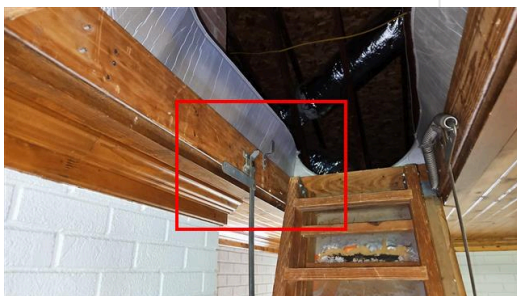
4.4 Item 1 (Picture)

1. The pull down stairs is damaged and dangerous (Missing spring). Injury could result if not repaired. Further investigation and repairs are needed.

A qualified person should repair or replace as needed.

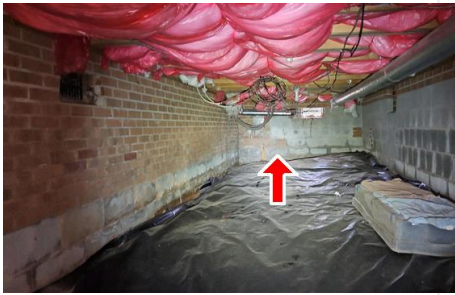
4.6 Item 1 (Picture)

1. Dark stains on the CMU (Concrete Masonry Unit) Indicated that water is inside the block. Dark stains and white efflorescence (powder substance) on block wall indicates moisture is in contact with the masonry. This does not necessarily indicate that intrusion will occur. Efflorescence is found on many homes without water intrusion occurring inside the home. But, it should alert you to the possibility that future steps may be needed. Further investigation and repairs are needed.

I recommend contact a licensed water intrusion specialist regarding these conditions.

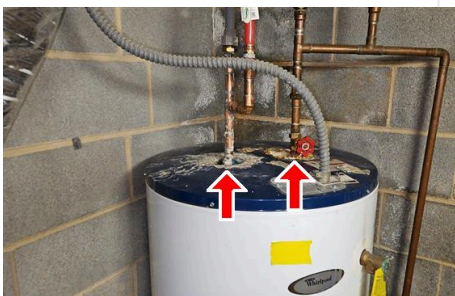
5.1 Item 1 (Picture)

1. The water heater appears to be leaking at hot supply outlet and cold supply inlet. Leaks can cause damage to unit or home. Further investigation and repairs are needed.

A qualified licensed plumber should repair or correct as needed.

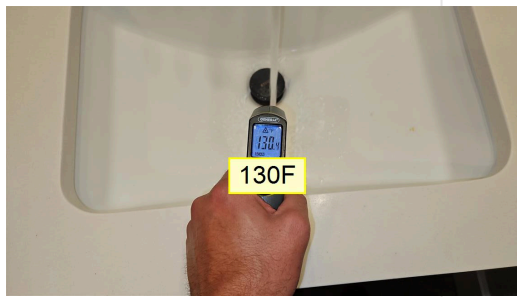
5.1 Item 5 (Picture)

1. The water heater is set over the recommended temperature. (Over 120) The risk is especially acute for

This is a safety issue. Repairs are needed

A qualified contractor should inspect and repair as needed.

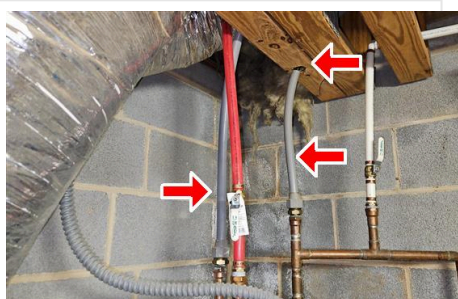
5.2 Item 1 (Picture)

1. Non typical water lines above the water heater and the floor system has been damaged. I recommend having a plumber review the water lines to ensure they are the proper. I recommend having a contractor review the damage to the truss. Further investigation and repairs are needed.

A qualified licensed plumber should repair or correct as needed.

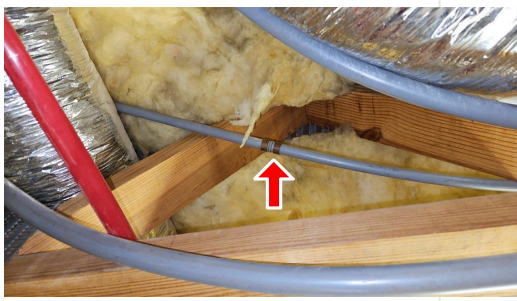
5.2 Item 3 (Picture)

1. Polybutylene plastic plumbing supply lines (PB) are installed in the subject house. Polybutylene has been used in this area for many years, but has had a higher than normal failure rate, and is no longer being widely used. Copper and Brass fittings used in later years have apparently reduced the failure rate. This subject house has copper fittings. For further details contact the Consumer Plumbing Recovery center at 1-800-392-7591 or the web at <http://www.pbpipe.com>

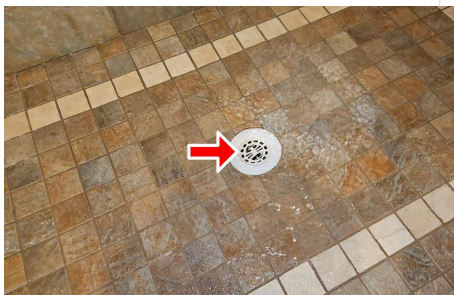
5.3 Item 1 (Picture)

1. The shower drain is damaged at the guest bath. This is a safety issue. Further investigation and repairs are needed.

A qualified licensed plumber should repair or correct as needed.

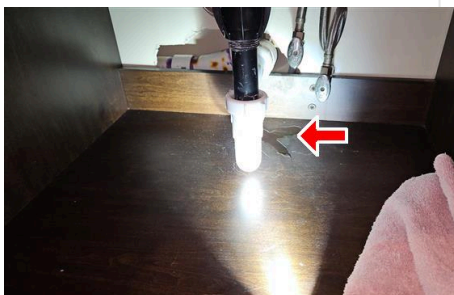
5.3 Item 3 (Picture)

1. The plumbing waste line leaks at the guest bath sink. Repairs are needed to prevent water damage from occurring to the home. Repairs are needed.

A qualified licensed plumber should repair or correct as needed.

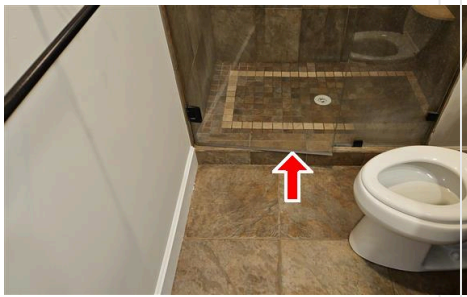
5.4 Item 1 (Picture)

and repairs are needed.

A qualified licensed plumber should repair or correct as needed.

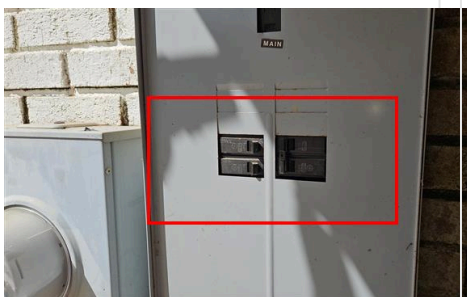
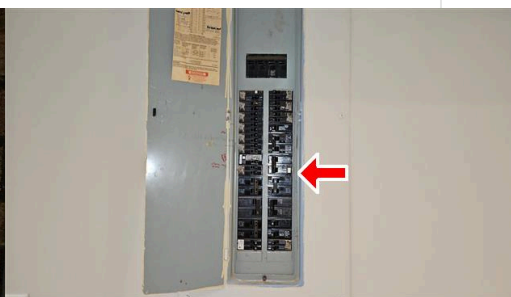
6.2 Item 1 (Picture)

1. Some labels are present, but are illegible or confusing for the electrical panels. This is a safety issue. Repairs are recommended.

A qualified licensed electrical contractor should correct as needed.

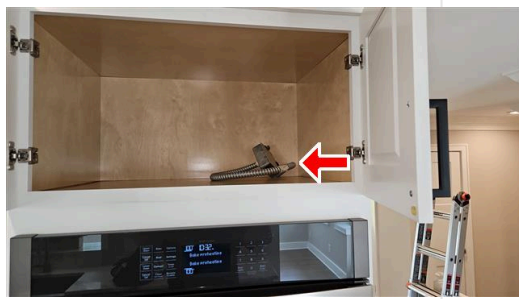
6.4 Item 1 (Picture)

1. The electrical conduit and junction box is loose above the ovens. This is a safety issue. Further investigation and repairs are needed.

A qualified licensed electrical contractor should correct as needed.

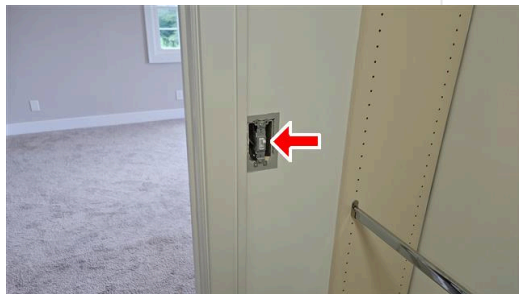
6.4 Item 2 (Picture)

1. The wall switch is missing "cover-plate" at the master bedroom closet. This is a safety issue that needs to be corrected. Repairs are needed..

A qualified licensed electrical contractor should correct as needed.

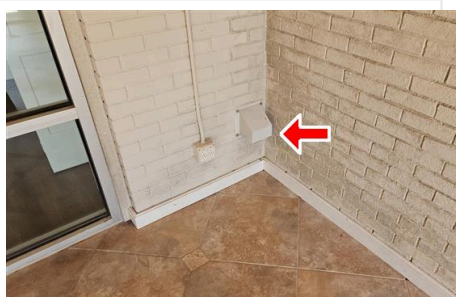
7.8 Item 1 (Picture)

1. It appears they are trying to heat and cool the sunroom in the basement. The connection is improper and the unit may not be sized for this. Further investigation and repairs are needed.

I recommend further inspection by a licensed HVAC contractor.

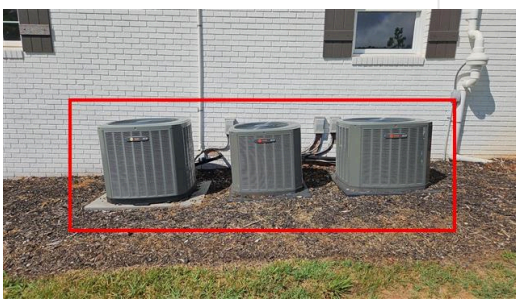
7.8 Item 5 (Picture)

1. The platform for condenser(s) is not level. This can cause damage to the unit or shorten its life span. Further investigation and repairs are needed.

I recommend further inspection by a licensed HVAC contractor.

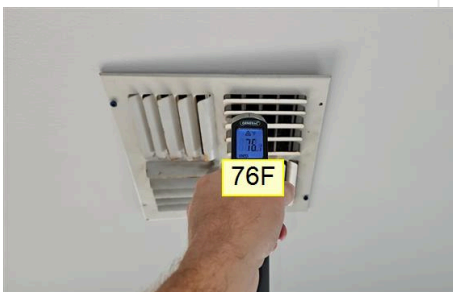
7.8 Item 6 (Picture)

1. The ambient air test was performed by using thermometers on the air handler of Heat pump in cool mode to determine if the difference in temperatures of the supply and return air are between 14 degrees and 22 degrees which indicates that the unit is cooling as intended. (For the pool house) The supply air temperature on your system read 76 degrees, and the return air temperature was 75 degrees. This indicates that the unit is **not** cooling properly and a licensed Heat/Air contractor should inspect for cause or problem.

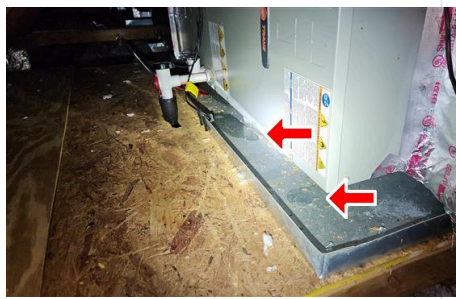
7.8 Item 8 (Picture)

1. The heat pump is leaking at the unit in the attic. Evidence suggest the primary condensation line may be clogged. Leaks can cause damage to unit or home. Further investigation and repairs are needed.

A qualified HVAC person should inspect further and repair or replace as needed.

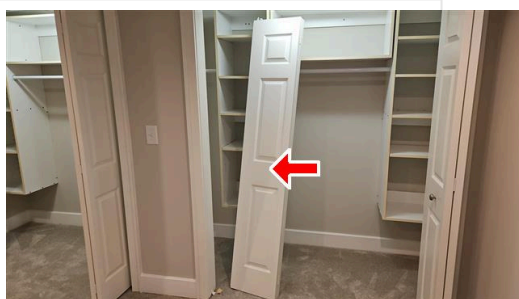
8.5 Item 1 (Picture)

1. The bifold door is damaged or not installed at the basement closet. As a result the door will not close properly. Repairs are needed.

A qualified person should repair or replace as needed.

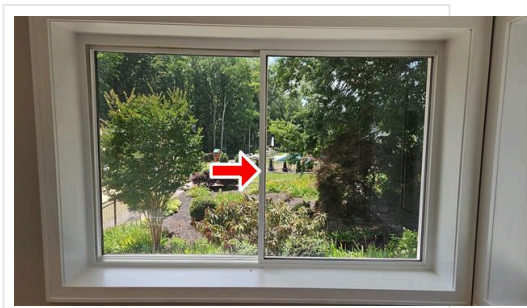
8.6 Item 1 (Picture)

1. One window will not shut properly at the Sunroom. Further investigation and repairs are needed..

A qualified person should repair or replace as needed.

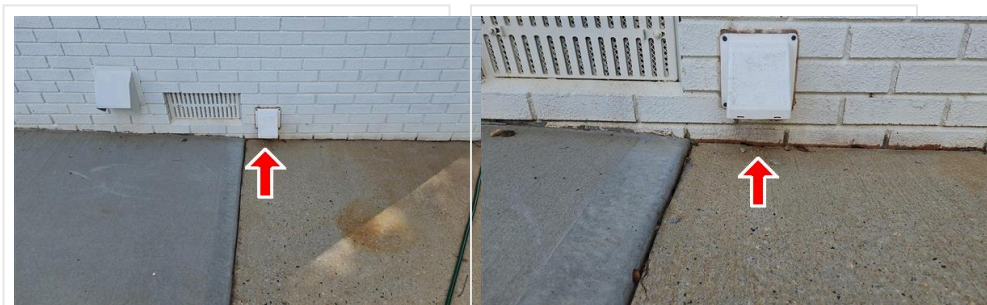
9.4 Item 1 (Picture)

1. The dryer vent hood at the right side (facing front) does not have the proper clearance from the grade/ground to function as intended. Dryer vent exhaust shall terminate not less than 12 inches above finish grade to prevent blockages. Current conditions should be considered a fire hazard until repaired. Repairs are needed.

A qualified person should repair or replace as needed.

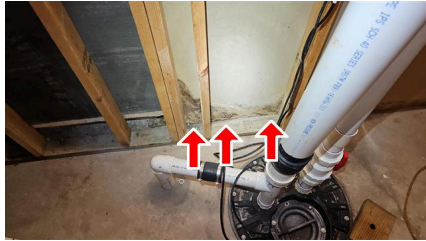
1.0 Item 1 (Picture)

1. Discoloration and some type of mold (Microbial) growth is present in the structure at several areas including but not limited to the crawl space and interior spaces. Evidence suggests that this condition is from a past or present elevated moisture conditions. We did not inspect, test or determine if this type of substance is or is not a health hazard. Further investigation is needed.

We recommend you contact a properly licensed expert for testing, investigation and or correction as deemed appropriate.

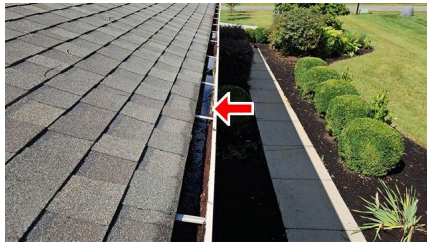
2.3 Item 1 (Picture)

1. The gutter is holding water due to leaves or debris at the front (right of main entry). Gutters that drain poorly or clogged can lead to many costly problems such as deterioration of fascia, soffit or roof edge. It can also cause gutters to pull loose and lead to possible water intrusion. Repairs are needed.

A qualified person should repair or replace as needed.

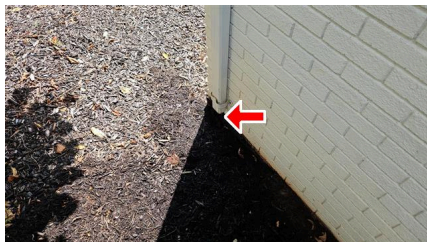
2.3 Item 3 (Picture)

1. The downspout missing part (S) at the front left corner of home. Erosion can continue or become worse if not corrected possibly leading to water intrusion. Repairs are needed.

A qualified person should repair or replace as needed.

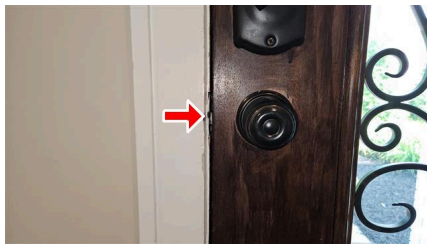
**3.3 Item 1 (Picture)**

1. The front door will not latch properly. Evidence suggest that the door needs strike and latch adjustment to shut properly. Repairs are needed.

A qualified person should repair or replace as needed.

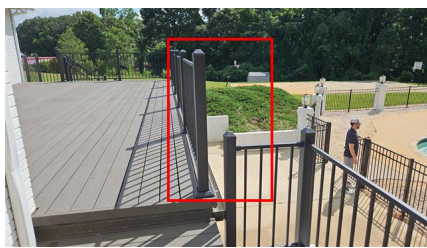
**3.4 Item 1 (Picture)**

1. The guardrail on steps at the rear of home are lower than 36 inches from deck floor. A fall or injury could occur if not corrected. A repair or replacement is needed.

A qualified contractor should repair or replace as needed.

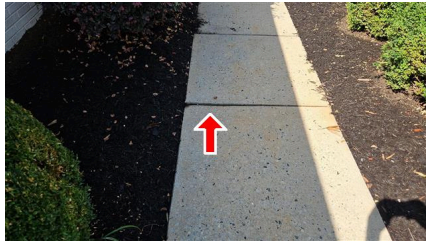
3.5 Item 1 (Picture)

1. The sidewalk at the front of home uneven, and can be a tripping hazard. Water can cause further deterioration if not repaired and sealed properly. A fall or injury can occur if not corrected. Repairs are needed.

A qualified person should repair or replace as needed.

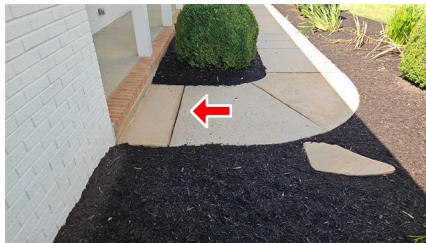
3.5 Item 3 (Picture)

1. The sidewalk at the front of home is sloped back towards the home. Water can cause further deterioration if not repaired and sealed properly. Further deterioration can occur if not repaired.

A qualified person should repair or replace as needed.

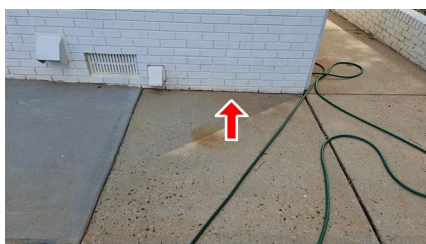
3.5 Item 4 (Picture)

1. The sidewalk at the front of home is sloped back towards the home. Water can cause further deterioration if not repaired and sealed properly. Further deterioration can occur if not repaired.

A qualified person should repair or replace as needed.

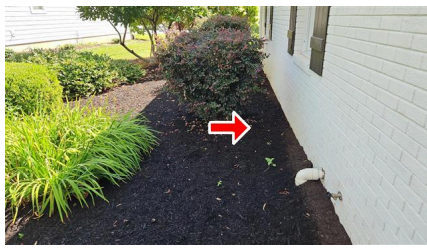
3.5 Item 5 (Picture)

1. There is a negative slope at the front of home and can cause or contribute to water intrusion or

deterioration. I recommend correcting landscape to drain water away from home.  
A qualified person should repair or replace as needed.

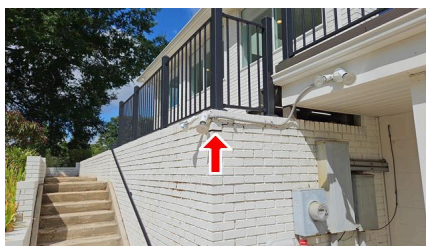
4.0 Item 1 (Picture)

1. The brick at the rear of home has cracks present with outward displacement/ movement present.

The wall(s) may need reinforcement. Further investigation and repairs are needed.

A qualified licensed general contractor should inspect further and repair as needed.

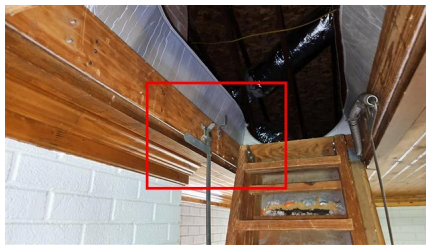
4.4 Item 1 (Picture)

1. The pull down stairs is damaged and dangerous (Missing spring). Injury could result if not repaired. Further investigation and repairs are needed.

A qualified person should repair or replace as needed.

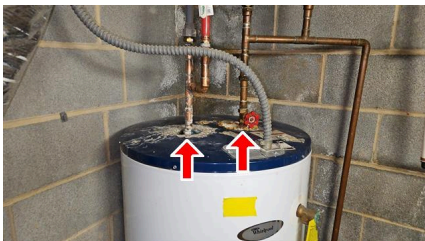
5.1 Item 1 (Picture)

1. The water heater appears to be leaking at hot supply outlet and cold supply inlet. Leaks can cause damage to unit or home. Further investigation and repairs are needed.

A qualified licensed plumber should repair or correct as needed.

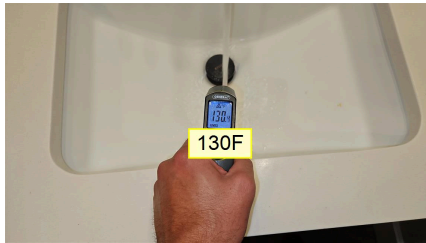
5.1 Item 5 (Picture)

1. The water heater is set over the recommended temperature. (Over 120) The risk is especially acute for infants, children, and the elderly. Water temperatures should never be set higher than 120 degrees. This is a safety issue. Repairs are needed

A qualified contractor should inspect and repair as needed.

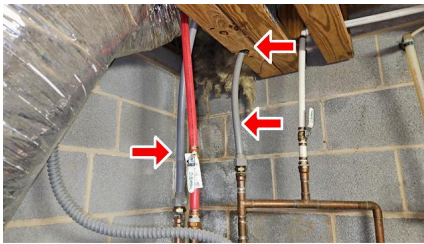
5.2 Item 1 (Picture)

1. Non typical water lines above the water heater and the floor system has been damaged. I recommend having a plumber review the water lines to ensure they are the proper. I recommend having a contractor review the damage to the truss. Further investigation and repairs are needed.

A qualified licensed plumber should repair or correct as needed.

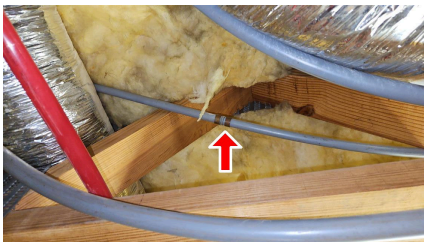
5.2 Item 3 (Picture)

1. Polybutylene plastic plumbing supply lines (PB) are installed in the subject house. Polybutylene has been used in this area for many years, but has had a higher than normal failure rate, and is no longer being widely used. Copper and Brass fittings used in later years have apparently reduced the failure rate. This subject house has copper fittings. For further details contact the Consumer Plumbing Recovery center at 1-800-392-7591 or the web at <http://www.pbpipe.com>

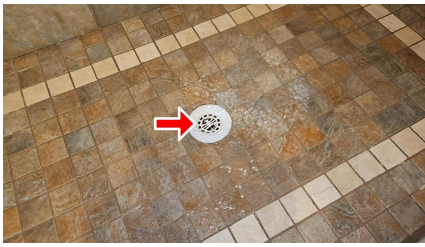
5.3 Item 1 (Picture)

1. The shower drain is damaged at the guest bath. This is a safety issue. Further investigation and repairs are needed.

A qualified licensed plumber should repair or correct as needed.

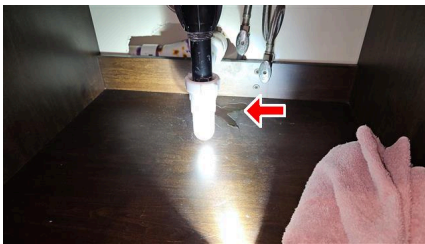
5.3 Item 3 (Picture)

1. The plumbing waste line leaks at the guest bath sink. Repairs are needed to prevent water damage from occurring to the home. Repairs are needed.

A qualified licensed plumber should repair or correct as needed.

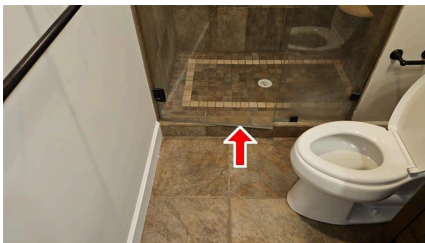
5.4 Item 1 (Picture)

1. The shower door does not shut properly at the guest bath. This is a safety issue. Further investigation and repairs are needed.

A qualified licensed plumber should repair or correct as needed.

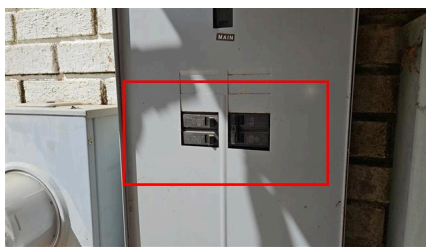
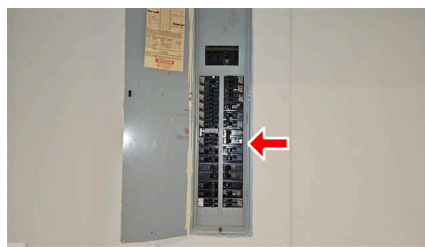
1. Some labels are present, but are illegible or confusing for the electrical panels. This is a safety issue. Repairs are recommended.

A qualified licensed electrical contractor should correct as needed.

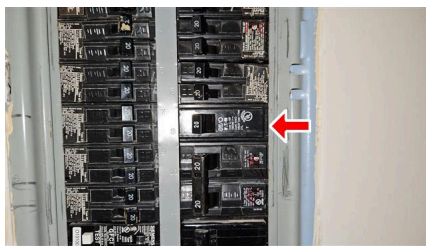
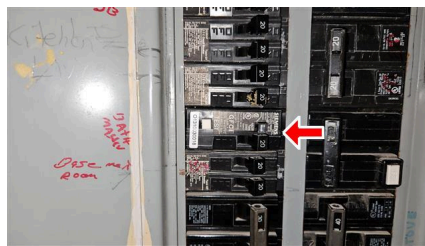
1. One or more circuit in main/sub panel is of a different brand than panel manufacturer. The manufacture requires that in order for the panel to be safe, only their brand is allowed to be used inside the panel. Even though these circuit breaker are all "UL approved," they are not approved to be used in panels of different manufactures unless so indicated on the panel label. Further investigation is needed.

A qualified licensed electrical contractor should correct as needed.

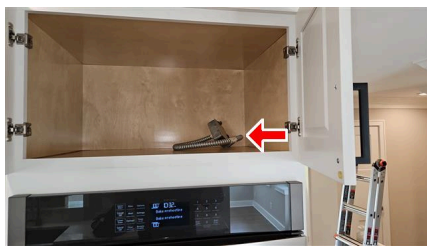
6.4 Item 1 (Picture)

1. The electrical conduit and junction box is loose above the ovens. This is a safety issue. Further investigation and repairs are needed.

A qualified licensed electrical contractor should correct as needed.

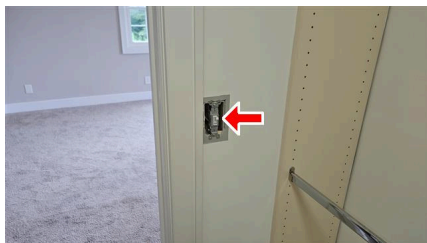
6.4 Item 2 (Picture)

1. The wall switch is missing "cover-plate" at the master bedroom closet. This is a safety issue that needs to be corrected. Repairs are needed..

A qualified licensed electrical contractor should correct as needed.

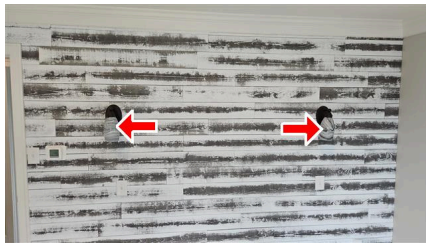
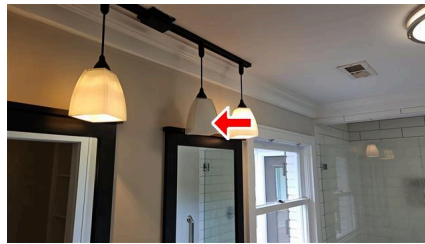
1. The light fixture does not work (try bulb first) at the throughout the home. Further investigation and repairs are needed..

A qualified licensed electrical contractor should correct as needed.

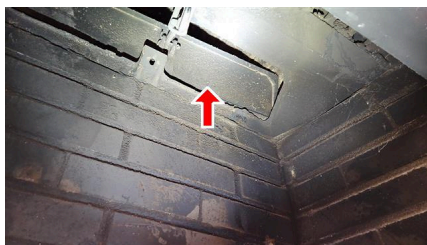
7.5 Item 1 (Picture)

1. The liner was mainly visible and appears good except for creosote dust that may conceal a hairline crack until cleaned and inspected by a licensed chimney sweep. For a detailed inspection of liner. Further investigation is needed.

I recommend a qualified chimney sweep inspect for safety.

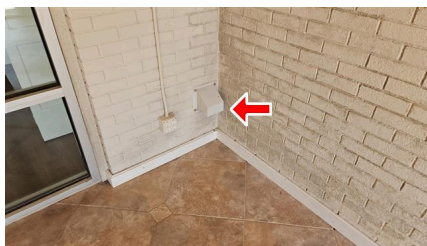
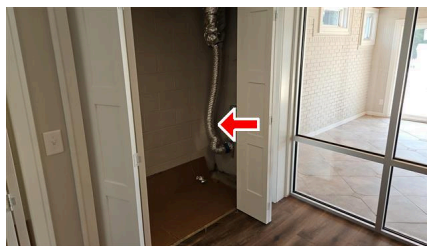
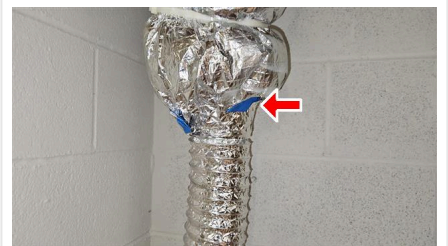
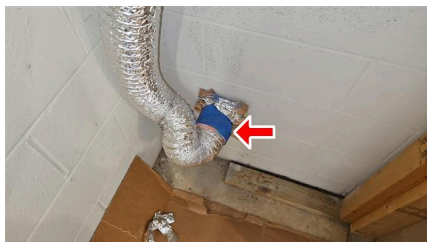
1. It appears they are trying to heat and cool the sunroom in the basement. The connection is improper and the unit may not be sized for this. Further investigation and repairs are needed.

I recommend further inspection by a licensed HVAC contractor.

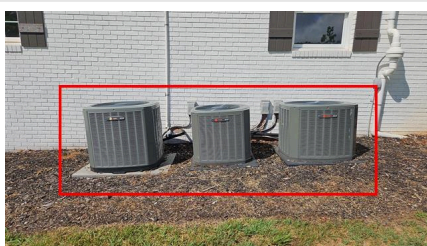
7.8 Item 5 (Picture)

1. The platform for condenser(s) is not level. This can cause damage to the unit or shorten its life span. Further investigation and repairs are needed.

I recommend further inspection by a licensed HVAC contractor.

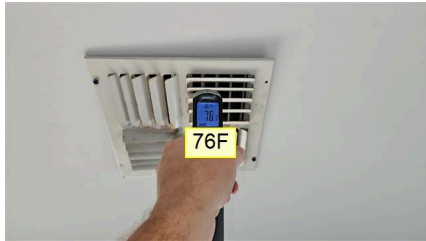
7.8 Item 6 (Picture)

1. The ambient air test was performed by using thermometers on the air handler of Heat pump in cool mode to determine if the difference in temperatures of the supply and return air are between 14 degrees and 22 degrees which indicates that the unit is cooling as intended. (For the pool house) The supply air temperature on your system read 76 degrees, and the return air temperature was 75 degrees. This indicates that the unit is **not** cooling properly and a licensed Heat/Air contractor should inspect for cause or problem.

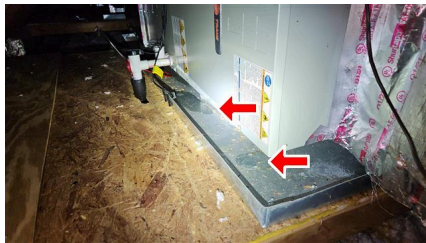
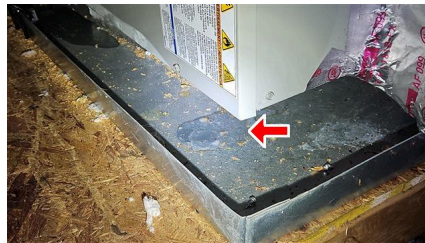
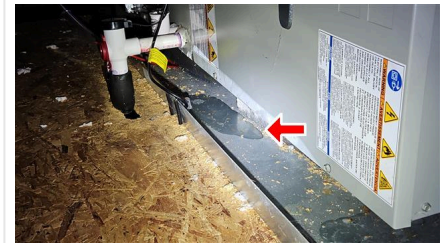
1. The heat pump is leaking at the unit in the attic. Evidence suggest the primary condensation line may be clogged. Leaks can cause damage to unit or home. Further investigation and repairs are needed.

A qualified HVAC person should inspect further and repair or replace as needed.

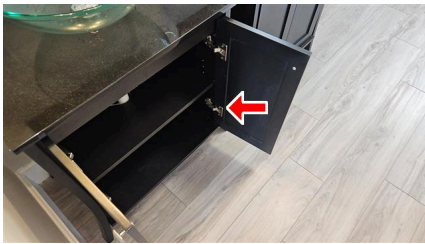
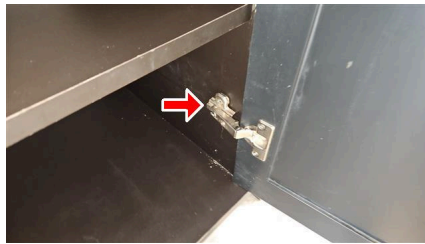
1. The hinge hardware in master bath is loose. Therefore it does not function as intended. Repairs are needed.

I recommend repair or replace as necessary.

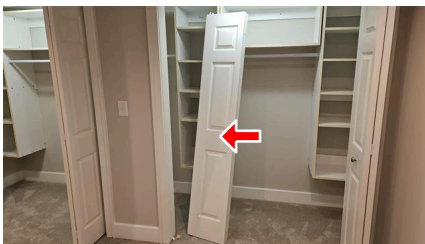
8.5 Item 1 (Picture)

1. The bifold door is damaged or not installed at the basement closet. As a result the door will not close properly. Repairs are needed.

A qualified person should repair or replace as needed.

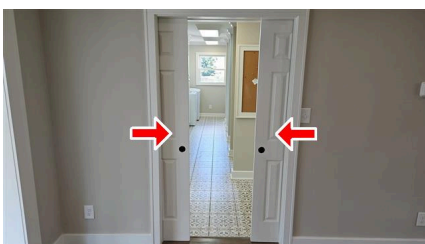
8.5 Item 2 (Picture)

1. The pocket door needs adjustment at the laundry room. As a result the door will not close properly. Repairs are needed.

A qualified person should repair or replace as needed.

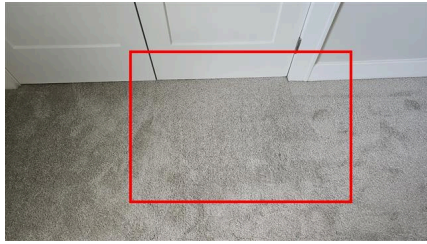
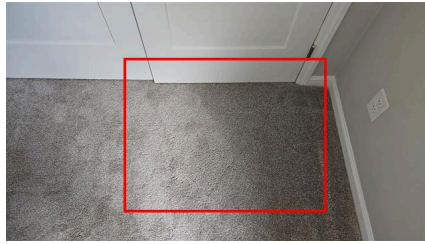
1. The closet door rubs floor when opened. Door needs to be trimmed at bottom by a skilled

craftsman at the guest bedrooms. As a result the door will not close properly. Repairs are needed. A qualified person should repair or replace as needed.

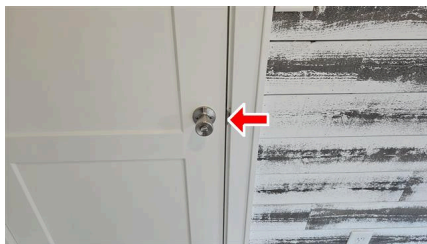
**8.5 Item 5 (Picture)**

1. The door at master Bedroom will not latch properly. Evidence suggest that the door needs strike and latch adjustment to shut properly. This is a small repair.

A qualified person should repair or replace as needed.

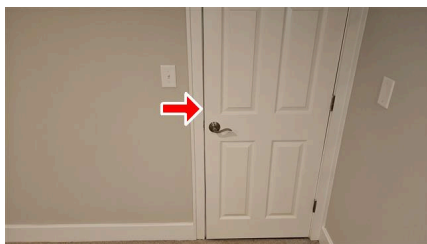
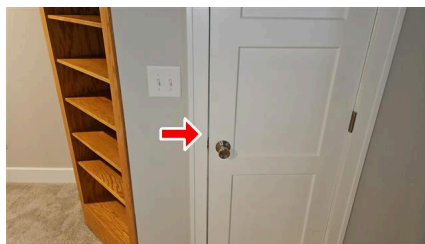
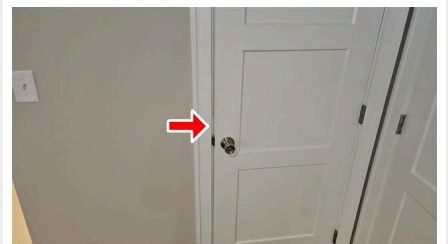
1. The doors rubs at jamb when closing in the basement. As a result the door will not close properly. Repairs are needed.

A qualified person should repair or replace as needed.

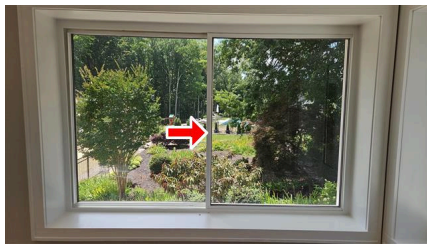
**8.6 Item 1 (Picture)**

1. One window will not shut properly at the Sunroom. Further investigation and repairs are needed..

A qualified person should repair or replace as needed.

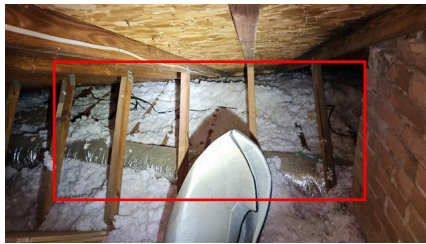
9.2 Item 1 (Picture)

1. Fiberglass (loose-fill) insulation is is compressed in areas of the attic due to foot traffic or storage in attic. Heat loss can occur more on this home than one that is properly insulated. Repairs are recommended .

A qualified person should repair or replace as needed.

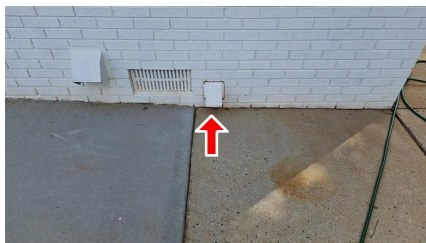
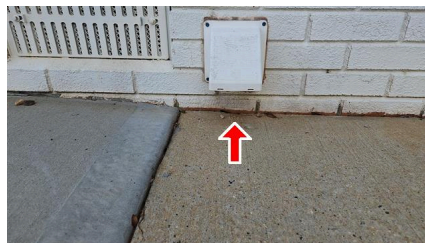
1. The dryer vent hood at the right side (facing front) does not have the proper clearance from the grade/ground to function as intended. Dryer vent exhaust shall terminate not less than 12 inches above finish grade to prevent blockages. Current conditions should be considered a fire hazard until repaired. Repairs are needed.

A qualified person should repair or replace as needed.

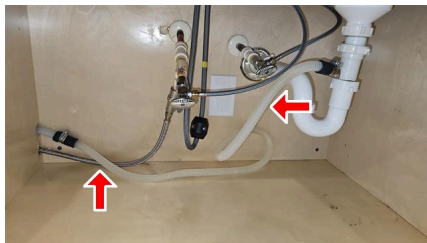
10.0 Item 1 (Picture)

1. The dishwasher drain hose needs to be looped above the level of the kitchen sink drain or an approved air gap installed to prevent back flow of waste water into the water supply. (food safety issue) This can allow waste for the sink to contaminate the dishwasher. This is a small repair.

A qualified licensed plumber should repair or correct as needed.
