INSPECTION REPORT  
129 Sun Ln  
Mooreville NC 28115

INSPECTED BY  
Alex Parr 3692  
Above Parr Home  
Inspections

INSPECTION DATE  
📅 10/23/2024  
🕒 09:00:00 AM

Inspection Date: 10/23/2024  
Report ID: 102324AP2

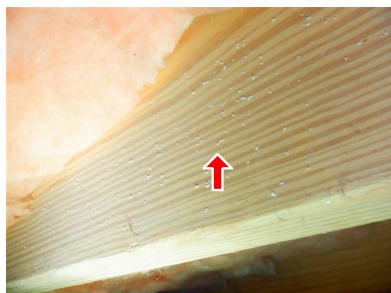
1.0 Item 1 (Picture)

1. Discoloration and some type of mold (Microbial) growth is present in the structure at several areas including but not limited to the crawl space and interior spaces. Evidence suggests that this condition is from a past or present elevated moisture conditions. We did not inspect, test or determine if this type of substance is or is not a health hazard. Further investigation is needed.

We recommend you contact a properly licensed expert for testing, investigation and or correction as deemed appropriate.

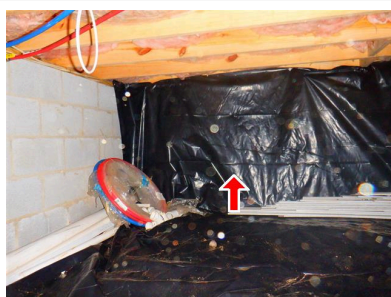
1.1 Item 1 (Picture)

1. The front of the crawl space is blocked with plastic. As a result the areas were not inspected. Hidden damage may be present. Further investigation and repairs are needed.

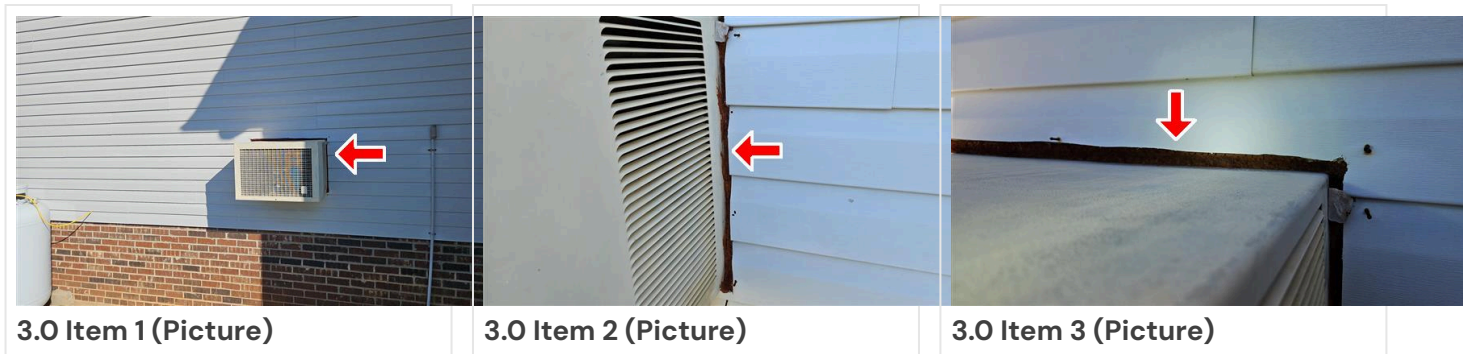
1. The vinyl siding at the rear of home is not flashed properly. This could allow water damage to occur to the home. Further investigation and repairs are needed.  
A qualified contractor should inspect and repair as needed.

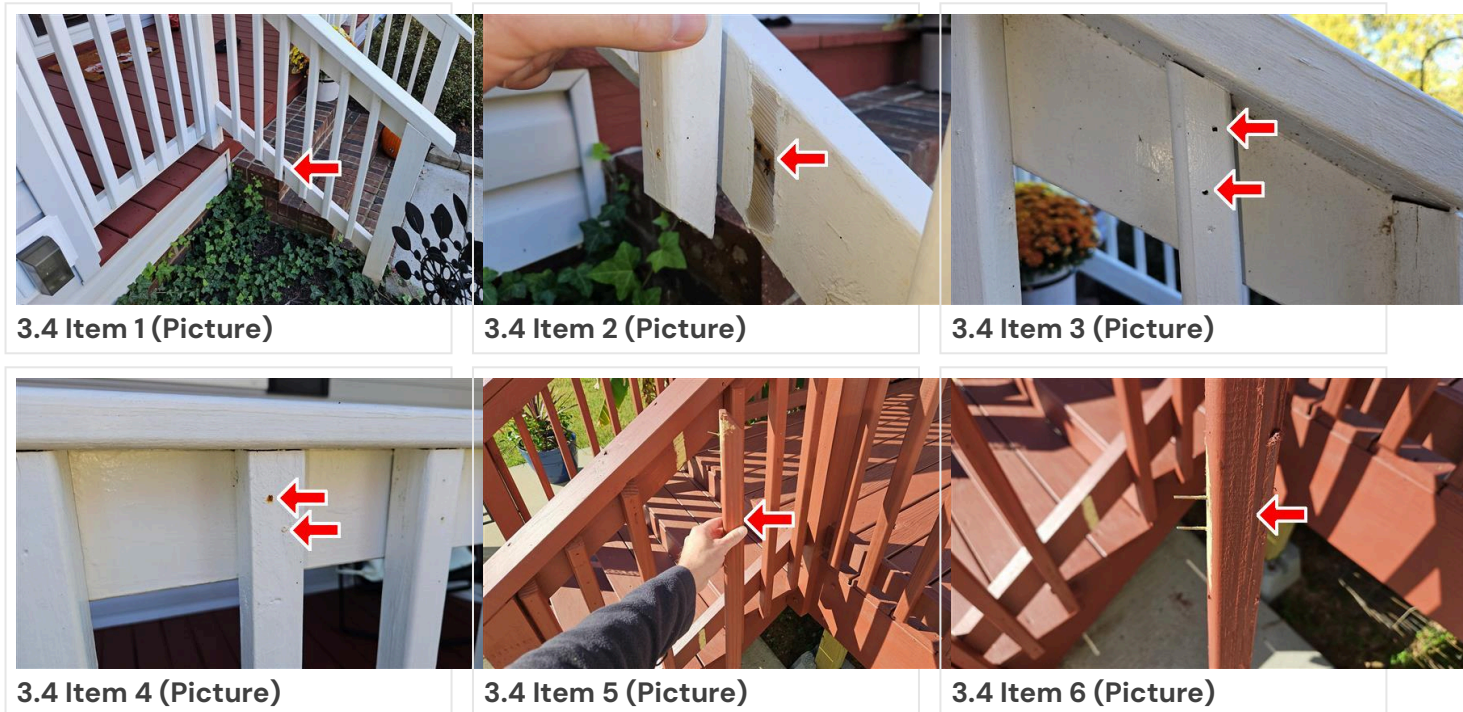
1. The balusters on decks at the front and rear of home are loose and nail improperly. This is a safety issue. A repair or replacement is needed.

A qualified contractor should repair or replace as needed.

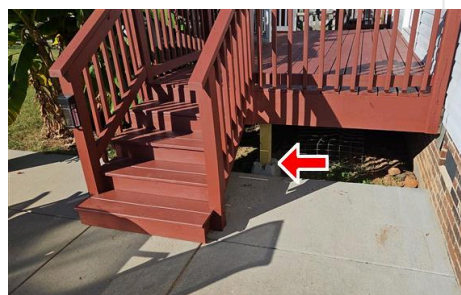
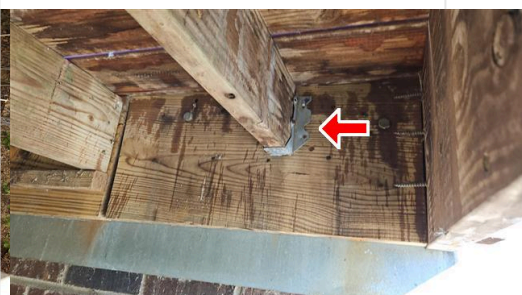
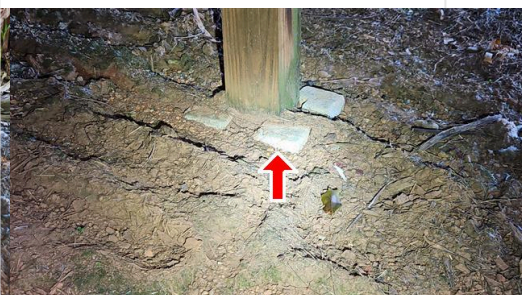
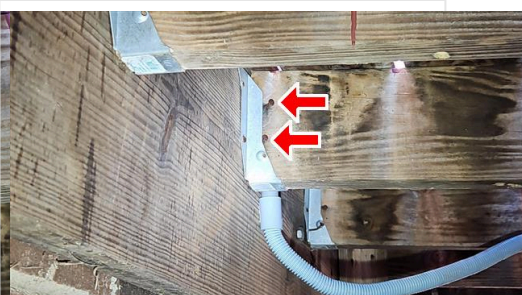
1. The deck at the rear of home is not constructed properly. A fall or injury can occur if not corrected. Further investigation and repairs are needed.

I recommend a complete evaluation of deck for a structural stability and safety.

A qualified contractor should repair or replace as needed.

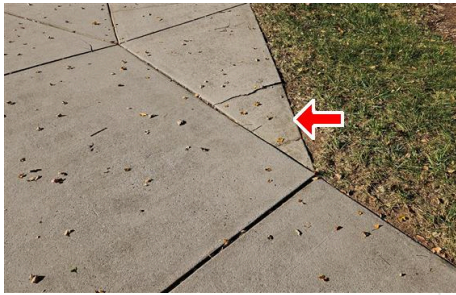
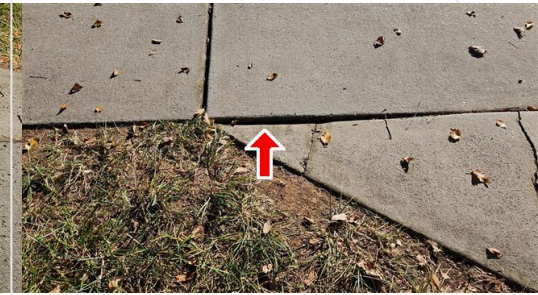
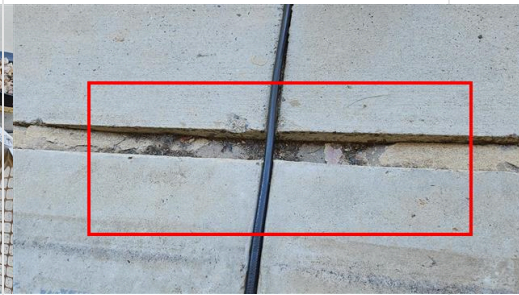
3.5 Item 1 (Picture)

1. The concrete drive at the front of home uneven, and can be a tripping hazard. Water can cause further deterioration if not repaired and sealed properly. A fall or injury can occur if not corrected. Repairs are needed.

A qualified person should repair or replace as needed.

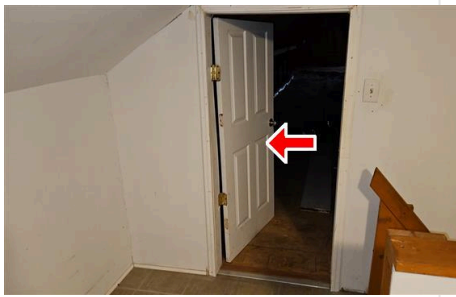
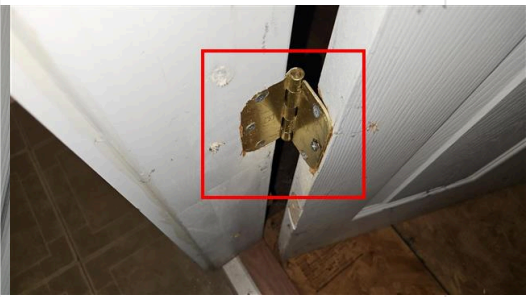
3.9 Item 1 (Picture)

1. The occupant door from inside bonus room to attic the home is not a fire rated door. This means that should a fire occur in garage, the occupant door does not afford protection until fireman arrive. This door should be replaced with a fire rated door. Repairs are needed.

A qualified person should repair or replace as needed.

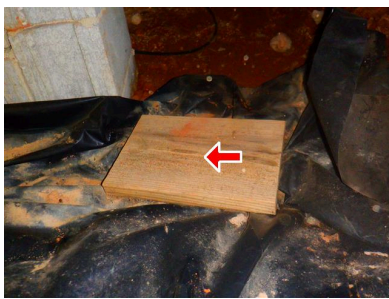
4.5 Item 1 (Picture)

1. Wood debris is in contact with the crawl space floor in numerous areas. This can attract wood destroying organisms. Removal is needed.

A qualified contractor should inspect and repair as needed.

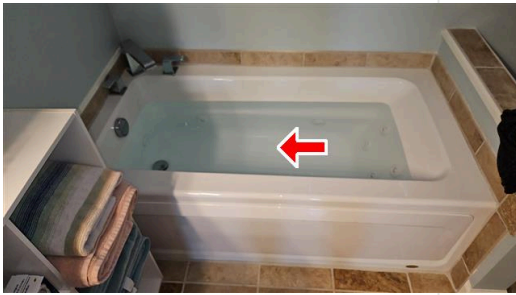
5.2 Item 1 (Picture)

1. The jacuzzi did not function at the time of inspection. Further investigation are repairs are needed.

I recommend contacting a licensed plumber.

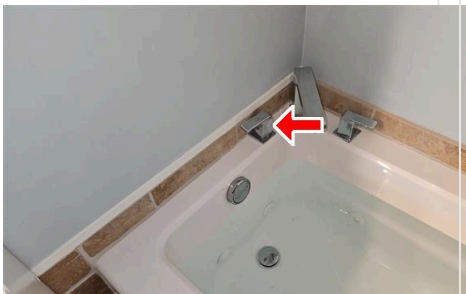
5.2 Item 2 (Picture)

1. The control knob rubs the tile wall. Deterioration may eventually occur. Further investigation and repairs are needed.

I recommend contacting a licensed plumber.

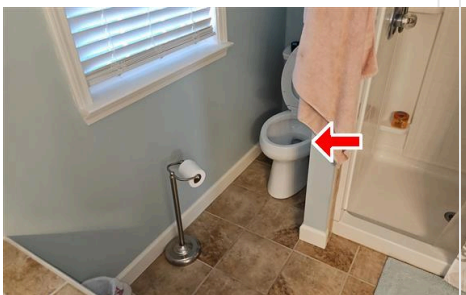
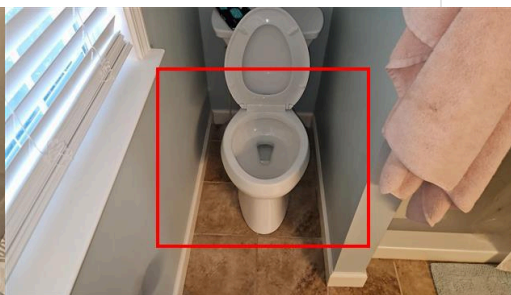
5.2 Item 4 (Picture)

1. The toilet at the master bath does not appear to have proper clearance. This is a safety issue. Further investigation and repairs are needed.

A qualified licensed plumber should repair or correct as needed.

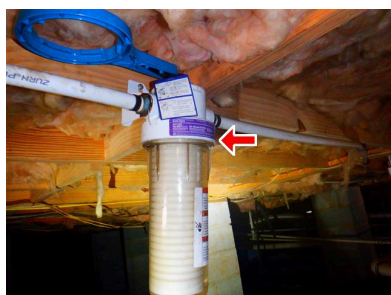
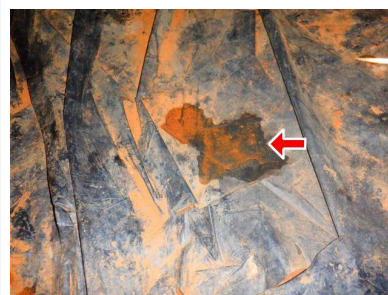
5.2 Item 6 (Picture)

1. The sediment filter leaks in the crawl space. Repairs are needed to prevent water damage from occurring to the home. Further investigation and repairs are needed.

A qualified licensed plumber should repair or correct as needed.

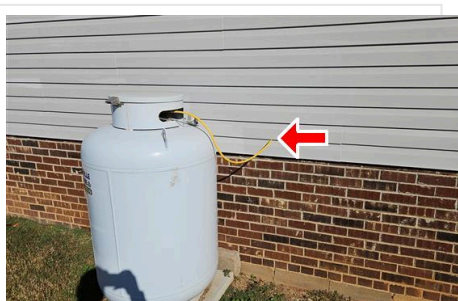
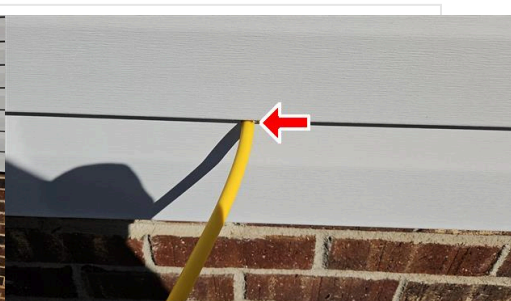
5.5 Item 1 (Picture)

1. The gas line was installed improperly using soft copper through wall instead of hard piping at the wall unit in the garage. This is a safety issue and should be repaired. Repairs are needed.

A qualified licensed HVAC (Heat/Ventilation/Air conditioning Contractor) should inspect further and repair as needed

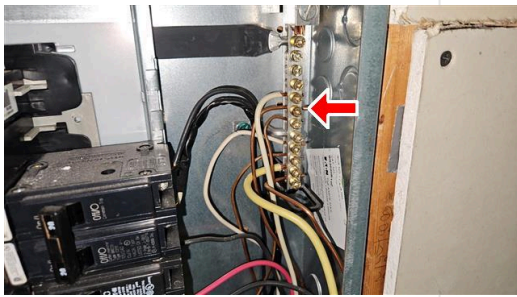
6.2 Item 1 (Picture)

1. The sub panel in the garage has ground and neutral bonded together. This will allow current to flow over the ground wire back to the main electrical panel. This is a safety issue. Electrical issues are considered a hazard until repaired. Further inspection is needed by a qualified licensed electrician.

A qualified licensed electrical contractor should correct as needed.

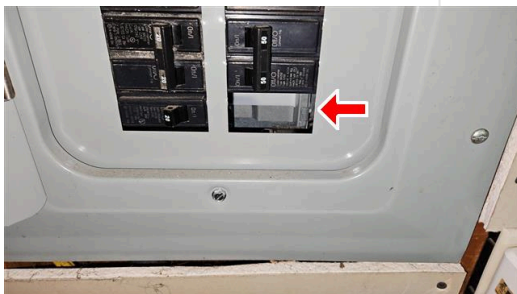
6.2 Item 2 (Picture)

1. The sub panel has missing knockouts. (safety issue) Unused openings in panel equipment need to be closed. Covering these openings helps to prevent accidental shocks (think of kids), helps to prevent pests from entering. Repairs are needed.

A qualified licensed electrical contractor should correct as needed.

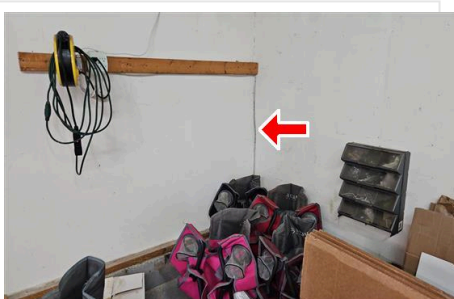
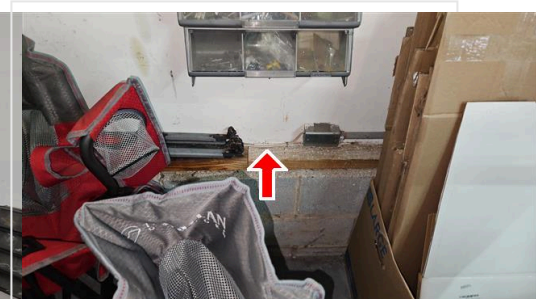
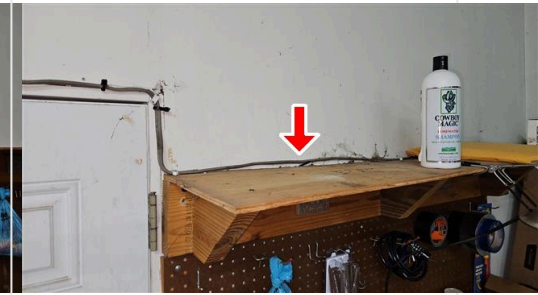
6.4 Item 1 (Picture)

1. The wiring in the garage is exposed. Exposed wiring is considered unsafe until repaired. Further investigation and repairs are needed..

I recommend a licensed electrical contractor correct as necessary.

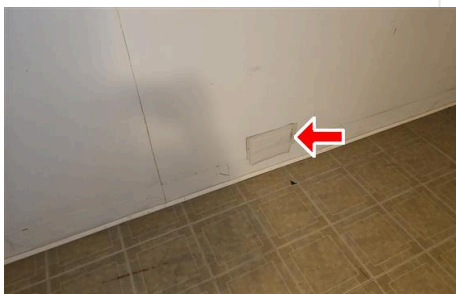
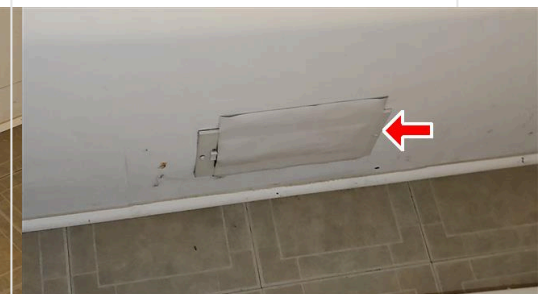
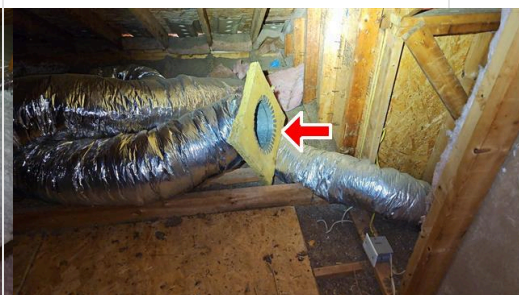
7.3 Item 1 (Picture)

1. The supply and return duct pipe is disconnected for the bonus room above the garage. Further investigation and repairs are needed..

A qualified HVAC person should inspect further and repair or replace as needed.

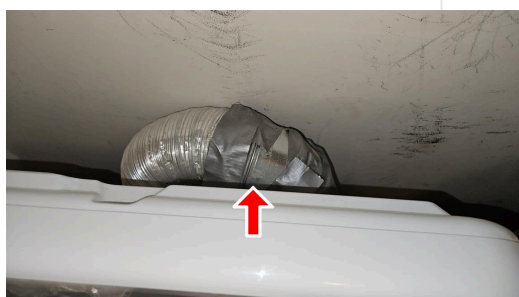
9.5 Item 1 (Picture)

1. The dryer vent piping is improperly put together with duct tape. "Duct tape is not UL rated for this application." Repairs are needed.

A qualified person should repair or replace as needed.

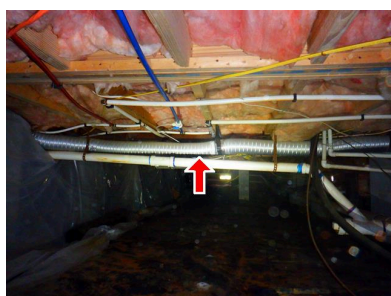
9.5 Item 2 (Picture)

1. The dryer vent piping is over 25 feet long and is flex type. Some professionals considered this type of vent pipe unsafe and recommend rigid metal pipe. Further investigation and repairs are needed.

A qualified person should repair or replace as needed.

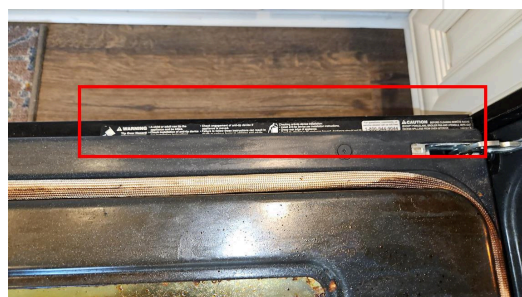
10.1 Item 1 (Picture)

1. The range/oven needs to be properly attached/anchored to the structure as to keep it from tipping over when the oven door is opened and/or oven racks are pulled out during use. This is a safety issue. Repairs are needed.

I recommend contacting appliance repair company.

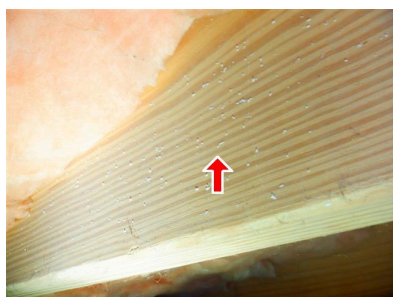
1.0 Item 1 (Picture)

1. Discoloration and some type of mold (Microbial) growth is present in the structure at several areas including but not limited to the crawl space and interior spaces. Evidence suggests that this condition is from a past or present elevated moisture conditions. We did not inspect, test or determine if this type of substance is or is not a health hazard. Further investigation is needed.

We recommend you contact a properly licensed expert for testing, investigation and or correction as deemed appropriate.

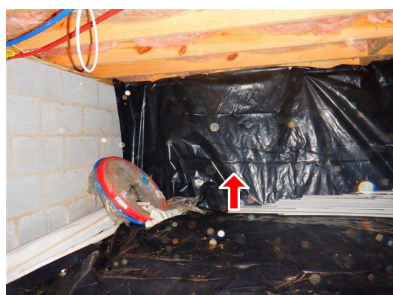
1.1 Item 1 (Picture)

1. The front of the crawl space is blocked with plastic. As a result the areas were not inspected. Hidden damage may be present. Further investigation and repairs are needed.

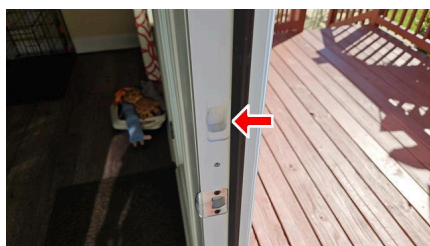
3.3 Item 1 (Picture)

1. The entry door at rear of home is missing the strike plate. Repairs are needed to make sure the door locks properly. Repairs are needed.

A qualified person should repair or replace as needed.

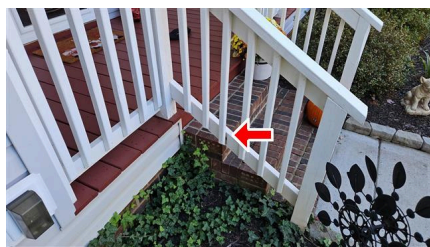
3.4 Item 1 (Picture)

1. The balusters on decks at the front and rear of home are loose and nail improperly. This is a safety issue. A repair or replacement is needed.

A qualified contractor should repair or replace as needed.

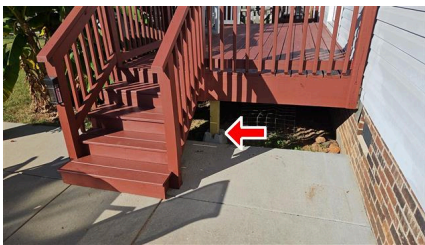
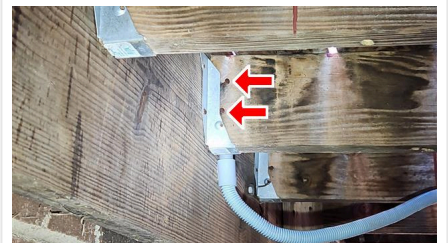
3.4 Item 7 (Picture)

1. The deck at the rear of home is not constructed properly. A fall or injury can occur if not corrected. Further investigation and repairs are needed.

I recommend a complete evaluation of deck for a structural stability and safety.

A qualified contractor should repair or replace as needed.

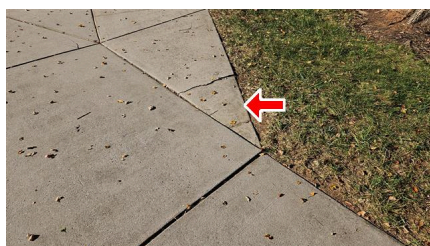
3.5 Item 1 (Picture)

1. The concrete drive at the front of home uneven, and can be a tripping hazard. Water can cause further deterioration if not repaired and sealed properly. A fall or injury can occur if not corrected. Repairs are needed.

A qualified person should repair or replace as needed.

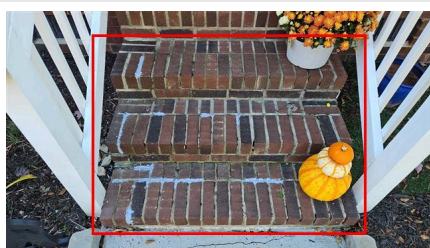
3.5 Item 6 (Picture)

1. The brick steps at the front of home deteriorated in areas. Further deterioration can occur if not repaired. Repairs are needed.

A qualified person should repair or replace as needed.

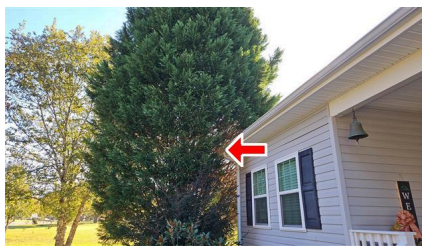
3.5 Item 12 (Picture)

1. The tree limbs that are in contact with roof and wall cladding. Damage could occur to the home. Repairs are needed.

A qualified person should repair or replace as needed.

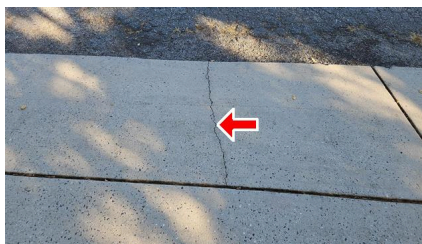
3.5 Item 14 (Picture)

1. The concrete driveway has cracks that should be sealed to prevent further damage, which is part of ongoing maintenance of a concrete driveway that will need to be performed on a regular basis. Repairs are recommended.

A qualified contractor should inspect and repair as needed.

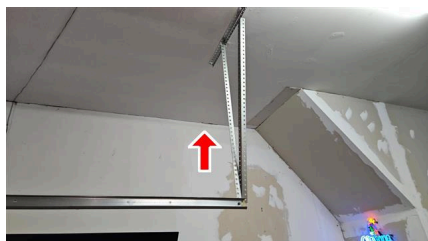
3.8 Item 1 (Picture)

1. The fire resistance sheathing in garage is compromised. This is considered unsafe until corrected. Repairs are needed.

A qualified person should correct for safety.

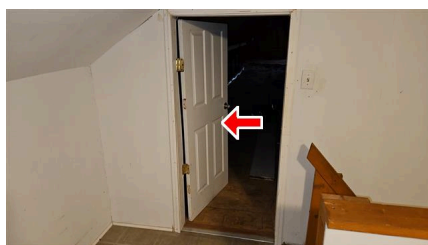
3.9 Item 1 (Picture)

1. The occupant door from inside bonus room to attic the home is not a fire rated door. This means that should a fire occur in garage, the occupant door does not afford protection until fireman arrive. This door should be replaced with a fire rated door. Repairs are needed.

A qualified person should repair or replace as needed.

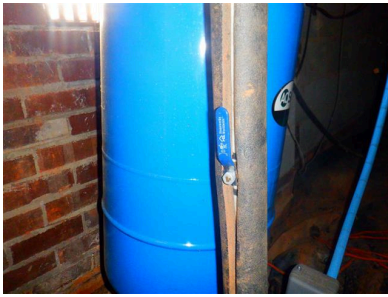
5.0 Item 1 (Picture)

The main shut off is the blue lever located underneath in the crawlspace. This is for your information.

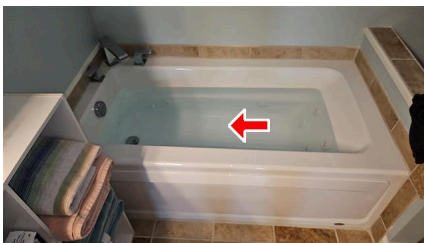
5.2 Item 1 (Picture)

1. The jacuzzi did not function at the time of inspection. Further investigation are repairs are needed.

I recommend contacting a licensed plumber.

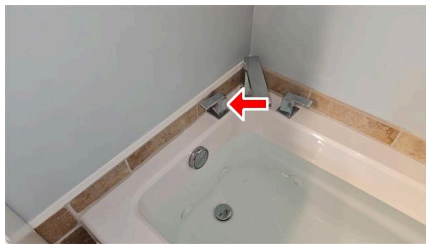
5.2 Item 2 (Picture)

1. The control knob rubs the tile wall. Deterioration may eventually occur. Further investigation and repairs are needed.

I recommend contacting a licensed plumber.

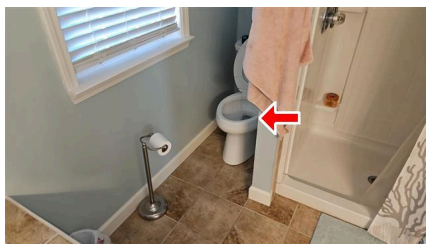
5.2 Item 4 (Picture)

1. The toilet at the master bath does not appear to have proper clearance. This is a safety issue. Further investigation and repairs are needed.

A qualified licensed plumber should repair or correct as needed.

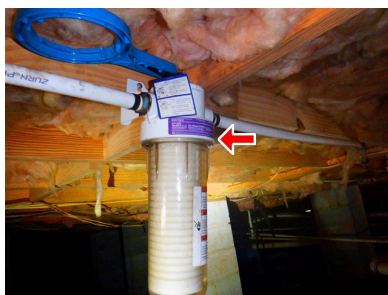
5.2 Item 6 (Picture)

1. The sediment filter leaks in the crawl space. Repairs are needed to prevent water damage from occurring to the home. Further investigation and repairs are needed.

A qualified licensed plumber should repair or correct as needed.

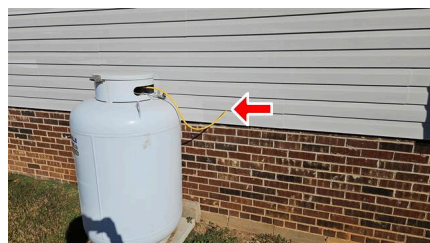
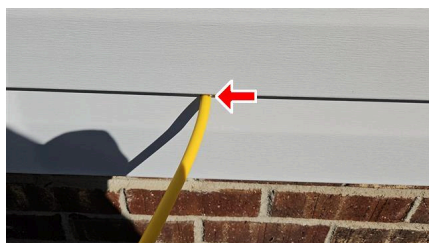
5.5 Item 1 (Picture)

1. The gas line was installed improperly using soft copper through wall instead of hard piping at the wall unit in the garage. This is a safety issue and should be repaired. Repairs are needed.

A qualified licensed HVAC (Heat/Ventilation/Air conditioning Contractor) should inspect further and repair as needed

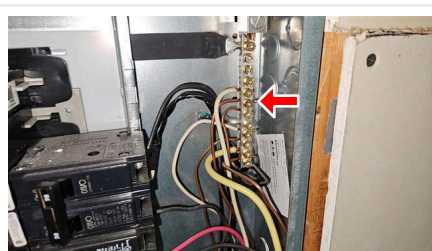
6.2 Item 1 (Picture)

1. The sub panel in the garage has ground and neutral bonded together. This will allow current to flow over the ground wire back to the main electrical panel. This is a safety issue. Electrical issues are considered a hazard until repaired. Further inspection is needed by a qualified licensed electrician.

A qualified licensed electrical contractor should correct as needed.

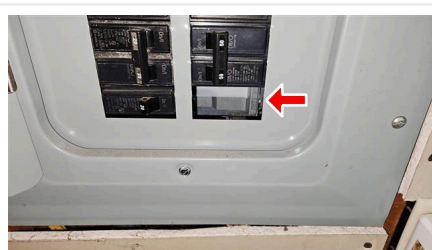
6.2 Item 2 (Picture)

1. The sub panel has missing knockouts. (safety issue) Unused openings in panel equipment need to be closed. Covering these openings helps to prevent accidental shocks (think of kids), helps to prevent pests from entering. Repairs are needed.

A qualified licensed electrical contractor should correct as needed.

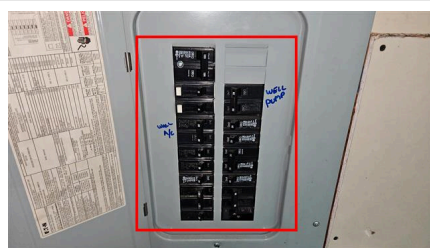
6.2 Item 3 (Picture)

1. Some labels are present, but are illegible or confusing for the electrical panel. This is a safety issue. Repairs are recommended.
-

A qualified licensed electrical contractor should correct as needed.

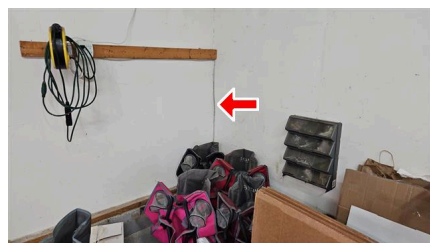
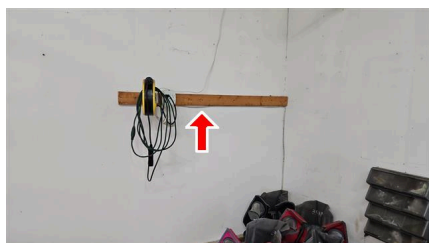
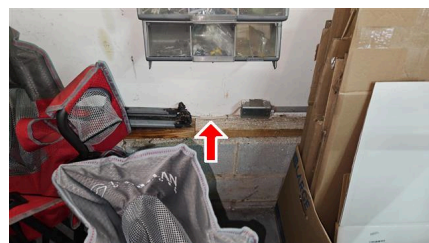
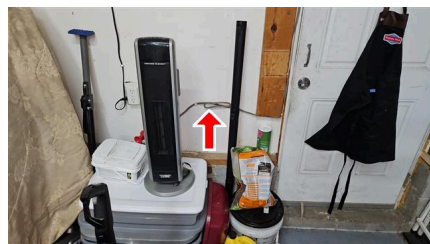
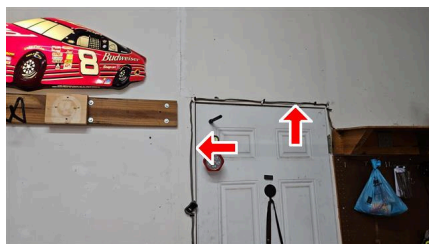
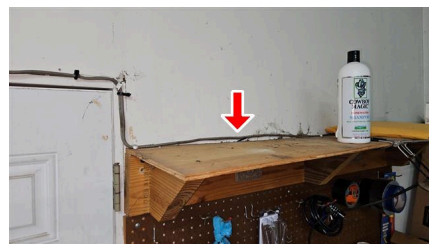
1. The wiring in the garage is exposed. Exposed wiring is considered unsafe until repaired. Further investigation and repairs are needed..

I recommend a licensed electrical contractor correct as necessary.

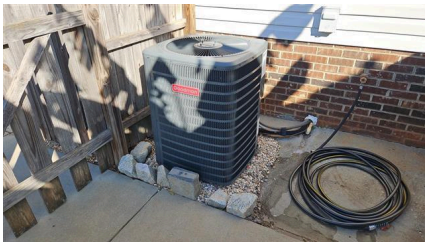
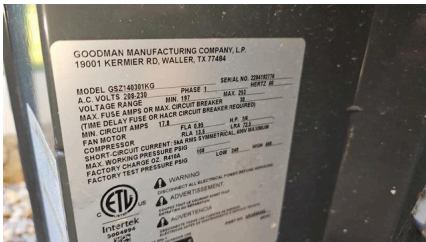
Complimentary photo of the heat pump

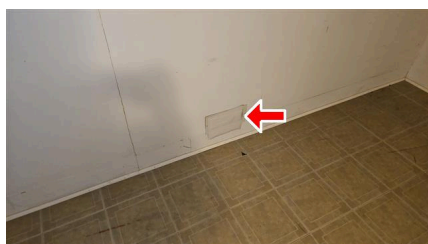
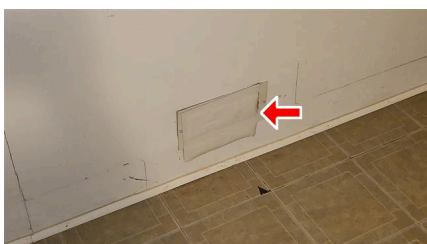
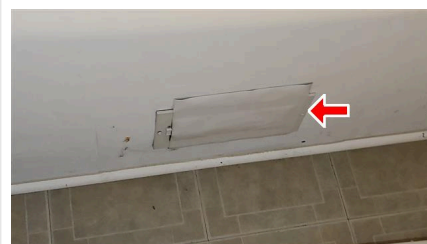
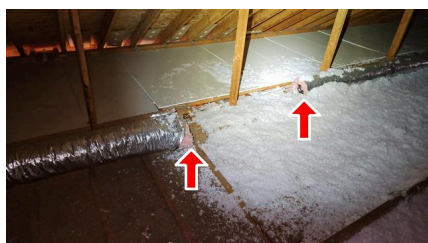
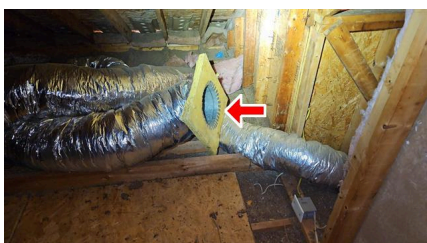
1. The supply and return duct pipe is disconnected for the bonus room above the garage. Further investigation and repairs are needed..

A qualified HVAC person should inspect further and repair or replace as needed.

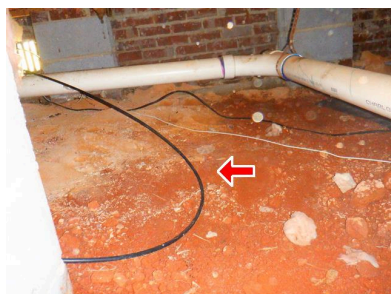
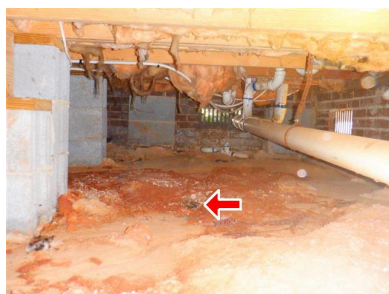
1. The vapor barrier (plastic) on the crawlspace ground is missing in areas. A vapor barrier provides added protection to the floor system from moisture or dampness that can enter from ground. Repairs are needed.

A qualified person should repair or replace as needed.

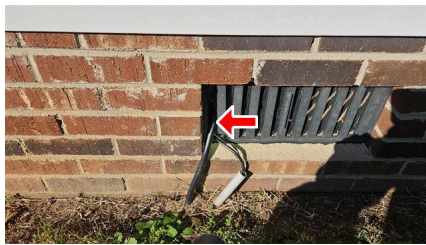
9.1 Item 1 (Picture)

1. The screen for foundation vent(s) damaged at the exterior. Rodents, reptiles or insects could enter into crawlspace. Repair are needed.

A qualified person should repair or replace as needed.

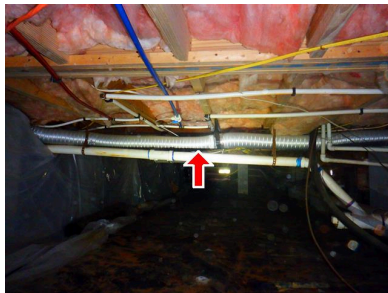
9.5 Item 2 (Picture)

1. The dryer vent piping is over 25 feet long and is flex type. Some professionals considered this type of vent pipe unsafe and recommend rigid metal pipe. Further investigation and repairs are needed.

A qualified person should repair or replace as needed.
