INSPECTION REPORT  
136 Oak Village Pkwy  
Mooresville NC 28117

INSPECTED BY  
Alex Parr 3692  
Above Parr Home  
Inspections

INSPECTION DATE  
📅 9/6/2023  
🕒 09:00:00 AM

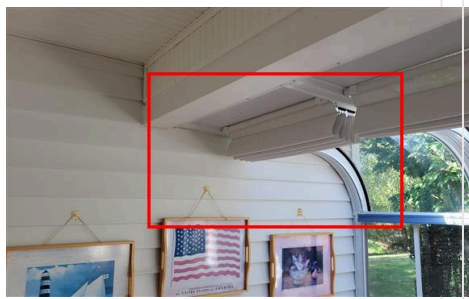
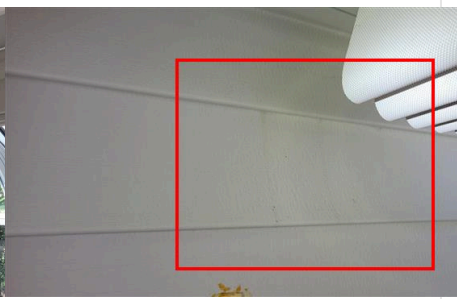
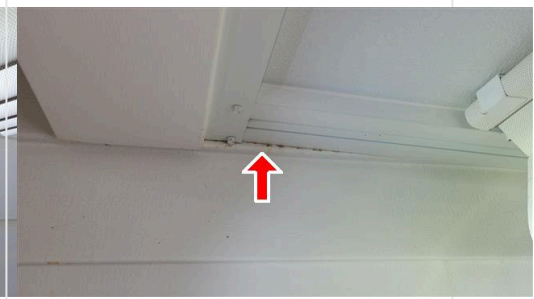
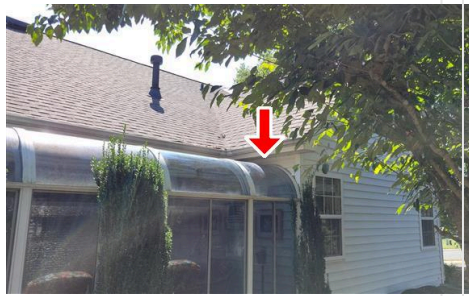
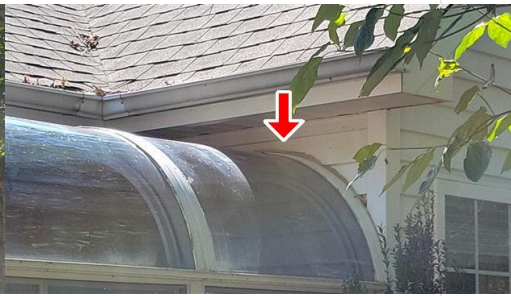
1. The patio roof cover at the rear of home does not appear to be flashed properly and has evidence of a leak. Unable to determine if this area will leak. Further investigation and repairs are needed.

A qualified person should repair or replace as needed.

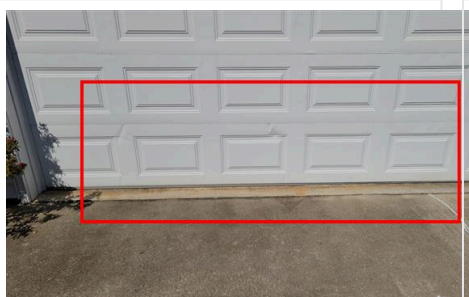
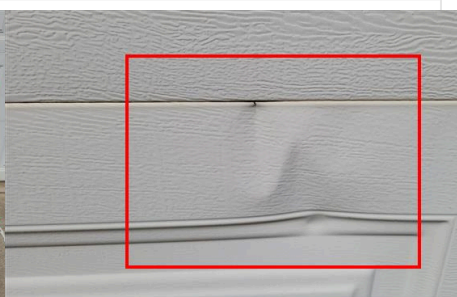
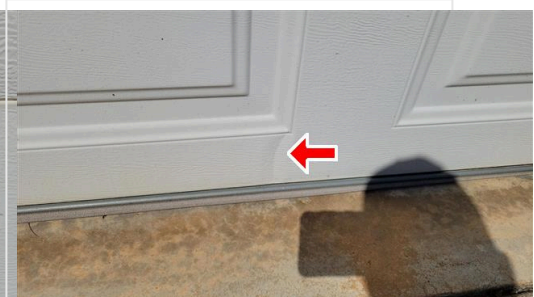
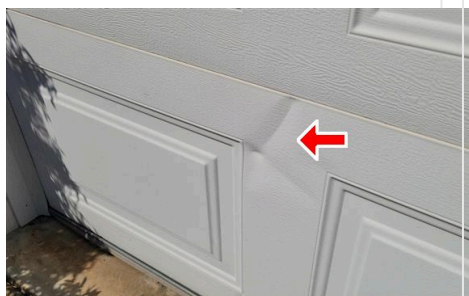
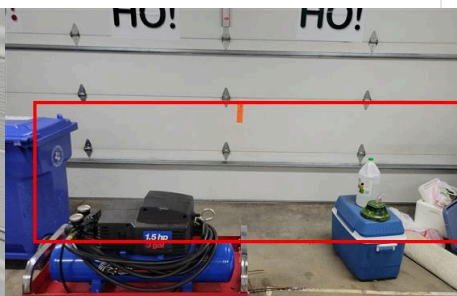
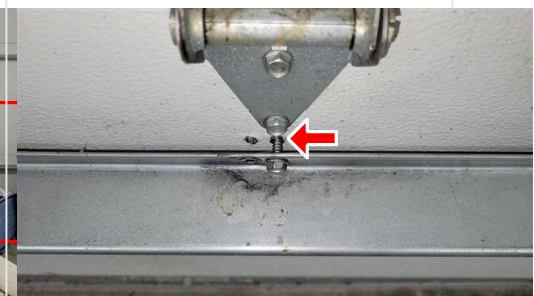
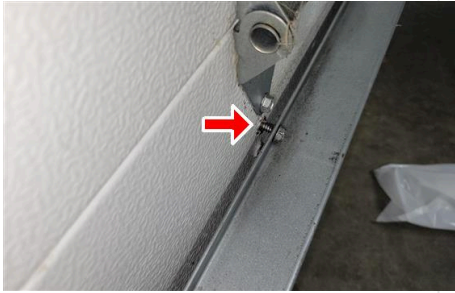
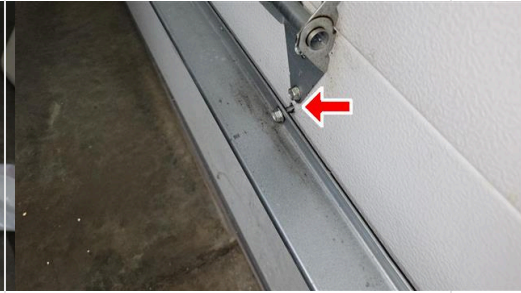
1. The two-door garage at the front of home is damaged at panel. Further deterioration may occur if not repaired. A repair or replacement is needed.

A qualified person should repair or replace as needed.

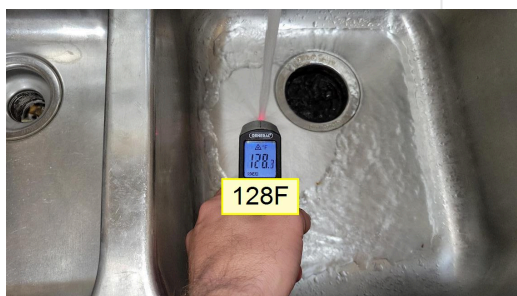
5.1 Item 1 (Picture)

1. The water heater is set over the recommended temperature. (Over 120) The risk is especially acute for infants, children, and the elderly. Water temperatures should never be set higher than 120 degrees.

This is a safety issue. Repairs are needed

A qualified contractor should inspect and repair as needed.

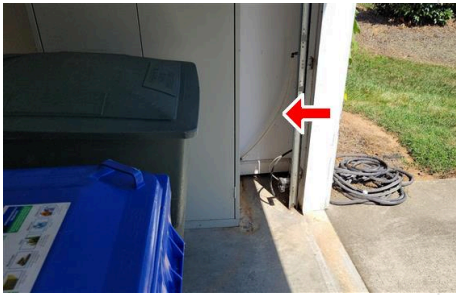
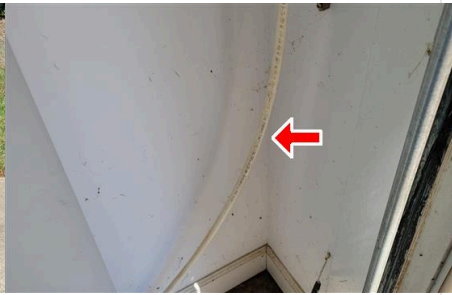
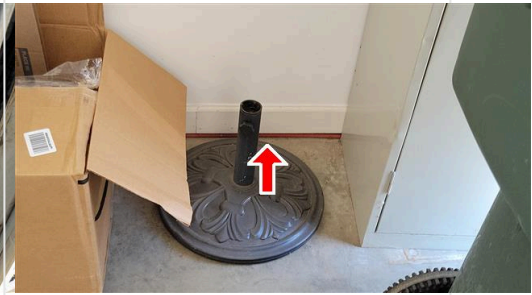
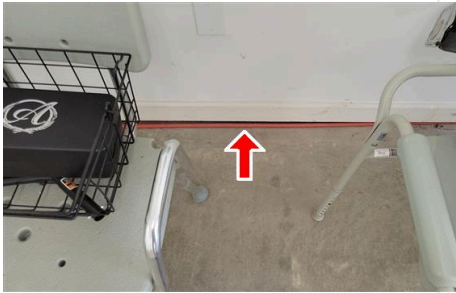
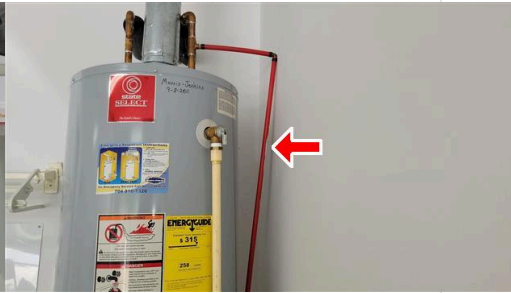
1. A water line has been improperly added in the garage. Repairs are needed to prevent water damage from occurring to the home. Repairs are needed.

A qualified licensed plumber should repair or correct as needed.

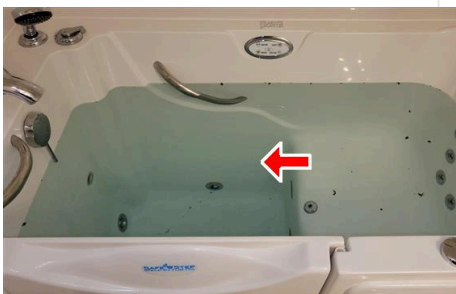
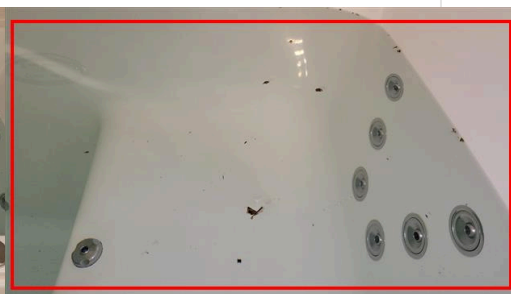
1. The jacuzzi shows signs of improper cleaning and maintenance, as a result black residue is present (likely bacteria) when the tub was operated. (Health Safety Issue) Repairs are needed.

I recommend contacting a licensed plumber.

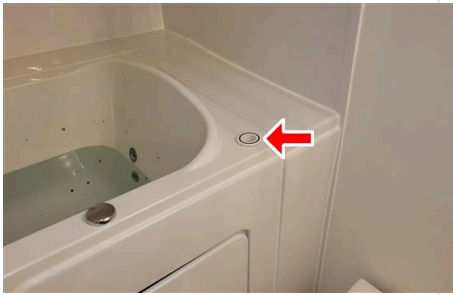
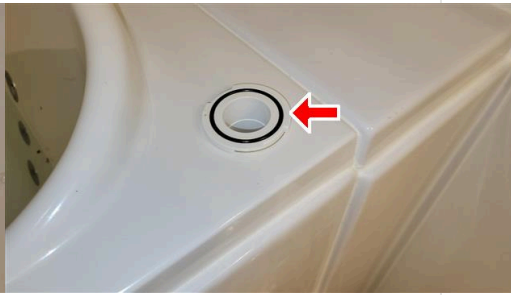
1. The guest bath fiberglass tub appears to be missing a part. This may affect the function of the tub. Further investigation and repairs are needed.

I recommend contacting a licensed plumber.

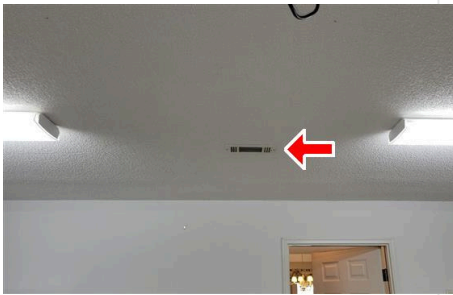
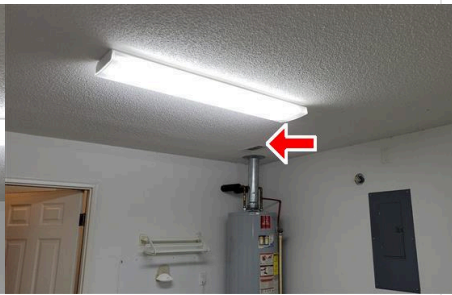
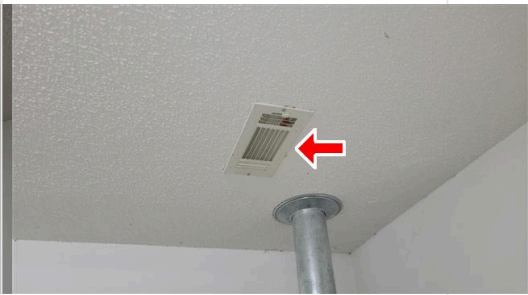
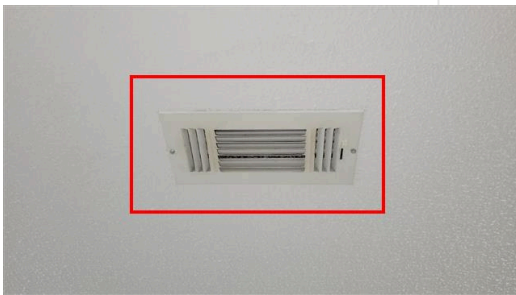
1. The supply duct pipes have been added in the garage. This condition could allow carbon monoxide into the home. This is a safety issue. Further investigation and repairs are needed..

A qualified HVAC person should inspect further and repair or replace as needed.

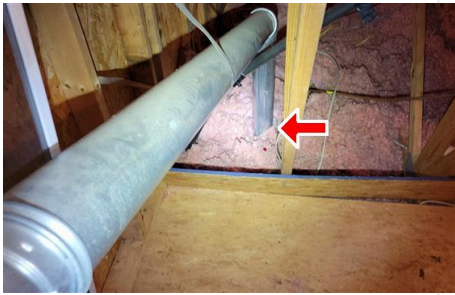
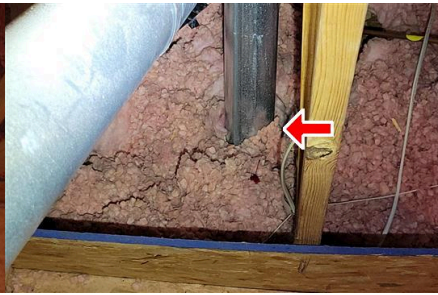
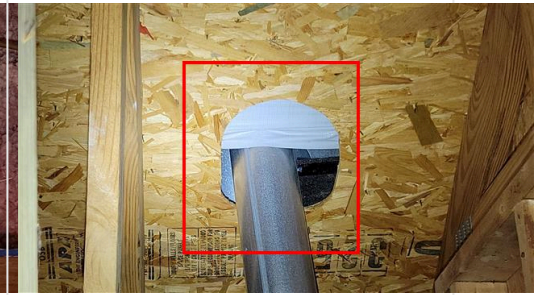
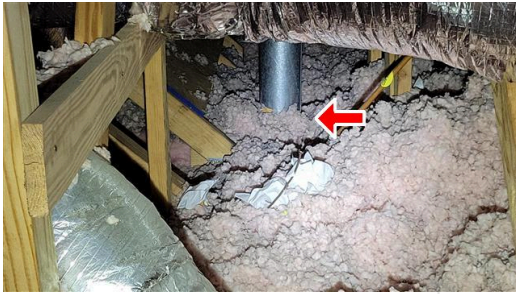
1. The vent pipe for gas water heater and fireplace needs a 1 inch clearance from combustibles. This is a safety issue and should be repaired. Repairs are needed.

I recommend a qualified licensed heat contractor inspect further and repair as needed.

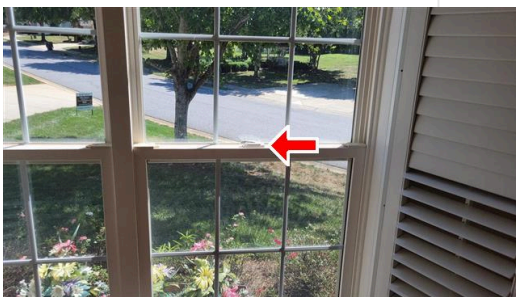
8.6 Item 1 (Picture)

1. The guest bedroom window would not unlock. As a result the window would not function as intended.

Further investigation and repairs are needed.

A qualified person should repair or replace as needed.

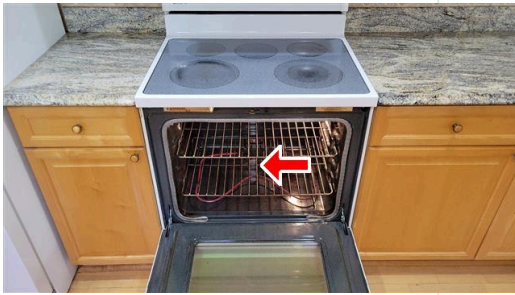
10.1 Item 1 (Picture)

over when the oven door is opened and/or oven racks are pulled out during use. This is a safety issue. Repairs are needed.

I recommend contacting appliance repair company.

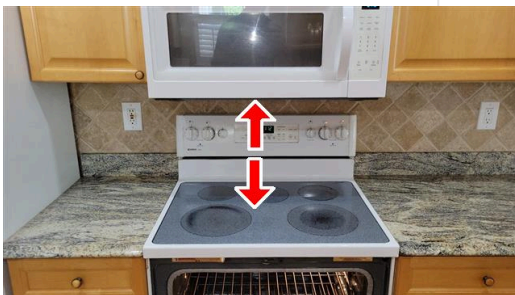
10.5 Item 1 (Picture)

1. Microwave clearance from stove top was noted to be less than the typical installation for this configuration. The main concerns related to the clearances from a stove top are: damage to microwave's electronics due to moisture/steam or heat, limited access to range top controls and restrictive use of large pots. Further investigation is needed.

I recommend contacting appliance repair company.

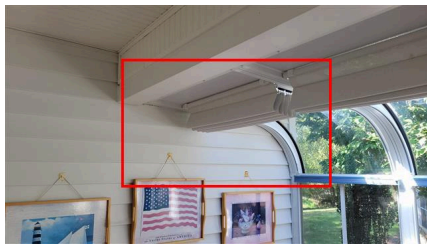
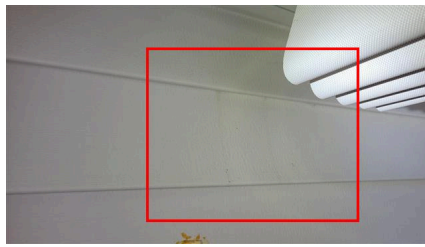
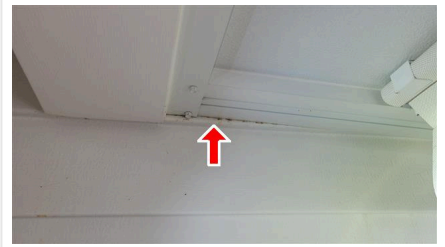
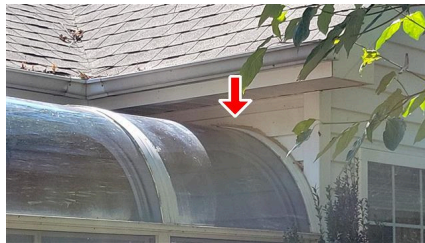
1. The patio roof cover at the rear of home does not appear to be flashed properly and has evidence of a leak. Unable to determine if this area will leak. Further investigation and repairs are needed.

A qualified person should repair or replace as needed.

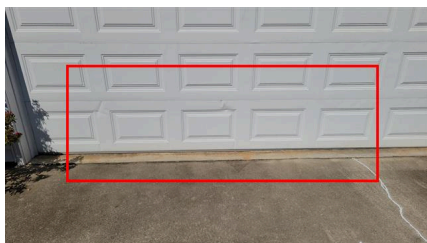
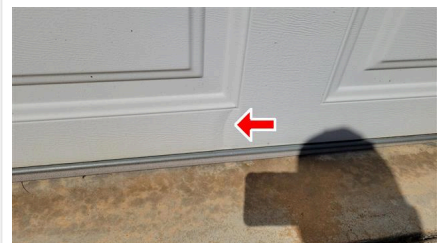
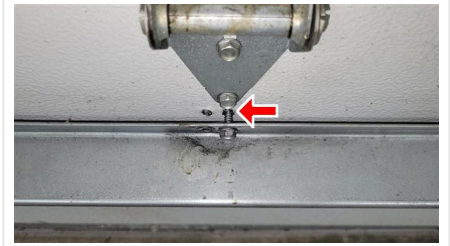
1. The two-door garage at the front of home is damaged at panel. Further deterioration may occur if not repaired. A repair or replacement is needed.

A qualified person should repair or replace as needed.

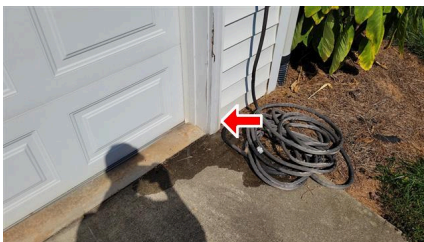
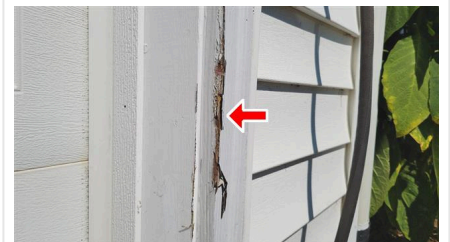
1. The garage door at the front of home shows deterioration on bottom of side jambs. Further deterioration may occur if not repaired. A repair or replacement is needed.

A qualified person should repair or replace as needed.

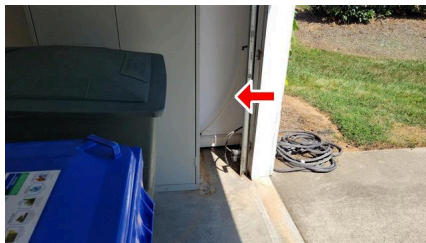
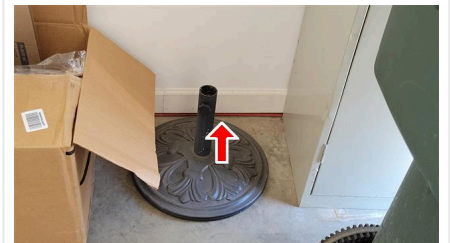
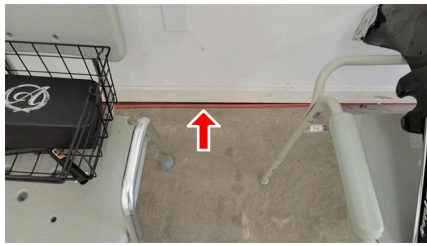
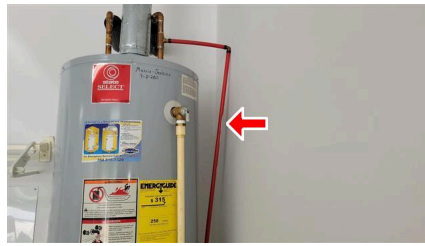
1. A water line has been improperly added in the garage. Repairs are needed to prevent water damage from occurring to the home. Repairs are needed.

A qualified licensed plumber should repair or correct as needed.

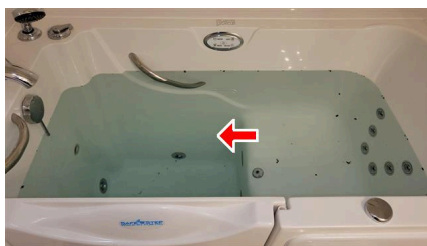
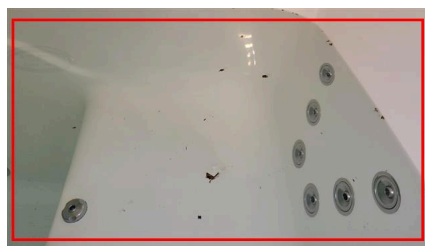
1. The jacuzzi shows signs of improper cleaning and maintenance, as a result black residue is present (likely bacteria) when the tub was operated. (Health Safety Issue) Repairs are needed.

I recommend contacting a licensed plumber.

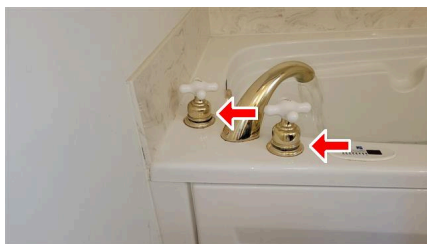
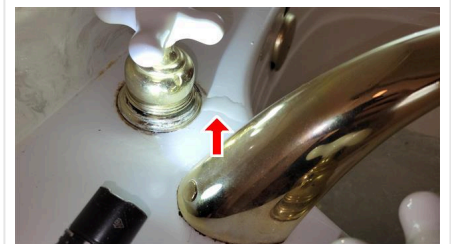
1. The hot control and cold control leaks at the master bath tub. Repairs are needed to prevent water damage from occurring to the home. Repairs are needed.

A qualified licensed plumber should repair or correct as needed.

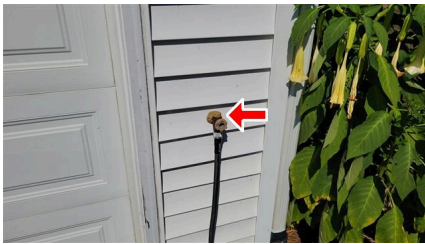
5.2 Item 11 (Picture)

1. The outside water faucet loose, and needs securing to wall at the front of home. This can allow undue stress to occur on supply lines allowing leaks to occur. Repairs are needed..

A qualified licensed plumber should repair or correct as needed.

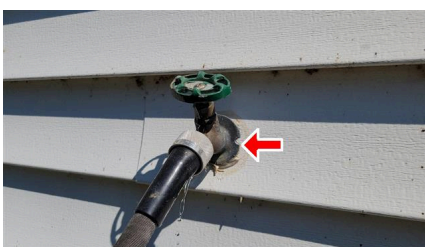
5.2 Item 12 (Picture)

1. The outside water faucet drips at knob when turned on at the left side (facing front). Further investigation and repairs are needed..

A qualified licensed plumber should repair or correct as needed.

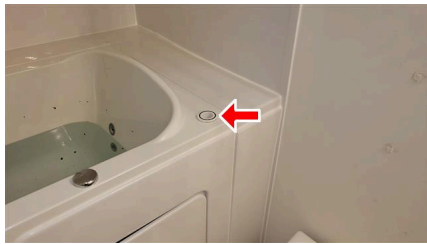
5.5 Item 1 (Picture)

1. The guest bath fiberglass tub appears to be missing a part. This may affect the function of the tub.

Further investigation and repairs are needed.

I recommend contacting a licensed plumber.

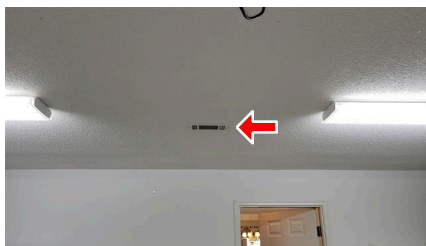
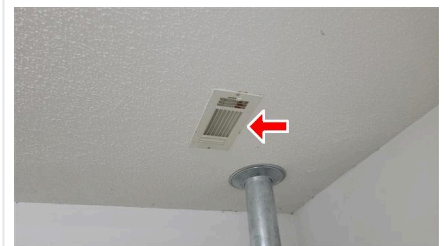
1. The supply duct pipes have been added in the garage. This condition could allow carbon monoxide into the home. This is a safety issue. Further investigation and repairs are needed..

A qualified HVAC person should inspect further and repair or replace as needed.

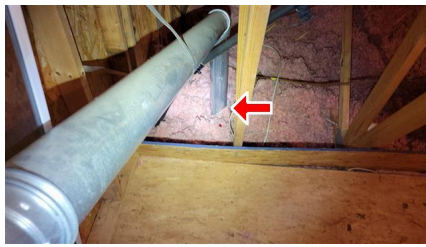
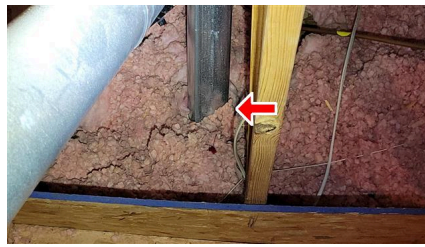
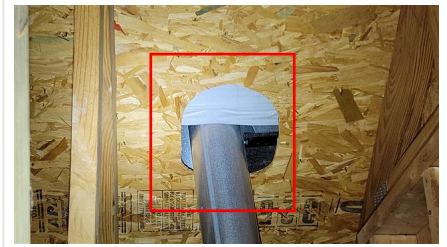
1. The vent pipe for gas water heater and fireplace needs a 1 inch clearance from combustibles. This is a safety issue and should be repaired. Repairs are needed.

I recommend a qualified licensed heat contractor inspect further and repair as needed.

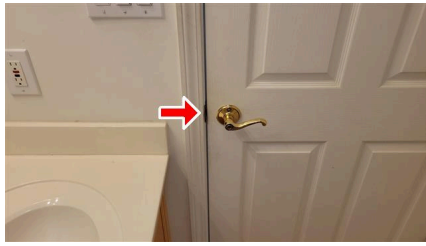
**8.5 Item 1 (Picture)**

1. The door at Hall Bath will not latch properly. Evidence suggest that the door needs strike and latch adjustment to shut properly. This is a small repair.

A qualified person should repair or replace as needed.

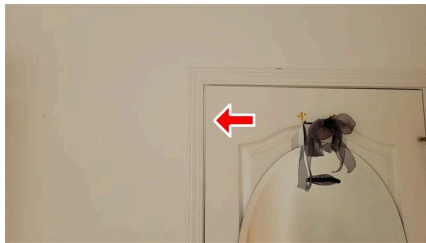
**8.5 Item 2 (Picture)**

1. The Privacy door rubs at jamb when closing at the guest Bedroom. As a result the door will not close properly. Repairs are needed.

A qualified person should repair or replace as needed.

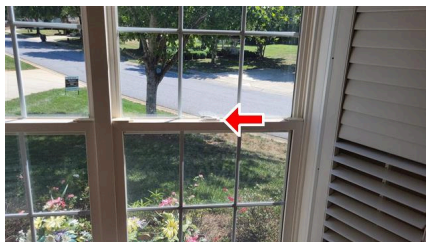
**8.6 Item 1 (Picture)**

1. The guest bedroom window would not unlock. As a result the window would not function as intended. Further investigation and repairs are needed.

A qualified person should repair or replace as needed.

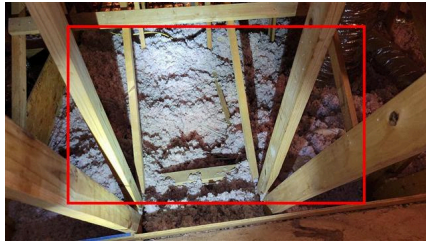
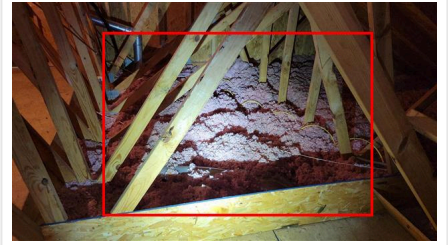
1. Fiberglass (loose-fill) insulation is is compressed in areas of the attic due to foot traffic or storage in attic. Heat loss can occur more on this home than one that is properly insulated. Repairs are recommended .

A qualified person should repair or replace as needed.

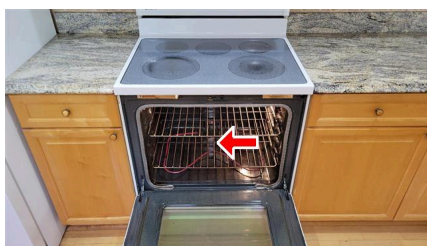
10.1 Item 1 (Picture)

1. The range/oven needs to be properly attached/anchored to the structure as to keep it from tipping over when the oven door is opened and oven racks are pulled out during use. This is a safety issue. Repairs are needed.

I recommend contacting appliance repair company.

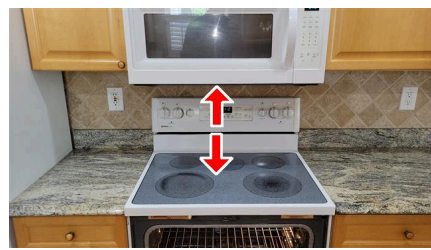
10.5 Item 1 (Picture)

1. Microwave clearance from stove top was noted to be less than the typical installation for this configuration. The main concerns related to the clearances from a stove top are: damage to microwave's electronics due to moisture/steam or heat, limited access to range top controls and restrictive use of large pots. Further investigation is needed.

I recommend contacting appliance repair company.
