INSPECTION REPORT  
140 Woodward Wy  
Iron Station NC 28080

INSPECTED BY  
Alex Parr 3692  
Above Parr Home  
Inspections

INSPECTION DATE  
📅 5/7/2024  
🕒 09:00:00 AM

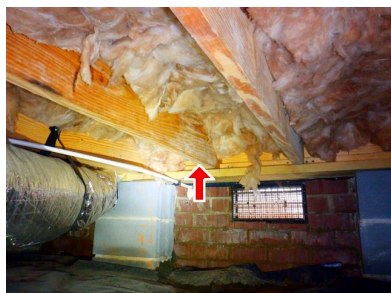
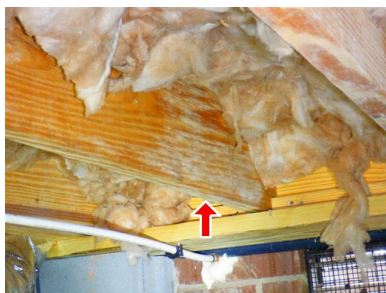
1. Discoloration and some type of mold (Microbial) growth is present in the structure at several areas including but not limited to the crawl space and interior spaces. Evidence suggests that this condition is from a past or present elevated moisture conditions. We did not inspect, test or determine if this type of substance is or is not a health hazard. Further investigation is needed.

We recommend you contact a properly licensed expert for testing, investigation and or correction as deemed appropriate.

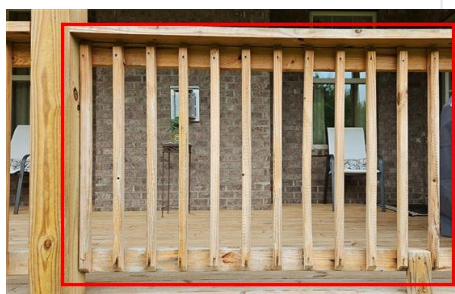
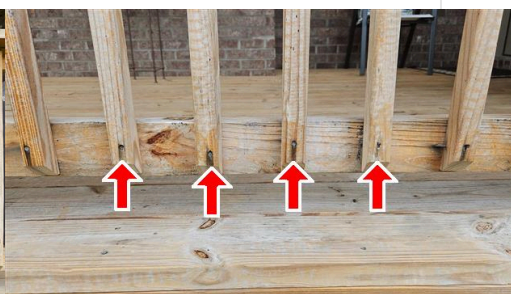
1. The balusters on deck, rear of home are attached improperly. Attached balusters are top and bottom (1) #8 wood screw or (2) 8d post frame threaded nails. A repair is needed to ensure stability or an injury might occur. Repairs are needed.

A qualified person should repair or replace as needed.

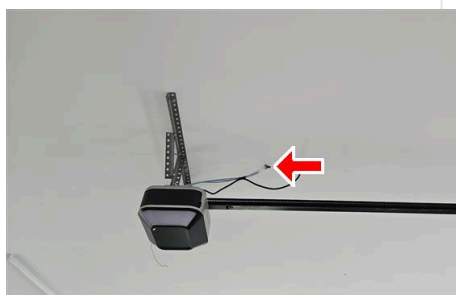
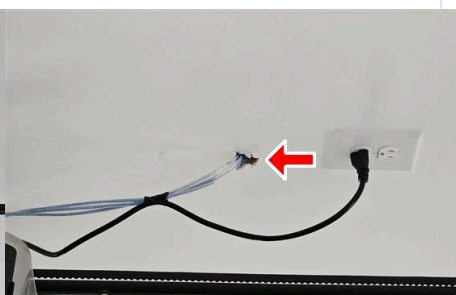
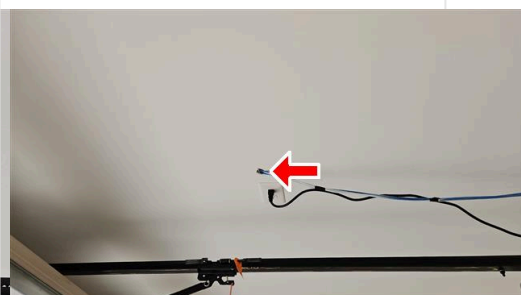
1. The fire resistance sheathing in garage is compromised. This is considered unsafe until corrected. Repairs are needed.

A qualified person should correct for safety.

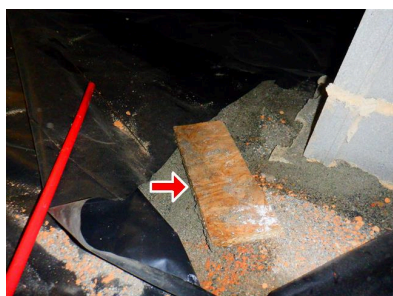
4.5 Item 1 (Picture)

1. Wood debris is in contact with the crawl space floor in numerous areas. This can attract wood destroying organisms. Removal is needed.

A qualified contractor should inspect and repair as needed.

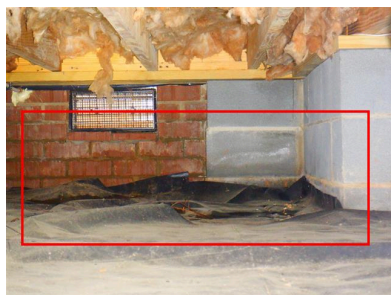
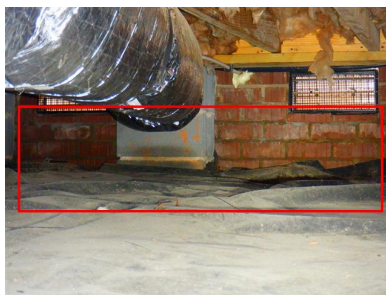
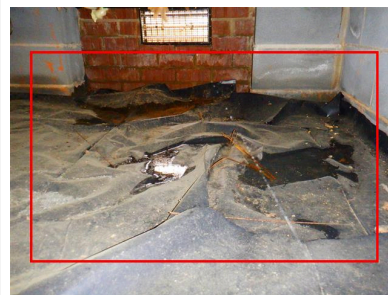
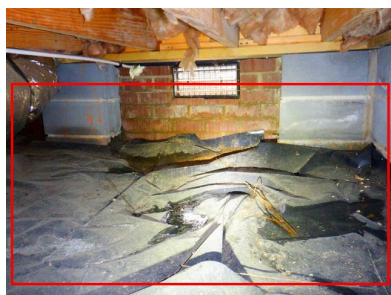
1. Visible signs of water intrusion in the crawlspace (along front of home) are present from standing water on plastic vapor barrier. Water intrusion if not corrected can lead to other problems including mold and cause excessive moisture to floor system that can lead to deterioration and increased repair cost. Further investigation and repairs are needed.

I recommend further investigation or correction by a qualified licensed contractor or water infiltration specialist.

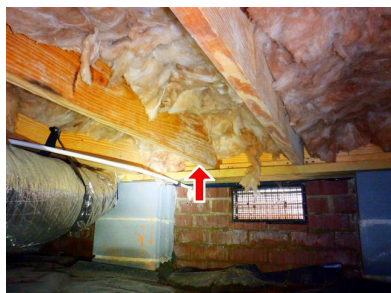
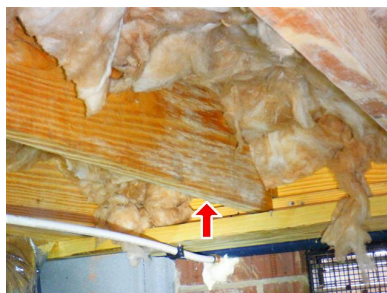
1. Discoloration and some type of mold (Microbial) growth is present in the structure at several areas including but not limited to the crawl space and interior spaces. Evidence suggests that this condition is from a past or present elevated moisture conditions. We did not inspect, test or determine if this type of substance is or is not a health hazard. Further investigation is needed.

We recommend you contact a properly licensed expert for testing, investigation and or correction as deemed appropriate.

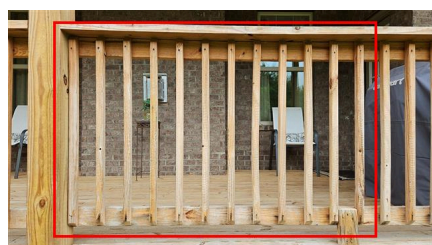
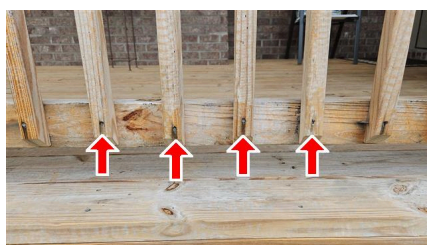
1. The balusters on deck, rear of home are attached improperly. Attached balusters are top and bottom (1) #8 wood screw or (2) 8d post frame threaded nails. A repair is needed to ensure stability or an injury might occur. Repairs are needed.

A qualified person should repair or replace as needed.

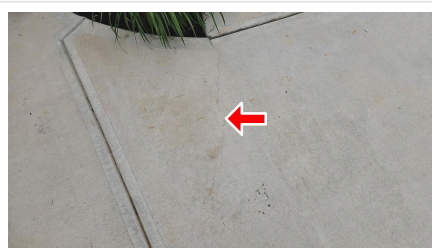
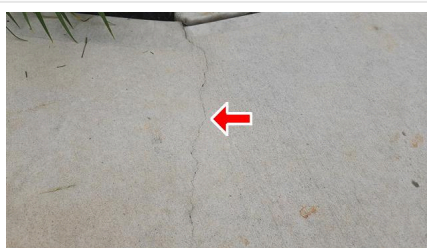
1. The concrete driveway has cracks that should be sealed to prevent further damage, which is part of ongoing maintenance of a concrete driveway that will need to be performed on a regular basis. Repairs are recommended.

A qualified contractor should inspect and repair as needed.

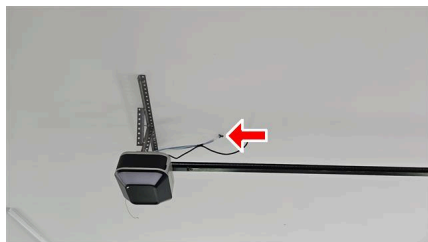
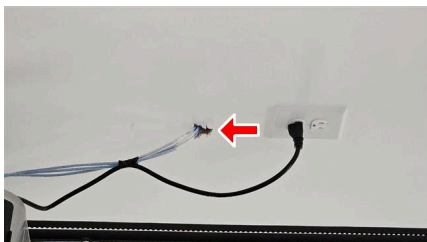
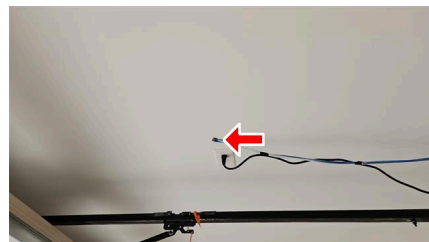
1. The fire resistance sheathing in garage is compromised. This is considered unsafe until corrected.

Repairs are needed.

A qualified person should correct for safety.

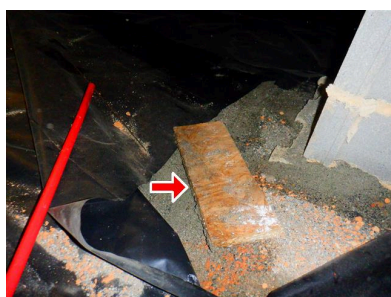
4.5 Item 1 (Picture)

1. Wood debris is in contact with the crawl space floor in numerous areas. This can attract wood destroying organisms. Removal is needed.

A qualified contractor should inspect and repair as needed.

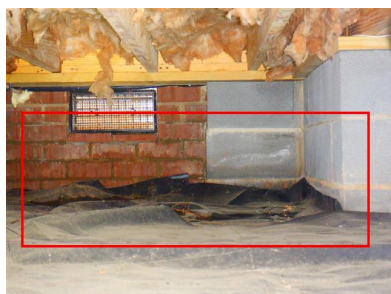
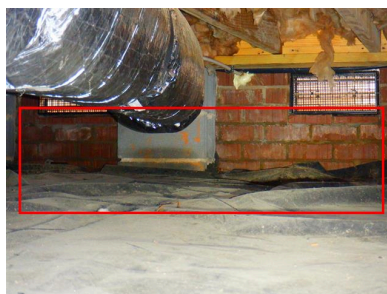
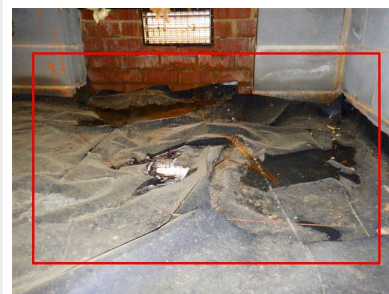
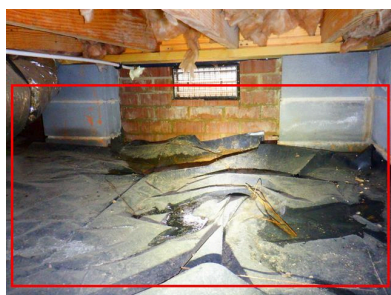
1. Visible signs of water intrusion in the crawlspace (along front of home) are present from standing water on plastic vapor barrier. Water intrusion if not corrected can lead to other problems including mold and cause excessive moisture to floor system that can lead to deterioration and increased repair cost. Further investigation and repairs are needed.

I recommend further investigation or correction by a qualified licensed contractor or water infiltration specialist.

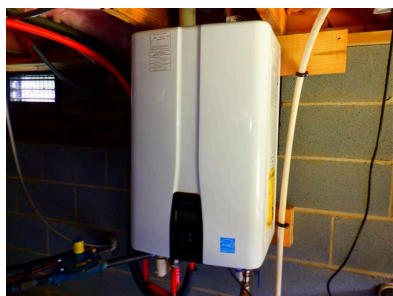
Complimentary photo of the water heater

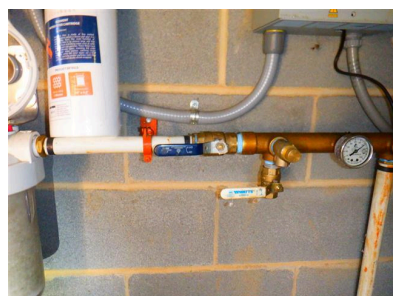
5.0 Item 1 (Picture)

The main shut off is the blue lever located underneath in the crawlspace. This is for your information.

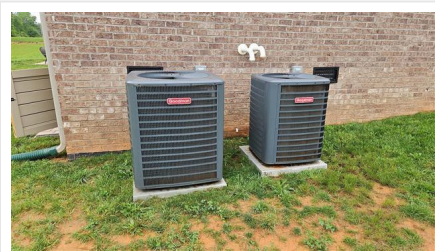
Complimentary photo of the heat pump

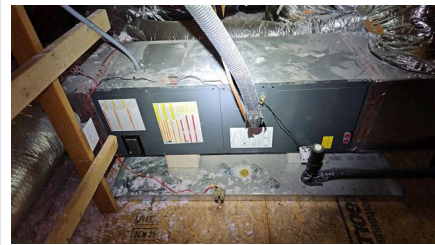
Complimentary photo of the heat pump

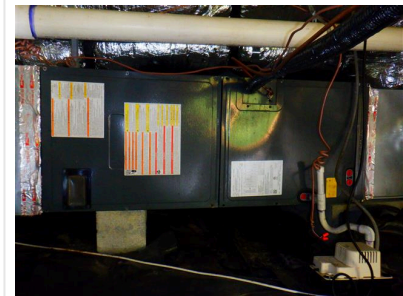
Complimentary photo of the heat pump
