INSPECTION REPORT  
152 E Callicutt Trail  
 Mooresville NC 28117

INSPECTED BY  
Alex Parr 3692  
Above Parr Home  
Inspections

INSPECTION DATE  
📅 5/15/2024  
🕒 09:00:00 AM

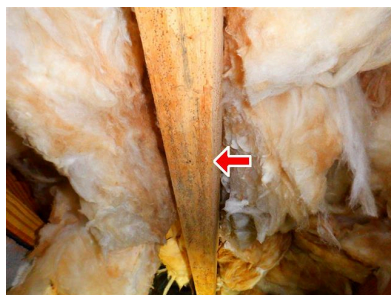
1.0 Item 1 (Picture)

1. Discoloration and some type of mold (Microbial) growth is present in the structure at several areas including but not limited to the crawl space and interior spaces. Evidence suggests that this condition is from a past or present elevated moisture conditions. We did not inspect, test or determine if this type of substance is or is not a health hazard. Further investigation is needed.

We recommend you contact a properly licensed expert for testing, investigation and or correction as deemed appropriate.

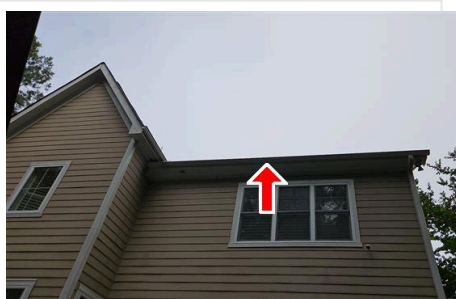
2.3 Item 1 (Picture)

1. The gutter are is clogged at the virtually all areas where gutters are installed. Gutters that drain poorly or clogged can lead to many costly problems such as deterioration of fascia, soffit or roof edge. It can also cause gutters to pull loose and lead to possible water intrusion. Repairs are needed.

A qualified person should repair or replace as needed.

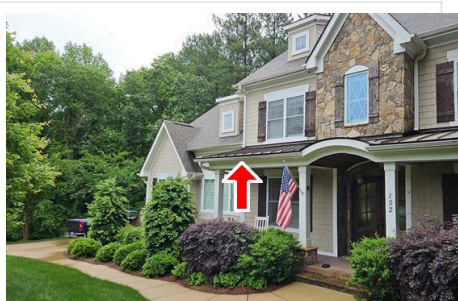
2.3 Item 3 (Picture)

1. The gutter is damaged at the front (left of main entry). Gutters that drain poorly or clogged can lead to many costly problems such as deterioration of fascia, soffit or roof edge. It can also cause gutters to pull loose and lead to possible water intrusion. Repairs are needed.

A qualified person should repair or replace as needed.

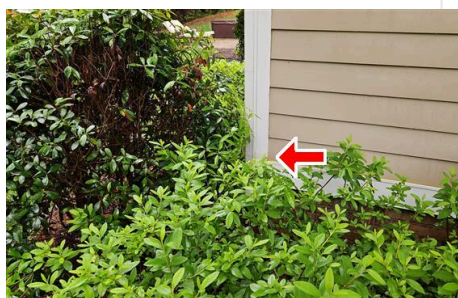
3.0 Item 1 (Picture)

1. The wood trim at the exterior in areas deteriorated. Further deterioration can occur if not corrected. Repairs are needed.

A qualified person should repair or replace as needed.

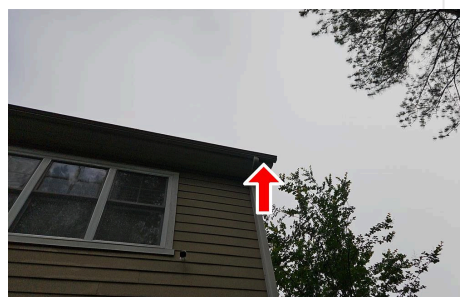
3.1 Item 1 (Picture)

1. The wood fascia at eave on the exterior damaged. Further deterioration may occur if not repaired.  
Repairs are needed.

A qualified person should repair or replace as needed.

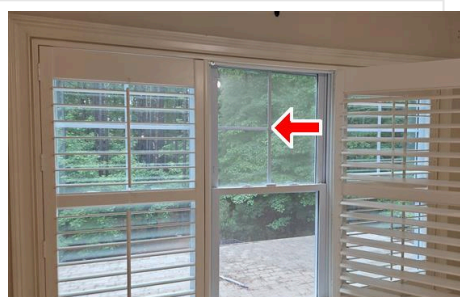
3.2 Item 1 (Picture)

1. Several windows have failed/compromised thermal seals/fogged window panes. This is indicated by the visible moisture, discoloration, calcium deposits and or crystallization visible between the glass window panes. A certified window technician should recheck all the windows throughout the home. Due to weather conditions many times compromised/failed windows cannot be identified at the time of inspection. Further investigation and repairs are needed.

We recommend contacting a properly licensed window technician/contractor regarding these conditions and have repairs made deemed appropriate

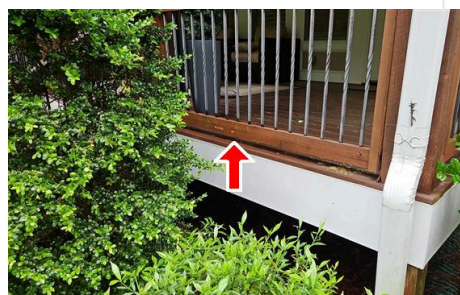
3.4 Item 1 (Picture)

1. The guardrails on deck at the rear of home is damage from woodpecker. Further deterioration can occur if not corrected. Further investigation and repairs are needed.

A qualified contractor should repair or replace as needed.

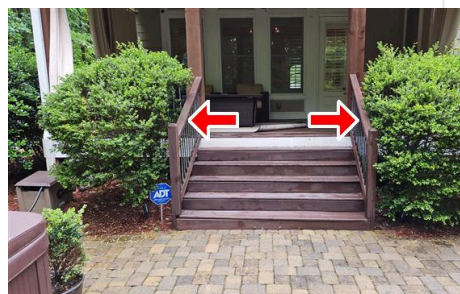
3.4 Item 6 (Picture)

1. The guardrails on steps at the rear of home are loose. A fall or injury could occur if not corrected. Repairs are needed.

A qualified contractor should repair or replace as needed.

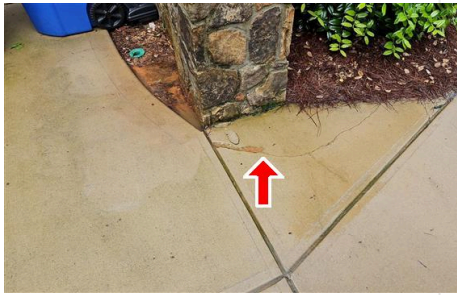
3.5 Item 1 (Picture)

1. The concrete drive at the left side (facing front) uneven, and can be a tripping hazard. Water can cause further deterioration if not repaired and sealed properly A fall or injury can occur if not corrected. Repairs are needed.

A qualified person should repair or replace as needed.

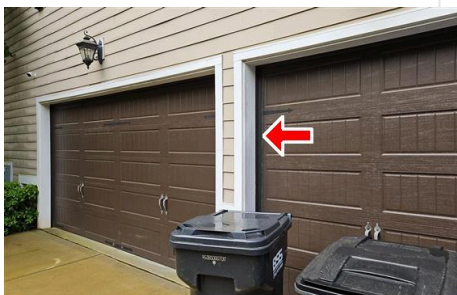
3.6 Item 1 (Picture)

1. The garage door at the left side (facing front) is damaged. This is considered unsafe and needs correcting. I did not inspect or operate either garage door. I recommend having a garage door company, repair and inspect both doors and garage door openers. Further investigation and repairs are needed.

A qualified contractor should inspect and repair as needed.

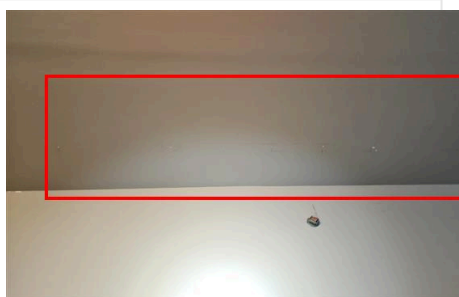
3.8 Item 1 (Picture)

1. The firewall that separates garage from heated space is compromised. This is considered unsafe until corrected. Repairs are needed.

A qualified person should correct for safety.

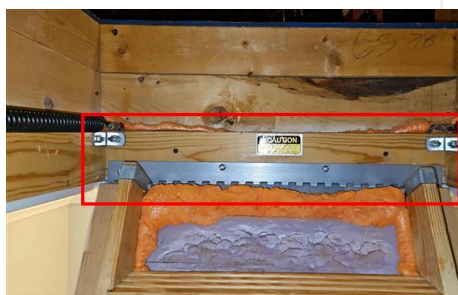
4.4 Item 1 (Picture)

1. The pull down stairs for the attic is installed with deck screws. The only approved means of securing attic stairs is a 16 penny nail per manufacture. An injury could occur if not corrected. Repairs are needed.

A qualified person should repair or replace as needed.

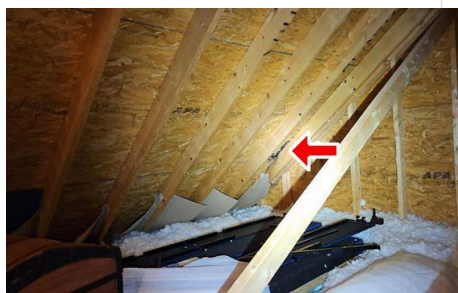
4.4 Item 5 (Picture)

1. Water signs are on plywood resulting from a roof leak found (above Guest bedroom). Repairs are needed to prevent water damage from occurring to the home. Further investigation and repairs are needed.

A qualified roofing contractor should inspect further and correct as needed.

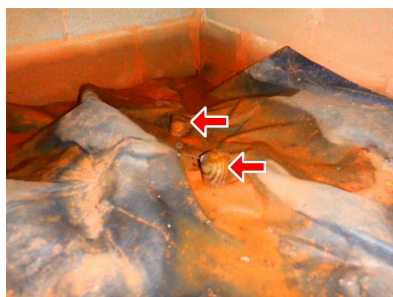
4.5 Item 1 (Picture)

1. Wood debris is in contact with the crawl space floor in numerous areas. This can attract wood destroying organisms. Removal is needed.

A qualified contractor should inspect and repair as needed.

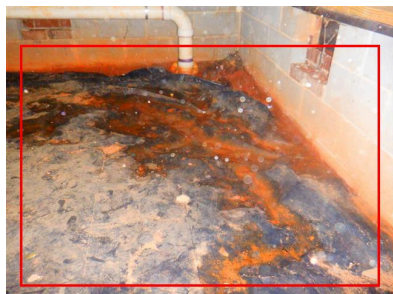
4.6 Item 1 (Picture)

1. Visible signs of water intrusion in the crawlspace (left side of home facing front) are present from standing water on plastic vapor barrier. Water intrusion if not corrected can lead to other problems including mold and cause excessive moisture to floor system that can lead to deterioration and increased repair cost. Further investigation and repairs are needed.

I recommend further investigation or correction by a qualified licensed contractor or water infiltration specialist.

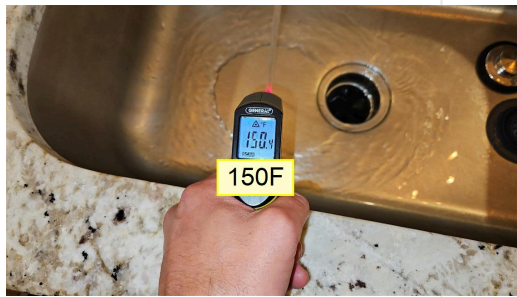
5.1 Item 1 (Picture)

1. The water heater is set over the recommended temperature. (Over 120) The risk is especially acute for infants, children, and the elderly. Water temperatures should never be set higher than 120 degrees.

This is a safety issue. Repairs are needed

A qualified contractor should inspect and repair as needed.

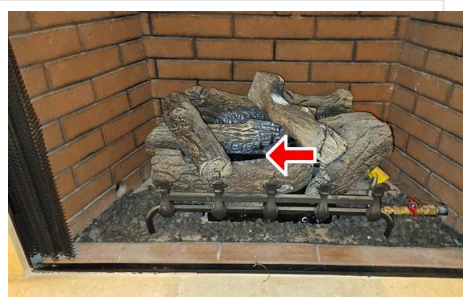
7.7 Item 1 (Picture)

1. The non-vented fire logs in the Living room is not operable (pilot would not ignite). Repairs should be made so unit works properly. Further investigation and repairs are needed.

A qualified person should repair or replace as needed.

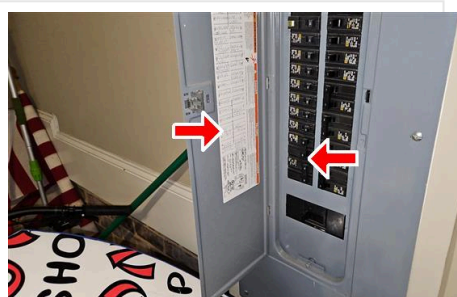
7.8 Item 1 (Picture)

1. The breaker for second floor heat pump tripped numerous times at the inspection. Therefore it is not functioning as intended. A more thorough inspection by a qualified contractor is needed. A qualified HVAC person should inspect further and repair or replace as needed.

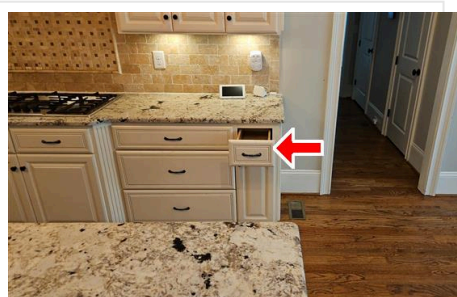
8.4 Item 1 (Picture)

1. Drawer is damaged in the kitchen. Therefore it is not functioning as intended. Recommend repair or replace as necessary. A qualified person should repair or replace as needed

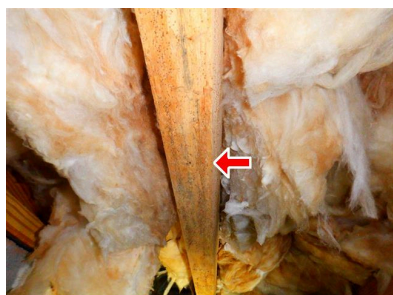
1.0 Item 1 (Picture)

1. Discoloration and some type of mold (Microbial) growth is present in the structure at several areas including but not limited to the crawl space and interior spaces. Evidence suggests that this condition is from a past or present elevated moisture conditions. We did not inspect, test or determine if this type of substance is or is not a health hazard. Further investigation is needed.

We recommend you contact a properly licensed expert for testing, investigation and or correction as deemed appropriate.

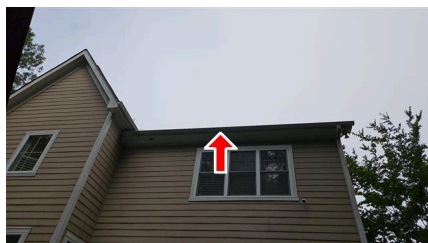
2.3 Item 1 (Picture)

1. The gutter are is clogged at the virtually all areas where gutters are installed. Gutters that drain poorly or clogged can lead to many costly problems such as deterioration of fascia, soffit or roof edge. It can also cause gutters to pull loose and lead to possible water intrusion. Repairs are needed.

A qualified person should repair or replace as needed.

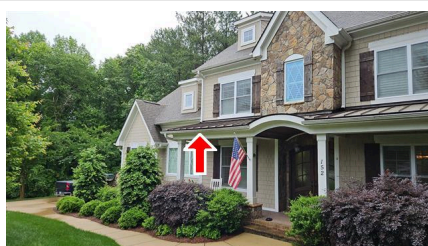
2.3 Item 3 (Picture)

1. The gutter is damaged at the front (left of main entry). Gutters that drain poorly or clogged can lead to many costly problems such as deterioration of fascia, soffit or roof edge. It can also cause gutters to pull loose and lead to possible water intrusion. Repairs are needed.

A qualified person should repair or replace as needed.

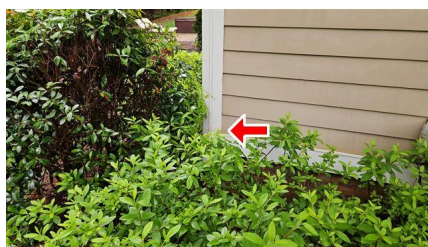
3.0 Item 1 (Picture)

1. The wood trim at the exterior in areas deteriorated. Further deterioration can occur if not corrected. Repairs are needed.

A qualified person should repair or replace as needed.

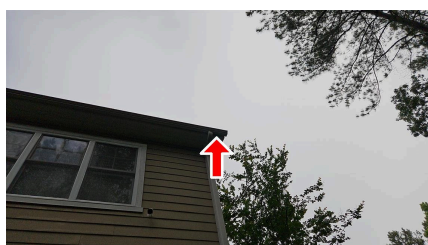
3.1 Item 1 (Picture)

1. The wood fascia at eave on the exterior damaged. Further deterioration may occur if not repaired. Repairs are needed.

A qualified person should repair or replace as needed.

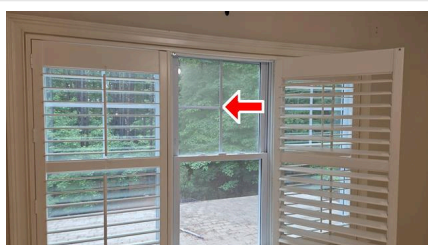
3.2 Item 1 (Picture)

1. Several windows have failed/compromised thermal seals/fogged window panes. This is indicated by the visible moisture, discoloration, calcium deposits and or crystallization visible between the glass window panes. A certified window technician should recheck all the windows throughout the home. Due to weather conditions many times compromised/failed windows cannot be identified at the time of inspection. Further investigation and repairs are needed.

We recommend contacting a properly licensed window technician/contractor regarding these conditions and have repairs made deemed appropriate

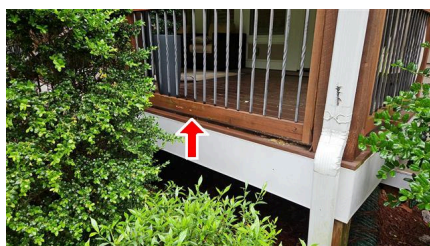
**3.4 Item 1 (Picture)**

1. The guardrails on deck at the rear of home is damage from woodpecker. Further deterioration can occur if not corrected. Further investigation and repairs are needed.

A qualified contractor should repair or replace as needed.

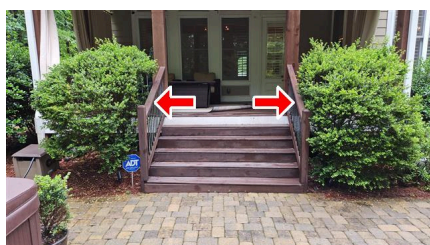
**3.4 Item 6 (Picture)**

1. The guardrails on steps at the rear of home are loose. A fall or injury could occur if not corrected. Repairs are needed.

A qualified contractor should repair or replace as needed.

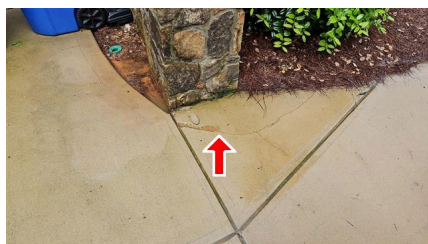
3.5 Item 1 (Picture)

1. The concrete drive at the left side (facing front) uneven, and can be a tripping hazard. Water can cause further deterioration if not repaired and sealed properly A fall or injury can occur if not corrected. Repairs are needed.

A qualified person should repair or replace as needed.

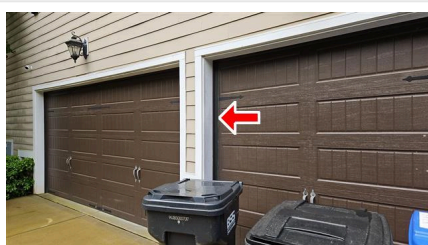
3.6 Item 1 (Picture)

1. The garage door at the left side (facing front) is damaged. This is considered unsafe and needs correcting. I did not inspect or operate either garage door. I recommend having a garage door company, repair and inspect both doors and garage door openers. Further investigation and repairs are needed.

A qualified contractor should inspect and repair as needed.

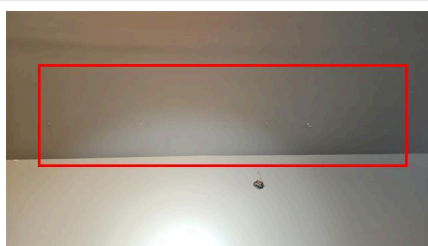
**3.8 Item 1 (Picture)**

1. The firewall that separates garage from heated space is compromised. This is considered unsafe until corrected. Repairs are needed.

A qualified person should correct for safety.

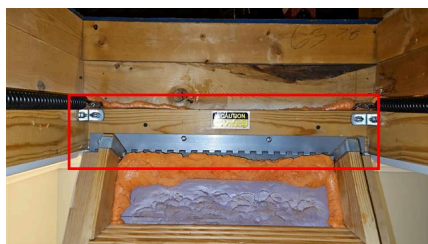
4.4 Item 1 (Picture)

Repairs are needed.

A qualified person should repair or replace as needed.

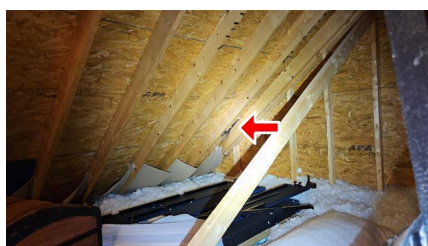
4.4 Item 5 (Picture)

1. Water signs are on plywood resulting from a roof leak found (above Guest bedroom). Repairs are needed to prevent water damage from occurring to the home. Further investigation and repairs are needed.

A qualified roofing contractor should inspect further and correct as needed.

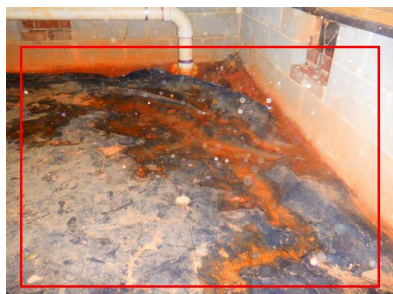
4.6 Item 1 (Picture)

1. Visible signs of water intrusion in the crawlspace (left side of home facing front) are present from standing water on plastic vapor barrier. Water intrusion if not corrected can lead to other problems including mold and cause excessive moisture to floor system that can lead to deterioration and increased repair cost. Further investigation and repairs are needed.

I recommend further investigation or correction by a qualified licensed contractor or water infiltration specialist.

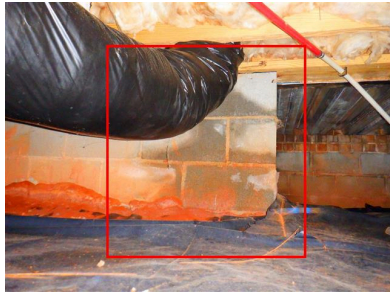
**4.6 Item 5 (Picture)**

1. Dark stains on the CMU (Concrete Masonry Unit) indicated that water is inside the block. Dark stains and white efflorescence (powder substance) on block wall indicates moisture is in contact with the masonry. This does not necessarily indicate that intrusion will occur. Efflorescence is found on many homes without water intrusion occurring inside the home. But, it should alert you to the possibility that future steps may be needed. Further investigation and repairs are needed.

I recommend contact a licensed water intrusion specialist regarding these conditions.

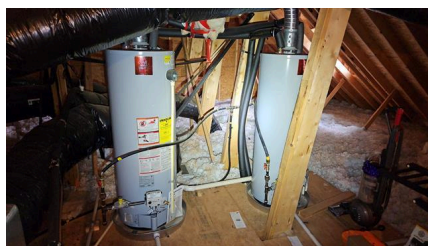
Complimentary photo of the water heaters

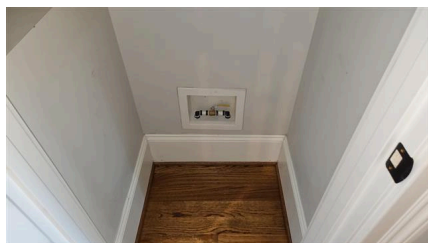
5.0 Item 1 (Picture)

The main shut-off is the yellow lever located in the entry code closet. This is for your information.

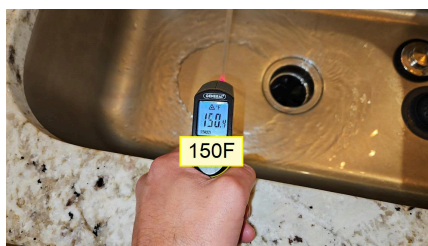
5.1 Item 1 (Picture)

1. The water heater is set over the recommended temperature. (Over 120) The risk is especially acute for infants, children, and the elderly. Water temperatures should never be set higher than 120 degrees. This is a safety issue. Repairs are needed

A qualified contractor should inspect and repair as needed.

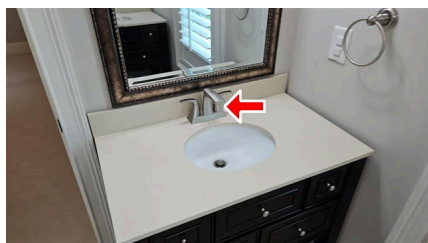
5.2 Item 1 (Picture)

1. The aerator sinks faucets at the guest bath spray water all over countertop. Repairs are needed to prevent water damage from occurring to the home. Repairs are needed.

A qualified licensed plumber should repair or correct as needed.

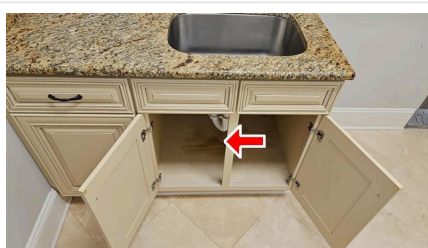
5.3 Item 1 (Picture)

1. The plumbing waste line leaks at the laundry room sink. Repairs are needed to prevent water damage from occurring to the home. Further investigation and repairs are needed.

A qualified licensed plumber should repair or correct as needed.

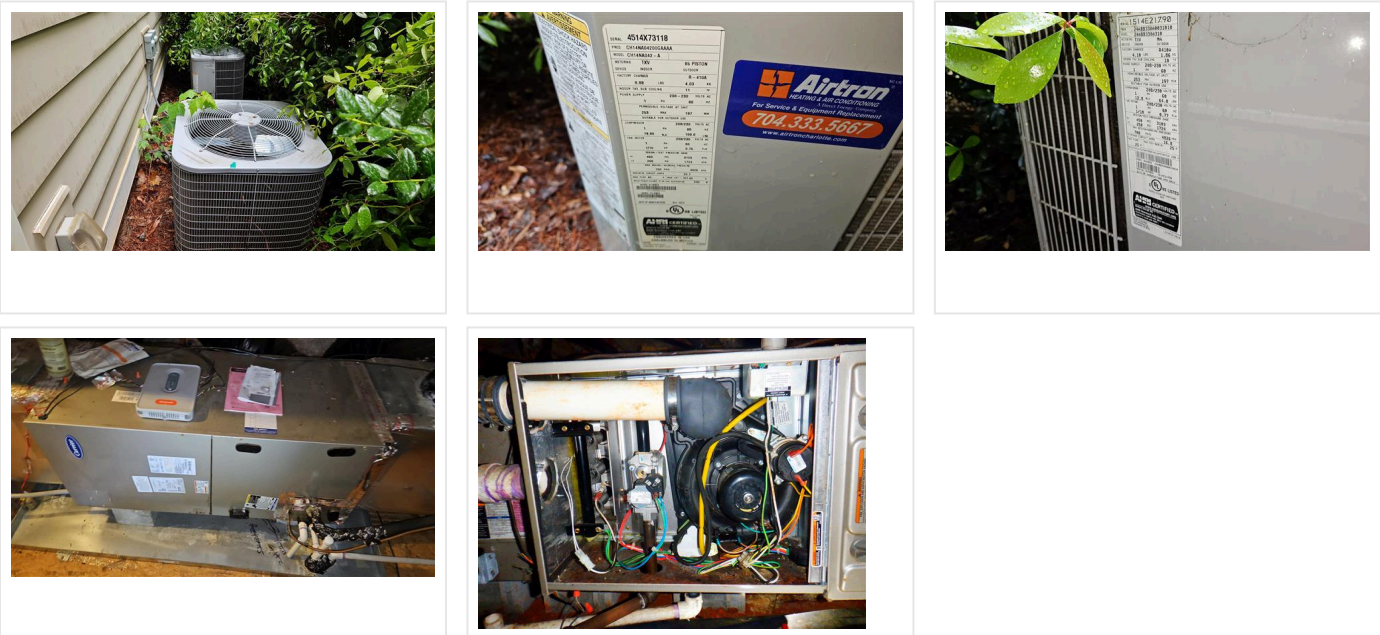
Complimentary photo of the heat pump

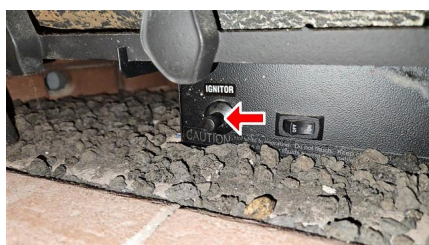
7.7 Item 2 (Picture)

1. The non-vented fire logs in the Living room is not operable (pilot would not ignite). Repairs should be made so unit works properly. Further investigation and repairs are needed.

A qualified person should repair or replace as needed.

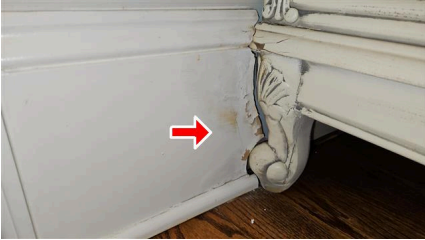
8.1 Item 2 (Picture)

1. The sheetrock and baseboard on the wall shows water stains indicating moisture at the Hall Bath downstairs and Washer/Dryer room. The moisture meter was used and it did not indicate an active leak. Repairs are needed.

A qualified contractor should inspect and repair as needed.

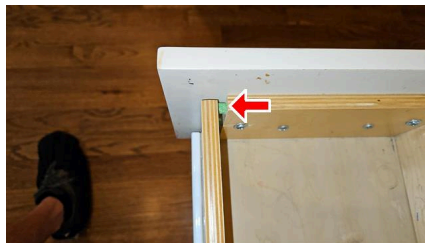
8.4 Item 2 (Picture)

1. Drawer is damaged in the kitchen. Therefore it is not functioning as intended. Recommend repair or replace as necessary.

A qualified person should repair or replace as needed

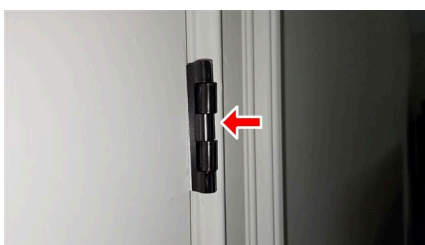
8.5 Item 2 (Picture)

1. The hinge pin is missing at the bonus room door period. Therefore, it does not function as intended. Repairs are needed.

A qualified person should repair or replace as needed.

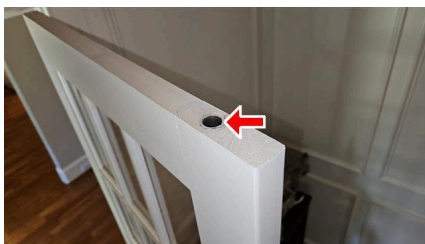
8.5 Item 4 (Picture)

1. The double doors has damage or missing roller ball catch. at the office. As a result the door will not close properly. Repairs are needed.

A qualified person should repair or replace as needed.
