INSPECTION REPORT  
203 N Kayla Dr  
Salisbury NC 28146

INSPECTED BY  
Alex Parr 3692  
Above Parr Home  
Inspections

INSPECTION DATE  
📅 3/16/2023  
🕒 09:00:00 AM

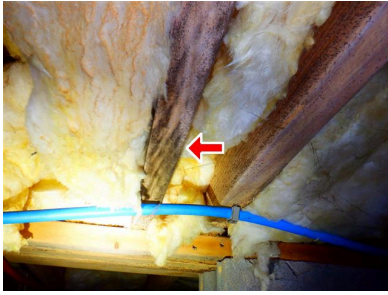
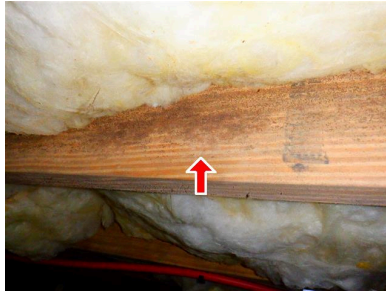
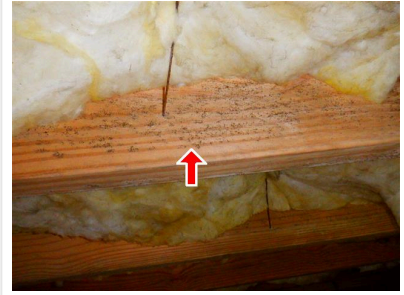
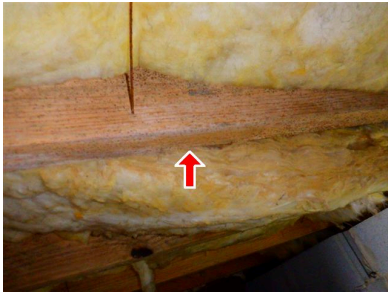
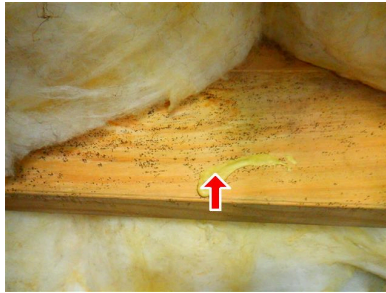
1. Discoloration and some type of mold (Microbial) growth is present in the structure at several areas including but not limited to the crawl space and interior spaces. Evidence suggests that this condition is from a past or present elevated moisture conditions. We did not inspect, test or determine if this type of substance is or is not a health hazard. Further investigation is needed.

We recommend you contact a properly licensed expert for testing, investigation and or correction as deemed appropriate.

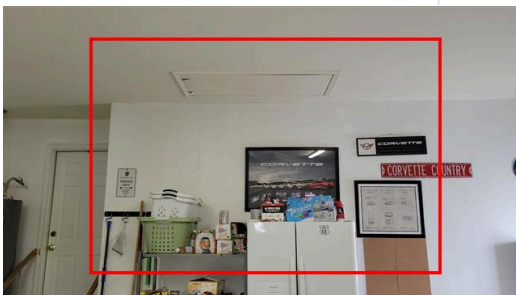
1.1 Item 1 (Picture)

1. Furniture, storage and or personal items in the garage and throughout the house. As a result the areas were not inspected. hidden damage may be present. Further investigation and repairs are needed.

We recommend having all personal items removed and these areas inspected prior to closing.

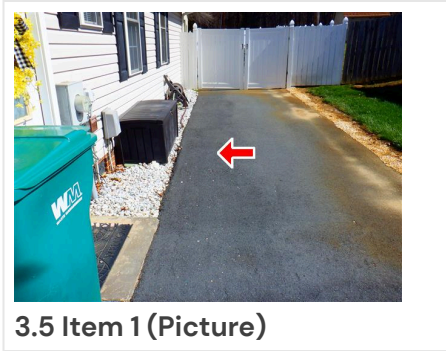
1. The asphalt drive at the right side (facing front) appears to drains toward foundation of home. This

may allow water intrusion to occur. Further investigation and repairs are needed.  
A qualified person should repair or replace as needed.

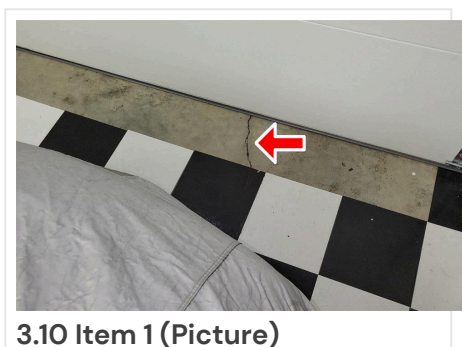
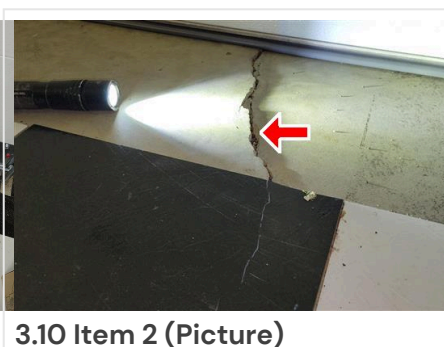
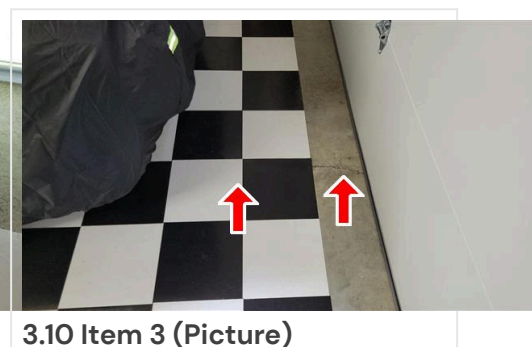
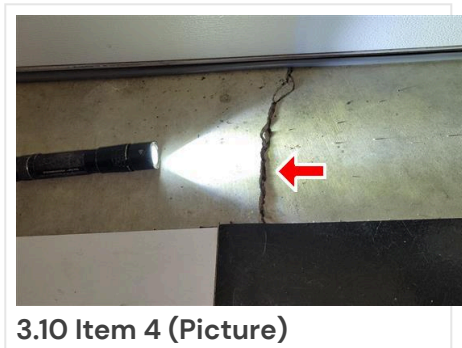
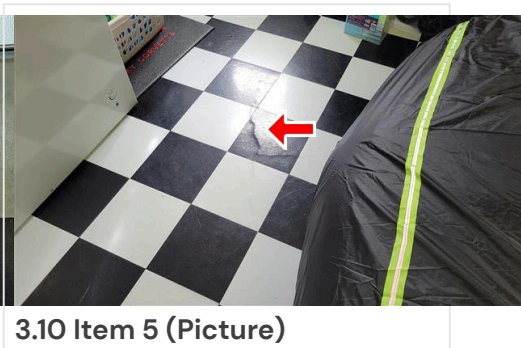
1. The concrete floor of garage has settled or settlement is occurring due to cracks or uneven cracks in the surface. Further settlement may occur. Further investigation and repairs are recommended.  
A qualified contractor should inspect and repair as needed.

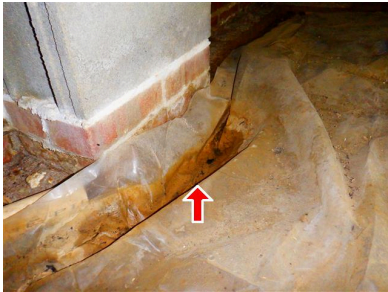
4.6 Item 1 (Picture)

1. Visible signs of water intrusion in the crawlspace right rear corner are present from standing water on plastic vapor barrier. Water intrusion if not corrected can lead to other problems including mold and cause excessive moisture to floor system that can lead to deterioration and increased repair cost. Further investigation and repairs are needed.

I recommend further investigation or correction by a qualified licensed contractor or water infiltration specialist.

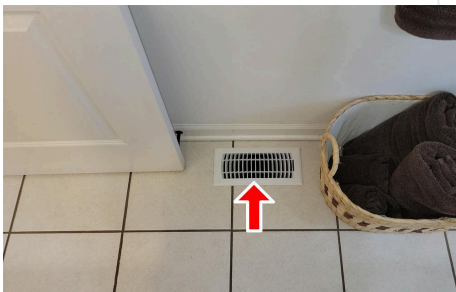
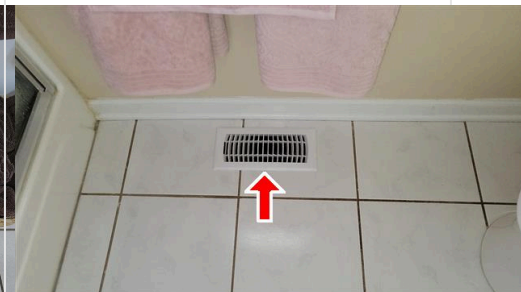
1. The supply register in floor is weak (not intended for floor) in the guest bath and in the master bath. This is a safety issue and should be repaired. A replacement is needed.

A licensed HVAC contractor should service or repair unit.

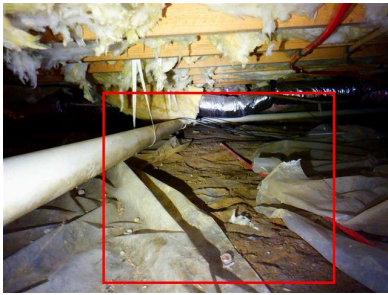
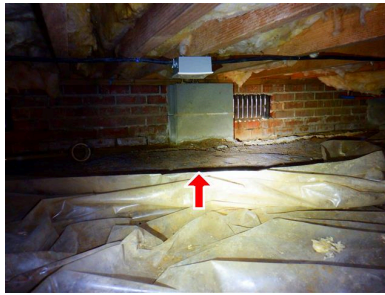
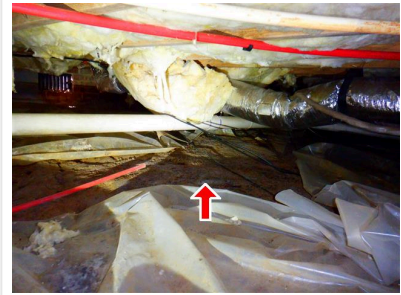
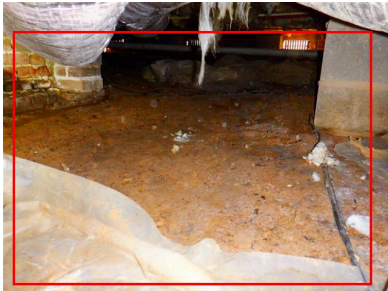
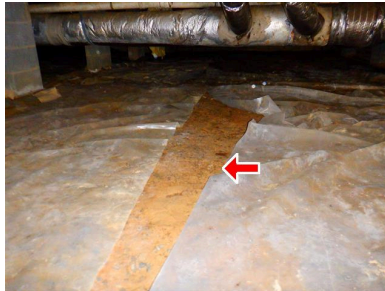
1. The vapor barrier (plastic) on the crawlspace ground is missing in areas. A vapor barrier provides added protection to the floor system from moisture or dampness that can enter from ground. Repairs are needed.

A qualified person should repair or replace as needed.

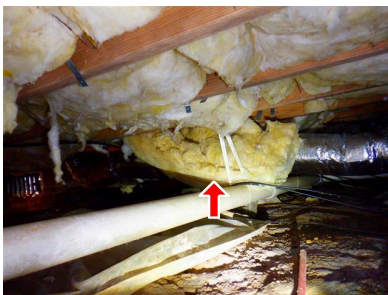
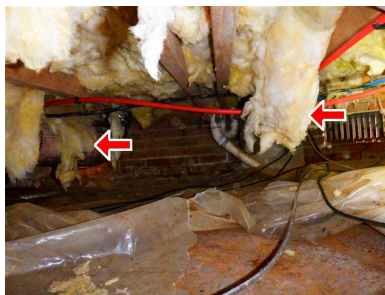
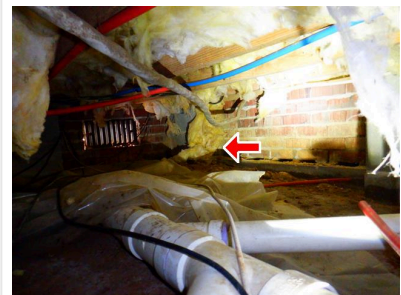
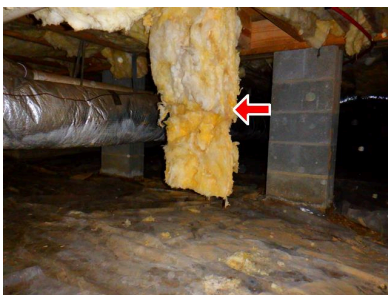
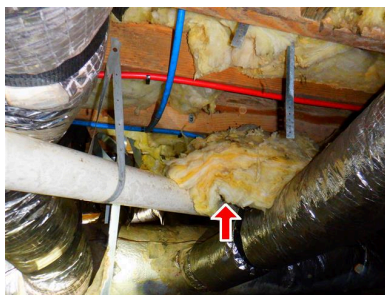
1. The insulation is loose/fallen in the crawlspace. Heat loss can occur more on this home than one that is properly insulated. Repairs are needed..

A qualified person should repair or replace as needed.

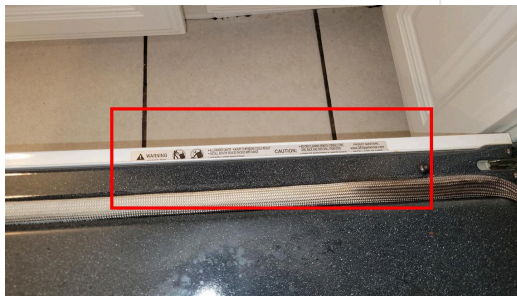
10.1 Item 1 (Picture)

1. The range/oven needs to be properly attached/anchored to the structure as to keep it from tipping over when the oven door is opened and/or oven racks are pulled out during use. This is a safety issue. Repairs are needed.

I recommend contacting appliance repair company.

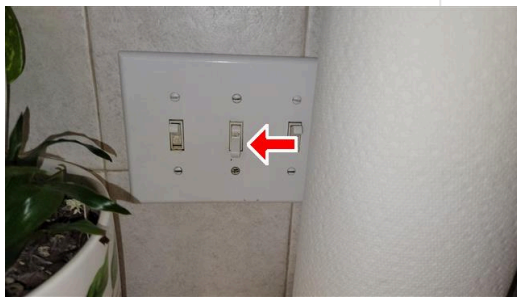
10.4 Item 1 (Picture)

1. The wall switch has a "short" or loose connection for the food waste disposer. Electrical issues are considered a hazard until repaired. Further investigation and repairs are needed..

A qualified licensed electrical contractor should correct as needed.

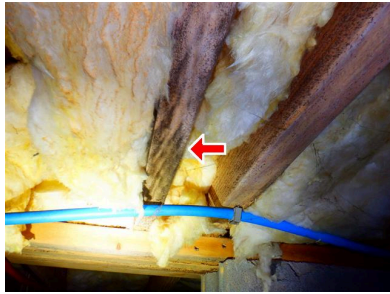
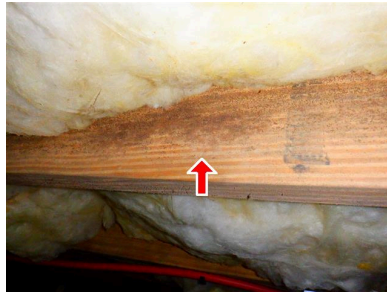
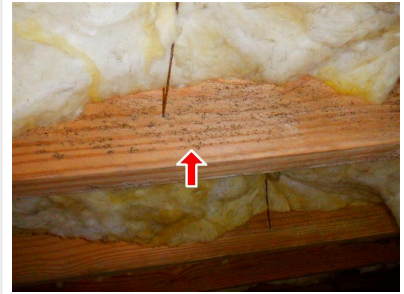
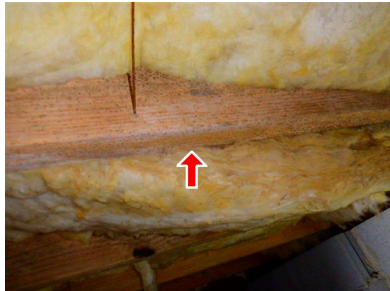
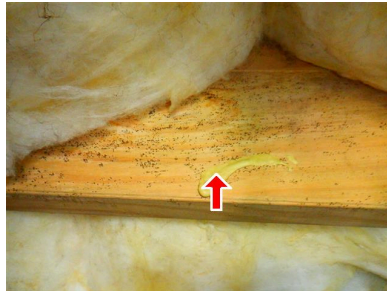
1. Discoloration and some type of mold (Microbial) growth is present in the structure at several areas including but not limited to the crawl space and interior spaces. Evidence suggests that this condition is from a past or present elevated moisture conditions. We did not inspect, test or determine if this type of substance is or is not a health hazard. Further investigation is needed.

We recommend you contact a properly licensed expert for testing, investigation and or correction as deemed appropriate.

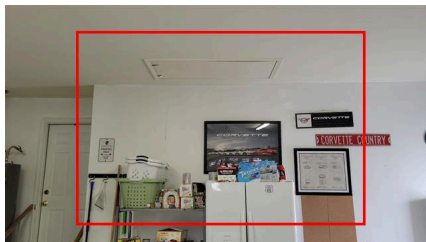
1.1 Item 1 (Picture)

1. Furniture, storage and or personal items in the garage and throughout the house. As a result the areas were not inspected. hidden damage may be present. Further investigation and repairs are needed.

We recommend having all personal items removed and these areas inspected prior to closing.

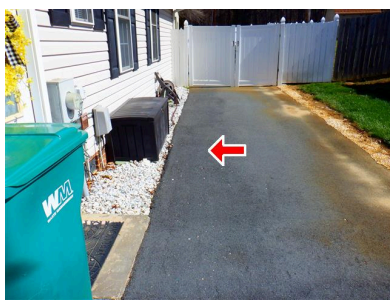
3.5 Item 1 (Picture)

1. The asphalt drive at the right side (facing front) appears to drains toward foundation of home. This may allow water intrusion to occur. Further investigation and repairs are needed.

A qualified person should repair or replace as needed.

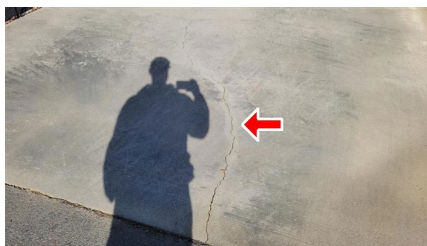
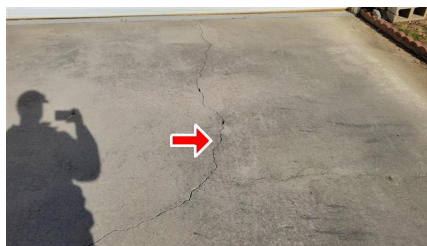
1. The concrete driveway has cracks that should be sealed to prevent further damage, which is part of ongoing maintenance of a concrete driveway that will need to be performed on a regular basis. Repairs are recommended.

A qualified contractor should inspect and repair as needed.

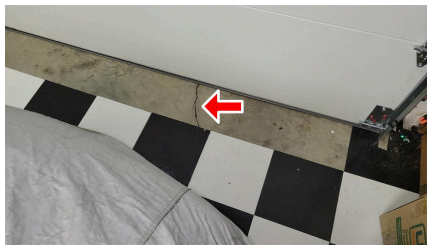
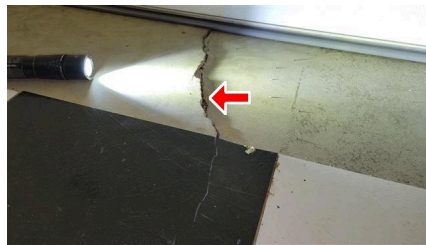
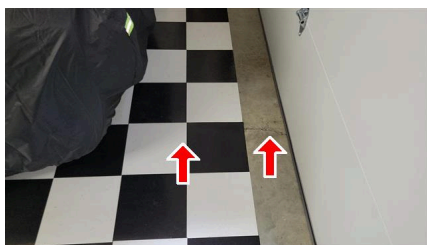
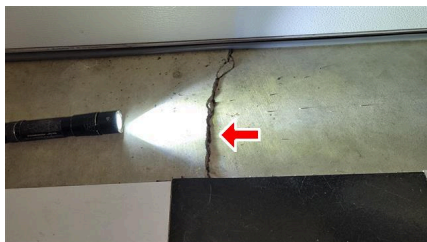
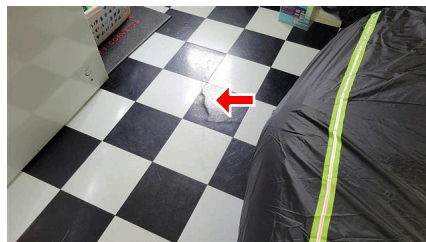
1. The concrete floor of garage has settled or settlement is occurring due to cracks or uneven cracks in the surface. Further settlement may occur. Further investigation and repairs are recommended. A qualified contractor should inspect and repair as needed.

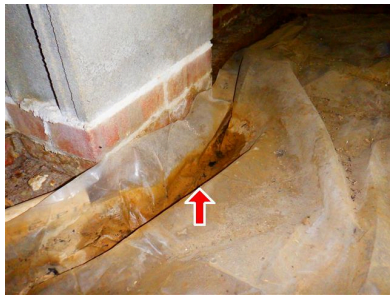
4.6 Item 1 (Picture)

1. Visible signs of water intrusion in the crawlspace right rear corner are present from standing water on plastic vapor barrier. Water intrusion if not corrected can lead to other problems including mold and cause excessive moisture to floor system that can lead to deterioration and increased repair cost. Further investigation and repairs are needed.

I recommend further investigation or correction by a qualified licensed contractor or water infiltration specialist.

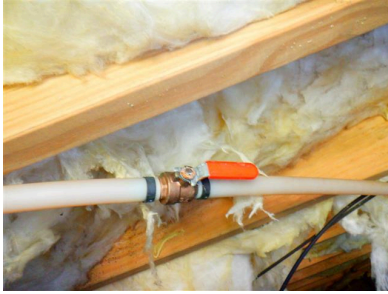
5.0 Item 1 (Picture)

The main shut off is the red lever located underneath in the crawlspace. This is for your information.

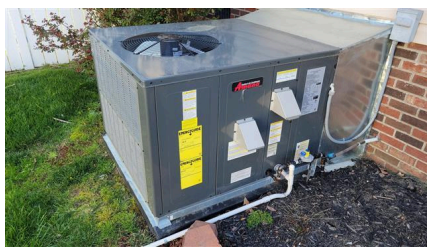
Complimentary photo of the package unit

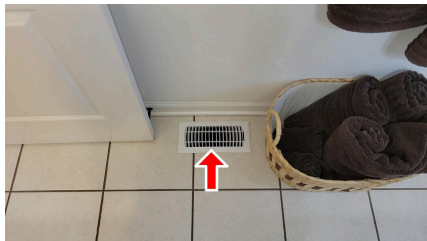
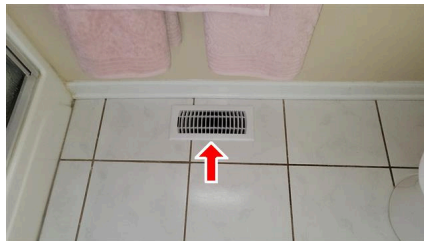
1. The supply register in floor is weak (not intended for floor) in the guest bath and in the master bath. This is a safety issue and should be repaired. A replacement is needed.

A licensed HVAC contractor should service or repair unit.

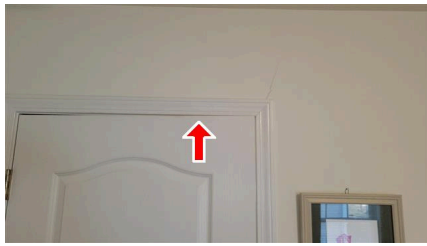
8.5 Item 1 (Picture)

1. The privacy door rubs at jamb when closing at the guest Bedroom. As a result the door will not close properly. Repairs are needed.

A qualified person should repair or replace as needed.

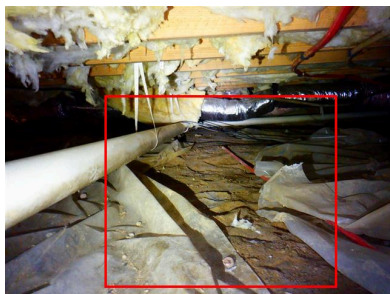
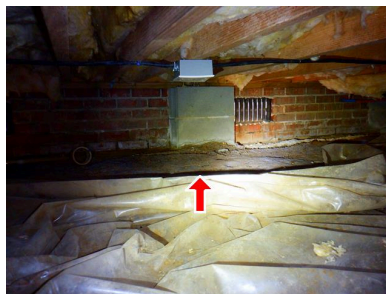
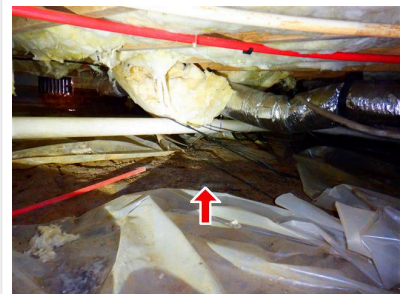
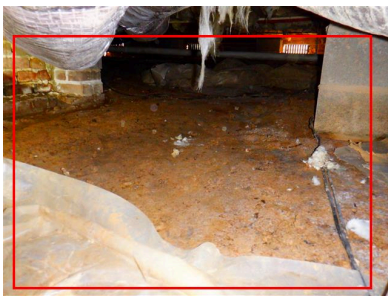
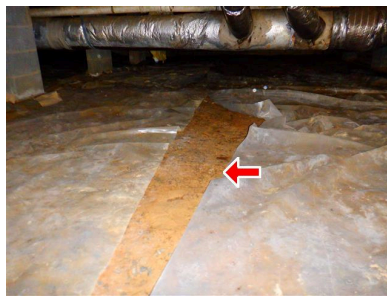
1. The vapor barrier (plastic) on the crawlspace ground is missing in areas. A vapor barrier provides added protection to the floor system from moisture or dampness that can enter from ground. Repairs are needed.

A qualified person should repair or replace as needed.

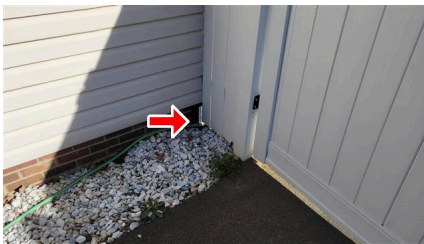
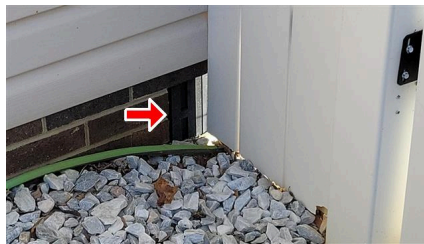
1. The foundation vent(s) are below ground level at right side (facing front) which can allow water to enter crawlspace. A half-round window well should be installed. The dirt inside well should be replaced with approximately four inches of gravel. A couple of inches clearance between gravel and vent opening recommended.

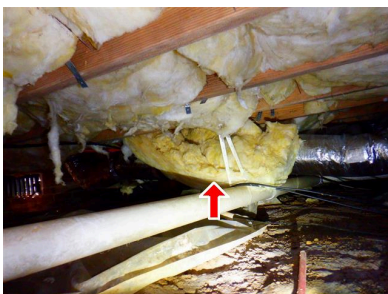
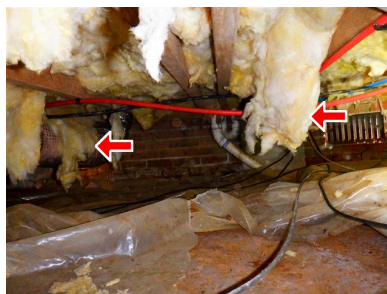
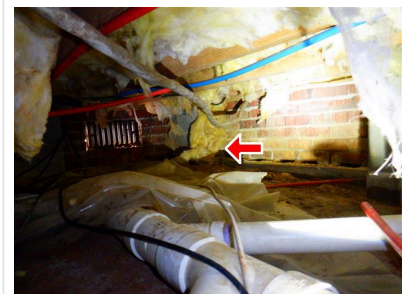
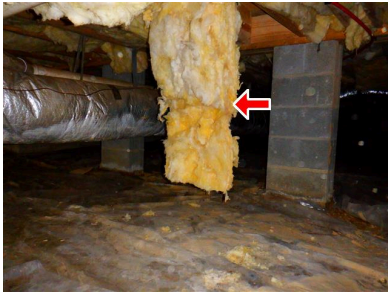
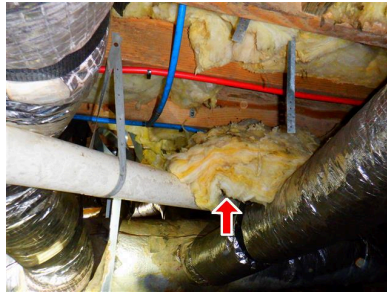
1. The insulation is loose/fallen in the crawlspace. Heat loss can occur more on this home than one that is properly insulated. Repairs are needed..  
A qualified person should repair or replace as needed.

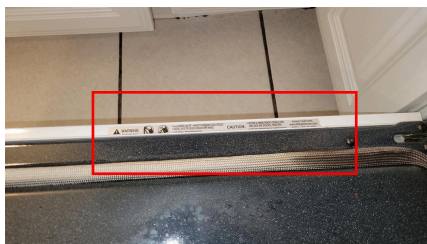
10.1 Item 1 (Picture)

1. The range/oven needs to be properly attached/anchored to the structure as to keep it from tipping over when the oven door is opened and/or oven racks are pulled out during use. This is a safety issue. Repairs are needed.

I recommend contacting appliance repair company.

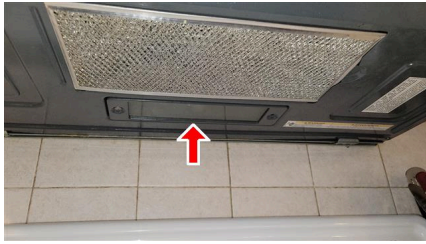
10.2 Item 1 (Picture)

1. The light bulb for fan did not work when tested. I recommend repair or replace as needed. I recommend contacting appliance repair company.

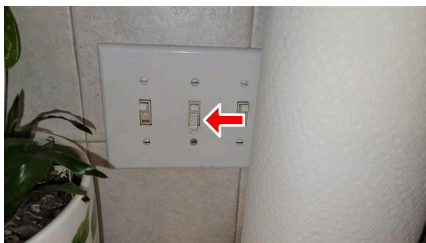
10.4 Item 1 (Picture)

1. The wall switch has a "short" or loose connection for the food waste disposer. Electrical issues are considered a hazard until repaired. Further investigation and repairs are needed..

A qualified licensed electrical contractor should correct as needed.
