INSPECTION REPORT  
2094 Weldon Smith Rd  
Lawsonville NC 27022

INSPECTION DATE  
📅 9/6/2024  
🕒 09:00:00 AM

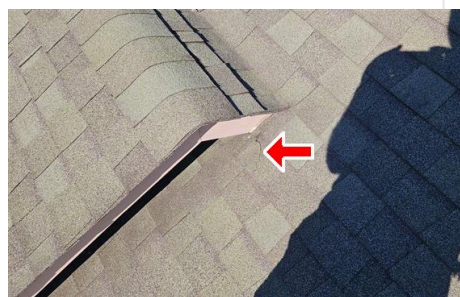
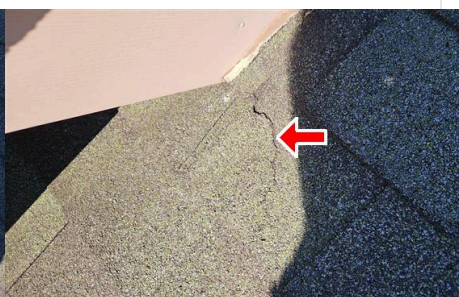
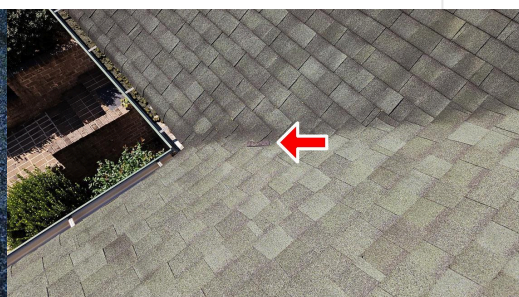
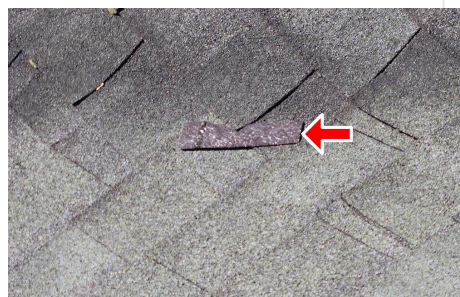
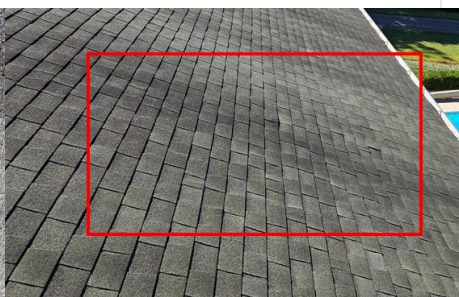
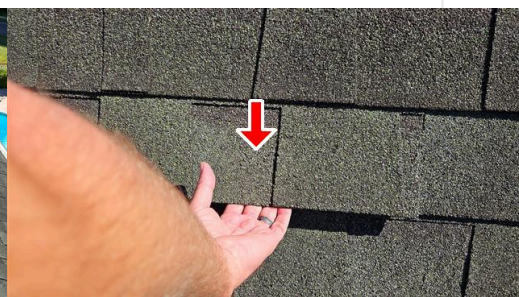
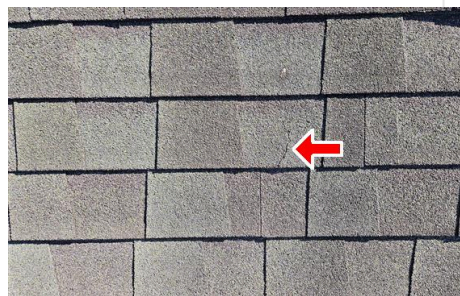
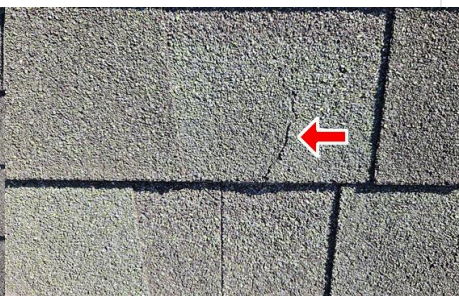
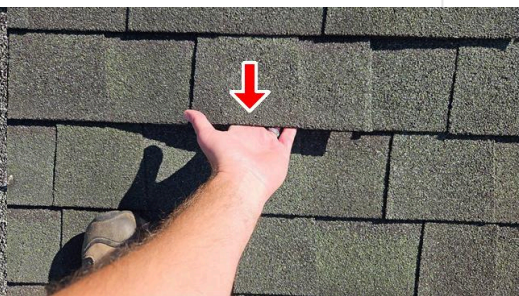
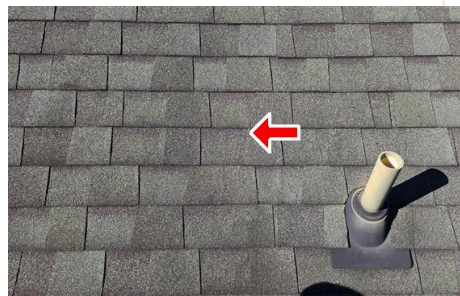
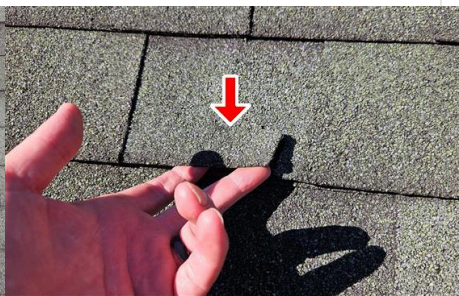
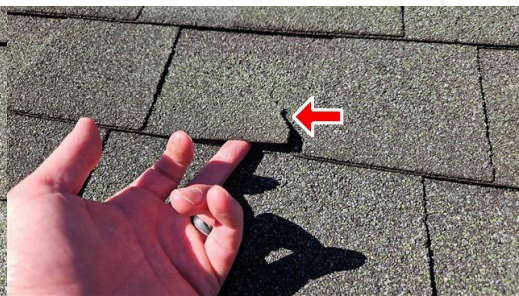
1. The roof shingles are damage and lose in areas. This damage should be repaired or replaced. Further investigation and repairs are needed.

A qualified contractor should inspect and repair as needed.

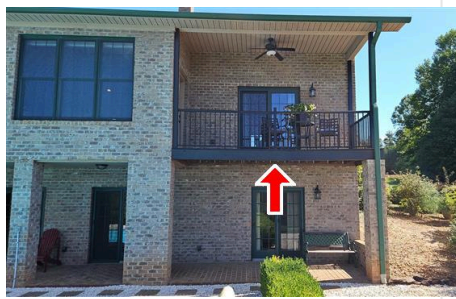
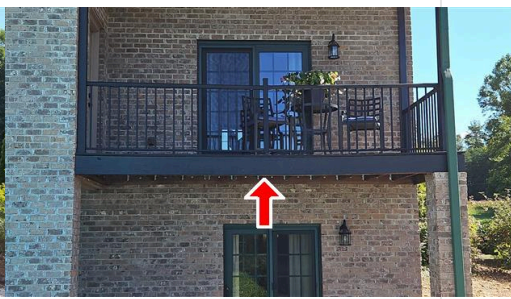
1. The exterior girders for the wood deck appear to sag in the middle. I recommend having the deck evaluated to ensure that it is structurally sound. Further investigation and repairs are needed.

A qualified contractor should perform the work.

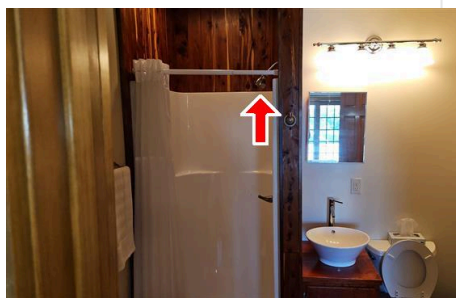
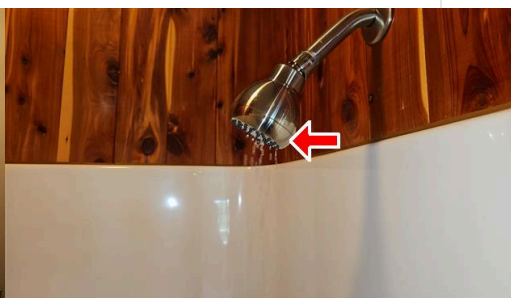
1. The shower at the guest bath in the basement has little to no water pressure. Therefore it did not function as intended. Further investigation and repairs are needed..

A qualified licensed plumber should repair or correct as needed.

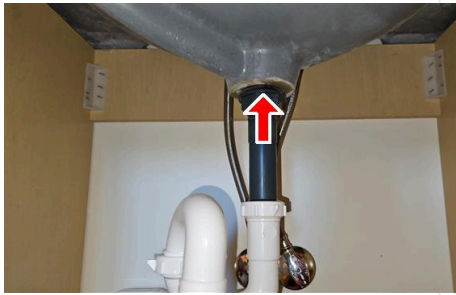
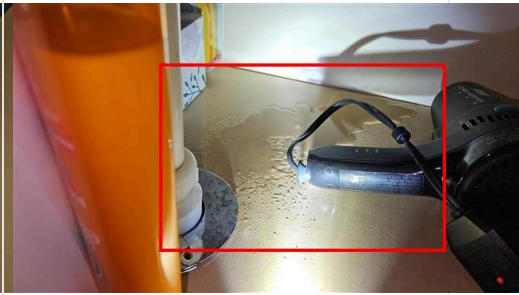
1. The plumbing waste line leaks at the guest bath sink. Repairs are needed to prevent water damage from occurring to the home. Further investigation and repairs are needed.

A qualified licensed plumber should repair or correct as needed.

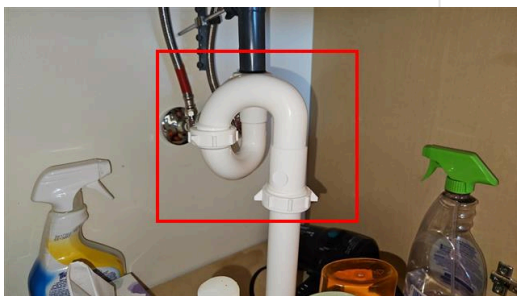
5.3 Item 3 (Picture)

1. The plumbing waste line is a S trap at the guest bath sink. A s-trap can gurgle struggling for air when draining water and sewer gases into the home. Further investigation and repairs are needed.

A qualified licensed plumber should repair or correct as needed.

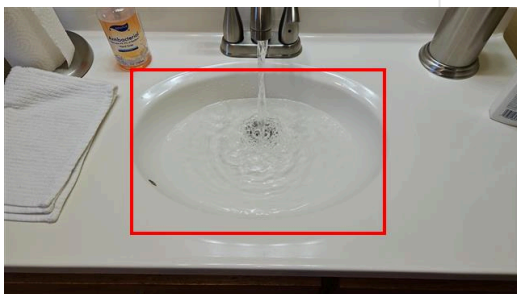
5.3 Item 4 (Picture)

1. The plumbing waste line drains slowly at the guest bath sink. A cause of a slow drain can range from a simple cleaning at stop valve or at the trap under sink. Sometimes the drain can be partially clogged down line. Further investigation and repairs are needed.

I am unable to determine the cause of the slow drain. A qualified licensed plumber should repair or correct as needed.

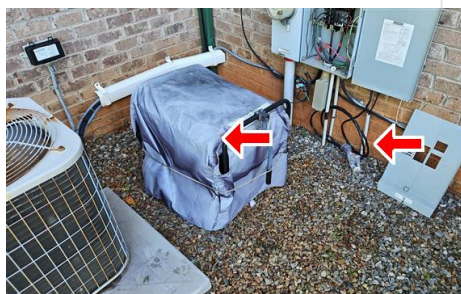
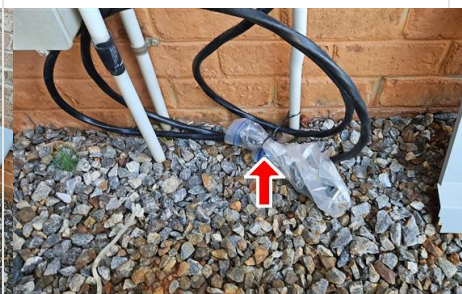
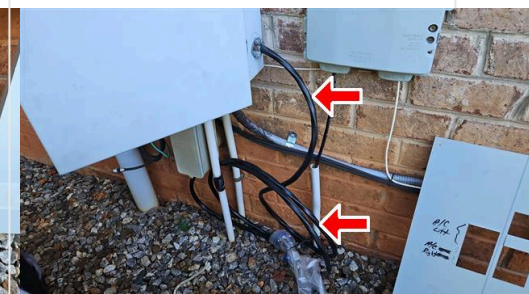
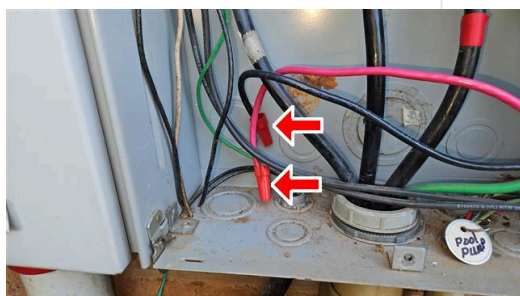
1. A generator hookup has been temporarily wired in the main electrical panel. There was not a dead man switch present. This is a safety issue. Further investigation and repairs are needed.

A qualified licensed electrical contractor should correct as needed.

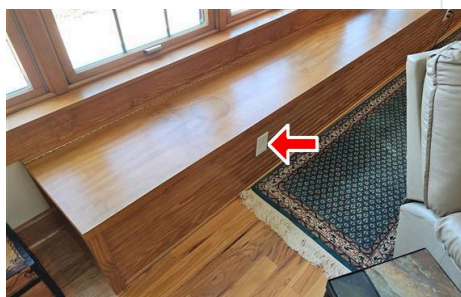
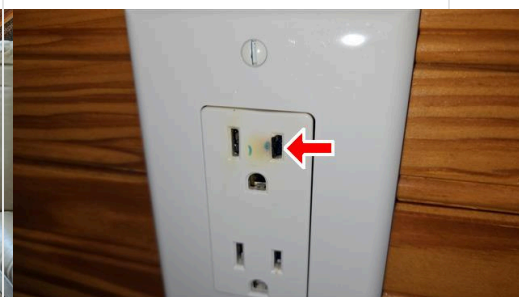
1. At least one "three-prong" outlet is damaged in the living room. This is a safety issue. Further investigation and repairs are needed.

A qualified licensed electrical contractor should correct as needed.

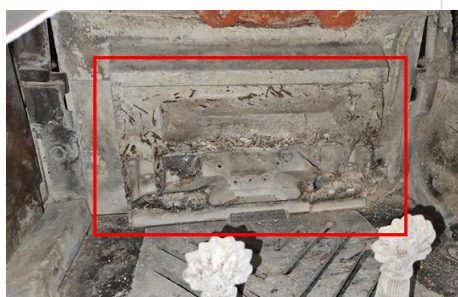
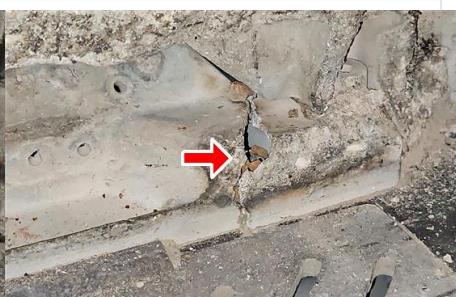
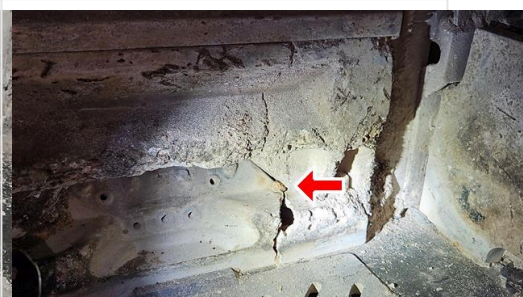
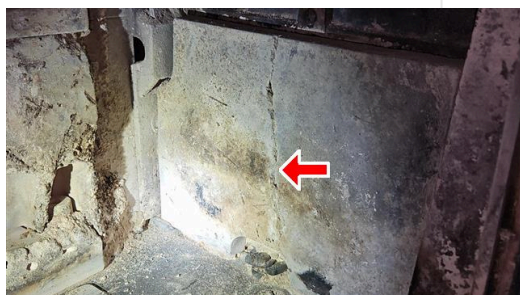
1. The (Burn Area) for the woodstove at the basement living room is damage. This burn area should be fireproof. Any repairs should be performed according to the manufacturer's specifications. Repairs should be made so unit works properly. Further investigation and repairs are needed.

A qualified contractor should inspect and repair as needed.

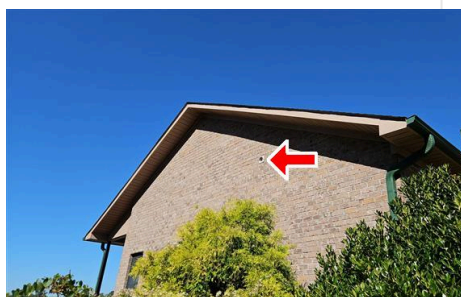
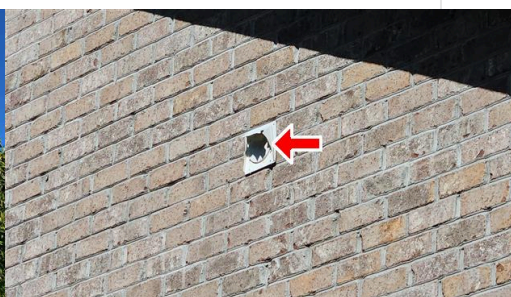
1. The exhaust fan has a damaged vent cover outside at the master bath. This may allow water intrusion to occur. Further investigation and repairs are needed.

A qualified person should repair or replace as needed.

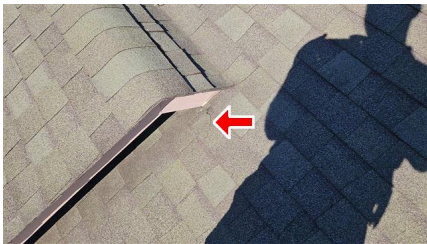
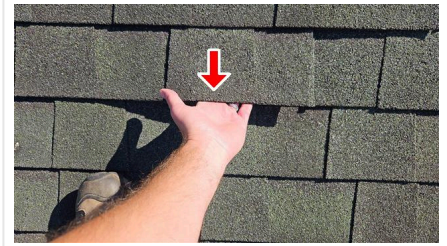
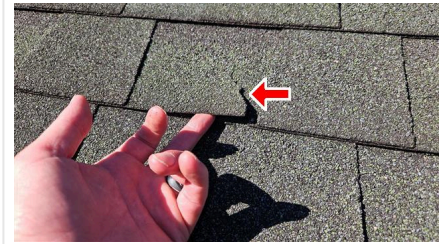
1. The roof shingles are damage and lose in areas. This damage should be repaired or replaced.  
Further investigation and repairs are needed.

A qualified contractor should inspect and repair as needed.

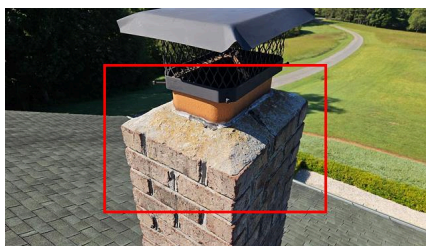
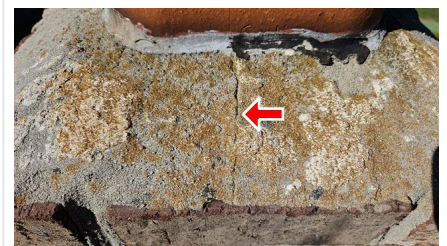
1. The chimney crown is crack and deteriorate. This can cause deterioration of mortar, loose bricks, other structural problems and water intrusion to occur. Further investigation and repairs are needed.

I recommend a chimney sweep inspect and repairs what is deemed necessary.

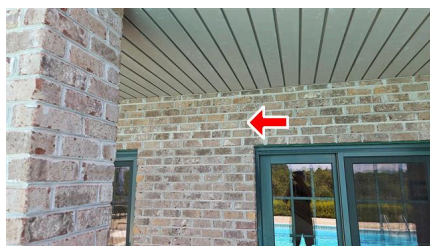
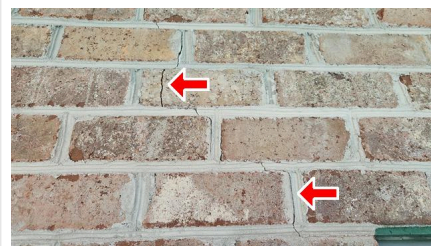
1. I observed small cracks in the brick veneer at the exterior. These are typical in nature due to age and normal masonry shrinkage. Although the cracks in the brick veneer are typical, these areas should be re sealed to prevent any water penetration or damage. Further evaluation by a qualified masonry contractor is recommended for this entire condition.

I recommend repair or replace using a qualified contractor.

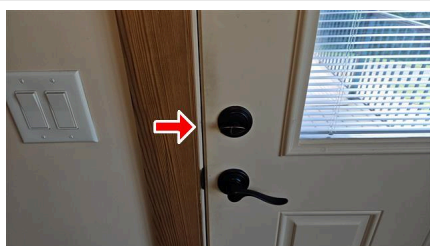
3.3 Item 1 (Picture)

1. The side entry door deadbolt does not latch properly. As a result the door will not lock properly. Further investigation and repairs are needed.

A qualified person should repair or replace as needed.

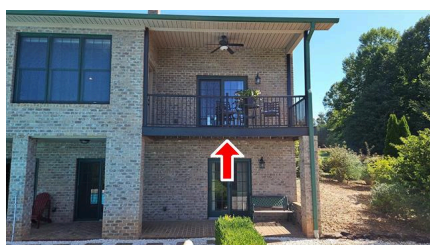
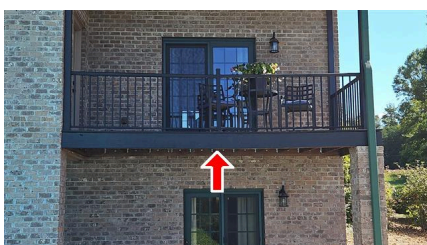
1. The exterior girders for the wood deck appear to sag in the middle. I recommend having the deck evaluated to ensure that it is structurally sound. Further investigation and repairs are needed.

A qualified contractor should perform the work.

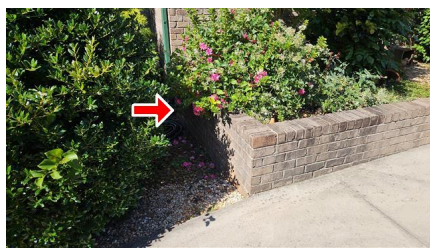
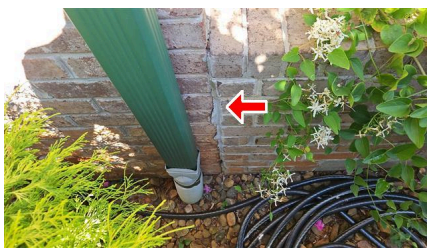
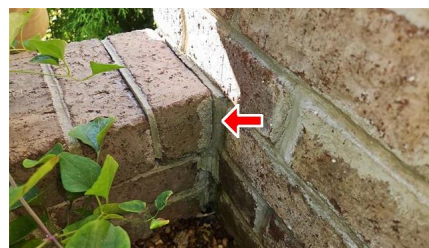
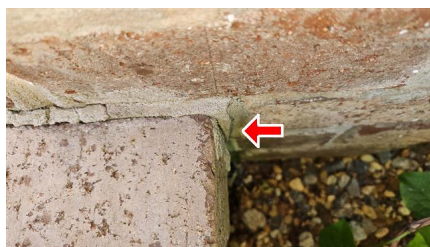
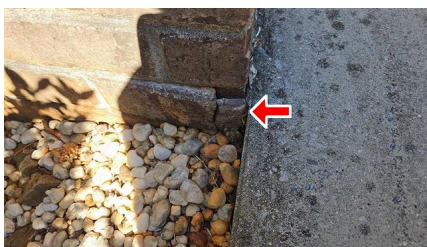
1. The retaining wall at the front of the home has evidence of movement. There was not a drain located at the time of inspection. Further deterioration may occur. Repairs are recommended.

A qualified contractor should inspect and repair as needed.

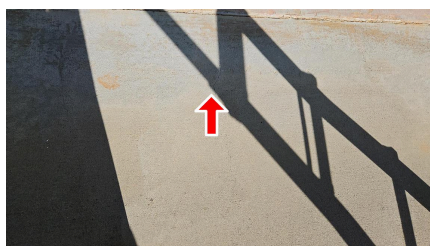
**3.5 Item 6 (Picture)**

1. The concrete driveway has cracks that should be sealed to prevent further damage, which is part of ongoing maintenance of a concrete driveway that will need to be performed on a regular basis. Repairs are recommended.

A qualified contractor should inspect and repair as needed.

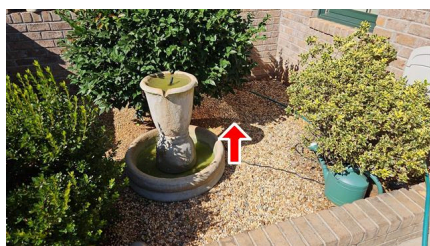
**3.5 Item 7 (Picture)**

1. There is a negative slope at the front of home and can cause or contribute to water intrusion or deterioration. I recommend correcting landscape to drain water away from home. Repairs are recommended.

A qualified contractor should inspect and repair as needed.

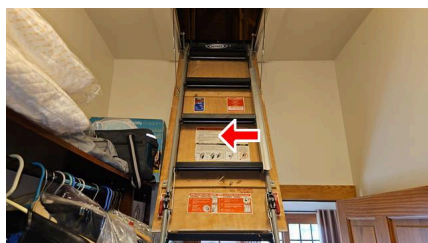
4.4 Item 1 (Picture)

1. The attic stairs is missing insulation. This can cause some heat loss in winter and loss of cool air in summer if not corrected. Repairs are needed.

A qualified person should repair or replace as needed.

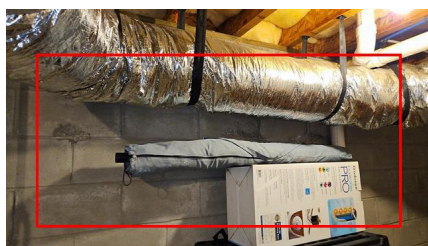
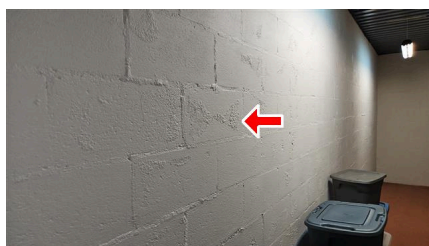
1. White efflorescence (powder substance) on block wall indicates moisture is in contact with the masonry. This does not necessarily indicate that intrusion will occur. I recommend checking the gutters and the downspout drain lines for proper operation. Also, a water proofing paint could be applied to the interior side of the block if necessary. Efflorescence is found on many homes without water intrusion occurring inside the home. But, it should alert you to the possibility that future steps may be needed.

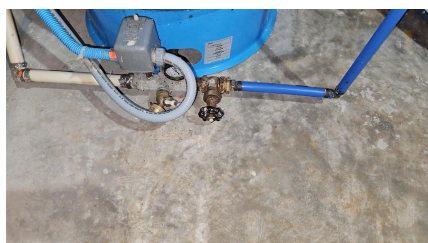
5.0 Item 1 (Picture)

The main shut off is the black knob located in the basement. This is for your information.

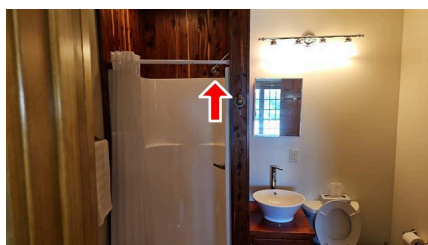
5.2 Item 1 (Picture)

1. The shower at the guest bath in the basement has little to no water pressure. Therefore it did not function as intended. Further investigation and repairs are needed..

A qualified licensed plumber should repair or correct as needed.

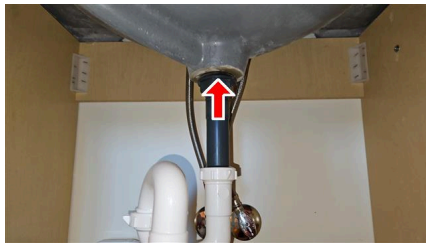
5.3 Item 1 (Picture)

1. The plumbing waste line leaks at the guest bath sink. Repairs are needed to prevent water damage from occurring to the home. Further investigation and repairs are needed.

A qualified licensed plumber should repair or correct as needed.

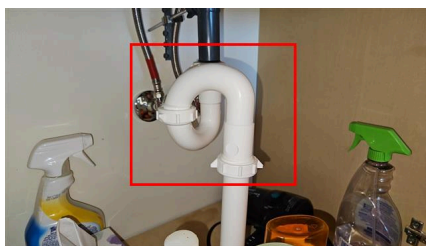
5.3 Item 3 (Picture)

1. The plumbing waste line is a S trap at the guest bath sink. A s-trap can gurgle struggling for air when draining water and sewer gases into the home. Further investigation and repairs are needed.

A qualified licensed plumber should repair or correct as needed.

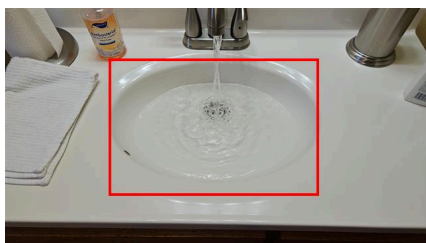
5.3 Item 4 (Picture)

1. The plumbing waste line drains slowly at the guest bath sink. A cause of a slow drain can range from a simple cleaning at stop valve or at the trap under sink. Sometimes the drain can be partially clogged down line. Further investigation and repairs are needed.

I am unable to determine the cause of the slow drain. A qualified licensed plumber should repair or correct as needed.

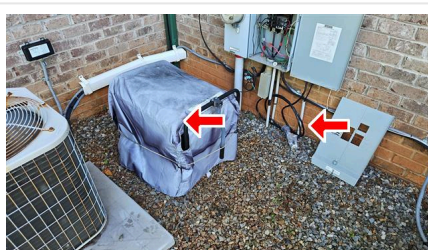
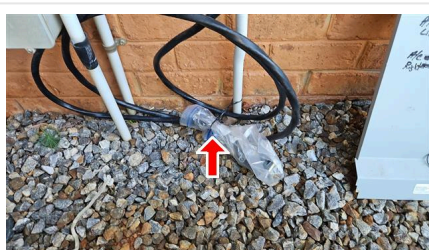
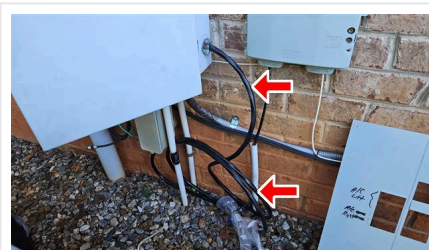
1. A generator hookup has been temporarily wired in the main electrical panel. There was not a dead man switch present. This is a safety issue. Further investigation and repairs are needed.

A qualified licensed electrical contractor should correct as needed.

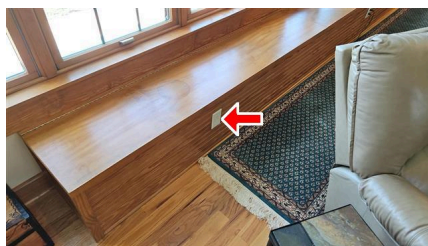
6.4 Item 1 (Picture)

1. At least one "three-prong" outlet is damaged in the living room. This is a safety issue. Further

investigation and repairs are needed.

A qualified licensed electrical contractor should correct as needed.

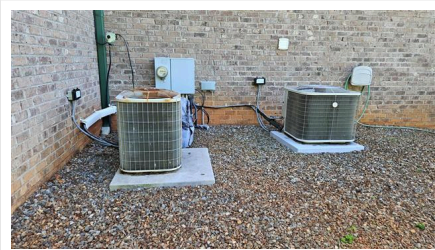
Complimentary photo of the heat pump

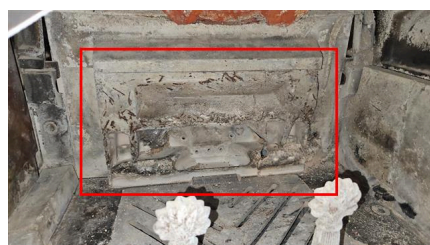
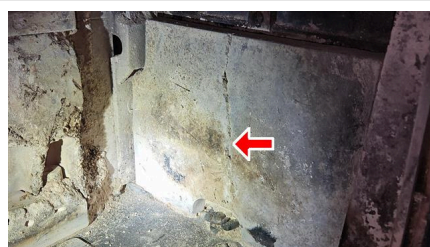
1. The (Burn Area) for the woodstove at the basement living room is damage. This burn area should be fireproof. Any repairs should be performed according to the manufacturer's specifications. Repairs should be made so unit works properly. Further investigation and repairs are needed.

A qualified contractor should inspect and repair as needed.

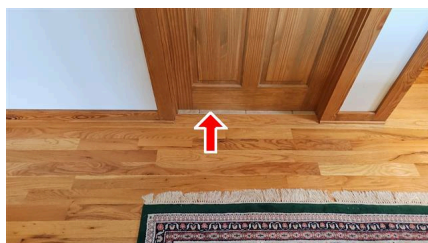
8.5 Item 1 (Picture)

craftsman at the master bath. As a result the door will not close properly. Further investigation and repairs are needed.

A qualified person should repair or replace as needed.

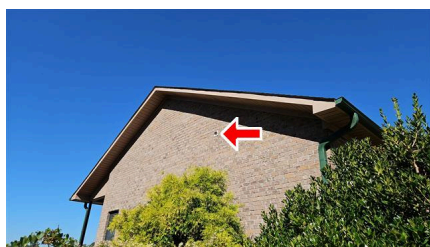
9.5 Item 1 (Picture)

1. The exhaust fan has a damaged vent cover outside at the master bath. This may allow water intrusion to occur. Further investigation and repairs are needed.

A qualified person should repair or replace as needed.

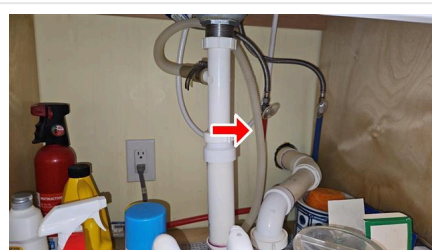
10.0 Item 1 (Picture)

1. The dishwasher drain hose needs to be looped above the level of the kitchen sink drain or an approved air gap installed to prevent back flow of waste water into the water supply. (food safety issue) This can allow waste for the sink to contaminate the dishwasher. This is a small repair.

A qualified licensed plumber should repair or correct as needed.
