INSPECTION REPORT  
215 Bethesda Rd  
Statesville NC 28677

INSPECTED BY  
Alex Parr 3692  
Above Parr Home  
Inspections

INSPECTION DATE  
📅 4/25/2025  
🕒 09:00:00 AM

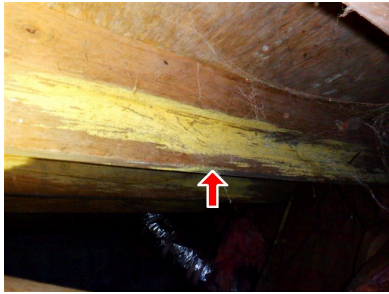
1.0 Item 1 (Picture)

1. Discoloration in some type of fungal growth (wood destroying fungus) is present in the structure at several areas including but not limited to the crawl space and or interior spaces. This type of substance commonly results in the building and finish type materials becoming weakened and or compromised. Evidence suggests that this condition is from a past or present elevated moisture

conditions. The extent of the damage cannot be determined until the moisture issue is corrected. We did not inspect, test or determine if this type of substance is or is not a health hazard as this is above the scope of a home inspection. We recommend contacting a licensed expert for testing, investigation and or correction as deemed appropriate

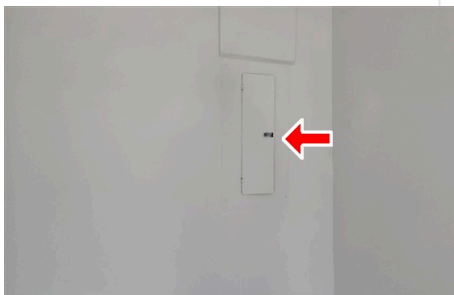
1.1 Item 1 (Picture)

1. The panel cover was not removed because the panel cover was painted to sheetrock. Removal would have damaged sheetrock. Further investigation is needed.

A qualified licensed electrical contractor should correct as needed.

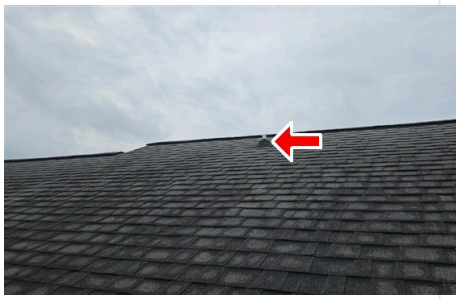
2.2 Item 1 (Picture)

1. The plumbing boot has signs of temporary repair. This may allow water intrusion to occur. Further investigation and repairs are needed..

A qualified contractor should repair or replace as needed.

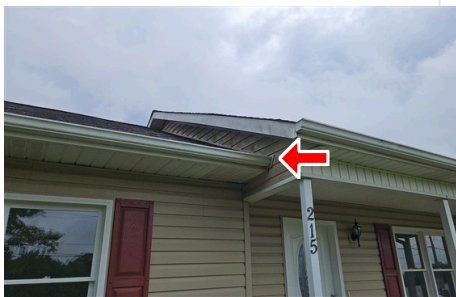
2.3 Item 1 (Picture)

1. The gutter at the front (left of main entry) has been installed improperly behind the siding. This may allow water damage to occur to the home. Further investigation and repairs are needed.

A qualified contractor should inspect and repair as needed.

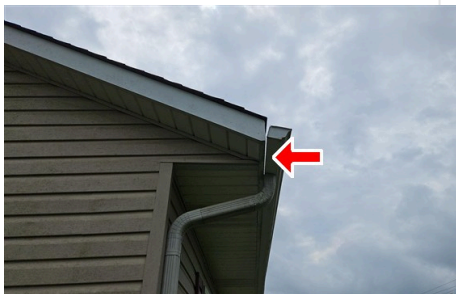
2.3 Item 3 (Picture)

1. The gutter is loose at the front (left of main entry). Gutters that drain poorly or clogged can lead to many costly problems such as deterioration of fascia, soffit or roof edge. It can also cause gutters to pull loose and lead to possible water intrusion. Repairs are needed.

A qualified contractor should inspect and repair as needed.

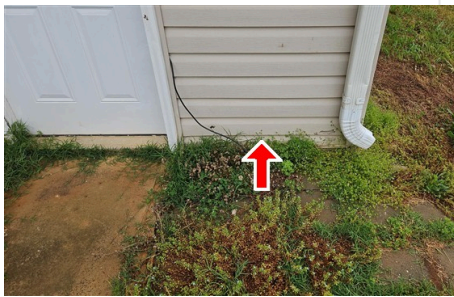
3.0 Item 1 (Picture)

1. The vinyl siding at the exterior in areas is damaged. Further deterioration can occur if not corrected.

Further investigation and repairs are needed.

A qualified contractor should inspect and repair as needed.

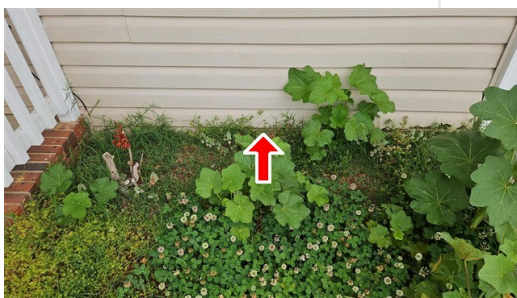
3.0 Item 16 (Picture)

1. Siding in contact with ground at front of home. Because the siding is in contact with ground it is possible for framing to be deteriorated. We did not inspect behind this siding. Recommend a ground clearance of six to eight inches where possible. Repairs are needed.

A qualified contractor should inspect and repair as needed.

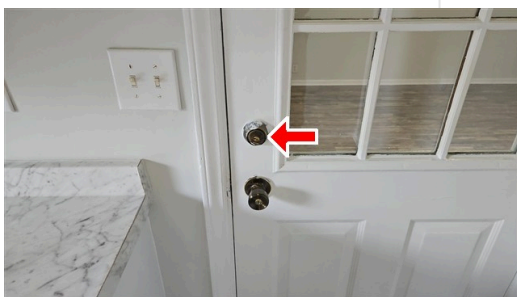
3.3 Item 1 (Picture)

1. The right side (facing front) entry door dead bolt is keyed. (Safety issue) All exterior doors should not be keyed type locks, as this can impede exiting the home should a fire occur. Repairs are needed.

A qualified person should repair or replace as needed.

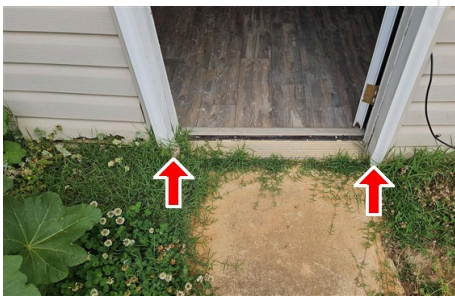
**3.3 Item 2 (Picture)**

1. The entry door at front of home is deteriorated at bottom of jamb (s) and at the door. Further

deterioration may occur if not repaired. Repairs are needed.  
A qualified contractor should inspect and repair as needed.

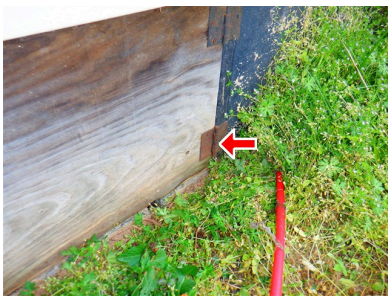
**3.3 Item 8 (Picture)**

1. The access door to the crawlspace has damaged hinged hardware. Therefore the door does not function as intended. Repairs are needed.

A qualified contractor should inspect and repair as needed.

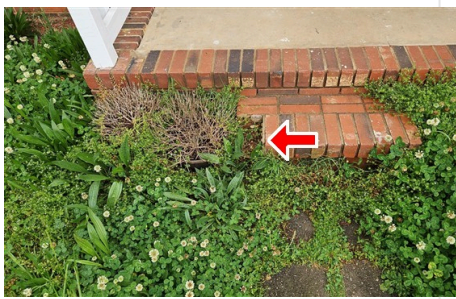
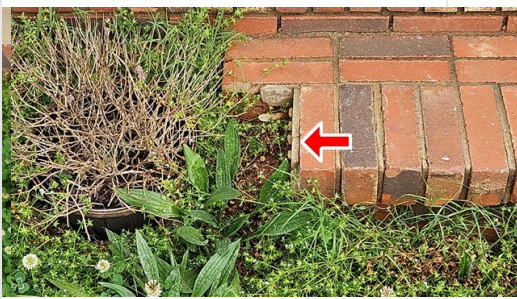
1. The brick steps at front entry are damaged and missing bricks. A fall or injury could occur if not corrected. A repair or replacement is needed.

A qualified contractor should repair or replace as needed.

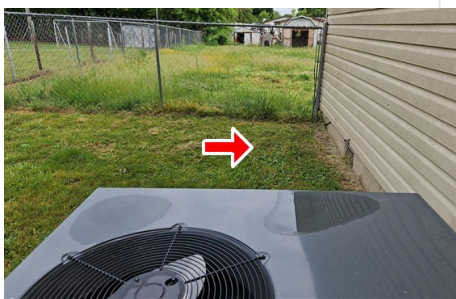
3.5 Item 1 (Picture)

1. There is a negative slope at the left side (facing front) and rear, this can cause or contribute to water intrusion or deterioration. I recommend correcting landscape to drain water away from home. Further investigation and repairs are needed.

A qualified contractor should repair or replace as needed.

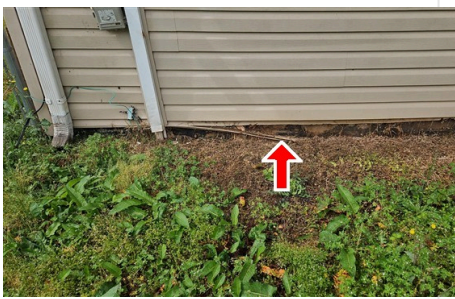
4.2 Item 1 (Picture)

1. The slab foundation at the rear of the home is damaged. Further damaged/deterioration could occur. Further investigation and repairs are needed.

A qualified licensed general contractor should inspect further and repair as needed.

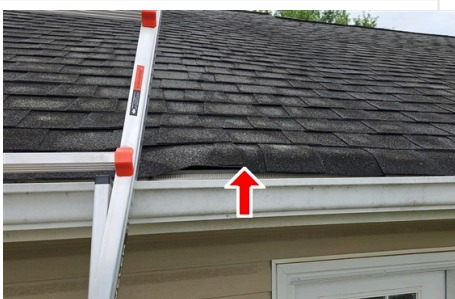
4.4 Item 1 (Picture)

1. The roof sheathing bowed. Repairs are needed to maintain the stability of roof. This may allow water intrusion to occur. Further investigation and repairs are needed.

A qualified contractor should repair as needed.

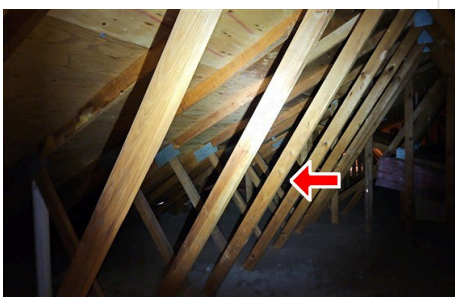
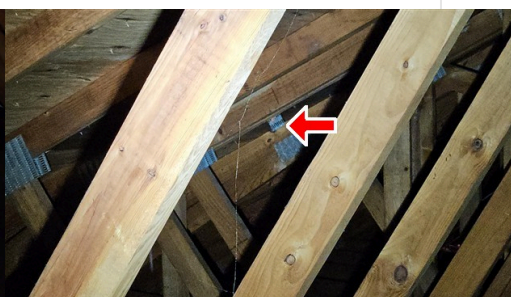
1. The truss system installed in the attic have been damage during or before installation of the truss. All truss repairs should be repaired via an approved method specified b the manufacture and or approved and stamped by licensed structural engineer. Further evaluation and repairs are needed.

A qualified licensed structural engineer/design professional is recommended to evaluate the trusses for any repairs. This should include a site specific letter from the registered design professional/engineer stating what repairs (if any) are needed approval of performed repairs, signature, state license number, and state registered stamp of the engineer.

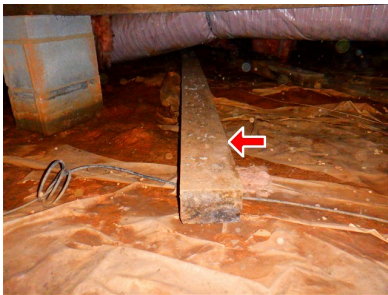
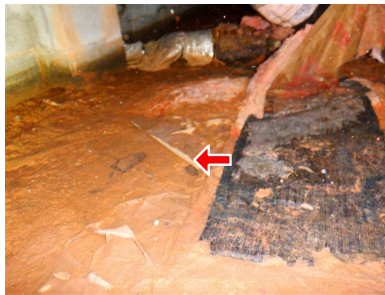
1. Wood debris is in contact with the crawl space floor in numerous areas. This can attract wood destroying organisms. Removal is needed.

A qualified contractor should inspect and repair as needed.

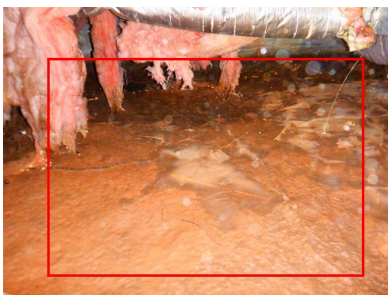
4.6 Item 1 (Picture)

1. Visible signs of water intrusion in the crawl space are present from standing water on ground. Water intrusion if not corrected can lead to other problems including mold and cause excessive moisture to floor system that can lead to deterioration and increased repair cost. Further investigation and repairs are needed.

I recommend further investigation or correction by a qualified licensed contractor or water infiltration specialist.

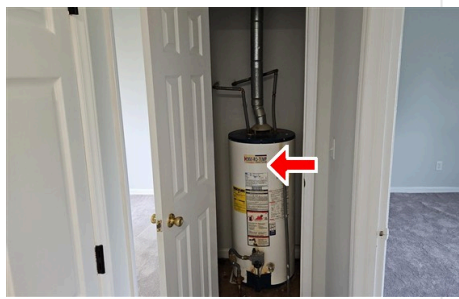
5.1 Item 1 (Picture)

1. The water heater does not appear to have proper fresh air supply. This is a safety issue. Further investigation and repairs are needed.

A qualified contractor should inspect and repair as needed.

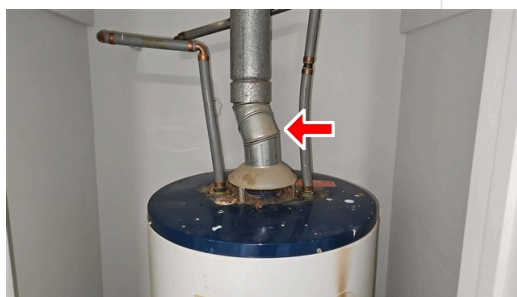
5.1 Item 5 (Picture)

1. The draft hood connection to flue vent connector: provide at least 12" vertical inches of the flue vent between the draft hood outlet and the first elbow. This is a safety issue and should be repaired. Further investigation and repairs are needed.

A qualified licensed plumber should repair or correct as needed.

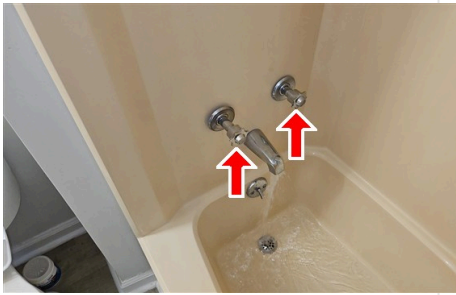
5.2 Item 1 (Picture)

1. The tub faucets and hot/cold control loose in wall at the guest bath. Repairs are needed to prevent water damage from occurring to the home. Further investigation and repairs are needed..

A qualified licensed plumber should repair or correct as needed.

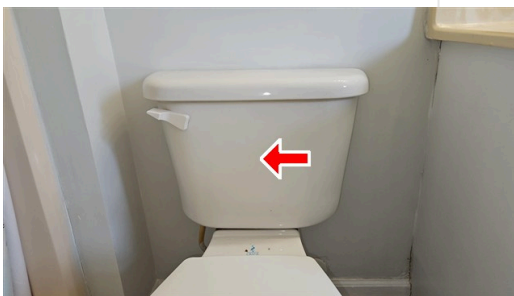
5.2 Item 3 (Picture)

1. The toilet tank is loose at the master bathroom. Repairs are needed to prevent water damage from occurring to the home. Further investigation and repairs are needed..

A qualified licensed plumber should repair or correct as needed.

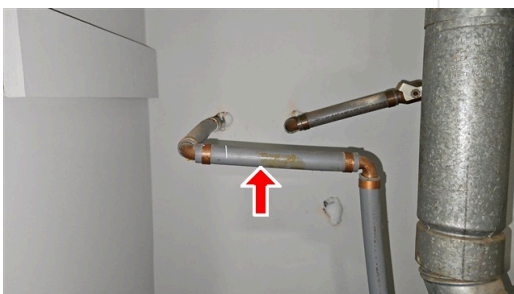
5.2 Item 4 (Picture)

1. Polybutylene plastic plumbing supply lines (PB) are installed in the subject house. Polybutylene has been used in this area for many years, but has had a higher than normal failure rate, and is no longer being widely used. Copper and Brass fittings used in later years have apparently reduced the failure rate. This subject house has copper fittings. For further details contact the Consumer Plumbing Recovery center at 1-800-392-7591 or the web at <http://www.pbpipe.com>

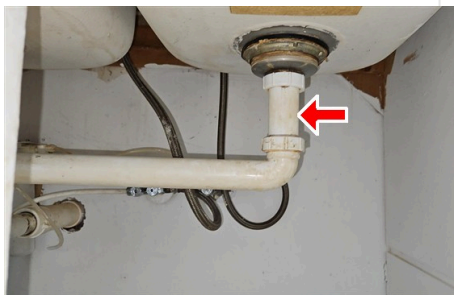
5.3 Item 1 (Picture)

1. The plumbing waste line leaks under the kitchen sink. Repairs are needed to prevent water damage from occurring to the home. Further investigation and repairs are needed.

A qualified licensed plumber should repair or correct as needed.

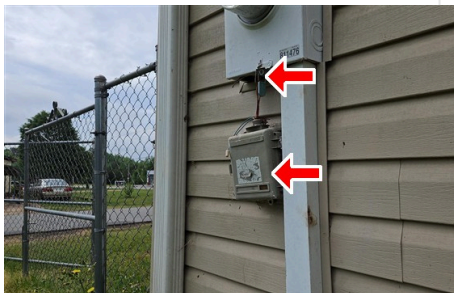
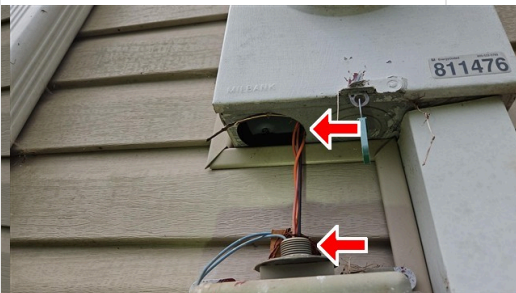
1. The electrical service meter has an opening at the bottom. This is a safety issue. Further investigation and repairs are needed.

I recommend a licensed electrical contractor inspect further and correct as needed.

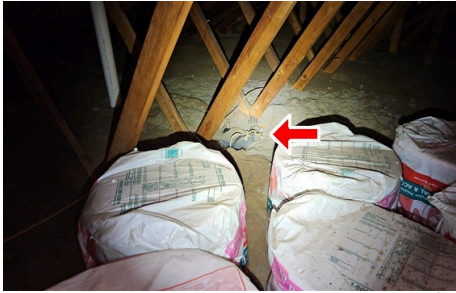
6.4 Item 1 (Picture)

1. Several open splices needs placing inside a box with a cover-plate in the attic space. Electrical issues are considered a hazard until repaired. Further investigation and repair are needed.

A qualified licensed electrical contractor should correct as needed.

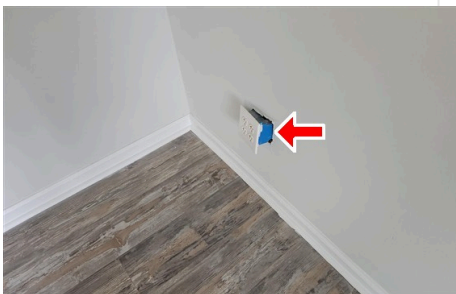
6.4 Item 3 (Picture)

1. At least one "three-prong" outlet is loose in wall in the living room. Electrical issues are considered a hazard until repaired. Further investigation and repairs are needed.

A qualified licensed electrical contractor should correct as needed.

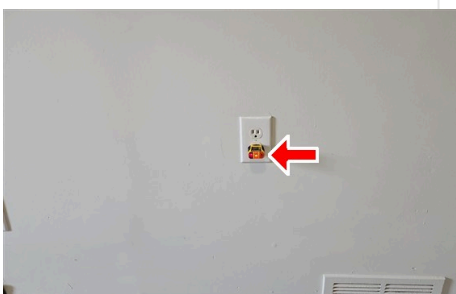
6.4 Item 5 (Picture)

1. One or more "three-prong" outlet is wired incorrectly "hot / neutral reversed" in the bedroom. Electrical issues are considered a hazard until repaired. Further investigation and repairs are needed.

A qualified licensed electrical contractor should correct as needed.

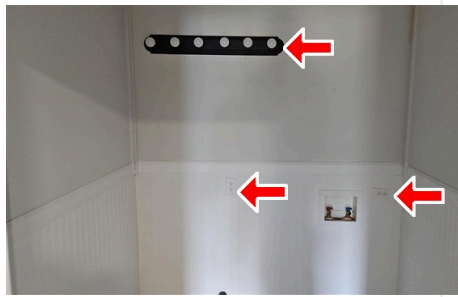
6.6 Item 1 (Picture)

1. The GFCI (Ground Fault Circuit Interrupter) outlet at the Washer/Dryer room was trip and would not reset. Electrical issues are considered a hazard until repaired. Further investigation and repairs are needed.

A qualified licensed electrical contractor should correct as needed.

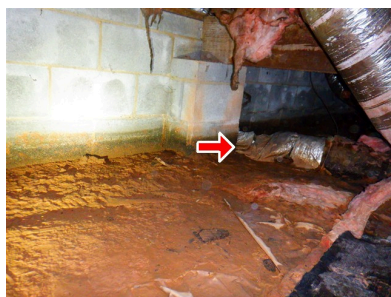
7.3 Item 1 (Picture)

1. The supply duct pipe is disconnected and is damaged in the crawlspace. Energy loss is occurring. Further investigation and repairs are needed.

A qualified HVAC person should inspect further and repair or replace as needed.

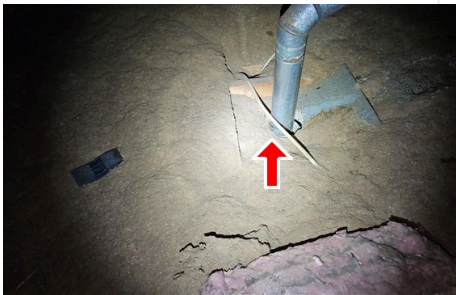
7.5 Item 1 (Picture)

1. The vent pipe for gas water heater needs a 1 inch clearance from combustibles. This is a safety issue and should be repaired. Further investigation and repairs are needed.

I recommend a qualified licensed heat contractor inspect further and repair as needed.

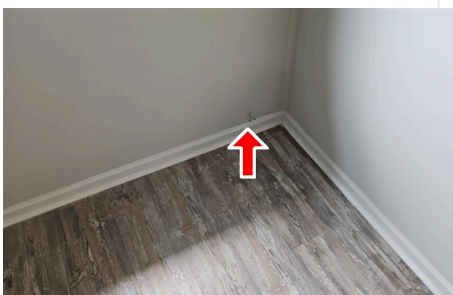
8.1 Item 1 (Picture)

1. The sheetrock has grass growing through the wall at the Den. The extent of damage cannot be realized until the covering is removed. Further investigation and repairs are needed.

A qualified contractor should inspect and repair as needed.

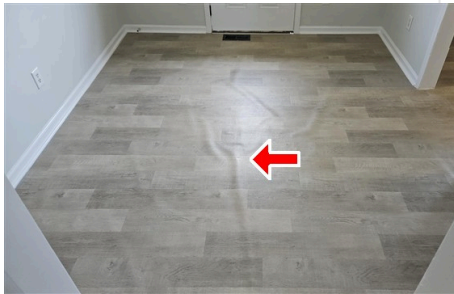
8.2 Item 1 (Picture)

1. The linoleum was not installed according to standard workmanlike practices at the throughout the home. Further deterioration can occur. Further investigation and repairs are needed.

A qualified person should repair or replace as needed.

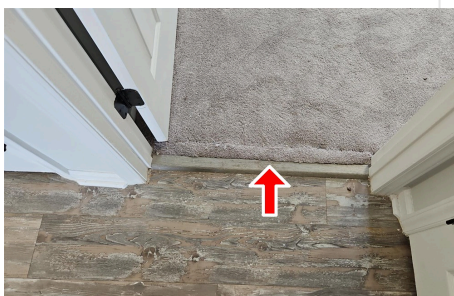
8.2 Item 4 (Picture)

1. The carpet was not installed according to standard workmanlike practices at the throughout the home. This can be a tripping hazard. Repairs are needed.

A qualified person should repair or replace as needed.

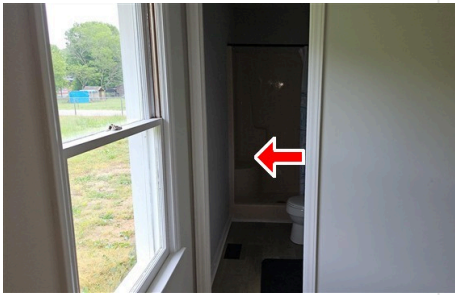
8.5 Item 1 (Picture)

1. Multiple doors throughout the home are missing. This is for your information.

A qualified person should repair or replace as needed.

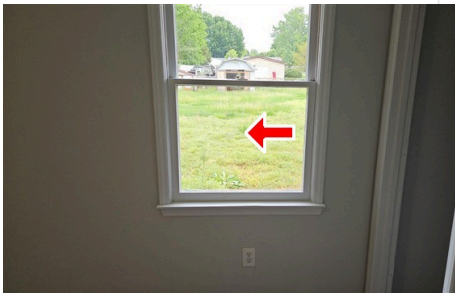
8.6 Item 1 (Picture)

1. Numerous windows stuck or painted shut at the throughout the home. As a result no means of egress is present. One window per bedroom must open as means of egress out of the home should a fire occur. (Safety issue) Repairs are needed..

A qualified person should repair or replace as needed.

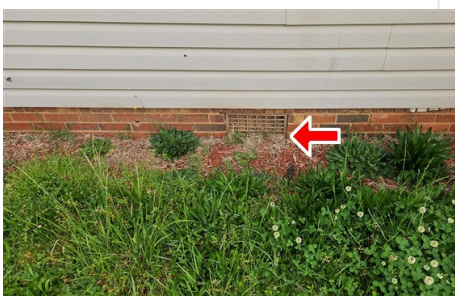
9.1 Item 1 (Picture)

1. The foundation vents are damaged and missing screens at the exterior. Rodents, reptiles or insects could enter into crawlspace. Further investigation and repairs are needed.

A qualified person should repair or replace as needed.

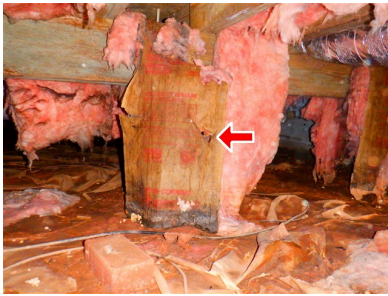
9.3 Item 1 (Picture)

1. The insulation is loose/fallen in the crawlspace. Heat loss can occur more on this home than one that is properly insulated. Repairs are needed.

A qualified contractor should inspect and repair as needed.

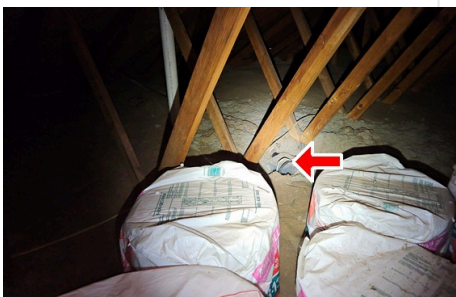
9.5 Item 1 (Picture)

1. The exhaust fan has a damaged vent pipe in attic at the guest bath. Vent pipes that terminate in attic space can sometimes cause moisture that can lead to mold or cause condensation. Repairs are needed.

A qualified person should repair or replace as needed.

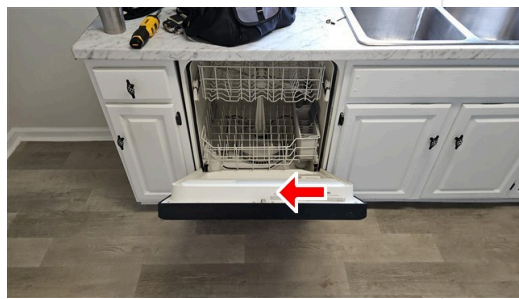
10.0 Item 1 (Picture)

1. The dishwasher door would not open or close properly. Evidence suggests the dishwasher was not installed properly. I recommend repair as necessary.

I recommend contacting appliance repair company.

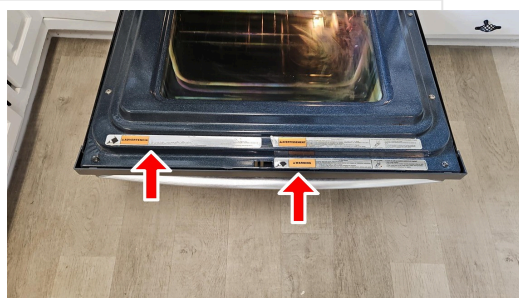
10.1 Item 1 (Picture)

1. The range/oven needs to be properly attached/anchored to the structure as to keep it from tipping over when the oven door is opened and oven racks are pulled out during use. This is a safety issue. Repairs are needed.

I recommend contacting appliance repair company.

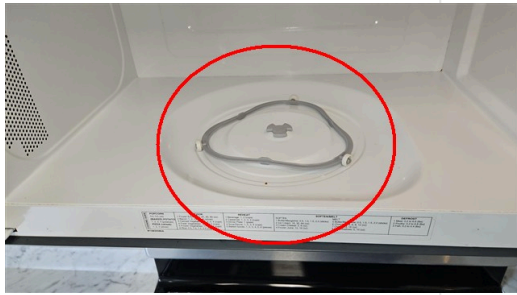
**10.4 Item 1 (Picture)**

1. The microwave plate is missing. Therefore the microwave cannot function as intended. I recommend repair as needed.

I recommend contacting appliance repair company.

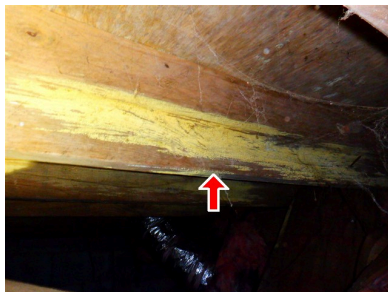
1.0 Item 1 (Picture)

1. Discoloration in some type of fungal growth (wood destroying fungus) is present in the structure at several areas including but not limited to the crawl space and or interior spaces. This type of substance commonly results in the building and finish type materials becoming weakened and or compromised. Evidence suggests that this condition is from a past or present elevated moisture conditions. The extent of the damage cannot be determined until the moisture issue is corrected. We did not inspect, test or determine if this type of substance is or is not a health hazard as this is above the scope of a home inspection. We recommend contacting a licensed expert for testing, investigation and or correction as deemed appropriate

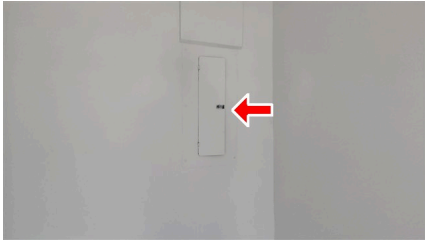
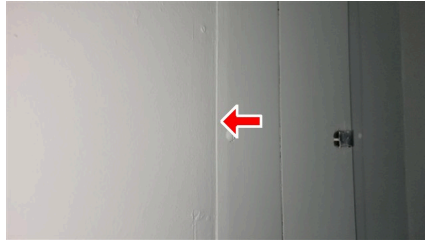
1. The panel cover was not removed because the panel cover was painted to sheetrock. Removal would have damaged sheetrock. Further investigation is needed.

A qualified licensed electrical contractor should correct as needed.

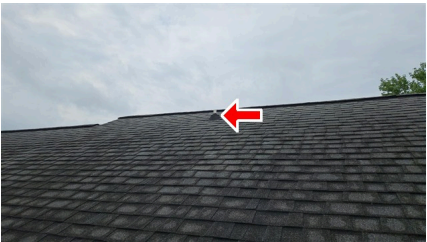
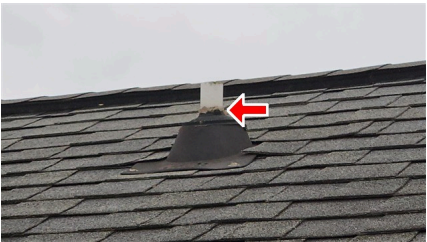
1. The plumbing boot has signs of temporary repair. This may allow water intrusion to occur. Further investigation and repairs are needed..

A qualified contractor should repair or replace as needed.

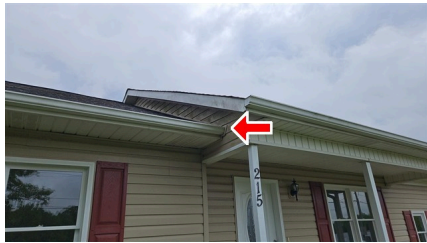
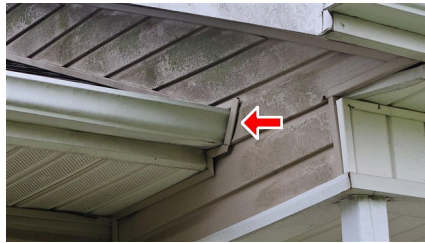
1. The gutter at the front (left of main entry) has been installed improperly behind the siding. This may allow water damage to occur to the home. Further investigation and repairs are needed.

A qualified contractor should inspect and repair as needed.

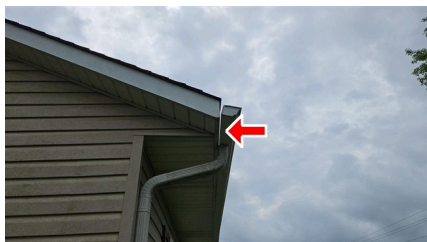
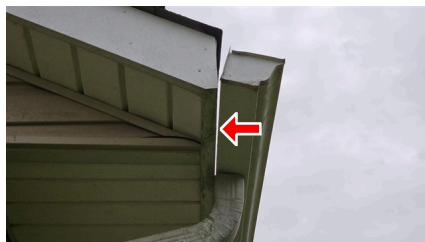
1. The gutter is loose at the front (left of main entry). Gutters that drain poorly or clogged can lead to many costly problems such as deterioration of fascia, soffit or roof edge. It can also cause gutters to pull loose and lead to possible water intrusion. Repairs are needed.

A qualified contractor should inspect and repair as needed.

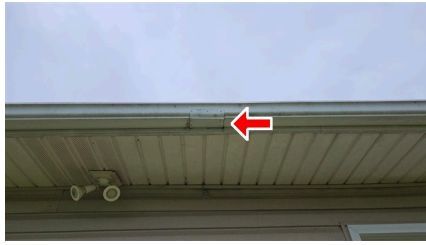
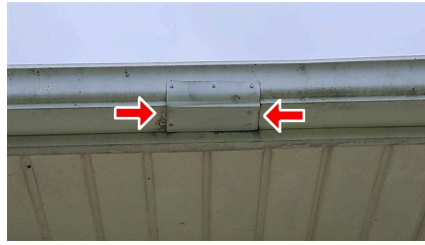
1. The gutter leaks at seam (s) at the rear of the home. Gutters that drain poorly or clogged can lead to many costly problems such as deterioration of fascia, soffit or roof edge. It can also cause gutters to pull loose and lead to possible water intrusion. Repairs are needed.

A qualified person should repair or replace as needed.

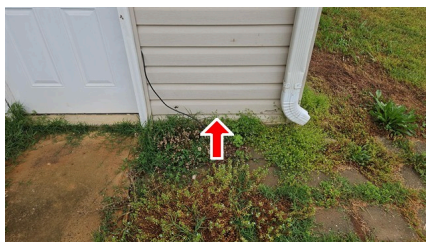
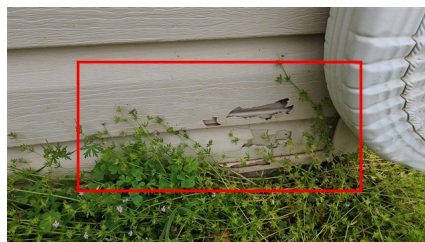
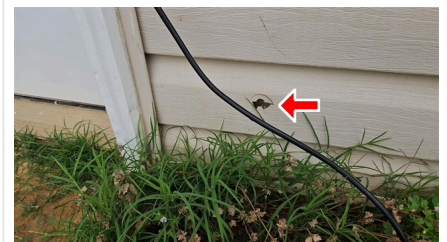
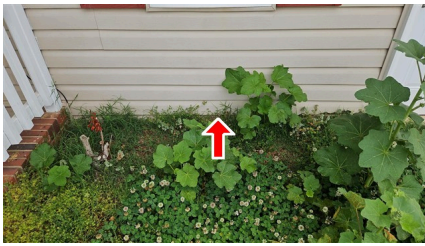
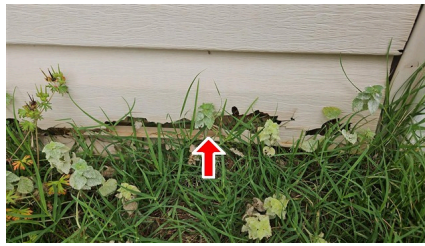
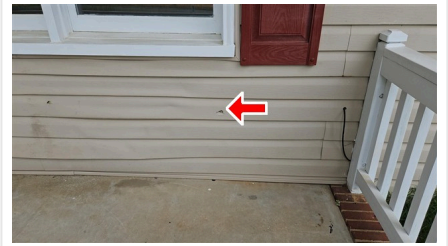
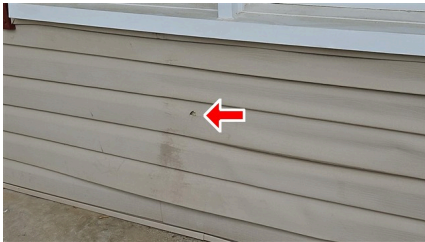
1. The vinyl siding at the exterior in areas is damaged. Further deterioration can occur if not corrected. Further investigation and repairs are needed.

A qualified contractor should inspect and repair as needed.

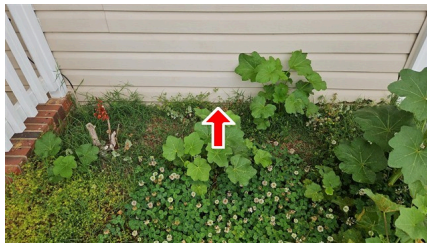
3.0 Item 16 (Picture)

1. Siding in contact with ground at front of home. Because the siding is in contact with ground it is possible for framing to be deteriorated. We did not inspect behind this siding. Recommend a ground clearance of six to eight inches where possible. Repairs are needed.

A qualified contractor should inspect and repair as needed.

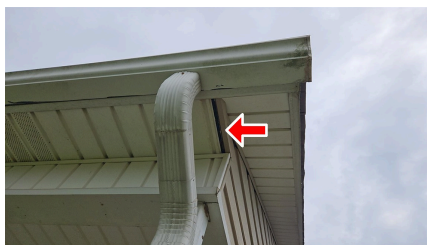
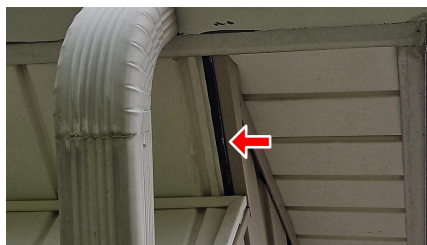
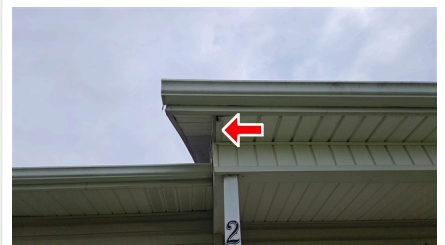
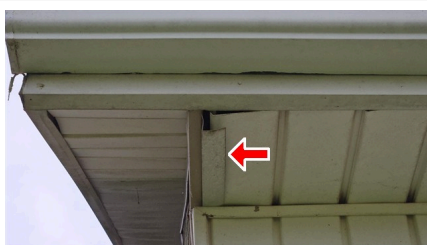
1. The metal fascia wrap at eave on the front of home is missing. Further deterioration may occur if not repaired. Repairs are needed.

A qualified person should repair or replace as needed.

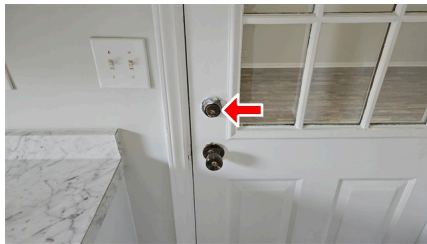
**3.3 Item 1 (Picture)**

1. The right side (facing front) entry door dead bolt is keyed. (Safety issue) All exterior doors should not be keyed type locks, as this can impede exiting the home should a fire occur. Repairs are needed.

A qualified person should repair or replace as needed.

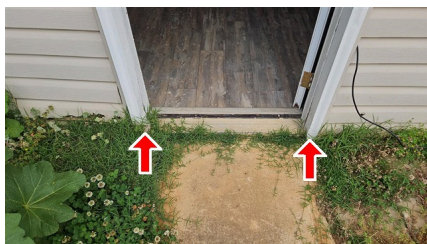
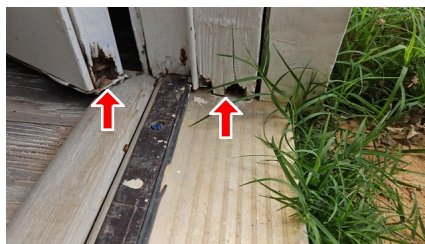
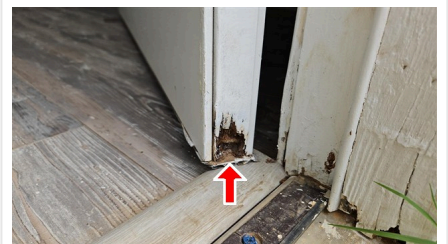
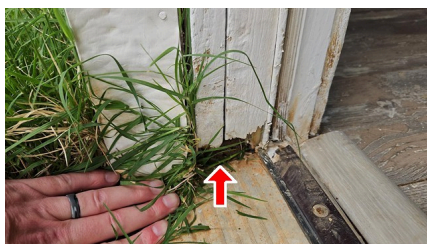
1. The entry door at front of home is deteriorated at bottom of jamb (s) and at the door. Further deterioration may occur if not repaired. Repairs are needed.

A qualified contractor should inspect and repair as needed.

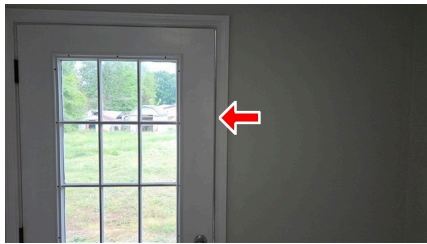
**3.3 Item 6 (Picture)**

1. The entry door at rear of home rubs at jamb when closing. As a result the door will not close properly. Repairs are needed.

A qualified person should repair or replace as needed.

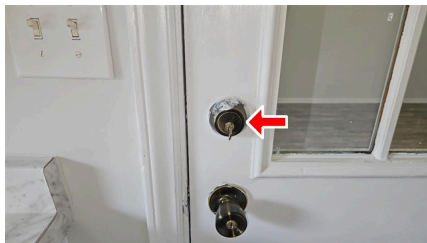
**3.3 Item 7 (Picture)**

1. The dead bolt does not latch properly at the side entry. Repairs are needed.

A qualified person should repair or replace as needed.

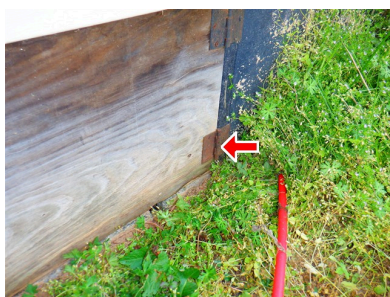
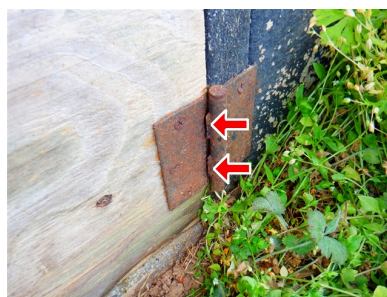
1. The access door to the crawlspace has damaged hinged hardware. Therefore the door does not function as intended. Repairs are needed.

A qualified contractor should inspect and repair as needed.

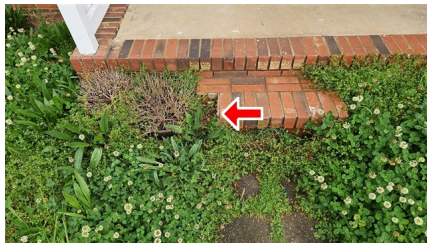
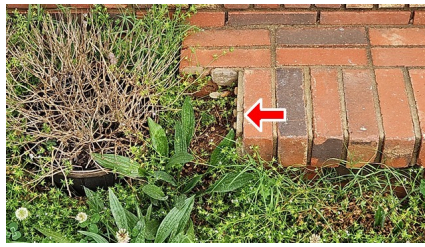
1. The brick steps at front entry are damaged and missing bricks. A fall or injury could occur if not corrected. A repair or replacement is needed.

A qualified contractor should repair or replace as needed.

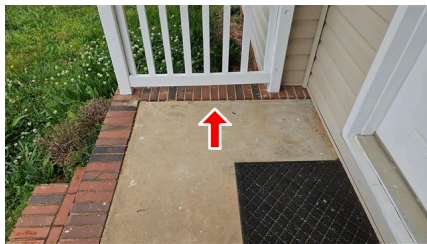
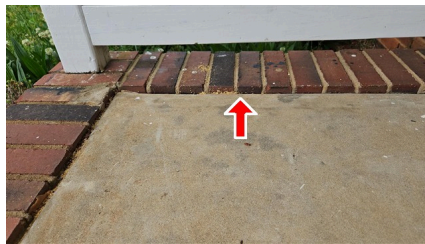
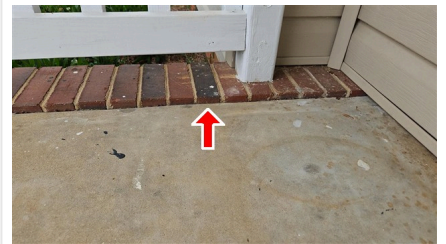
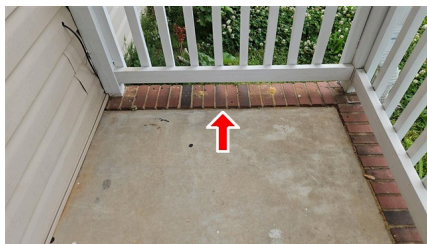
1. The concrete floor on the covered porch at the front of home has settled. Further deterioration can occur if not repaired. Repairs are needed.

A qualified person should repair or replace as needed.

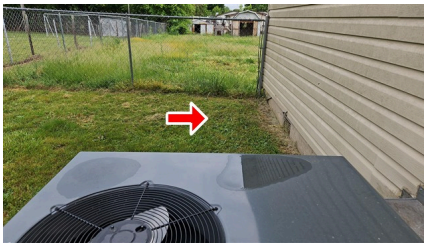
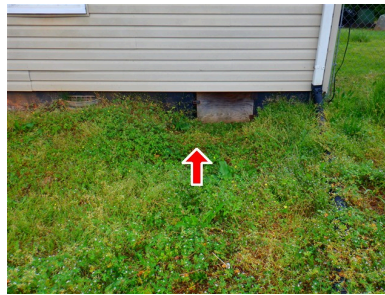
1. There is a negative slope at the left side (facing front) and rear, this can cause or contribute to water intrusion or deterioration. I recommend correcting landscape to drain water away from home.

Further investigation and repairs are needed.

A qualified contractor should repair or replace as needed.

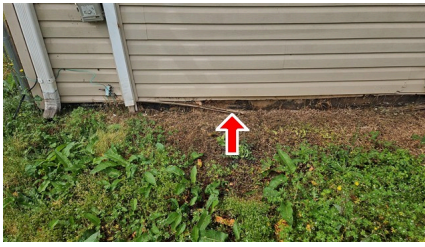
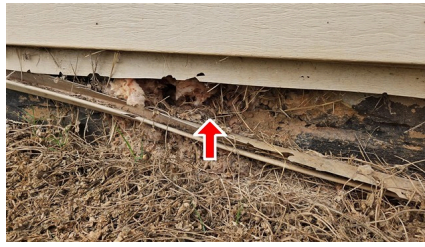
1. The slab foundation at the rear of the home is damaged. Further damaged/deterioration could occur. Further investigation and repairs are needed.

A qualified licensed general contractor should inspect further and repair as needed.

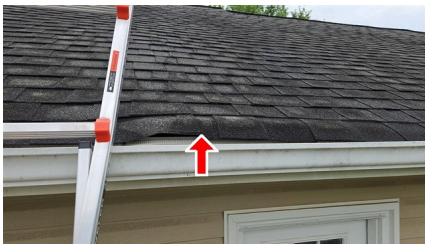
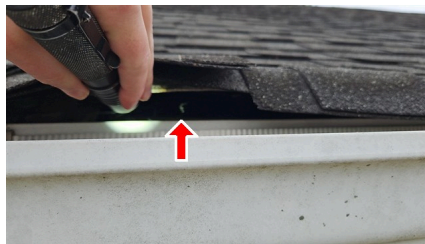
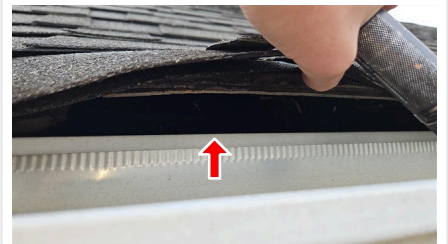
1. The roof sheathing bowed. Repairs are needed to maintain the stability of roof. This may allow water intrusion to occur. Further investigation and repairs are needed.

A qualified contractor should repair as needed.

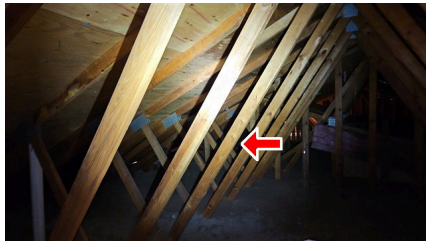
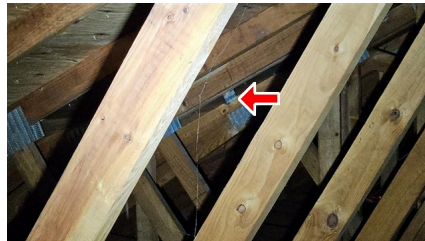
1. The truss system installed in the attic have been damage during or before installation of the truss. All truss repairs should be repaired via an approved method specified b the manufacture and or approved and stamped by licensed structural engineer. Further evaluation and repairs are needed.

A qualified licensed structural engineer/design professional is recommended to evaluate the trusses for any repairs. This should include a site specific letter from the registered design professional/engineer stating what repairs (if any) are needed approval of performed repairs, signature, state license number, and state registered stamp of the engineer.

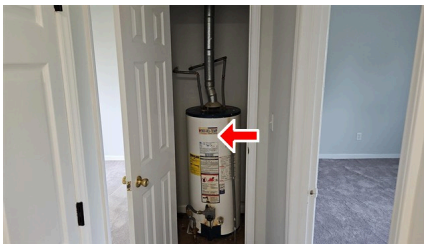
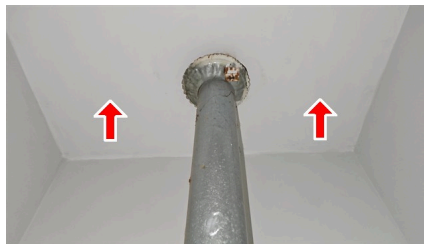
1. The water heater does not appear to have proper fresh air supply. This is a safety issue. Further investigation and repairs are needed.

A qualified contractor should inspect and repair as needed.

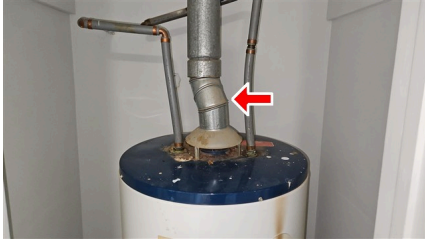
5.1 Item 5 (Picture)

1. The draft hood connection to flue vent connector: provide at least 12" vertical inches of the flue vent between the draft hood outlet and the first elbow. This is a safety issue and should be repaired. Further investigation and repairs are needed.

A qualified licensed plumber should repair or correct as needed.

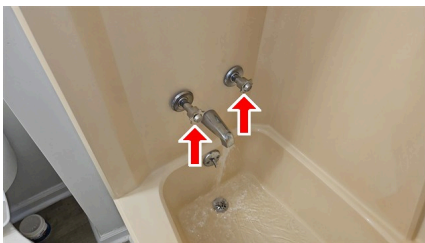
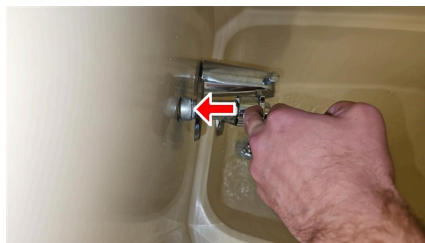
1. The tub faucets and hot/cold control loose in wall at the guest bath. Repairs are needed to prevent water damage from occurring to the home. Further investigation and repairs are needed..

A qualified licensed plumber should repair or correct as needed.

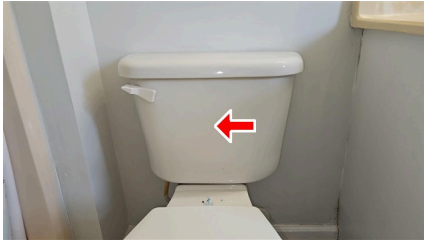
5.2 Item 3 (Picture)

1. The toilet tank is loose at the master bathroom. Repairs are needed to prevent water damage from occurring to the home. Further investigation and repairs are needed..

A qualified licensed plumber should repair or correct as needed.

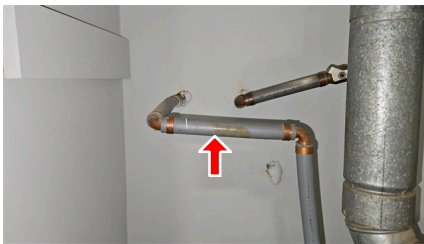
5.2 Item 4 (Picture)

1. Polybutylene plastic plumbing supply lines (PB) are installed in the subject house. Polybutylene has been used in this area for many years, but has had a higher than normal failure rate, and is no longer being widely used. Copper and Brass fittings used in later years have apparently reduced the failure rate. This subject house has copper fittings. For further details contact the Consumer Plumbing Recovery center at 1-800-392-7591 or the web at <http://www.pbpipe.com>

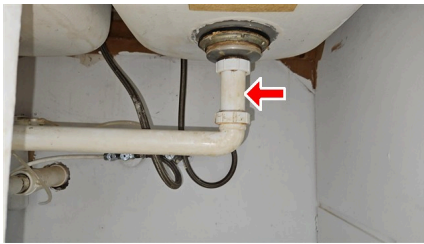
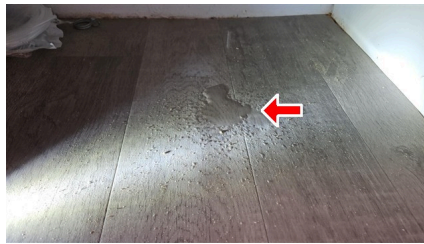
1. The plumbing waste line leaks under the kitchen sink. Repairs are needed to prevent water damage from occurring to the home. Further investigation and repairs are needed.

A qualified licensed plumber should repair or correct as needed.

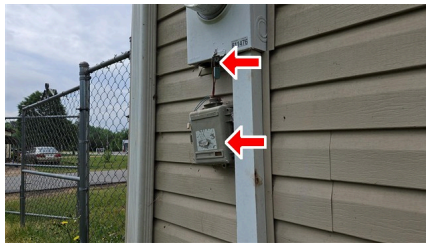
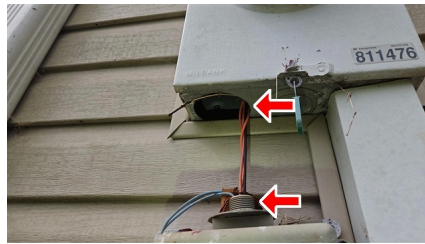
1. The electrical service meter has an opening at the bottom. This is a safety issue. Further investigation and repairs are needed.

I recommend a licensed electrical contractor inspect further and correct as needed.

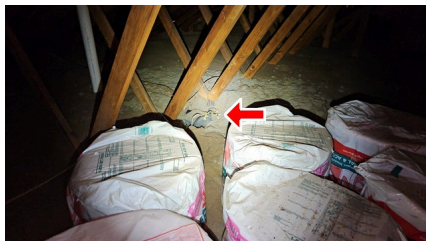
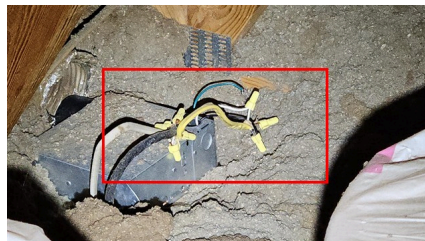
1. Several open splices needs placing inside a box with a cover-plate in the attic space. Electrical issues are considered a hazard until repaired. Further investigation and repair are needed.

A qualified licensed electrical contractor should correct as needed.

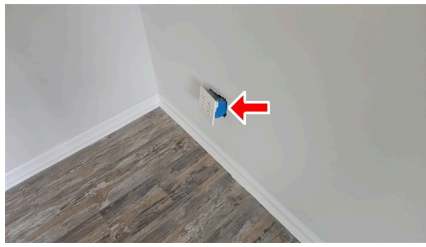
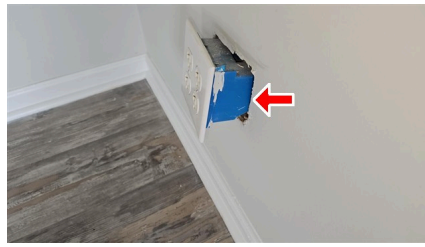
1. At least one "three-prong" outlet is loose in wall in the living room. Electrical issues are considered a hazard until repaired. Further investigation and repairs are needed.

A qualified licensed electrical contractor should correct as needed.

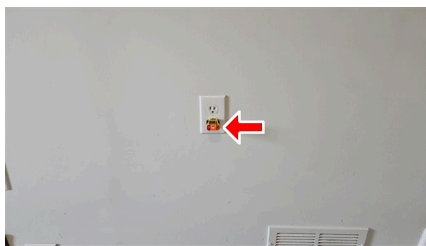
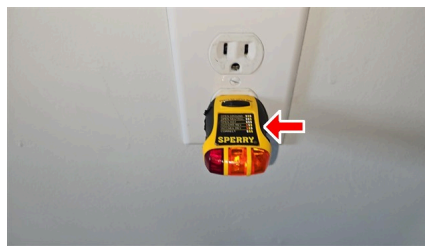
1. One or more "three-prong" outlet is wired incorrectly "hot / neutral reversed" in the bedroom. Electrical issues are considered a hazard until repaired. Further investigation and repairs are needed.

A qualified licensed electrical contractor should correct as needed.

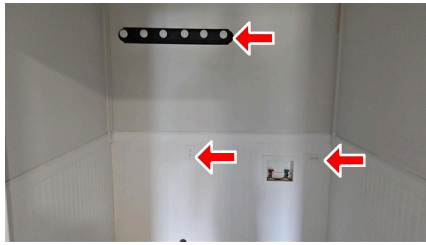
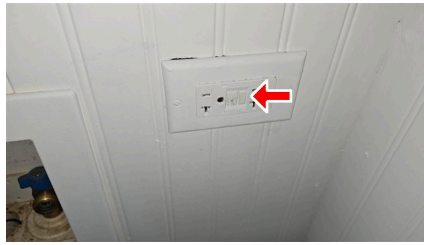
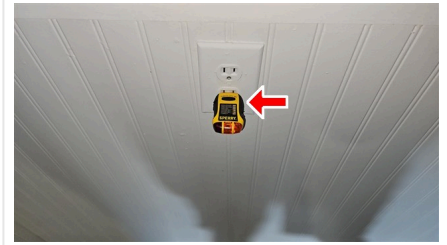
1. The GFCI (Ground Fault Circuit Interrupter) outlet at the Washer/Dryer room was trip and would not reset. Electrical issues are considered a hazard until repaired. Further investigation and repairs are needed.

A qualified licensed electrical contractor should correct as needed.

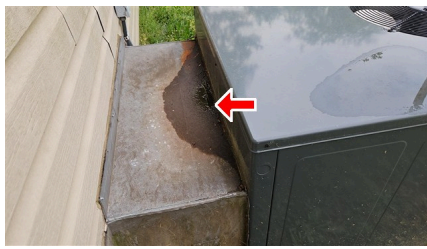
7.0 Item 1 (Picture)

1. Metal flashing in between the house and a packaged unit is holding water. Further deterioration can occur. Further investigation and repairs are needed.

I recommend further inspection by a licensed HVAC contractor.

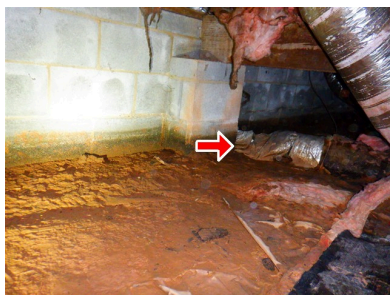
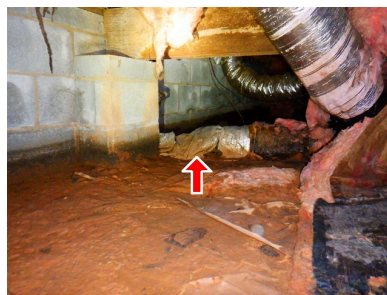
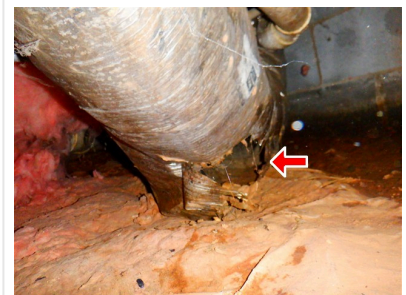
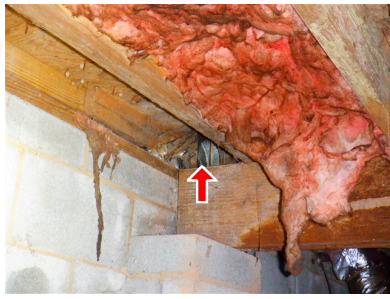
1. The supply duct pipe is disconnected and is damaged in the crawlspace. Energy loss is occurring. Further investigation and repairs are needed.

A qualified HVAC person should inspect further and repair or replace as needed.

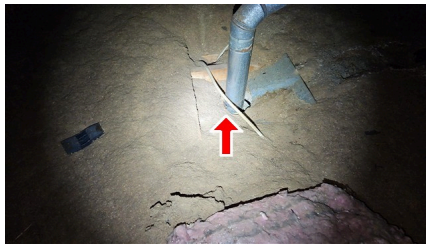
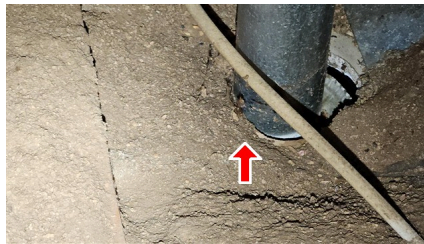
1. The vent pipe for gas water heater needs a 1 inch clearance from combustibles. This is a safety issue and should be repaired. Further investigation and repairs are needed.

I recommend a qualified licensed heat contractor inspect further and repair as needed.

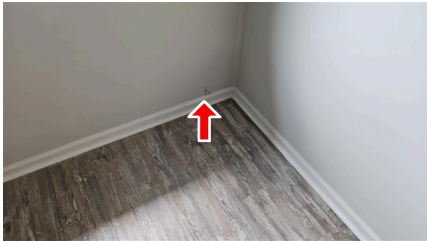
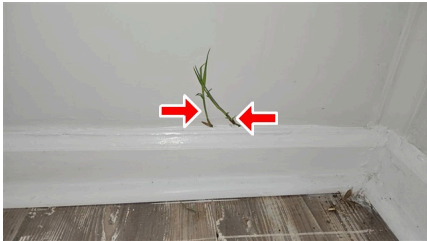
1. The sheetrock has grass growing through the wall at the Den. The extent of damage cannot be realized until the covering is removed. Further investigation and repairs are needed.

A qualified contractor should inspect and repair as needed.

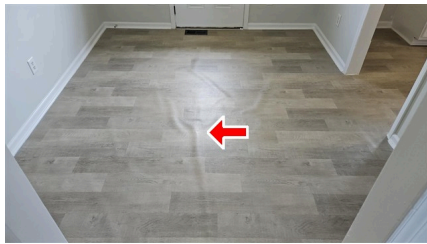
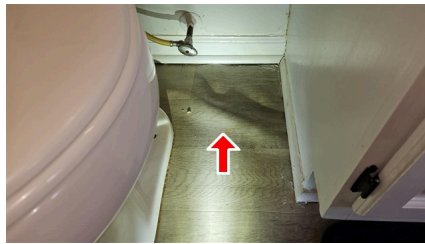
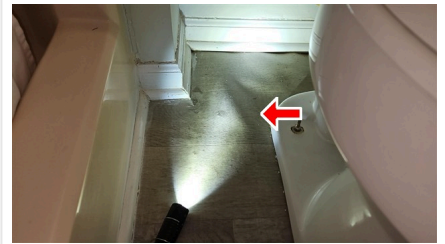
1. The linoleum was not installed according to standard workmanlike practices at the throughout the home. Further deterioration can occur. Further investigation and repairs are needed.

A qualified person should repair or replace as needed.

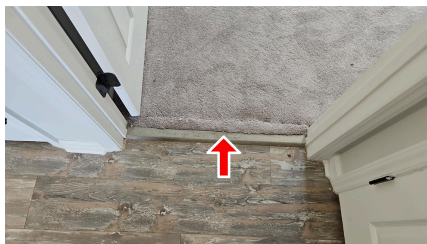
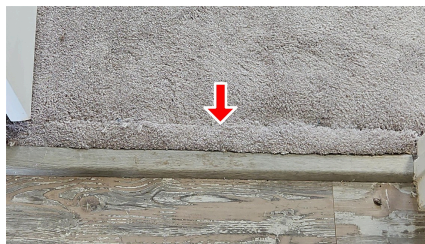
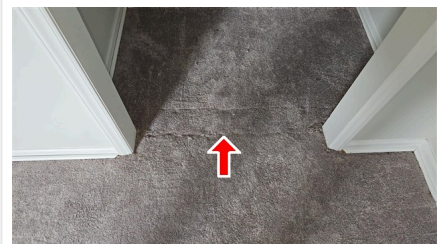
1. The carpet was not installed according to standard workmanlike practices at the throughout the home. This can be a tripping hazard. Repairs are needed.

A qualified person should repair or replace as needed.

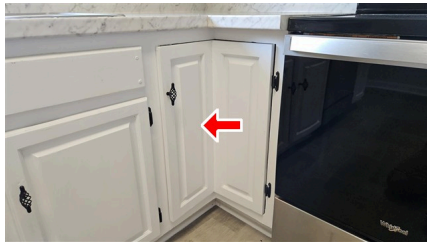
8.4 Item 1 (Picture)

1. The corner cabinet does not shut properly. Therefore it does not function as intended. Repairs are needed.

A qualified person should repair or replace as needed.

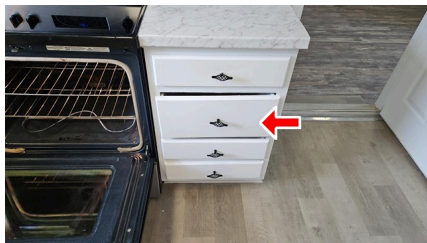
8.4 Item 3 (Picture)

1. Drawer track does not work smoothly in the kitchen. Recommend repair or replace as necessary.

A qualified person should repair or replace as needed

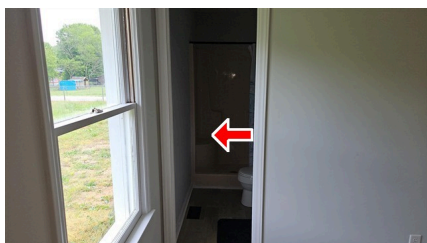
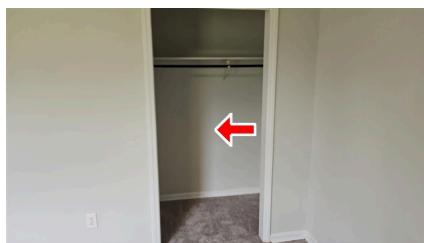
1. Multiple doors throughout the home are missing. This is for your information.

A qualified person should repair or replace as needed.

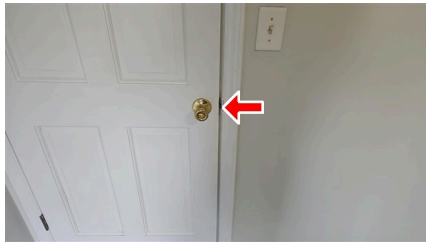
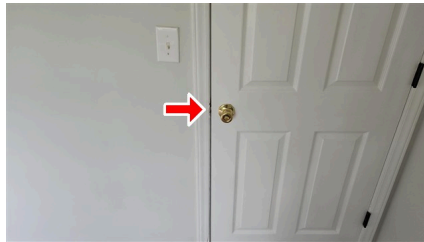
1. The door throughout the home will not latch properly. Evidence suggest that the door needs strike and latch adjustment to shut properly. This is a small repair.

A qualified person should repair or replace as needed.

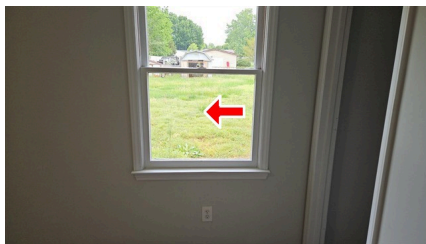
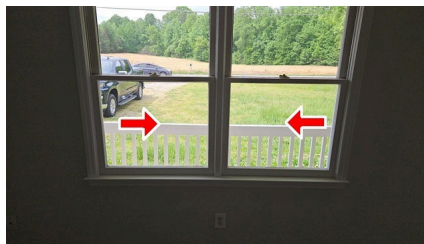
1. Numerous windows stuck or painted shut at the throughout the home. As a result no means of egress is present. One window per bedroom must open as means of egress out of the home should a fire occur. (Safety issue) Repairs are needed..

A qualified person should repair or replace as needed.

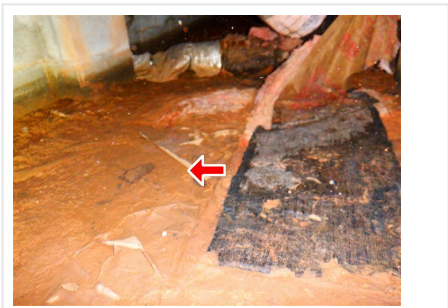
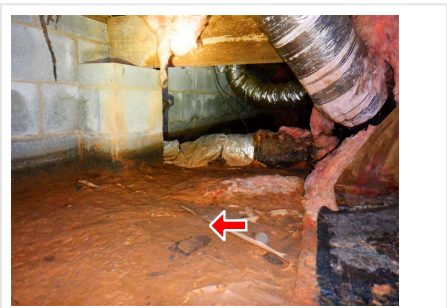
1. The vapor barrier (plastic) on the crawlspace ground is missing in areas. A vapor barrier provides added protection to the floor system from moisture or dampness that can enter from ground.  
Repairs are needed.

A qualified person should repair or replace as needed.
