INSPECTION REPORT  
215 Bethesda Rd  
Statesville NC 28677

INSPECTED BY  
Alex Parr 3692  
Above Parr Home  
Inspections

INSPECTION DATE  
📅 4/25/2025  
🕒 09:00:00 AM

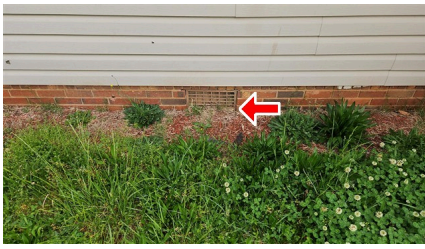
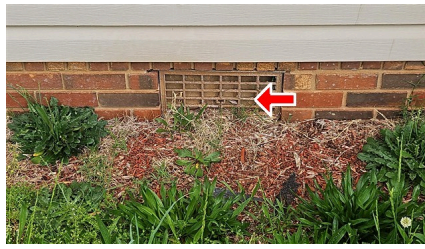
1. The foundation vents are damaged and missing screens at the exterior. Rodents, reptiles or insects could enter into crawlspace. Further investigation and repairs are needed.

A qualified person should repair or replace as needed.

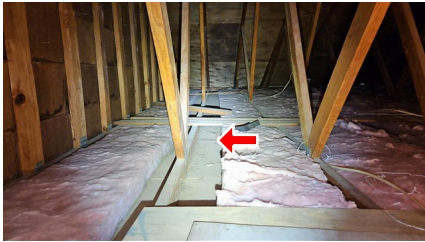
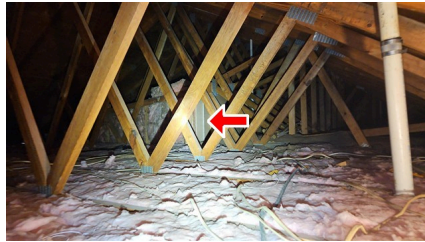
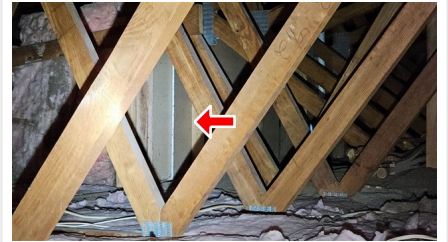
1. Insulation is missing in areas in attic. Heat loss can occur more on this home than one that is properly insulated. Repairs are needed.

A qualified person should repair or replace as needed.

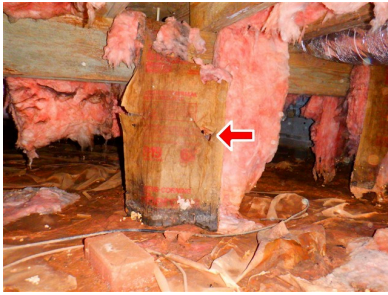
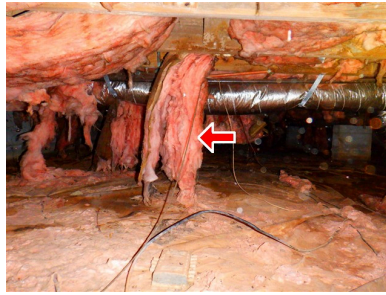
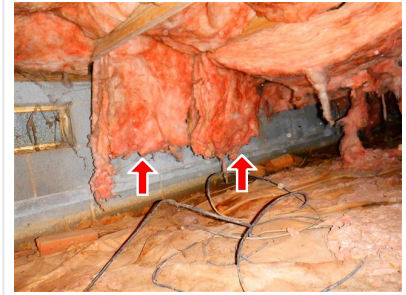
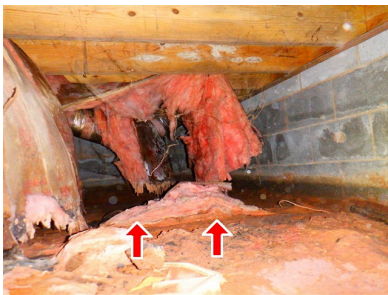
1. The insulation is loose/fallen in the crawlspace. Heat loss can occur more on this home than one that is properly insulated. Repairs are needed.

A qualified contractor should inspect and repair as needed.

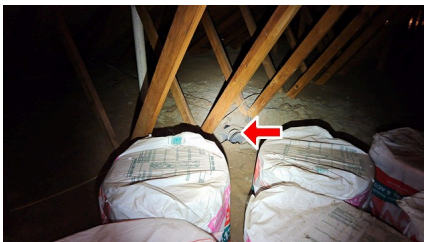
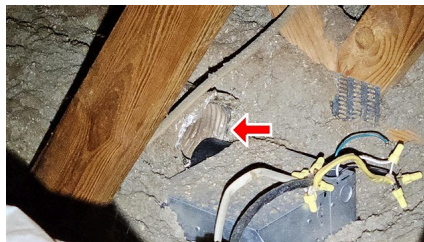
1. The exhaust fan has a damaged vent pipe in attic at the guest bath. Vent pipes that terminate in attic space can sometimes cause moisture that can lead to mold or cause condensation. Repairs are needed.

A qualified person should repair or replace as needed.

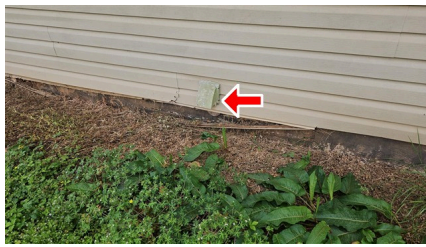
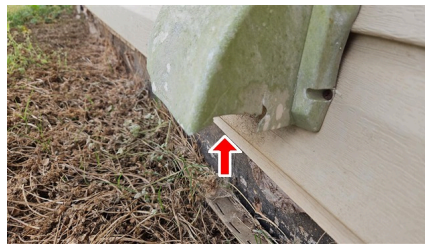
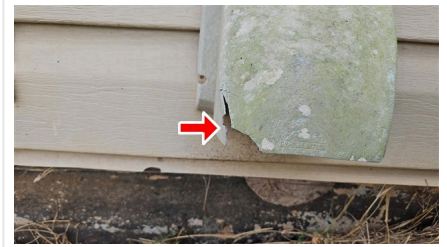
1. The dryer vent cover is damaged outside at the rear of the home. Repairs are recommended

A qualified person should repair or replace as needed.

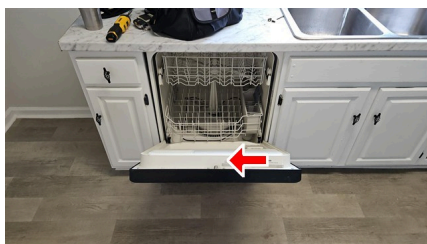
10.0 Item 1 (Picture)

1. The dishwasher door would not open or close properly. Evidence suggests the dishwasher was not installed properly. I recommend repair as necessary.

I recommend contacting appliance repair company.

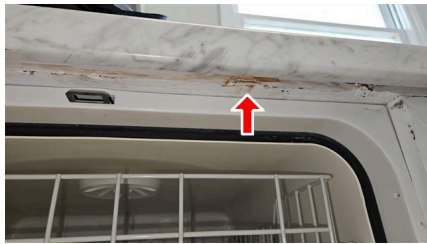
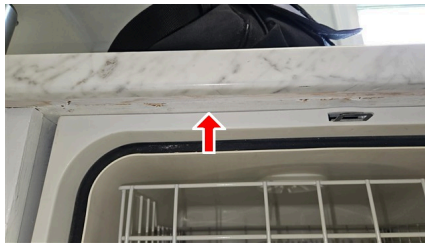
1. The dishwasher is loose and needs securing to underside of countertop (using a proper length screw). I recommend repair as necessary.

I recommend contacting appliance repair company.

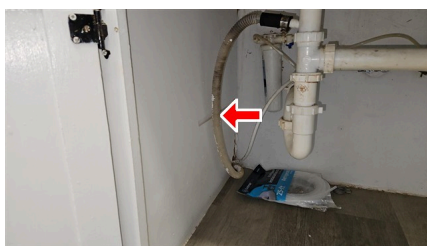
10.0 Item 4 (Picture)

1. The dishwasher drain hose needs to be looped above the level of the kitchen sink drain or an approved air gap installed to prevent back flow of waste water into the water supply. (food safety issue) This can allow waste for the sink to contaminate the dishwasher. This is a small repair.

A qualified licensed plumber should repair or correct as needed.

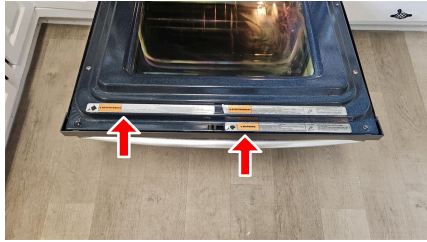
10.1 Item 1 (Picture)

1. The range/oven needs to be properly attached/anchored to the structure as to keep it from tipping over when the oven door is opened and/or oven racks are pulled out during use. This is a safety issue. Repairs are needed.

I recommend contacting appliance repair company.

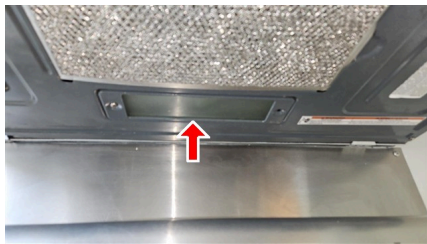
10.2 Item 1 (Picture)

1. The light bulb for fan did not work when tested. I recommend repair or replace as needed.  
I recommend contacting appliance repair company.

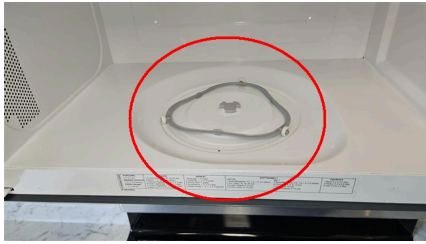
**10.4 Item 1 (Picture)**

1. The microwave plate is missing. Therefore the microwave cannot function as intended. I recommend repair as needed.

I recommend contacting appliance repair company.
