INSPECTION REPORT  
2339 Perry Rd.  
Denver NC 28037

INSPECTED BY  
Mike Sweeting  
(704)651-8190  
MikeS@hicarolina.com  
NC #5106

INSPECTION DATE  
📅 3/26/2025  
Home Inspection  
Carolina

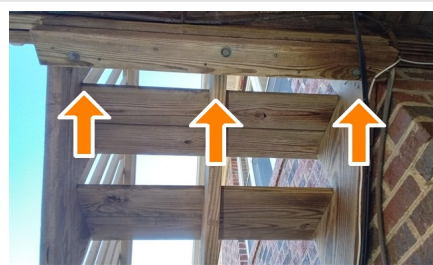
(1) The stair stringers are not secured by any ledger or joist hanger. A ledger or joist hanger gives the joist additional support, also preventing it from twisting or moving. A ledger or joist hanger needs to be installed to provide proper support and stability.

Consult with a qualified licensed contractor to evaluate the area(s) of concern and make any additional repairs as deemed necessary during their evaluation.

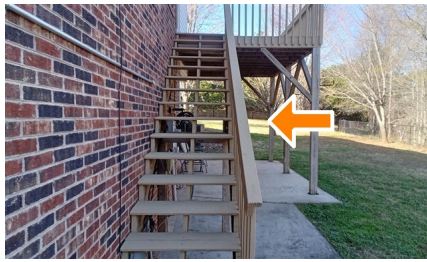
(2) There are loose railing(s) that need to be secured properly to prevent continual movement and/or a possible hazard at the rear deck.

Consult with a qualified licensed contractor to evaluate the area(s) of concern and make any additional repairs as deemed necessary during their evaluation.

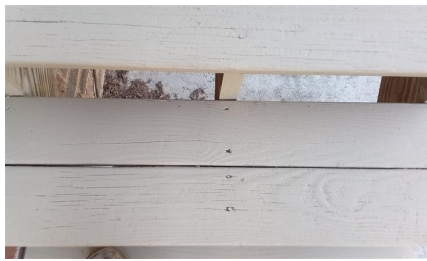
(3) There are loose and cupping/bowing boards noted throughout the stair surface. The boards need to be secured properly and the cupping or bowing boards may need to be replaced to prevent a tripping hazard and/or continual movement or cupping.

Consult with a qualified licensed contractor to evaluate the area(s) of concern and make any additional repairs as deemed necessary during their evaluation.

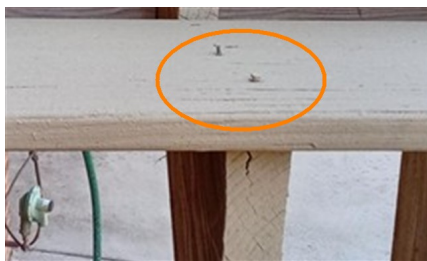
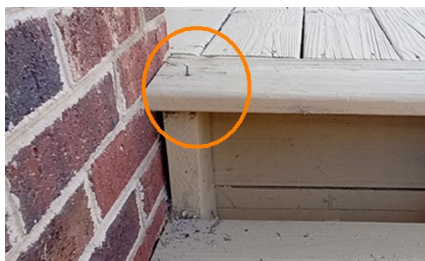
(4) There are nails protruding from the stairs resulting or can result in the boards to become loose as well as creating a possible trip hazard proper corrections and repairs are needed at the rear deck steps.

Consult with a qualified licensed contractor to evaluate the area(s) of concern and make any additional repairs as deemed necessary during their evaluation.

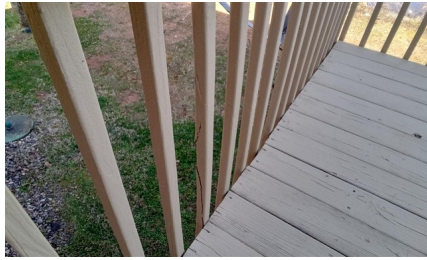
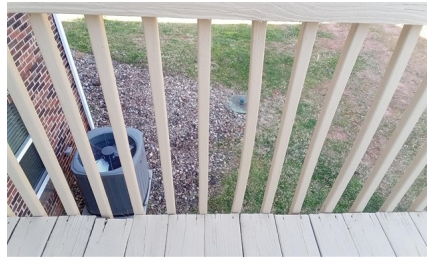
(5) There are cracked and/or warped spindles found on or around the deck railing. Proper corrections, repairs, and/or replacement are needed for the spindles to allow for proper protection. Consult with a qualified licensed contractor to evaluate the area(s) of concern and make any additional repairs as deemed necessary during their evaluation.

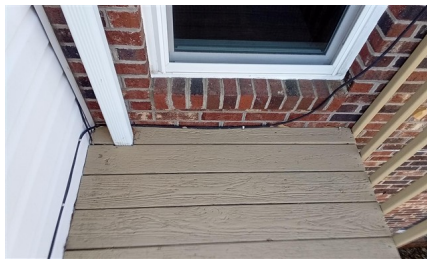
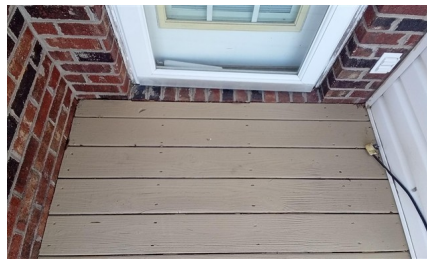
(6) The rear deck is not flashed or no signs of flashing were present at the time of inspection. Flashing is needed to prevent water penetration and wood rot between the deck and siding where it attaches. Consult with a qualified licensed contractor to evaluate the area(s) of concern and make any additional repairs as deemed necessary during their evaluation.

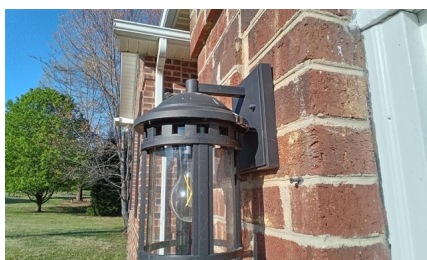
front

(1) The exterior light fixtures lack proper sealing at the points where they meet the outer walls on the home, potentially leading to moisture intrusion. It is important to address this issue to prevent potential damage to the structure over time if left unaddressed.

Consult with a qualified licensed contractor to evaluate the area(s) of concern and make any additional repairs as deemed necessary during their evaluation.

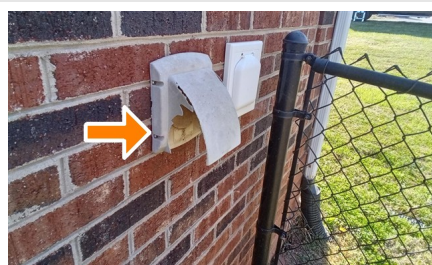
(2) The flap, which is meant to cover the exhaust vent on the left side of the home, is currently missing or damaged. This issue poses a risk of potential rodent and insect intrusion. To safeguard against such unwanted guests, it is important to address this by either repairing or replacing the flap.

Consult with a qualified licensed contractor to evaluate the area(s) of concern and make any additional repairs as deemed necessary during their evaluation.

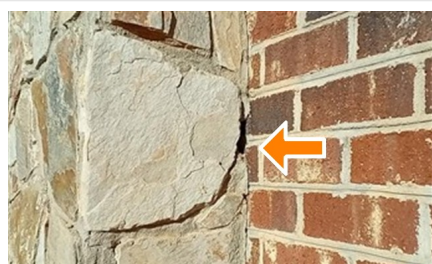
front

(1) Spacing and/or gapping was noted at the sidewalk and stone veneer where it meets the brick veneer. Properly sealing these areas is needed to prevent water penetration where the trim meets the brick veneer at the trim around the home.

Consult with a qualified licensed contractor to evaluate the area(s) of concern and make any additional repairs as deemed necessary during their evaluation.

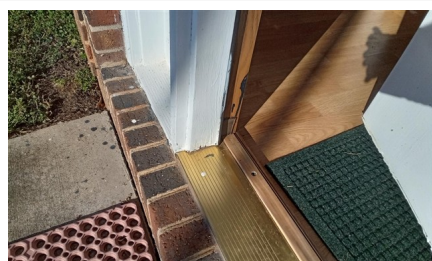
front door

(2) Wood rot has been observed at the trim where it intersects the threshold of the exterior doors. A more thorough assessment is required to ascertain the extent of repair or replacement necessary.

Consult with a qualified licensed contractor to evaluate the area(s) of concern and make any additional repairs as deemed necessary during their evaluation.

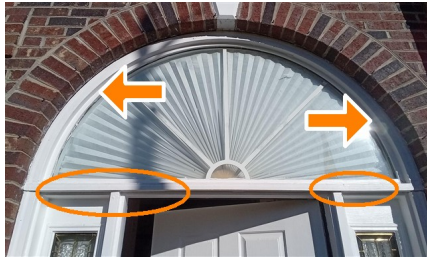
front window/door

(3) Sealant deficiencies, such as missing or poorly sealed areas, were observed on the exterior siding and trim in various sections around the home, including window and door frames. Corrections are required to prevent potential water seepage or insect infestation.

Consult with a qualified licensed contractor to evaluate the area(s) of concern and make any additional repairs as deemed necessary during their evaluation.

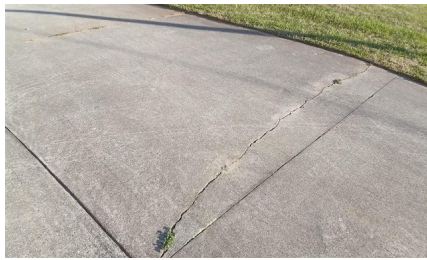
(1) There are cracks noted at the driveway and/or sidewalk(s) that need to be sealed and or repaired properly to prevent water penetration and or continual cracking. At a minimum, continue to monitor and make any additional repairs as needed.

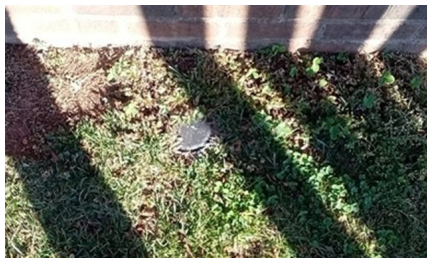
(2) There are termite bait stations around the exterior foundation of the home. This home may be under a termite bond and may be transferable. Ask the seller if the home is bonded and the rates to transfer the bond to a new owner.

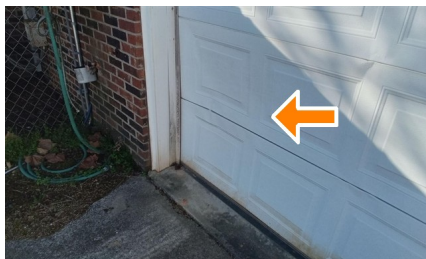
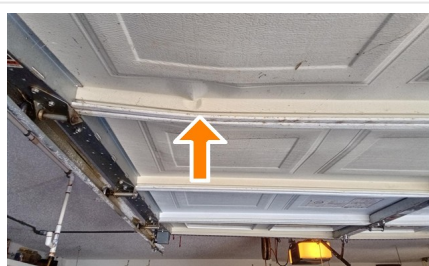
There is a dent in the garage door that could prevent the door from opening/closing properly requiring proper corrections and/or repairs/replacement.

Consult with a qualified licensed contractor to evaluate the area(s) of concern and make any additional repairs as deemed necessary during their evaluation.

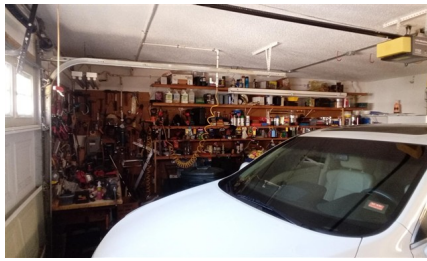
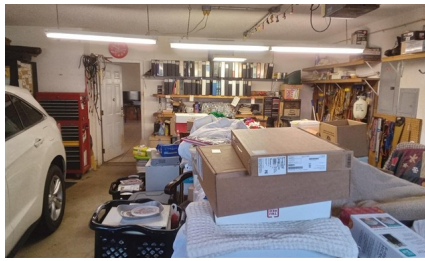
(2) The garage walls, foundation and/or floor were not fully visible due to stored items along the walls and floor in the garage. Due to the stored items obstructing the viewing of the walls, floor and foundation within the garage, the inspector cannot determine if there is hidden or concealed damage or defects in the garage that may have been obstructed at the time of inspection. The conditions in the obstructed areas are unknown at the time of inspection. It is recommended that all of the stored items be removed from the garage so that a qualified professional can further evaluate the conditions within the garage before the closing or due diligence date as there may be hidden or concealed damage.

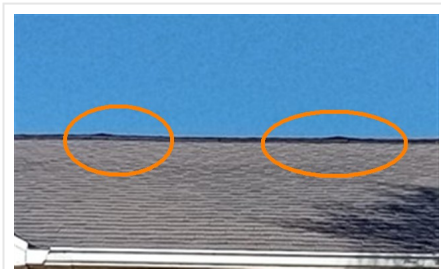
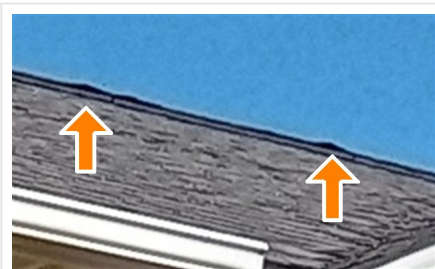
(1) Multiple nail pops or otherwise lifted shingles were noted in multiple locations throughout the roof surface.

This can result in damaged shingles and moisture penetration.

Consult with a qualified licensed contractor to evaluate the area(s) of concern and make any additional repairs as deemed necessary during their evaluation.

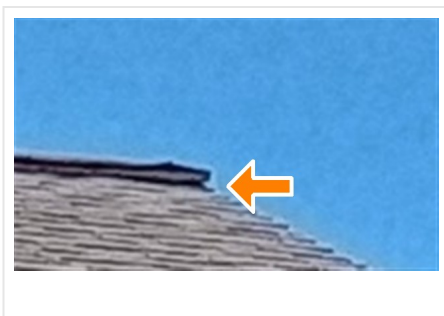
(2) The ridge vent along the top of the roof is loose and needs to be secured properly to prevent possible water penetration.

Consult with a qualified licensed contractor to evaluate the area(s) of concern and make any additional repairs as deemed necessary during their evaluation.

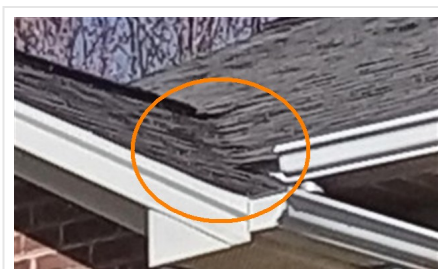
front left

(3) There are lifting, cupping, or bowing shingles noted in the valleys that need repair or corrections to prevent possible wind damage and or water penetration.

Consult with a qualified licensed contractor to evaluate the area(s) of concern and make any additional repairs as deemed necessary during their evaluation.

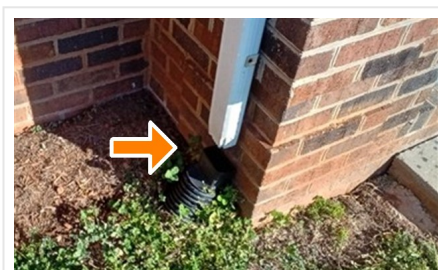
front

(1) The gutters drain into a corrugated piping drain and are missing the coupling that connects the gutter and corrugated piping together. This is needed to prevent debris from entering the corrugated piping and clogging it. Underground drainage from gutters or a drainage system is not inspected at the time of inspection.

Consult with a qualified licensed contractor to evaluate the area(s) of concern and make any additional repairs as deemed necessary during their evaluation.

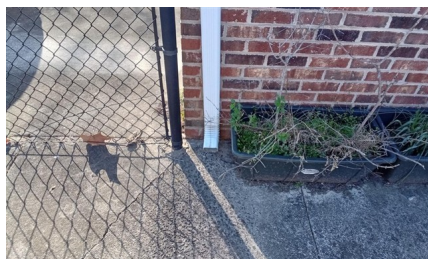
rear

(2) A splash block is needed to properly direct water away from the foundation of the home under all gutter down spouts around the home.

Consult with a qualified licensed contractor to evaluate the area(s) of concern and make any additional repairs as deemed necessary during their evaluation.

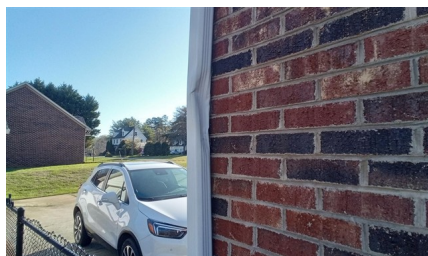
rear right

(3) The gutters are bent, loose, and/or damaged around the home. They are in need of repairs and/or replacement to properly direct water away from the home and foundation.

Consult with a qualified licensed contractor to evaluate the area(s) of concern and make any additional repairs as deemed necessary during their evaluation.

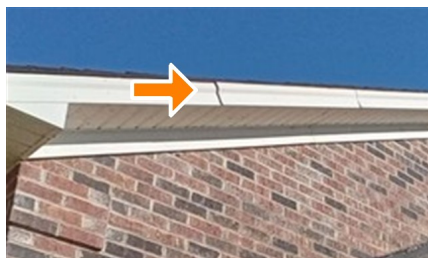
(1) There are loose piece(s) of fascia that need to be re-installed and/or secured properly to prevent water penetration and/or possible damage at the front of the home.

Consult with a qualified licensed contractor to evaluate the area(s) of concern and make any additional repairs as deemed necessary during their evaluation.

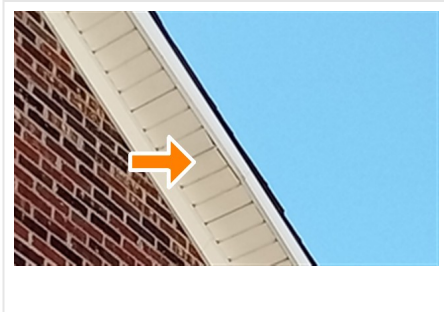
(2) There is damaged and/or rotted soffit that needs repaired and/or replaced. The source of the water that caused or is causing the damage needs to be located and corrected to prevent continual rot at the right of the home.

Consult with a qualified licensed contractor to evaluate the area(s) of concern and make any additional repairs as deemed necessary during their evaluation.

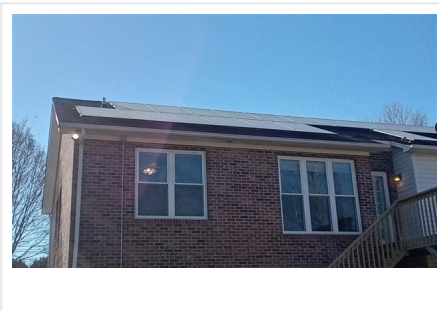
Solar panels were found to be installed on the roof of the home. Solar panels are not inspected or tested during the home inspection, as this is outside the standards of practice. During the inspection, it is unable to determine the installation process or if they were installed to prevent water penetration at the time of inspection. Continue to monitor areas around the panels and the sheathing in the attic area for signs of possible water penetration. Ask the seller for documentation and disclosure for any transferable warranty information. Due to the height of the home, the gutters could not be viewed from the top. Underground drainage from gutters or a drainage system is not inspected at the time of inspection, as this is beyond the scope of a normal home inspection.

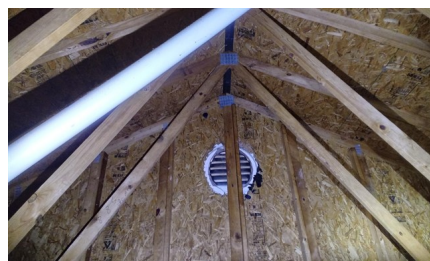
(1) A ridge vent has been installed on the home with gable vents installed. When ridge vents are installed with gable vents air will pull in and directly up then out through the ridge vent but not through the attic area. **The presences of both systems are counterproductive and are preventing proper ventilation of the attic area.** This may result in poor and/or improper ventilation throughout the attic area, which can lead to high moisture/ wood rot.

Consult with a qualified licensed contractor to evaluate the area(s) of concern and make any additional repairs as deemed necessary during their evaluation.

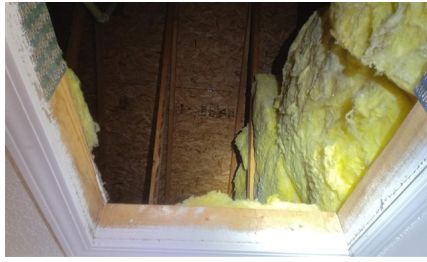
The attic was observed from hatch areas only. Access is restricted by low headroom and/or no floored area. The structure condition could not be fully viewed and the conditions are unknown. Ask the seller for full disclosure as to any repairs or defects that may have occurred in the past and if corrections have been made to correct them.

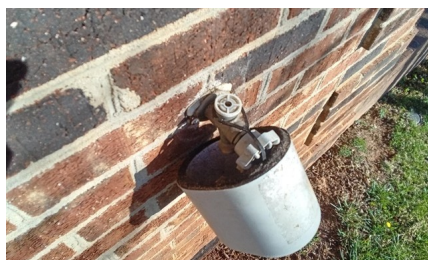
(1) There are not any anti-backflow preventer valves installed at the front exterior hose faucet. Backflow preventer valves are required to prevent cross-contamination between water supply sources. Consult with a qualified licensed contractor to fully understand the extent of the repairs needed and determine if corrective actions are required.

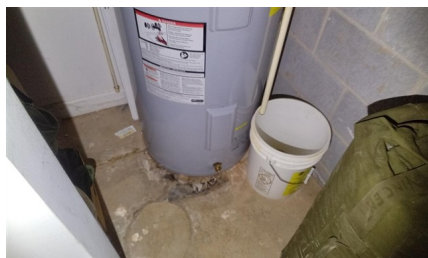
Water heater is located at an interior area and is not provided with an emergency overflow pan. These pans, with their drain lines, act to prevent damage to carpeting and furnishings, should the unit begin leaking. Oftentimes, installations more than a few years of age are not equipped with such pans. They are a good idea however, and should be installed at the time of water heater replacement, provided an exterior wall through which the drain line can flow by gravity is located conveniently nearby.

Consult with a qualified licensed contractor to evaluate the area(s) of concern and make any additional repairs as deemed necessary during their evaluation.

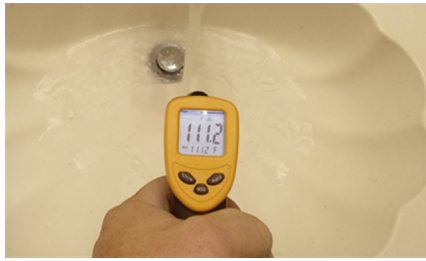
basement

(1) The water temperature was found to range between 110 and 119 degrees. To ensure optimal performance, adjust the temperature to 120 degrees. [Click here](#) to discover how to set your water heater to a safe and efficient temperature level.

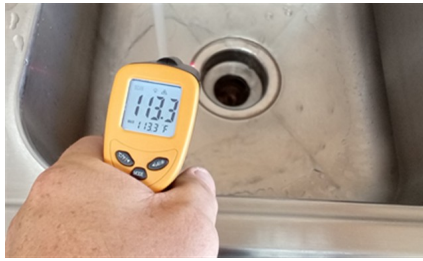
kitchen

(2) The water temperature was found to range between 110 and 119 degrees. To ensure optimal performance, adjust the temperature to 120 degrees. [Click here](#) to discover how to set your water heater to a safe and efficient temperature level.

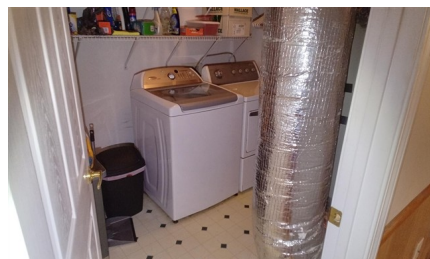
Unable to view the walls, flooring, and piping at the time of inspection due to the washing machine and/or dryer being installed obstructing viewing of these areas. No claims can be made to the condition of these areas at the time of inspection.

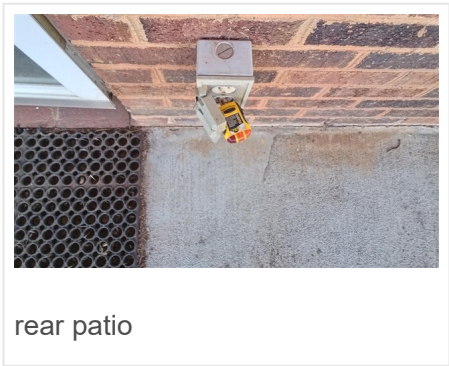
(1) Outlets where found in and/or throughout the home to have broken and/or damaged outlets. The outlet(s) are cracked and need replacement to prevent a loose or improper connection. Consult with a qualified licensed contractor to evaluate the area(s) of concern and make any additional repairs as deemed necessary during their evaluation.

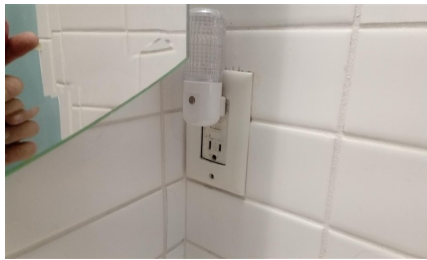
primary bathroom

(2) Loose outlets were noted throughout the home. Loose outlets can result in loose electrical connections which can increase the potential for a safety hazard and/or equipment failure. Consult with a qualified licensed contractor to evaluate the area(s) of concern and make any additional repairs as deemed necessary during their evaluation.

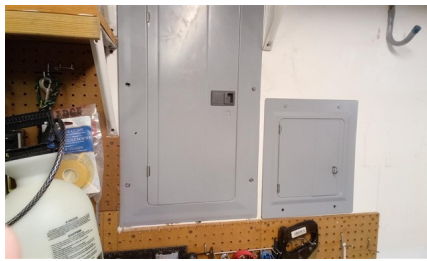
(3) There are missing screws at the electrical panel that need replacement to properly secure the electrical panel cover to the panel prevent access to the interior of the panel.

Consult with a qualified licensed contractor to evaluate the area(s) of concern and make any additional repairs as deemed necessary during their evaluation.

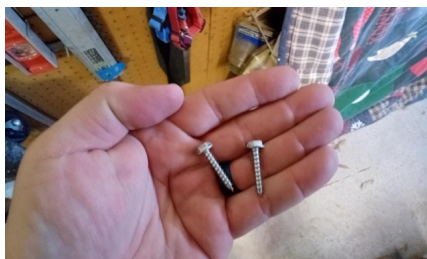
(4) There are pointed or tipped screws (wood screws) installed to secure the exterior cover of the electrical panel. Pointed or tipped screws may puncture the wiring installed in the panel and need to be replaced to flat/ blunt tipped screws.

Consult with a qualified licensed contractor to evaluate the area(s) of concern and make any additional repairs as deemed necessary during their evaluation.

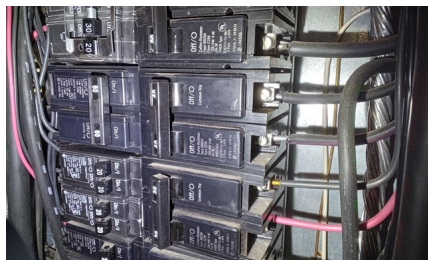
(5) The electrical system of this home has single strand aluminum wiring present on the lighting and receptacle branch circuits. As a result of documented fire hazards, the use of single strand aluminum wiring for lighting and receptacle branch circuits was discontinued in 1974 until material improvement could be made. Due to the concealed nature of the electrical components, the general condition of the system could not be determined during the home inspection. A licensed electrical contractor should be consulted for a complete evaluation of the electrical system to determine if repair, modification, or replacement is needed to ensure safe and reliable

service. For more information on aluminum household wiring and recommended repair methods, refer to the C.P.S.C. booklet "Repairing Aluminum Wiring." The toll-free hotline number for obtaining this booklet is 1-800-638-2772, or you can visit: <https://www.cpsc.gov/s3fs-public/516.pdf>

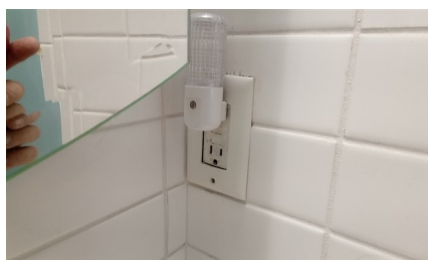
(6) There are GFCI's installed down stream of a main GFCI located in the primary bathroom. If the GFCI downstream trips the lead GFCI must be reset before the GFCI downstream can be reset. Consult with a qualified licensed contractor to evaluate the area(s) of concern and make any additional repairs as deemed necessary during their evaluation.

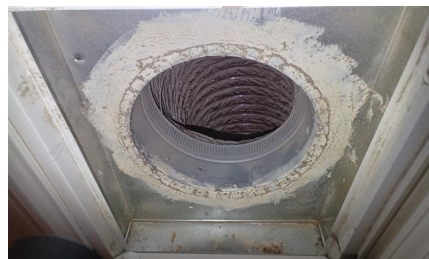
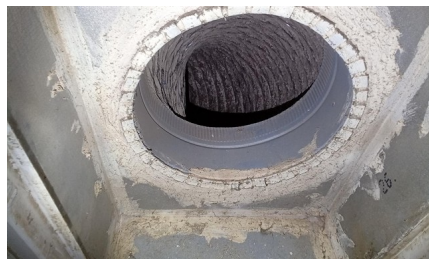
**There is dust and/or dirt noted inside the duct system** viewed from the air filter location. This may be an indication that the ducts are in need of cleaning to ensure efficiency of the unit(s).

Consult with a qualified licensed contractor to evaluate the area(s) of concern and make any additional repairs as deemed necessary during their evaluation.

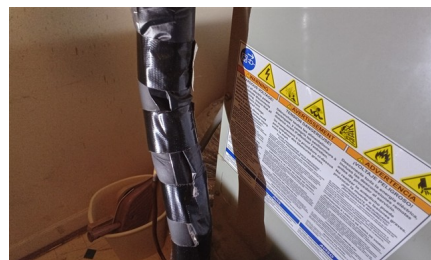
The panel was not removed due to risk of damaging the freon line. No statement can be made about the inside conditions of the heat pump unit in the basement.

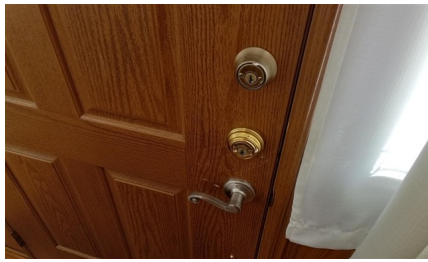
front door

(1) This home is equipped with multiple dead bolts that can only be opened from the interior with a key when locked. These types of dead bolts restrict easy access to the exterior of the home in the event of an emergency. It is recommended to replace the dead bolts with the type that can be easily opened from the interior of the home.

Consult with a qualified licensed contractor to evaluate the area(s) of concern and make any additional repairs as deemed necessary during their evaluation.

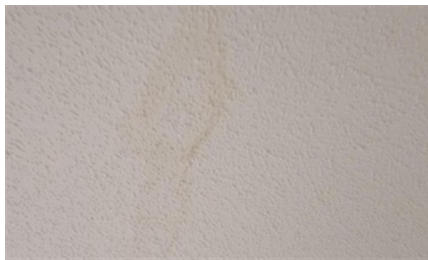
(2) Moisture staining/damage was noted on the ceiling in the basement. Unable to determine if an active leak exists at the time of inspection as the stains were dry relative to unaffected areas at the time of inspection. Moisture penetration/leakage into or within a home can result in moisture damage to the structure and adverse environmental conditions. Unable to determine if there is hidden or concealed damage that was not visible at the time of inspection. Ask the seller the history of the stains and if repairs have been made to correct any leaks that may have caused the stain. If the sellers are unaware of the stain or no repairs have been made then it should be treated as an active issue and further evaluation is needed by a licensed general contractor. Consult with a qualified licensed contractor to evaluate the area(s) of concern and make any additional repairs as deemed necessary during their evaluation.

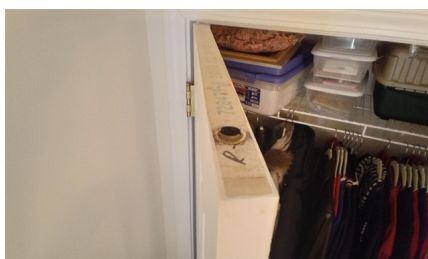
(3) The Drive-In Ball Catch w/ Strike Plate are missing at the top of the following doors: front bedroom door(s) Consult with a qualified licensed contractor to evaluate the area(s) of concern and make any additional repairs as deemed necessary during their evaluation.

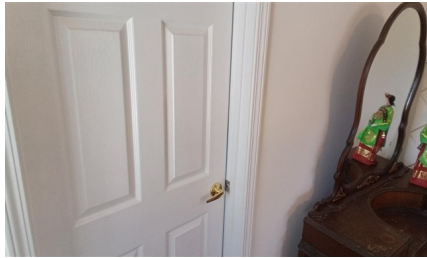
primary bathroom

(4) The following door(s) listed below rubbed at the frame/flooring and need adjustment and/or repair for the door(s) to open and close properly without rubbing: bathroom door(s), primary bedroom  
Consult with a qualified licensed contractor to evaluate the area(s) of concern and make any additional repairs as deemed necessary during their evaluation.

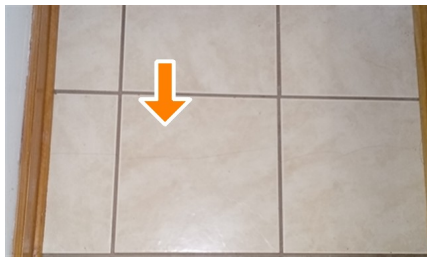
(5) There were cracked floor tile(s) noted in the following location(s): basement steps. Corrections are needed in order to prevent possible further damage.  
Consult with a qualified licensed contractor to evaluate the area(s) of concern and make any additional repairs as deemed necessary during their evaluation.

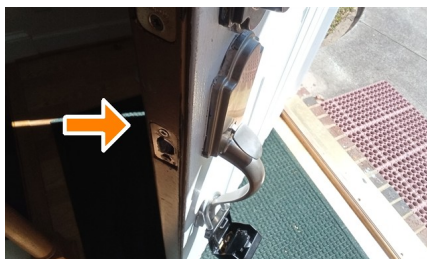
(6) The front door did not latch closed at the time of inspection. Corrections are needed so the door can function as intended. Have a qualified licensed contractor further evaluate and make the necessary repairs.  
Consult with a qualified licensed contractor to evaluate the area(s) of concern and make any additional repairs as deemed necessary during their evaluation.

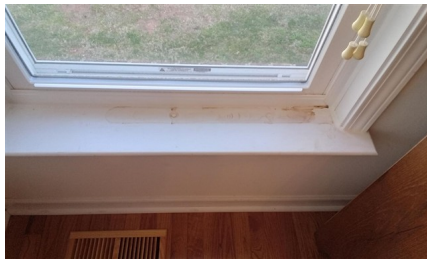
left rear bedroom

There is wood rot and/or water damage noted (but not limited to) the windows framing/casing around the windows at the following location(s) listed below. Repair and/or replacement is needed at the window or window framing to ensure that there is not any hidden or concealed damage that was otherwise unseen at the time of inspection.

Consult with a qualified licensed contractor to evaluate the area(s) of concern and make any additional repairs as deemed necessary during their evaluation.

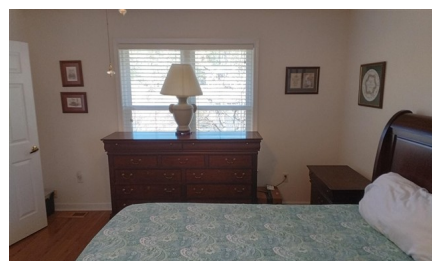
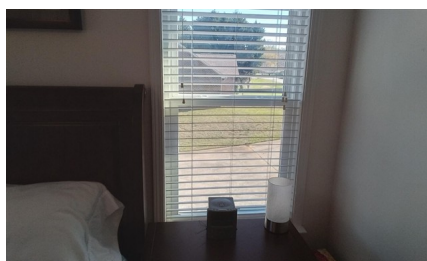
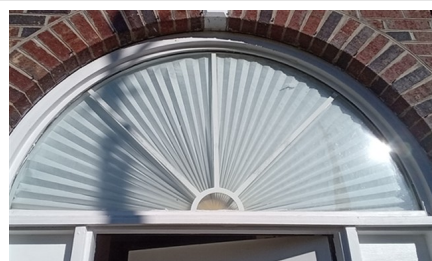
Unable to test or fully view the following rooms windows due to stored items, window treatments blocking the windows preventing access or operation at the time of inspection: master bedroom, front window.

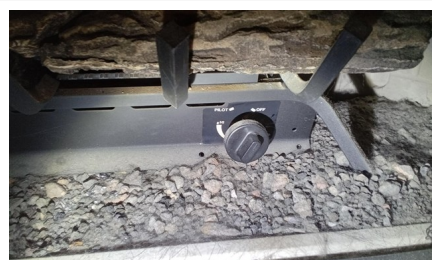
The pilot light was not lit at the time of inspection. Note: Pilot lights must be lit at the time of inspection to ensure safety. When pilots are off and/or the fireplace has not been used for sometime, it may take a long time to light the unit. The units may not light at all due to the lines needing to be bled. Because of the time constraints of a home inspection, pilot lights cannot be lit. Please Note: Unable to determine if the unit functions and/or functions properly at the time of inspection due to the pilot not being lit.

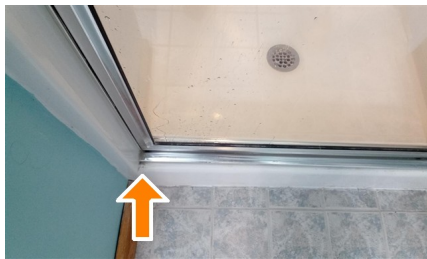
(1) The shower door leaks at the seal on the bottom. Corrections are needed in order to prevent possible further leaking or damage. Consult with a qualified licensed contractor to evaluate the area(s) of concern and make any additional repairs as deemed necessary during their evaluation.

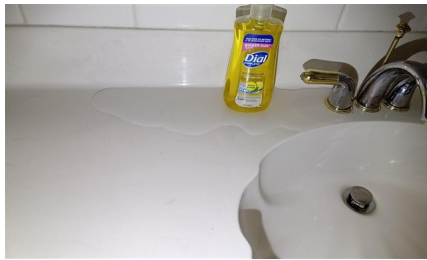
(2) There is a leak at the faucet or faucet handle that needs repairs or replacement to prevent possible further leaking.

Consult with a qualified licensed contractor to evaluate the area(s) of concern and make any additional repairs as deemed necessary during their evaluation.

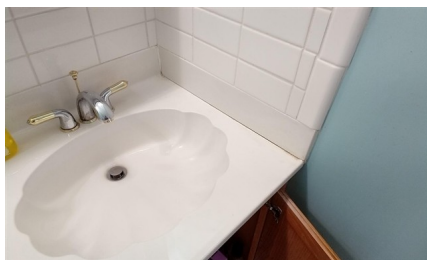
(3) Caulk is needed to fill the gaps where the sink countertop and backsplash meet to prevent water penetration.

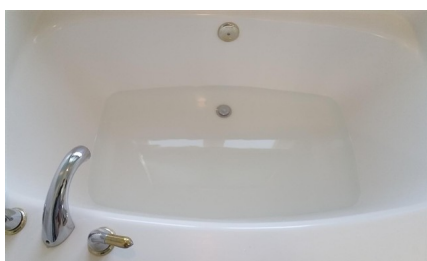
(4) The primary bathroom tub does not achieve functional drainage. This means that the tub will fill with water faster than it can drain water even when the stopper is not engaged.

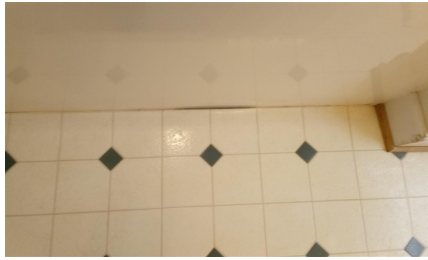
Caulk/grout is needed to seal the gaps where the upstairs hall bathroom tub and shower wall meet to prevent water penetration.

Consult with a qualified licensed contractor to evaluate the area(s) of concern and make any additional repairs as deemed necessary during their evaluation.

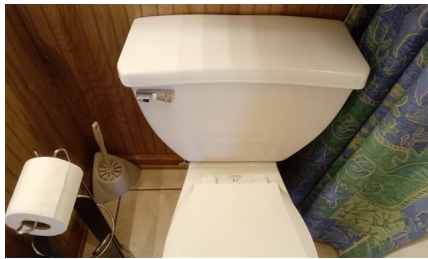
The tank is loose where it attaches to the base of the toilet and needs to be properly secured to prevent leakage.

Consult with a qualified licensed contractor to evaluate the area(s) of concern and make any additional repairs as deemed necessary during their evaluation.

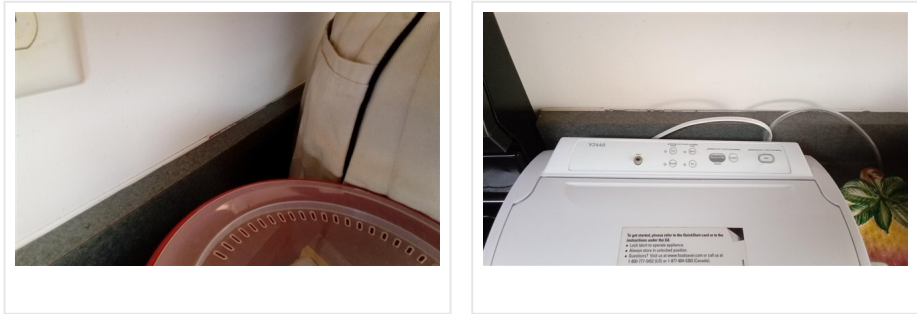
Sealant/Caulk is needed to prevent water penetration and seal the gap(s) where the countertop meets the backsplash around the entire kitchen.

Consult with a qualified licensed contractor to evaluate the area(s) of concern and make any additional repairs as deemed necessary during their evaluation.

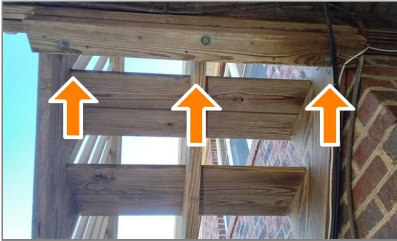
1. (1) The stair stringers are not secured by any ledger or joist hanger. A ledger or joist hanger gives the joist additional support, also preventing it from twisting or moving. A ledger or joist hanger needs to be installed to provide proper support and stability.

Consult with a qualified licensed contractor to evaluate the area(s) of concern and make any additional repairs as deemed necessary during their evaluation.

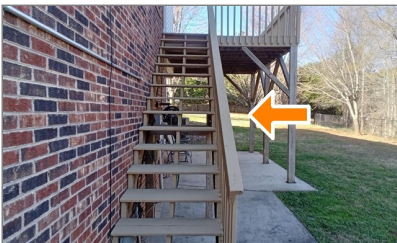
2. (2) There are loose railing(s) that need to be secured properly to prevent continual movement and/or a possible hazard at the rear deck.

Consult with a qualified licensed contractor to evaluate the area(s) of concern and make any additional repairs as deemed necessary during their evaluation.

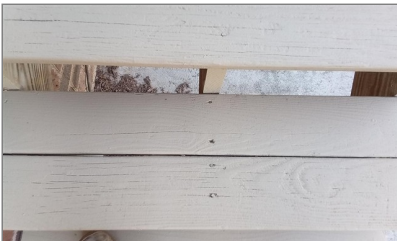
stairs

3. (3) There are loose and cupping/bowing boards noted throughout the stair surface. The boards need to be secured properly and the cupping or bowing boards may need to be replaced to prevent a tripping hazard and/or continual movement or cupping.

Consult with a qualified licensed contractor to evaluate the area(s) of concern and make any additional repairs as deemed necessary during their evaluation.

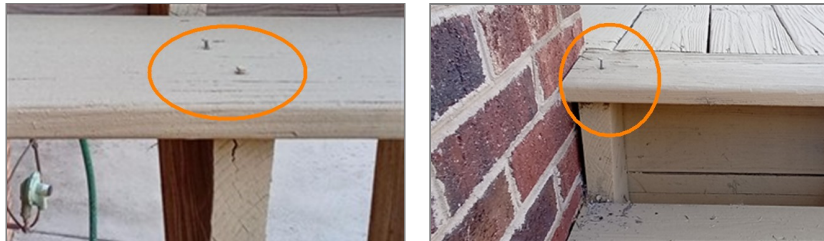
4. (4) There are nails protruding from the stairs resulting or can result in the boards to become loose as well as creating a possible trip hazard proper corrections and repairs are needed at the rear deck steps.  
Consult with a qualified licensed contractor to evaluate the area(s) of concern and make any additional repairs as deemed necessary during their evaluation.

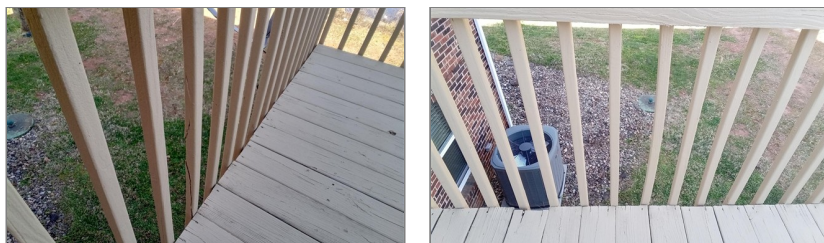
5. (5) There are cracked and/or warped spindles found on or around the deck railing. Proper corrections, repairs, and/or replacement are needed for the spindles to allow for proper protection.  
Consult with a qualified licensed contractor to evaluate the area(s) of concern and make any additional repairs as deemed necessary during their evaluation.

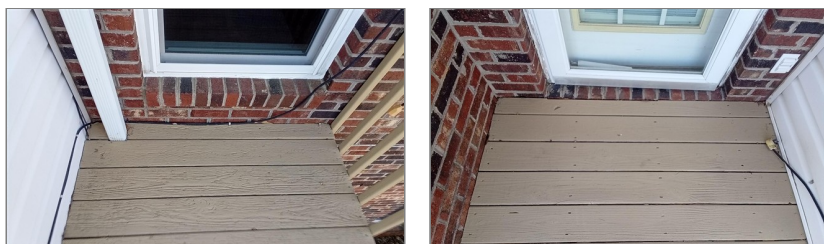
6. (6) The rear deck is not flashed or no signs of flashing were present at the time of inspection. Flashing is needed to prevent water penetration and wood rot between the deck and siding where it attaches.  
Consult with a qualified licensed contractor to evaluate the area(s) of concern and make any additional repairs as deemed necessary during their evaluation.

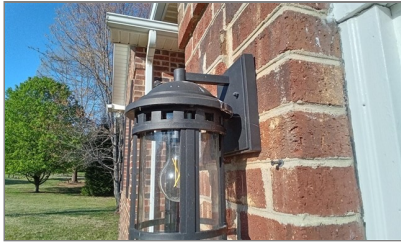
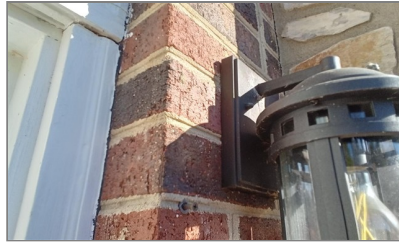
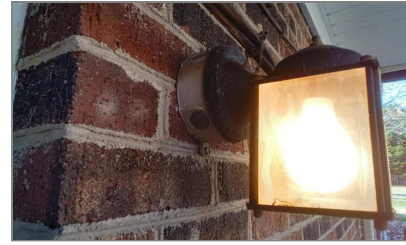
7. (1) The exterior light fixtures lack proper sealing at the points where they meet the outer walls on the home, potentially leading to moisture intrusion. It is important to address this issue to prevent potential damage to the structure over time if left unaddressed. Consult with a qualified licensed contractor to evaluate the area(s) of concern and make any additional repairs as deemed necessary during their evaluation.

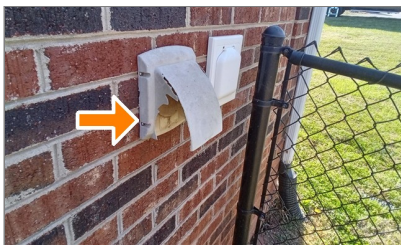
8. (2) The flap, which is meant to cover the exhaust vent on the left side of the home, is currently missing or damaged. This issue poses a risk of potential rodent and insect intrusion. To safeguard against such unwanted guests, it is important to address this by either repairing or replacing the flap. Consult with a qualified licensed contractor to evaluate the area(s) of concern and make any additional repairs as deemed necessary during their evaluation.

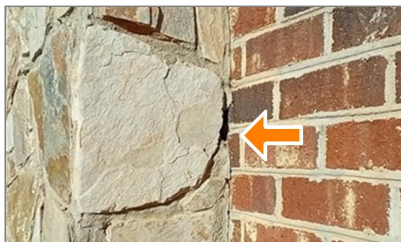
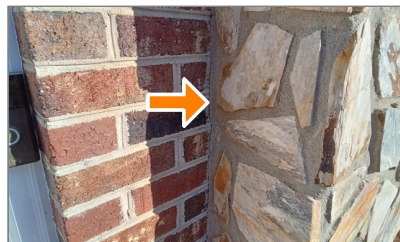
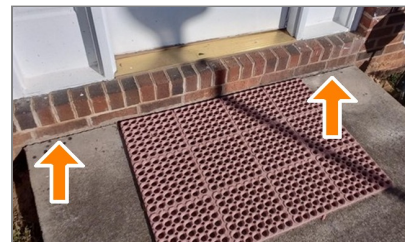
9. (1) Spacing and/or gapping was noted at the sidewalk and stone veneer where it meets the brick veneer. Properly sealing these areas is needed to prevent water penetration where the trim meets the brick veneer at the trim around the home. Consult with a qualified licensed contractor to evaluate the area(s) of concern and make any additional repairs as deemed necessary during their evaluation.

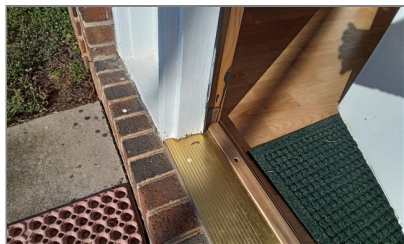
front door

10. (2) Wood rot has been observed at the trim where it intersects the threshold of the exterior doors. A more thorough assessment is required to ascertain the extent of repair or replacement necessary.

Consult with a qualified licensed contractor to evaluate the area(s) of concern and make any additional repairs as deemed necessary during their evaluation.

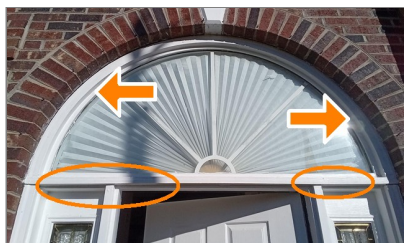
front window/door

11. (3) Sealant deficiencies, such as missing or poorly sealed areas, were observed on the exterior siding and trim in various sections around the home, including window and door frames. Corrections are required to prevent potential water seepage or insect infestation.

Consult with a qualified licensed contractor to evaluate the area(s) of concern and make any additional repairs as deemed necessary during their evaluation.

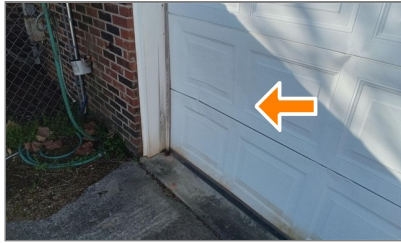
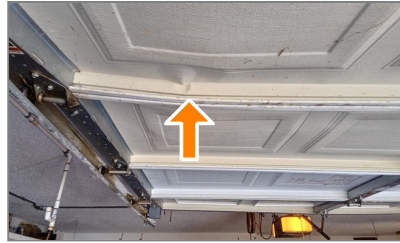
12. There is a dent in the garage door that could prevent the door from opening/closing properly requiring proper corrections and/or repairs/replacement.

Consult with a qualified licensed contractor to evaluate the area(s) of concern and make any additional repairs as deemed necessary during their evaluation.

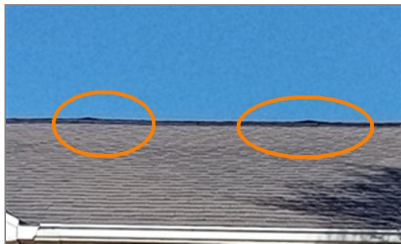
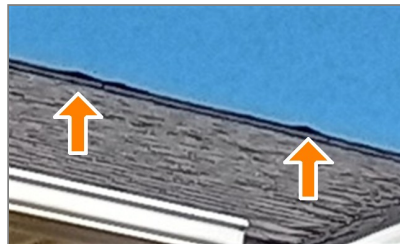
14. (1) Multiple nail pops or otherwise lifted shingles were noted in multiple locations throughout the roof surface. This can result in damaged shingles and moisture penetration. Consult with a qualified licensed contractor to evaluate the area(s) of concern and make any additional repairs as deemed necessary during their evaluation.

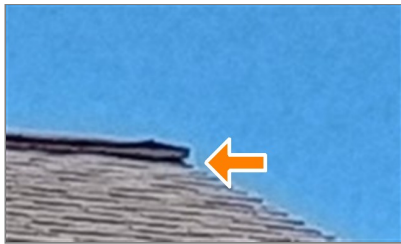
15. (2) The ridge vent along the top of the roof is loose and needs to be secured properly to prevent possible water penetration. Consult with a qualified licensed contractor to evaluate the area(s) of concern and make any additional repairs as deemed necessary during their evaluation.

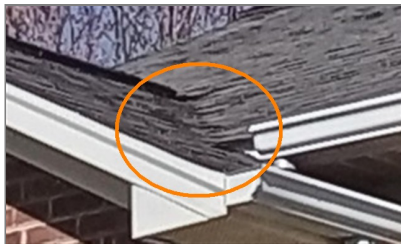
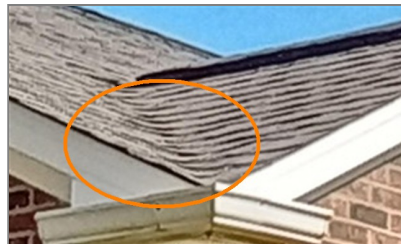
front left

16. (3) There are lifting, cupping, or bowing shingles noted in the valleys that need repair or corrections to prevent possible wind damage and or water penetration. Consult with a qualified licensed contractor to evaluate the area(s) of concern and make any additional repairs as deemed necessary during their evaluation.

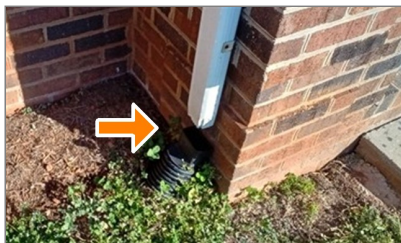
front

17. (1) The gutters drain into a corrugated piping drain and are missing the coupling that connects the gutter and corrugated piping together. This is needed to prevent debris from entering the corrugated piping and clogging it. Underground drainage from gutters or a drainage system is not inspected at the time of inspection. Consult with a qualified licensed contractor to evaluate the area(s) of concern and make any additional repairs as deemed necessary during their evaluation.

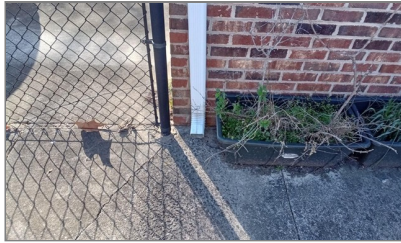
rear

18. (2) A splash block is needed to properly direct water away from the foundation of the home under all gutter down spouts around the home. Consult with a qualified licensed contractor to evaluate the area(s) of concern and make any additional repairs as deemed necessary during their evaluation.

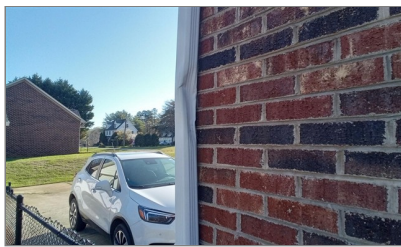
rear right

19. (3) The gutters are bent, loose, and/or damaged around the home. They are in need of repairs and/or replacement to properly direct water away from the home and foundation.

Consult with a qualified licensed contractor to evaluate the area(s) of concern and make any additional repairs as deemed necessary during their evaluation.

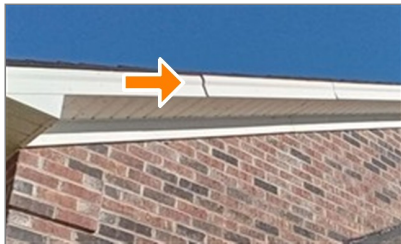
20. (1) There are loose piece(s) of fascia that need to be re-installed and/or secured properly to prevent water penetration and/or possible damage at the front of the home.

Consult with a qualified licensed contractor to evaluate the area(s) of concern and make any additional repairs as deemed necessary during their evaluation.

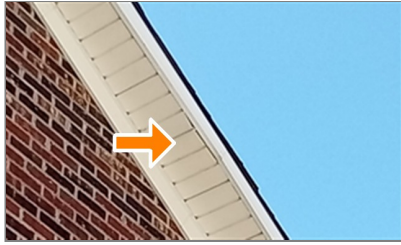
21. (2) There is damaged and/or rotted soffit that needs repaired and/or replaced. The source of the water that caused or is causing the damage needs to be located and corrected to prevent continual rot at the right of the home.

Consult with a qualified licensed contractor to evaluate the area(s) of concern and make any additional repairs as deemed necessary during their evaluation.

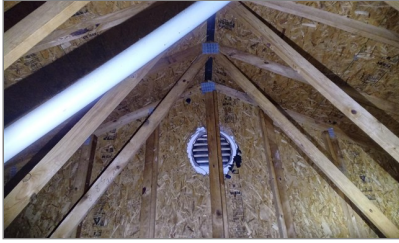
23. (1) A ridge vent has been installed on the home with gable vents installed. When ridge vents are installed with gable vents air will pull in and directly up then out through the ridge vent but not through the attic area. **The presences of both systems are counterproductive and are preventing proper ventilation of the attic area.** This may result in poor and/or improper ventilation throughout the attic area, which can lead to high moisture/wood rot.

Consult with a qualified licensed contractor to evaluate the area(s) of concern and make any additional repairs as deemed necessary during their evaluation.

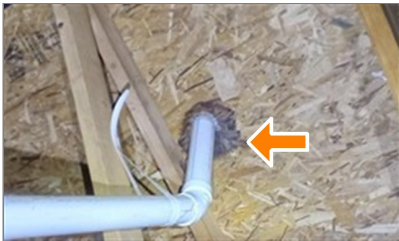
24. (2) Moisture staining/damage was noted along the bottom of the roof sheathing/decking and/or on the attic framing in the left area of the attic. Unable to determine if an active leak exist at the time of inspection as the stain(s) were either dry relative to unaffected areas or were not safely accessible for testing with a moisture meter at the time of inspection. Water penetration in the building can result in damage and/or undesirable environmental conditions. Have a qualified licensed general contractor further evaluate and make any additional repairs as needed or deemed necessary.
- Consult with a qualified licensed contractor to evaluate the area(s) of concern and make any additional repairs as deemed necessary during their evaluation.

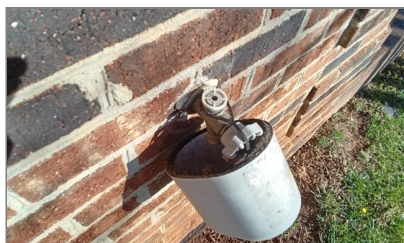
26. (1) There are not any anti-backflow preventer valves installed at the front exterior hose faucet. Backflow preventer valves are required to prevent cross-contamination between water supply sources. Consult with a qualified licensed contractor to fully understand the extent of the repairs needed and determine if corrective actions are required.

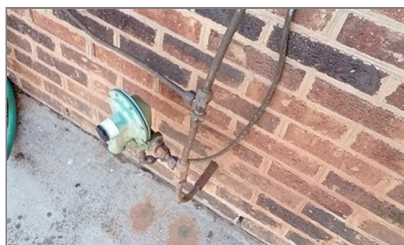
27. (2) There is no shut off valve at the gas line on the rear exterior. Shut off valve is needed in case there is a possible emergency and the gas line needs turned off. Consult with a qualified licensed contractor to evaluate the area(s) of concern and make any additional repairs as deemed necessary during their evaluation.

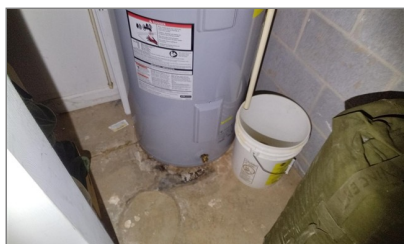
28. Water heater is located at an interior area and is not provided with an emergency overflow pan. These pans, with their drain lines, act to prevent damage to carpeting and furnishings, should the unit begin leaking. Oftentimes, installations more than a few years of age are not equipped with such pans. They are a good idea however, and should be installed at the time of water heater replacement, provided an exterior wall through which the drain line can flow by gravity is located conveniently nearby. Consult with a qualified licensed contractor to evaluate the area(s) of concern and make any additional repairs as deemed necessary during their evaluation.

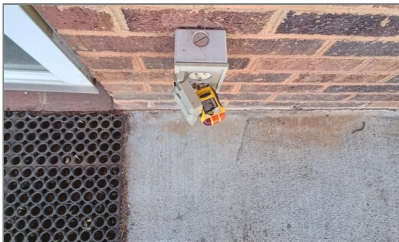
rear patio

30. (1) Outlets were found in and/or throughout the home to have broken and/or damaged outlets. The outlet(s) are cracked and need replacement to prevent a loose or improper connection. Consult with a qualified licensed contractor to evaluate the area(s) of concern and make any additional repairs as deemed necessary during their evaluation.

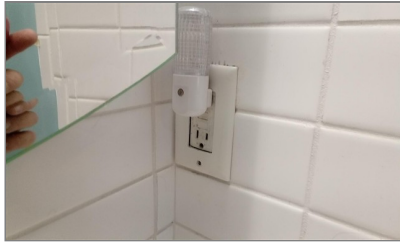
primary bathroom

31. (2) Loose outlets were noted throughout the home. Loose outlets can result in loose electrical connections which can increase the potential for a safety hazard and/or equipment failure. Consult with a qualified licensed contractor to evaluate the area(s) of concern and make any additional repairs as deemed necessary during their evaluation.

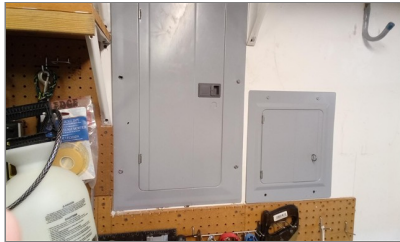
32. (3) There are missing screws at the electrical panel that need replacement to properly secure the electrical panel cover to the panel prevent access to the interior of the panel. Consult with a qualified licensed contractor to evaluate the area(s) of concern and make any additional repairs as deemed necessary during their evaluation.

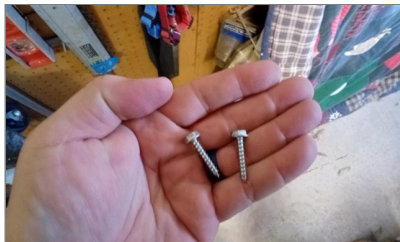
33. (4) There are pointed or tipped screws (wood screws) installed to secure the exterior cover of the electrical panel. Pointed or tipped screws may puncture the wiring installed in the panel and need to be replaced to flat/blunt tipped screws. Consult with a qualified licensed contractor to evaluate the area(s) of concern and make any additional repairs as deemed necessary during their evaluation.

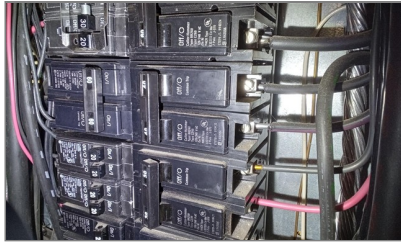
34. (5) The electrical system of this home has single strand aluminum wiring present on the lighting and receptacle branch circuits. As a result of documented fire hazards, the use of single strand aluminum wiring for lighting and receptacle branch circuits was discontinued in 1974 until material improvement could be made. Due to the concealed nature of the electrical components, the general condition of the system could not be determined during the home inspection. A licensed electrical contractor should be consulted for a complete evaluation of the electrical system to determine if repair, modification, or replacement is needed to ensure safe and reliable service. For more information on aluminum household wiring and recommended repair methods, refer to the C.P.S.C. booklet "Repairing Aluminum Wiring." The toll-free hotline number for obtaining this booklet is 1-800-638-2772, or you can visit: <https://www.cpsc.gov/s3fs-public/516.pdf>

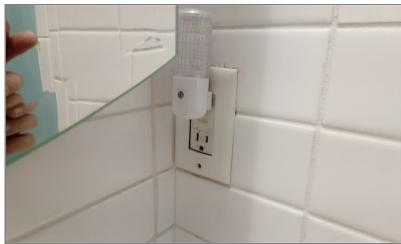
35. (6) There are GFCI's installed down stream of a main GFCI located in the primary bathroom. If the GFCI downstream trips the lead GFCI must be reset before the GFCI downstream can be reset. Consult with a qualified licensed contractor to evaluate the area(s) of concern and make any additional repairs as deemed necessary during their evaluation.

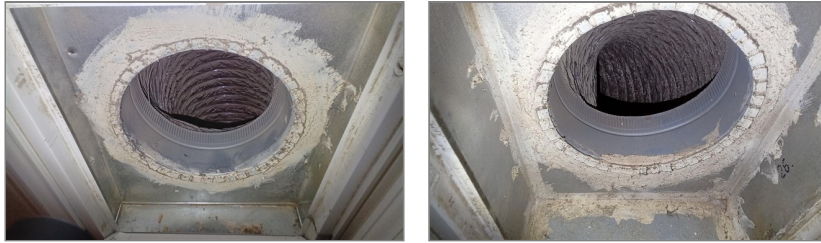
37. **There is dust and/or dirt noted inside the duct system** viewed from the air filter location. This may be an indication that the ducts are in need of cleaning to ensure efficiency of the unit(s).

Consult with a qualified licensed contractor to evaluate the area(s) of concern and make any additional repairs as deemed necessary during their evaluation.

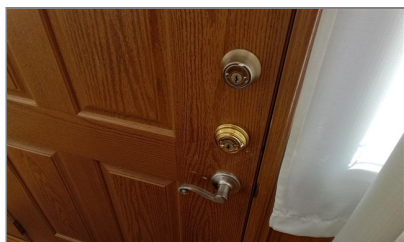
front door

40. (1) This home is equipped with multiple dead bolts that can only be opened from the interior with a key when locked. These types of dead bolts restrict easy access to the exterior of the home in the event of an emergency. It is recommended to replace the dead bolts with the type that can be easily opened from the interior of the home.

Consult with a qualified licensed contractor to evaluate the area(s) of concern and make any additional repairs as deemed necessary during their evaluation.

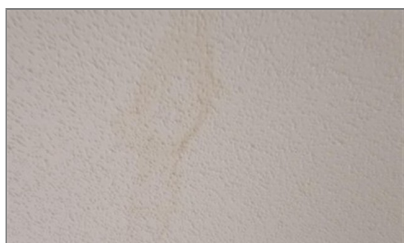
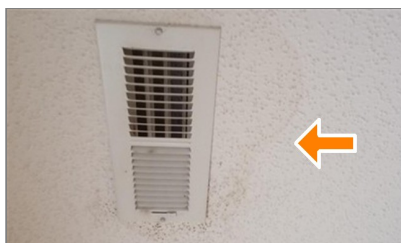
41. (2) Moisture staining/damage was noted on the ceiling in the basement. Unable to determine if an active leak exists at the time of inspection as the stains were dry relative to unaffected areas at the time of inspection. Moisture penetration/leakage into or within a home can result in moisture damage to the structure and adverse environmental conditions. Unable to determine if there is hidden or concealed damage that was not visible at the time of inspection. Ask the seller the history of the stains and if repairs have been made to correct any leaks that may have caused the stain. If the sellers are unaware of the stain or no repairs have been made then it should be treated as an active issue and further evaluation is needed by a licensed general contractor.

Consult with a qualified licensed contractor to evaluate the area(s) of concern and make any additional repairs as deemed necessary during their evaluation.

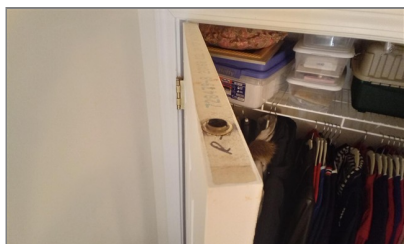
42. (3) The Drive-In Ball Catch w/ Strike Plate are missing at the top of the following doors: front bedroom door(s). Consult with a qualified licensed contractor to evaluate the area(s) of concern and make any additional repairs as deemed necessary during their evaluation.
