INSPECTION REPORT  
2339 Perry Rd.  
Denver NC 28037

INSPECTED BY  
Mike Sweeting  
(704)651-8190  
MikeS@hicarolina.com  
NC #5106

INSPECTION DATE  
📅 3/26/2025  
Home Inspection  
Carolina

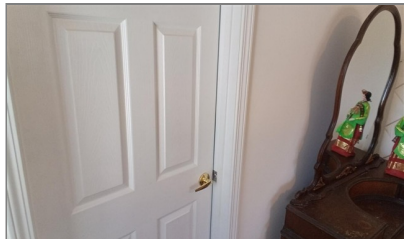
primary bathroom

43. (4) The following door(s) listed below rubbed at the frame/flooring and need adjustment and/or repair for the door(s) to open and close properly without rubbing: bathroom door(s), primary bedroom  
Consult with a qualified licensed contractor to evaluate the area(s) of concern and make any additional repairs as deemed necessary during their evaluation.

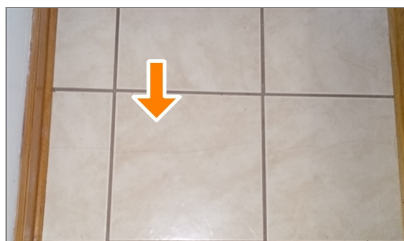
44. (5) There were cracked floor tile(s) noted in the following location(s): basement steps. Corrections are needed in order to prevent possible further damage.  
Consult with a qualified licensed contractor to evaluate the area(s) of concern and make any additional repairs as deemed necessary during their evaluation.

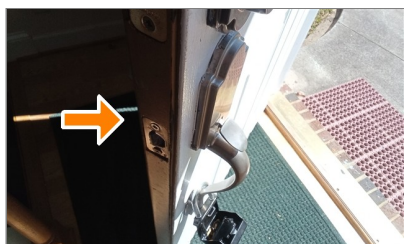
45. (6) The front door did not latch closed at the time of inspection. Corrections are needed so the door can function as intended. Have a qualified licensed contractor further evaluate and make the necessary repairs.  
Consult with a qualified licensed contractor to evaluate the area(s) of concern and make any additional repairs as deemed necessary during their evaluation.

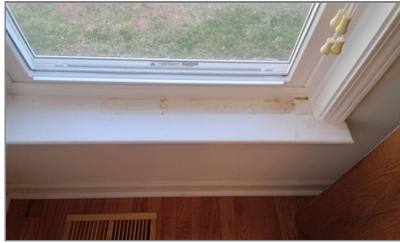
left rear bedroom

46. There is wood rot and/or water damage noted (but not limited to) the windows framing/casing around the windows at the following location(s) listed below. Repair and/or replacement is needed at the window or window framing to ensure that there is not any hidden or concealed damage that was otherwise unseen at the time of inspection.

Consult with a qualified licensed contractor to evaluate the area(s) of concern and make any additional repairs as deemed necessary during their evaluation.

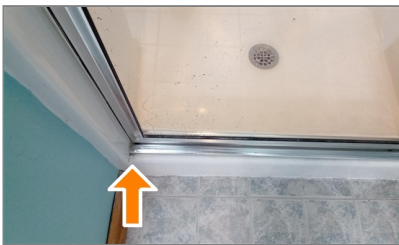
51. (1) The shower door leaks at the seal on the bottom. Corrections are needed in order to prevent possible further leaking or damage. Consult with a qualified licensed contractor to evaluate the area(s) of concern and make any additional repairs as deemed necessary during their evaluation.

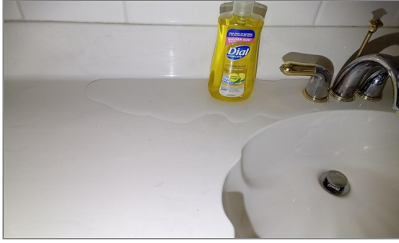
52. (2) There is a leak at the faucet or faucet handle that needs repairs or replacement to prevent possible further leaking.  
Consult with a qualified licensed contractor to evaluate the area(s) of concern and make any additional repairs as deemed necessary during their evaluation.

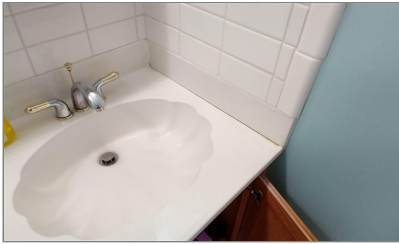
53. (3) Caulk is needed to fill the gaps where the sink countertop and backsplash meet to prevent water penetration. Consult with a qualified licensed contractor to evaluate the area(s) of concern and make any additional repairs as deemed necessary during their evaluation.

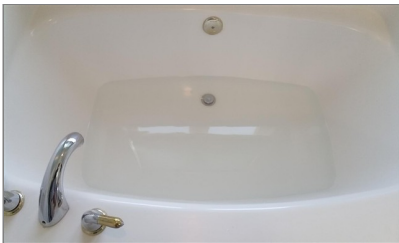
54. (4) The primary bathroom tub does not achieve functional drainage. This means that the tub will fill with water faster than it can drain water even when the stopper is not engaged. Consult with a qualified licensed contractor to evaluate the area(s) of concern and make any additional repairs as deemed necessary during their evaluation.

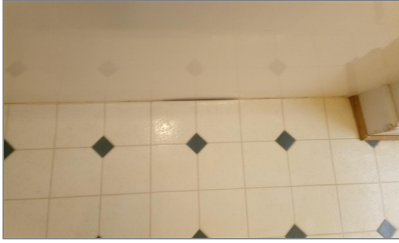
55. Caulk/grout is needed to seal the gaps where the upstairs hall bathroom tub and shower wall meet to prevent water penetration. Consult with a qualified licensed contractor to evaluate the area(s) of concern and make any additional repairs as deemed necessary during their evaluation.

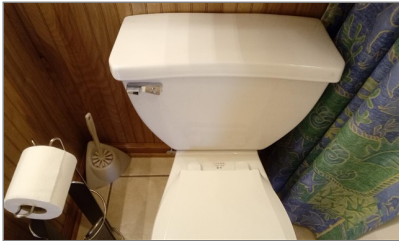
56. The tank is loose where it attaches to the base of the toilet and needs to be properly secured to prevent leakage. Consult with a qualified licensed contractor to evaluate the area(s) of concern and make any additional repairs as deemed necessary during their evaluation.

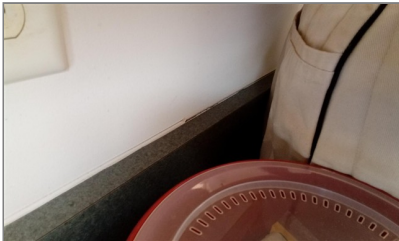
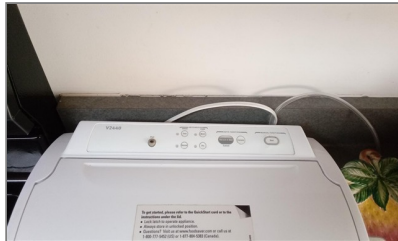
57. Sealant/Caulk is needed to prevent water penetration and seal the gap(s) where the countertop meets the backsplash around the entire kitchen. Consult with a qualified licensed contractor to evaluate the area(s) of concern and make any additional repairs as deemed necessary during their evaluation.
