INSPECTION REPORT  
392 Agnew Rd  
Mooreville NC

INSPECTED BY  
Alex Parr 3692  
Above Parr Home  
Inspections

INSPECTION DATE  
📅 8/15/2023  
🕒 02:00:00 PM

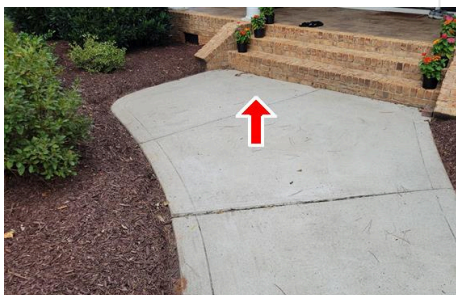
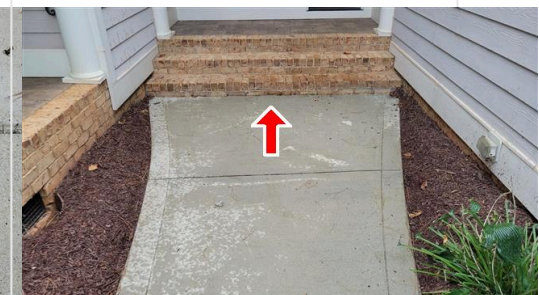
1. The sidewalks at the front of home has dropped or settled causing a steep or uneven step. Water can cause further deterioration if not repaired. This may allow for water intrusion to occur. Further investigation and repairs are needed.

A qualified person should repair or replace as needed.

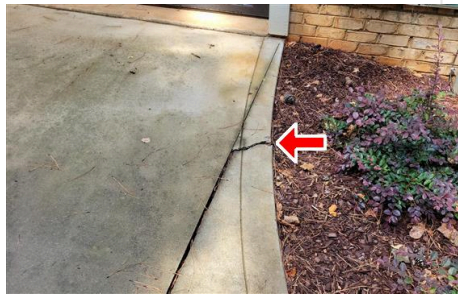
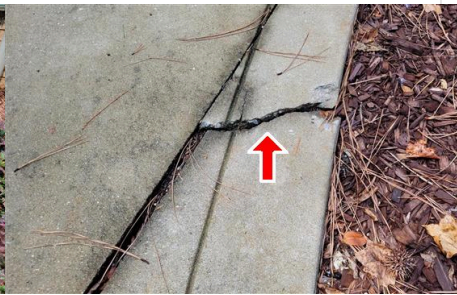
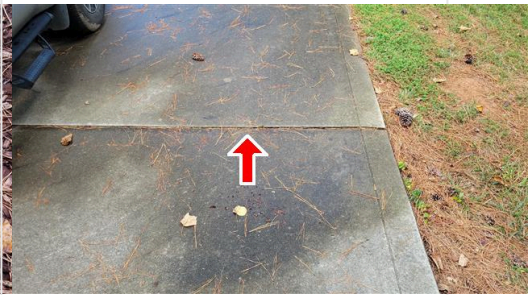
1. The concrete drive at the right side (facing front) uneven, and can be a tripping hazard. Water can cause further deterioration if not repaired and sealed properly. A fall or injury can occur if not corrected.

A qualified person should repair or replace as needed.

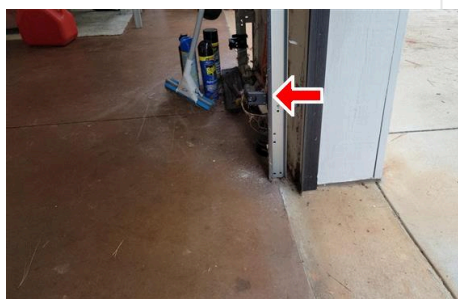
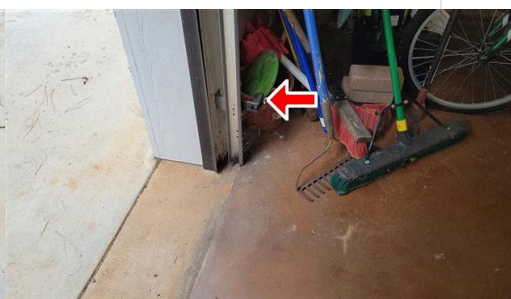
1. The two-door garage at the right side (facing front) has electronic sensors located higher than six inches off floor which may not be installed according to manufacturers specification. This is considered unsafe and needs correcting. A repair or replacement is needed.

A qualified person should repair or replace as needed.

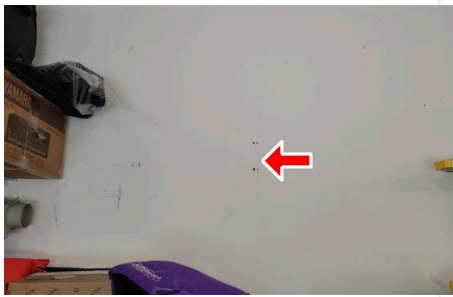
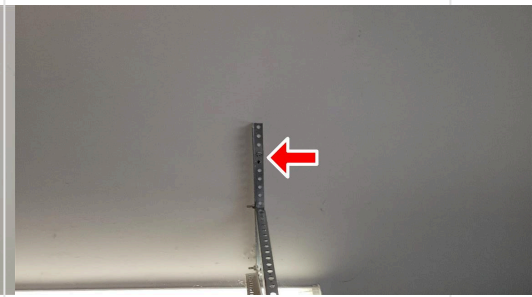
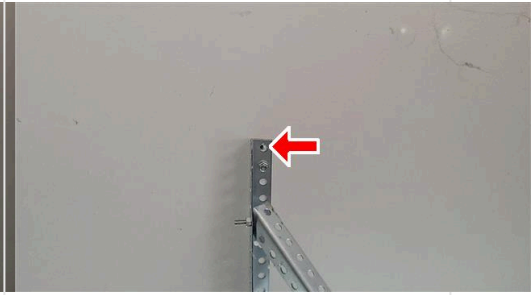
1. The fire resistance sheathing that separates garage from heated space is compromised. This is considered unsafe until corrected. Repairs are needed.

A qualified person should correct for safety.

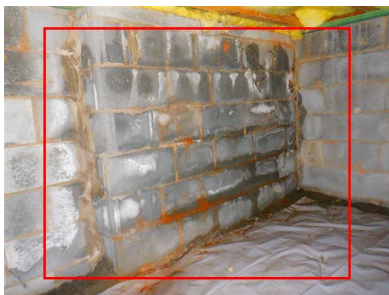
4.6 Item 1 (Picture)

1. Dark stains on the CMU (Concrete Masonry Unit) Indicated that water is inside the block. Dark stains and white efflorescence (powder substance) on block wall indicates moisture is in contact with the masonry. This does not necessarily indicate that intrusion will occur. Efflorescence is found on many homes without water intrusion occurring inside the home. But, it should alert you to the possibility that future steps may be needed. Further investigation and repairs are needed.

I recommend contact a licensed water intrusion specialist regarding these conditions.

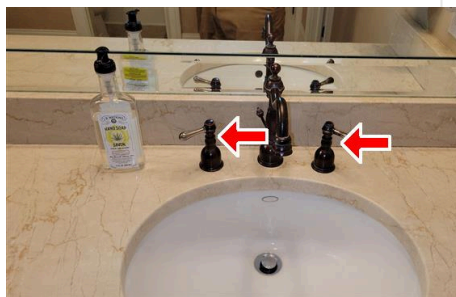
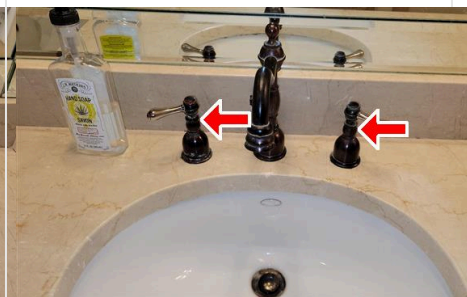
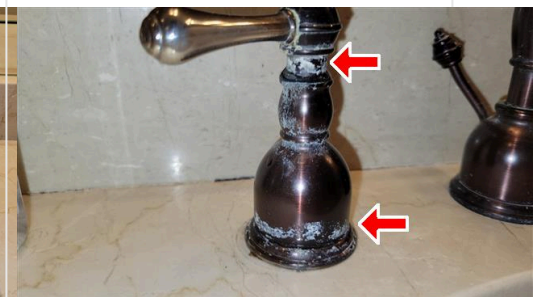
1. The control knob on faucet leaks and are difficult to operate throughout the home. Repairs are needed to prevent water damage from occurring to the home. Further investigation and repairs are needed.

I recommend a qualified licensed plumber repair or correct as needed.

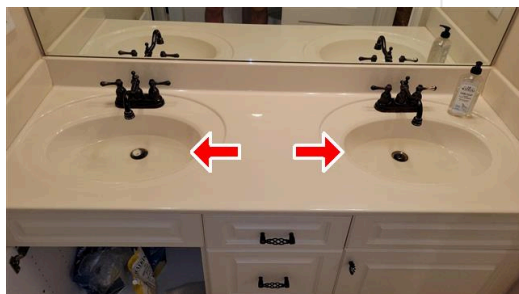
5.3 Item 1 (Picture)

1. The plumbing waste line drains slowly at the Guest Bath sink. A cause of a slow drain can range from a simple cleaning at stop valve or at the trap under sink. Sometimes the drain can be partially clogged down line. I am unable to determine the cause of the slow drain. Further investigation and repairs are needed..

A qualified licensed plumber should repair or correct as needed.

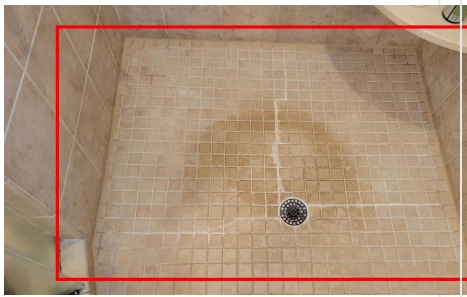
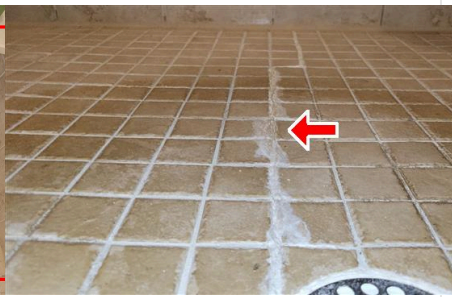
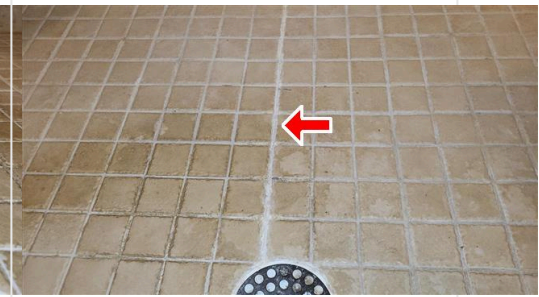
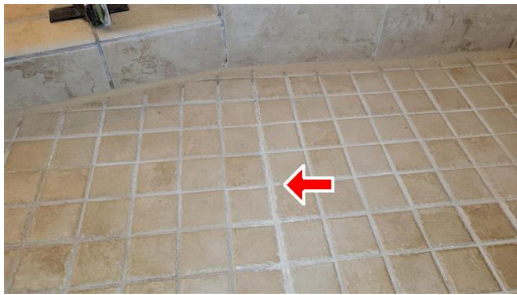
1. The master bath shower tile floor has evidence of repairs. This condition could allow water damage to occur to the home. Further investigation and repairs are needed.

I recommend contacting a licensed plumber.

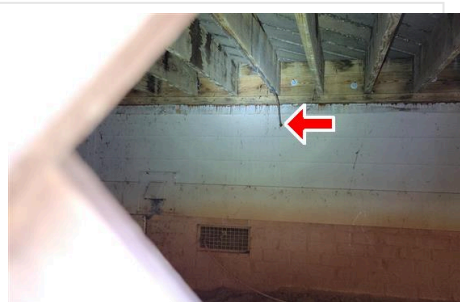
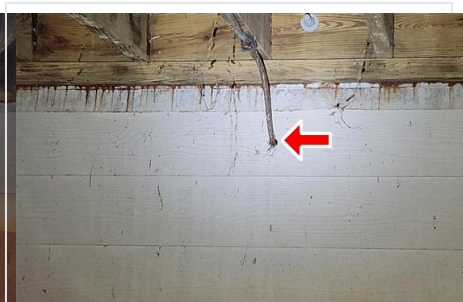
1. The gas line was installed improperly using soft copper through wall instead of hard piping at the rear of the home. This is a safety issue and should be repaired.

A qualified licensed HVAC (Heat/Ventilation/Air conditioning Contractor) should inspect further and repair as needed

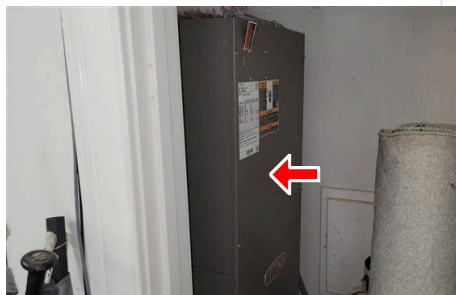
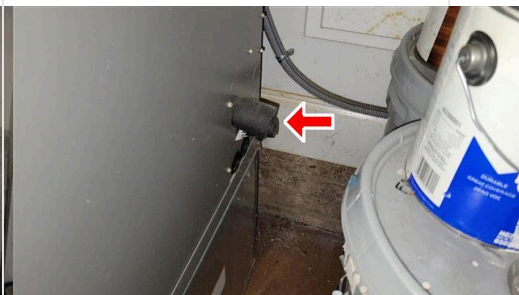
1. The heater in the garage was unable to be tested due to the temperature. This is an inspection limitation and for information.

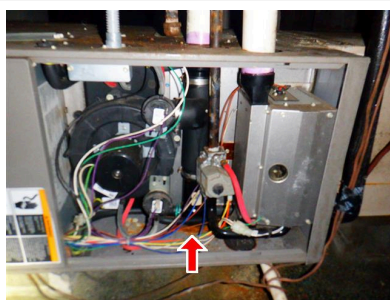
7.0 Item 3 (Picture)

1. The gas furnace has rust inside the unit in the crawl space. This can cause damage to the unit or shorten its life span. Further investigation and repairs are needed.

I recommend a qualified licensed contractor inspect further and repair as needed.

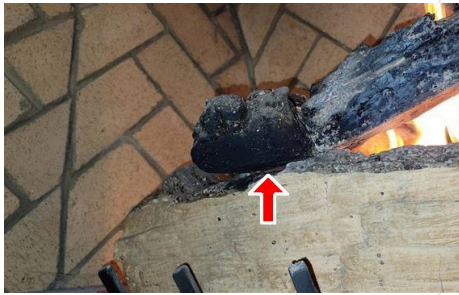
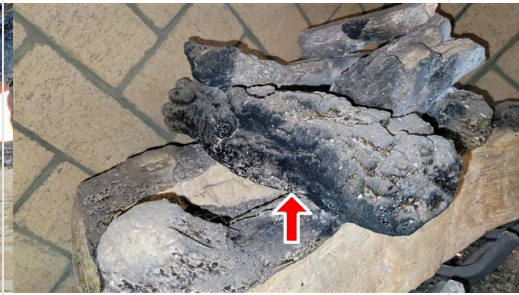
1. The black soot build-up indicates that Gas Fire logs do not appear to be arranged or positioned according to manufacturer's specs. If logs are not positioned correctly, carbon monoxide can be produced. Further investigation and repairs are needed.

A qualified licensed HVAC (Heat/Ventilation/Air conditioning Contractor) should inspect further and repair as

needed.

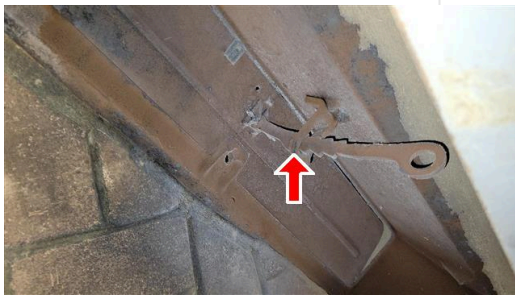
7.7 Item 3 (Picture)

1. The damper arm and linkage for vented fire logs at the Living room is missing a clamp or lock that forces lid to stay open (required for Vented Gas/LP logs). Without a clamp to force open the damper, it could shut and cause unsafe carbon dioxide to enter into living space. Repair are needed.

A qualified licensed HVAC (Heat/Ventilation/Air conditioning Contractor) should inspect further and repair as needed.

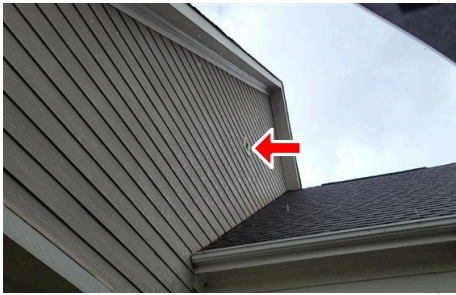
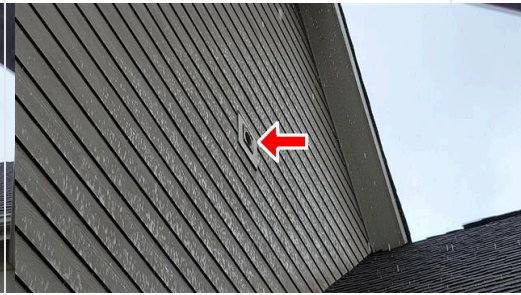
1. The Exhaust fan has a damaged vent cover outside at the upstairs bath. This may allow insects or critters to enter home. Repairs are needed.

A qualified person should repair or replace as needed.

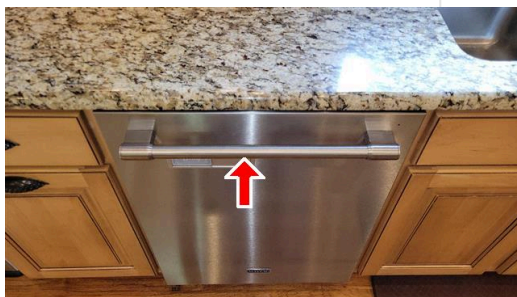
10.0 Item 1 (Picture)

1. The dishwasher handle is loose. I recommend repair as necessary.

I recommend contacting appliance repair company.

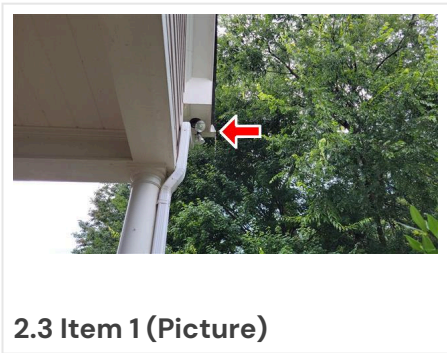
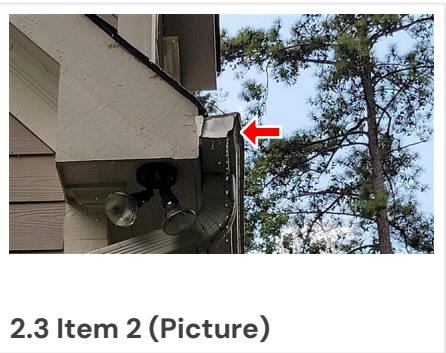
- (1)
1. The gutter is damaged at the front (left of main entry). Erosion can continue or become worse if not corrected possibly leading to water intrusion. Repairs are needed.

A qualified person should repair or replace as needed.

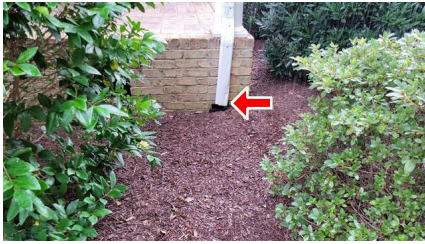
2.3 Item 3 (Picture)

- (2)
1. The downspout needs reconnecting to existing drain line at the front (left of main entry). Erosion

can continue or become worse if not corrected possibly leading to water intrusion. Repairs are needed.

A qualified person should repair or replace as needed.

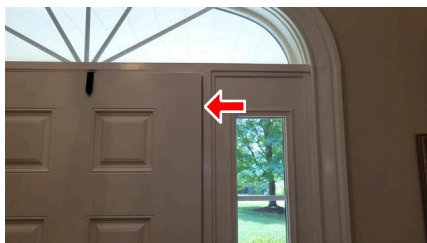
3.3 Item 1 (Picture)

1. The main entry door rubs at jamb when closing. As a result the door will not close properly. Repairs are needed.

A qualified person should repair or replace as needed.

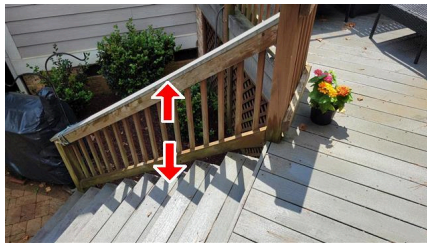
3.4 Item 1 (Picture)

1. The guardrails on deck at the rear of home are lower than 36 inches from deck floor. A fall or injury

could occur if not corrected. A repair or replacement is needed.  
A qualified contractor should repair or replace as needed.

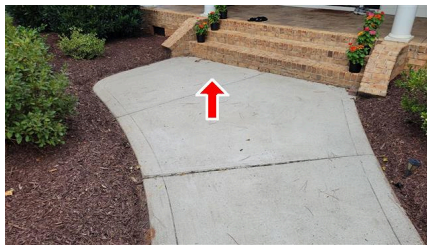
3.5 Item 1 (Picture)

1. The sidewalks at the front of home has dropped or settled causing a steep or uneven step. Water can cause further deterioration if not repaired. This may allow for water intrusion to occur. Further investigation and repairs are needed.

A qualified person should repair or replace as needed.

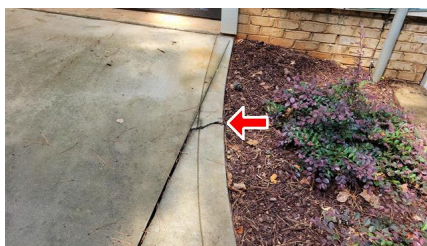
3.5 Item 4 (Picture)

1. The concrete drive at the right side (facing front) uneven, and can be a tripping hazard. Water can cause further deterioration if not repaired and sealed properly. A fall or injury can occur if not corrected.

A qualified person should repair or replace as needed.

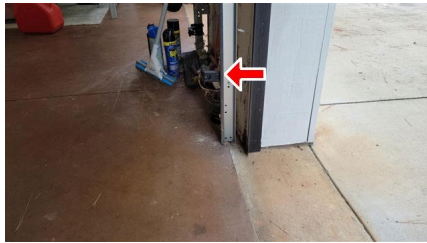
3.6 Item 1 (Picture)

1. The two-door garage at the right side (facing front) has electronic sensors located higher than six inches off floor which may not be installed according to manufacturers specification. This is considered unsafe and needs correcting. A repair or replacement is needed.

A qualified person should repair or replace as needed.

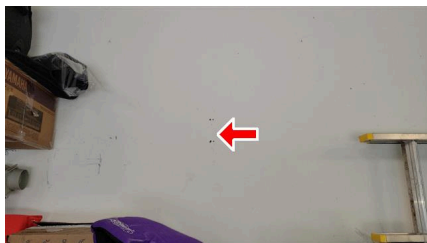
3.8 Item 1 (Picture)

1. The fire resistance sheathing that separates garage from heated space is compromised. This is considered unsafe until corrected. Repairs are needed.

A qualified person should correct for safety.

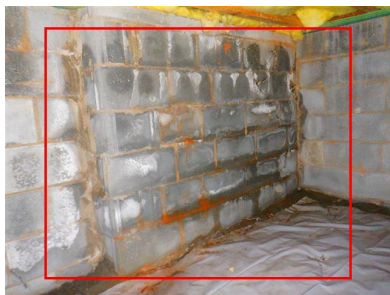
**4.6 Item 1 (Picture)**

1. Dark stains on the CMU (Concrete Masonry Unit) indicated that water is inside the block. Dark stains and white efflorescence (powder substance) on block wall indicates moisture is in contact with the masonry. This does not necessarily indicate that intrusion will occur. Efflorescence is found on many homes without water intrusion occurring inside the home. But, it should alert you to the possibility that future steps may be needed. Further investigation and repairs are needed.

I recommend contact a licensed water intrusion specialist regarding these conditions.

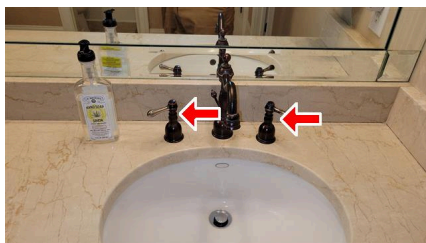
5.2 Item 1 (Picture)

1. The control knob on faucet leaks and are difficult to operate throughout the home. Repairs are needed to prevent water damage from occurring to the home. Further investigation and repairs are needed.

I recommend a qualified licensed plumber repair or correct as needed.

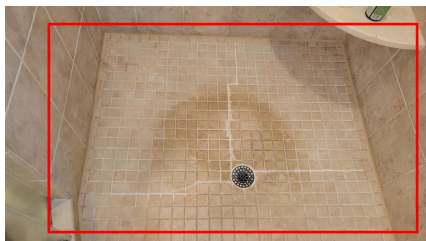
5.4 Item 1 (Picture)

1. The master bath shower tile floor has evidence of repairs. This condition could allow water damage to occur to the home. Further investigation and repairs are needed.

I recommend contacting a licensed plumber.

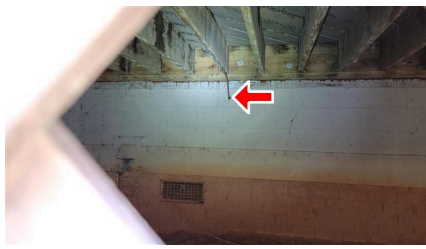
5.5 Item 1 (Picture)

1. The gas line was installed improperly using soft copper through wall instead of hard piping at the rear of the home. This is a safety issue and should be repaired.

A qualified licensed HVAC (Heat/Ventilation/Air conditioning Contractor) should inspect further and repair as needed

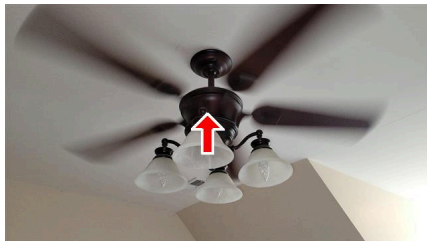
6.4 Item 1 (Picture)

1. The ceiling fan does work, but "wobbles" in the Guest bedroom. Some fans that wobble cannot be corrected without replacement. Repairs are needed.

A qualified licensed electrical contractor should correct as needed.

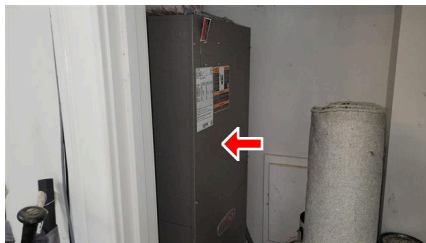
7.0 Item 1 (Picture)

1. The heater in the garage was unable to be tested due to the temperature. This is an inspection limitation and for information.

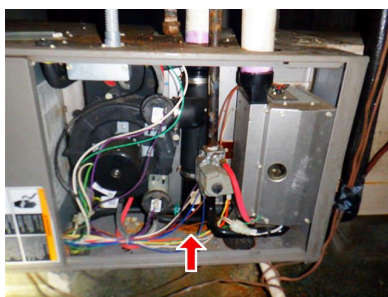
7.0 Item 3 (Picture)

1. The gas furnace has rust inside the unit in the crawl space. This can cause damage to the unit or shorten its life span. Further investigation and repairs are needed.

I recommend a qualified licensed contractor inspect further and repair as needed.

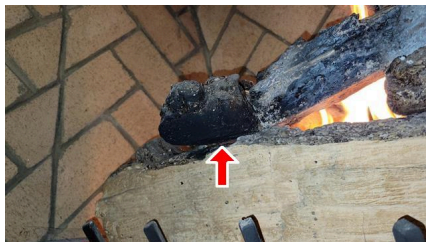
7.7 Item 1 (Picture)

1. The black soot build-up indicates that Gas Fire logs do not appear to be arranged or positioned according to manufacturer's specs. If logs are not positioned correctly, carbon monoxide can be produced. Further investigation and repairs are needed.

A qualified licensed HVAC (Heat/Ventilation/Air conditioning Contractor) should inspect further and repair as needed.

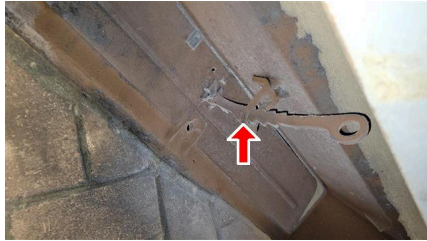
7.7 Item 3 (Picture)

1. The damper arm and linkage for vented fire logs at the Living room is missing a clamp or lock that forces lid to stay open (required for Vented Gas/LP logs). Without a clamp to force open the damper, it could shut and cause unsafe carbon dioxide to enter into living space. Repair are needed.

A qualified licensed HVAC (Heat/Ventilation/Air conditioning Contractor) should inspect further and repair as needed.

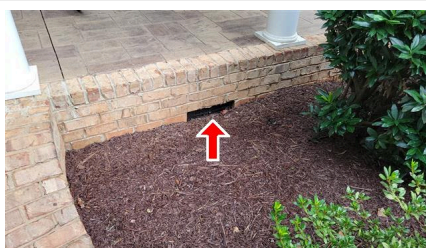
9.1 Item 1 (Picture)

1. The foundation vent(s) are below ground level at exterior which can allow water to enter crawlspace. A half-round window well should be installed. The dirt inside well should be replaced with approximately four inches of gravel. A couple of inches clearance between gravel and vent opening recommended.

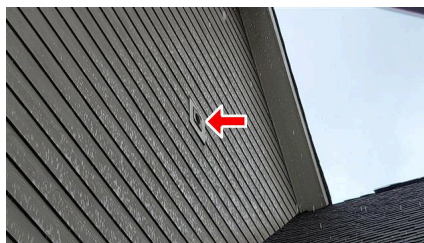
9.5 Item 2 (Picture)

1. The Exhaust fan has a damaged vent cover outside at the upstairs bath. This may allow insects or critters to enter home. Repairs are needed.

A qualified person should repair or replace as needed.
