INSPECTION REPORT  
398 Catalina Dr  
Mooresville NC 28117

INSPECTED BY  
Alex Parr 3692  
Above Parr Home  
Inspections

INSPECTION DATE  
📅 2/2/2023  
🕒 09:00:00 AM

Inspection Date: 2/2/2023  
Report ID: 020223AP1

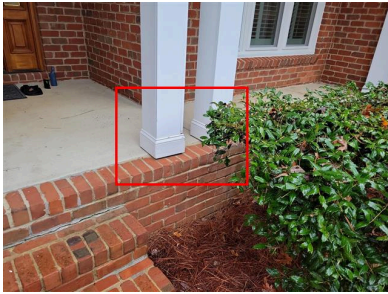
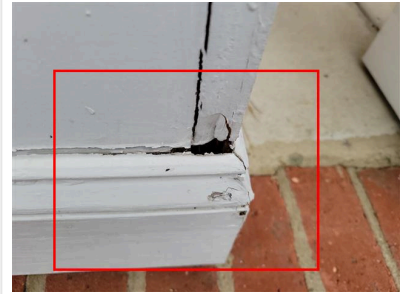
1. The wood trim at the front of home is deteriorated. Further deterioration can occur if not corrected.

Repairs are needed.

A qualified person should repair or replace as needed.

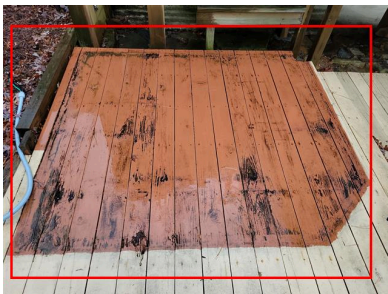
3.4 Item 1 (Picture)

1. The deck floor on the deck at the rear of home is deteriorated. Further deterioration can occur if not repaired. A fall or injury can occur if not corrected. Repairs are needed.

A qualified contractor should repair or replace as needed.

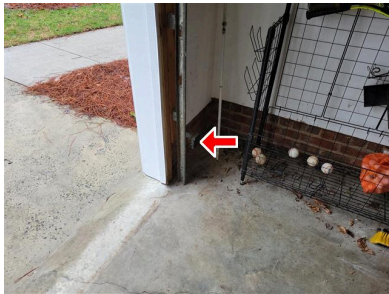
3.7 Item 1 (Picture)

1. The automatic opener for two-door garage at the front of home has electronic sensors located higher than six inches off floor which may not be installed according to manufacturers specification. This is considered unsafe and needs correcting. Repairs are needed.

A qualified person should repair or replace as needed.

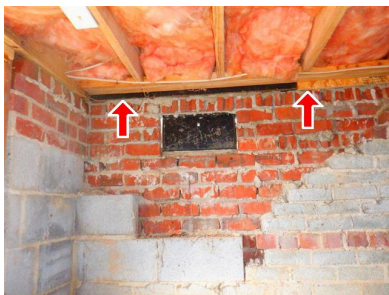
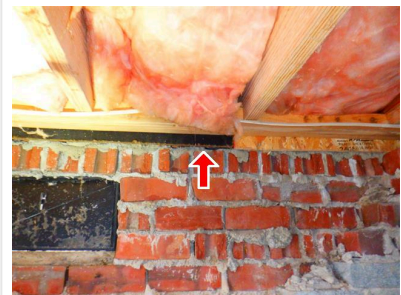
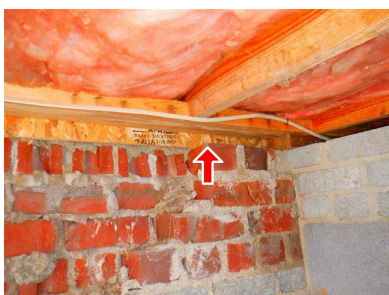
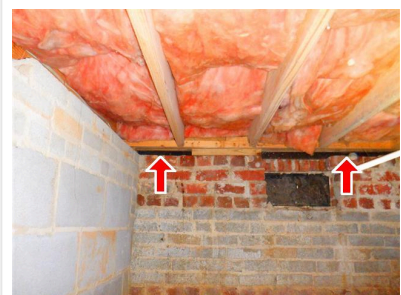
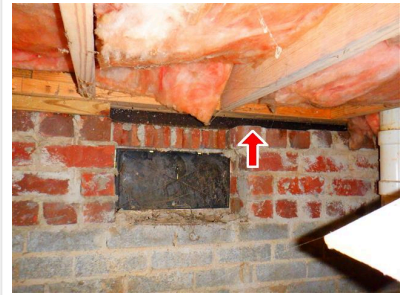
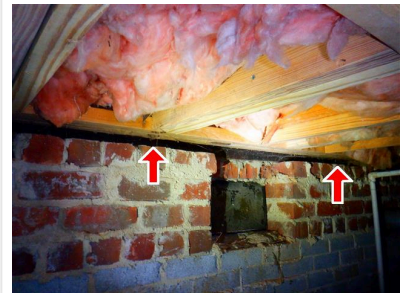
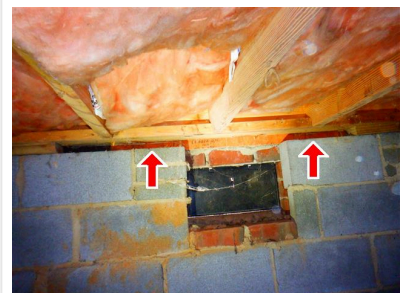
1. The floors system in the crawlspace is improperly supported. This could allow for movement or failure of the floor system. This is not typical construction. I recommend having a qualified structural engineer evaluate the support of the floor system and the attachment of the floor system to the foundation. Further investigation and repairs are needed.

A qualified engineer should inspect and repair or replace as needed.

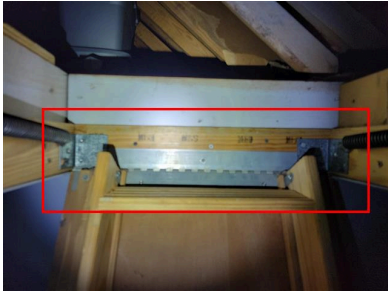
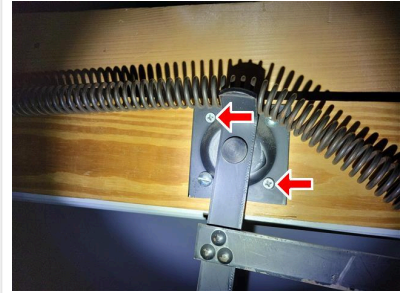
1. The pull down stairs for the attic is installed with deck screws. The only approved means of securing attic stairs is a 16 penny nail per manufacture. An injury could occur if not corrected. Repairs are needed.

A qualified person should repair or replace as needed.

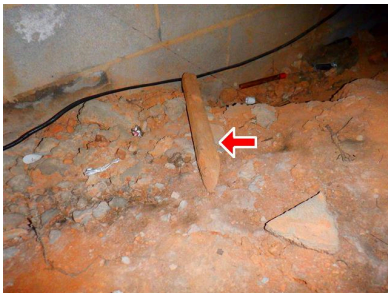
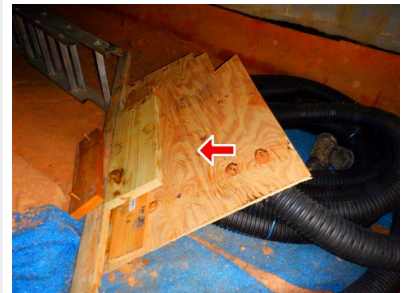
1. Wood debris is in contact with the crawl space floor in numerous areas. This can attract wood destroying organisms. Removal is needed.

A qualified contractor should inspect and repair as needed.

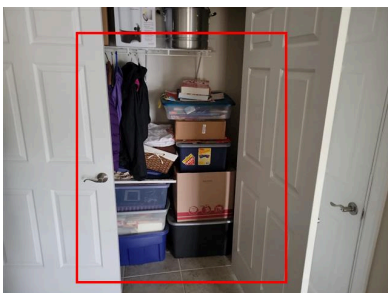
5.7 Item 1 (Picture)

1. Could not gain access to the sump pump was blocked by personal items. This is an inspection limitation and for your information.

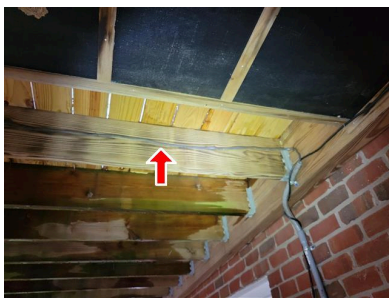
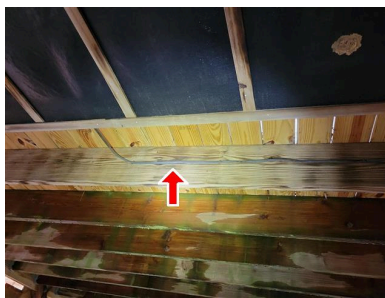
1. Exposed electrical wires were present at the exterior of the home. Even though standard NM cable has a vinyl outer jacket and waterproof insulation around the individual conducting wires, it is not intended for use in outdoor locations. Exposed or buried wiring must be listed for this application. Evidence suggests that the current wiring is not allowed for safety reasons. Further investigation and repairs are needed.

A qualified licensed electrical contractor should correct as needed.

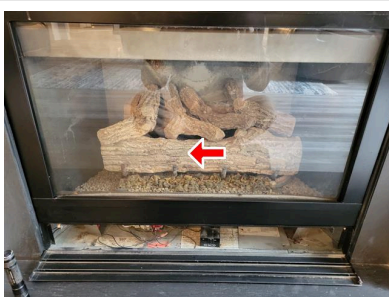
7.7 Item 1 (Picture)

1. The vented fire logs in the living room is not operable (pilot would not ignite). Repairs should be made so unit works properly. Repairs are needed.

A qualified licensed HVAC (Heat/Ventilation/Air conditioning Contractor) should inspect further and repair as needed.

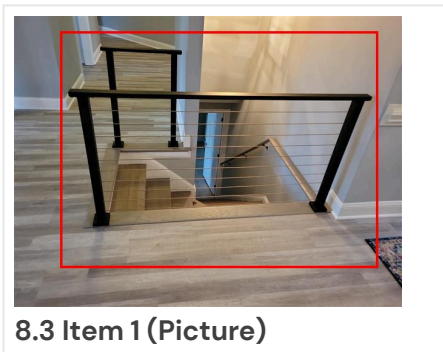
8.3 Item 1 (Picture)

1. The hand/guard rail for the upstairs are climbable. A fall or injury could occur if not corrected A repair or replacement is needed.

A qualified contractor should repair or replace as needed.

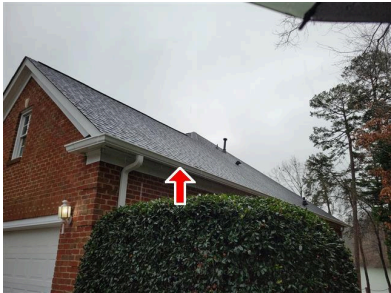
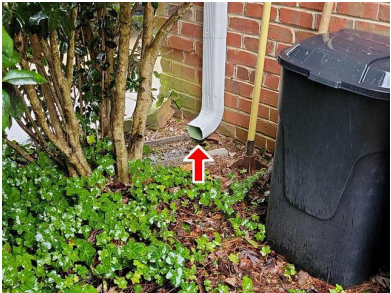
1. The gutter is clogged at the front right corner of home. Erosion can continue or become worse if not corrected possibly leading to water intrusion. Repairs are needed.

A qualified person should repair or replace as needed.

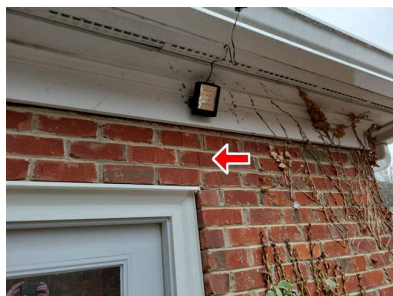
3.0 Item 1 (Picture)

1. I observed small cracks in the brick veneer at the rear of home. These are typical in nature due to age and normal masonry shrinkage. Although the cracks in the brick veneer are typical, these areas should be re sealed to prevent any water penetration or damage. Further evaluation by a qualified masonry contractor is recommended for this entire condition.

I recommend repair or replace using a qualified contractor.

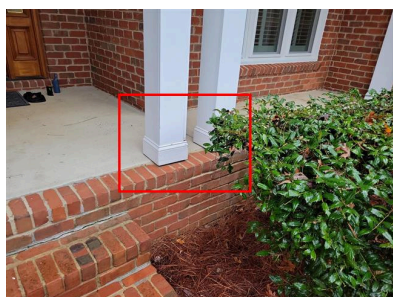
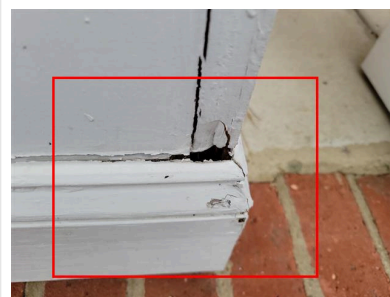
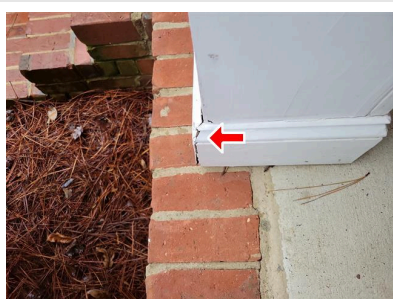
1. The wood trim at the front of home is deteriorated. Further deterioration can occur if not corrected. Repairs are needed.

A qualified person should repair or replace as needed.

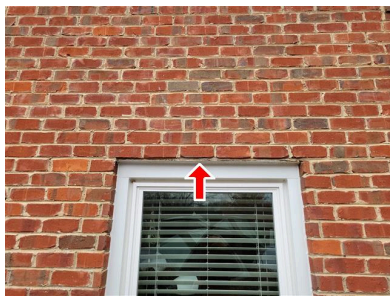
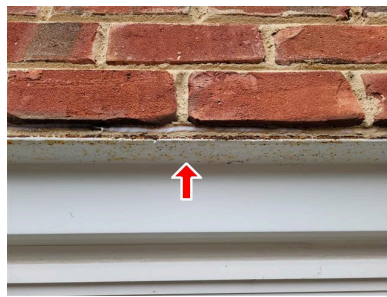
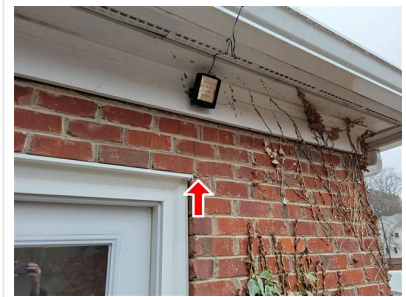
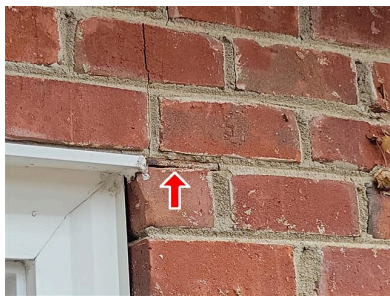
1. The steel lintels around the exterior of the home are beginning to rust or have rust present. A lintel is

a horizontal architectural member or steel beam support placed over a wall opening to carry the weight of the masonry placed over it. In most situations, the lintel above windows and doors will be steel angle iron or I beam. Either due to age or improper rust proofing or weep chord and flashing placement during installation, lintels will begin to rust. Rusting lintels can expand to become much thicker than their original size. The expansive forces of rusting steel can shift entire multi-story elevations. If your lintels are currently rusting, a telltale sign of expansion is diagonal "step" pattern cracks, which can be found on either end of the window or door opening. Repairs are needed to prevent further damage to the structure. Further deterioration may occur if not repaired.

I recommend a qualified contractor inspect and repair as needed.

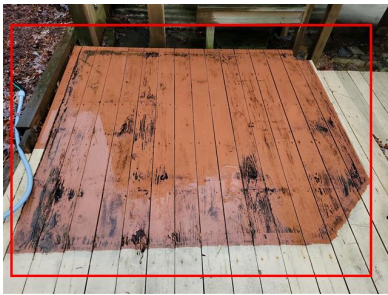
3.4 Item 1 (Picture)

1. The deck floor on the deck at the rear of home is deteriorated. Further deterioration can occur if not repaired. A fall or injury can occur if not corrected. Repairs are needed.

A qualified contractor should repair or replace as needed.

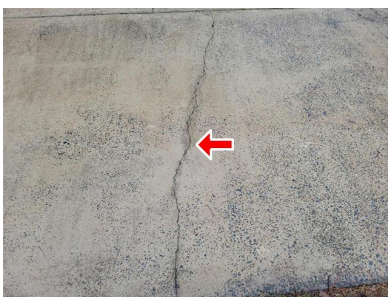
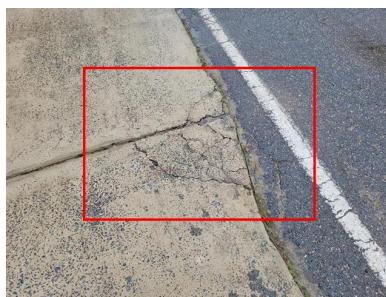
1. The concrete driveway has cracks that should be sealed to prevent further damage, which is part of ongoing maintenance of a concrete driveway that will need to be performed on a regular basis. Repairs are recommended.

A qualified contractor should inspect and repair as needed.

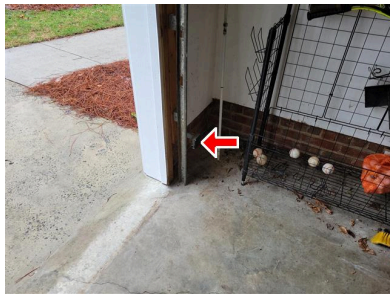
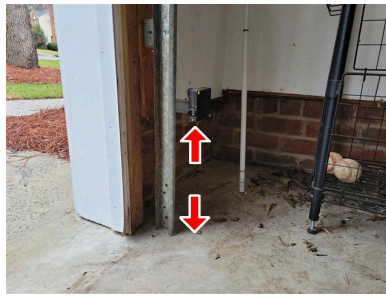
This is considered unsafe and needs correcting. Repairs are needed.

A qualified person should repair or replace as needed.

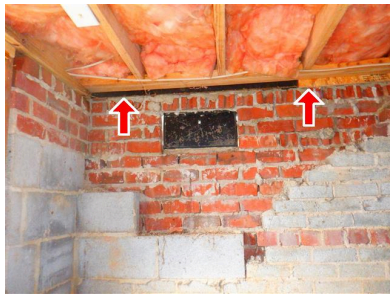
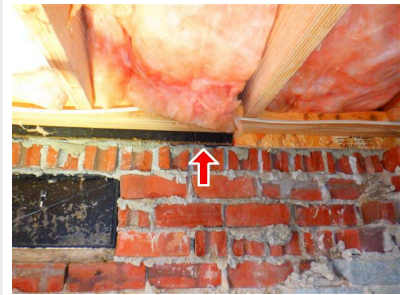
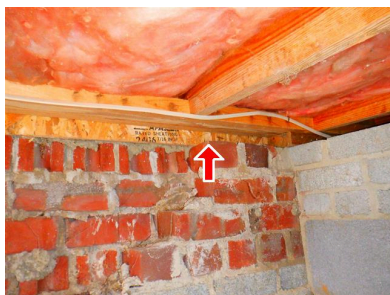
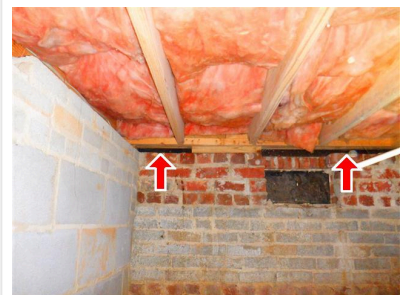
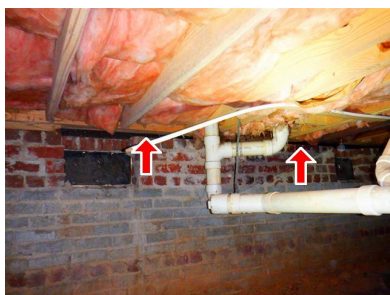
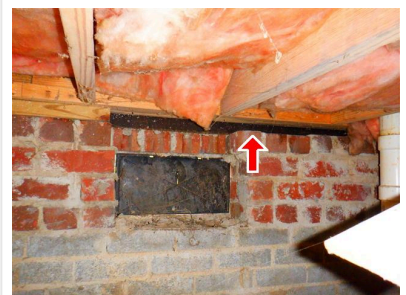
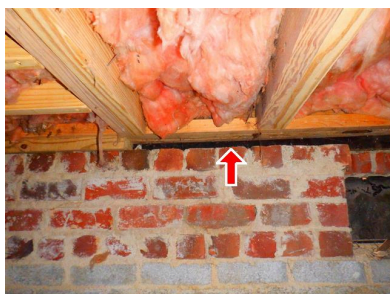
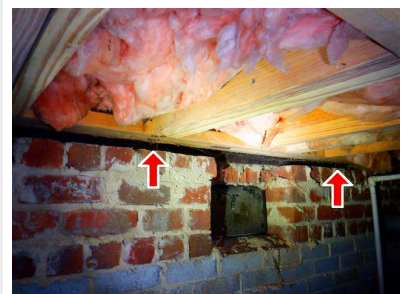
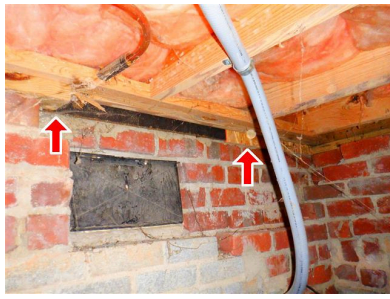
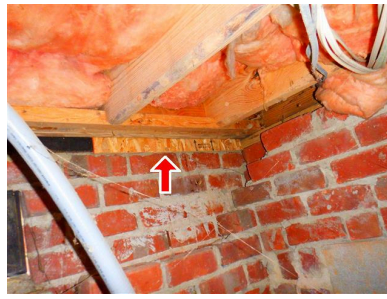
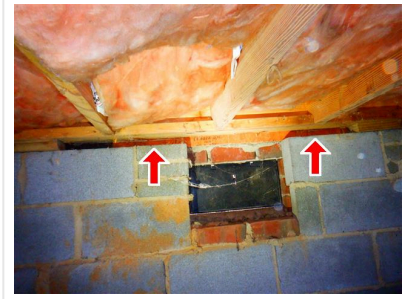
1. The floors system in the crawlspace is improperly supported. This could allow for movement or failure of the floor system. This is not typical construction. I recommend having a qualified structural engineer evaluate the support of the floor system and the attachment of the floor system to the foundation. Further investigation and repairs are needed.

A qualified engineer should inspect and repair or replace as needed.

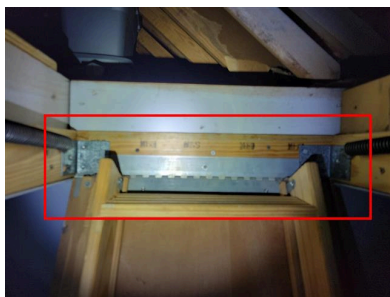
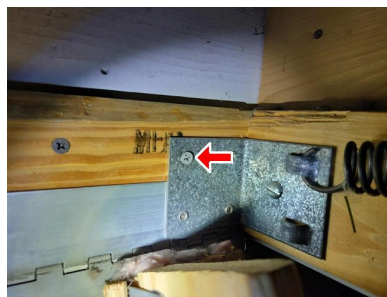
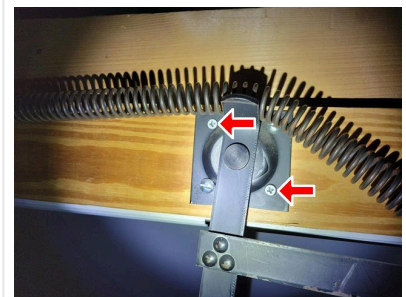
1. The pull down stairs for the attic is installed with deck screws. The only approved means of securing attic stairs is a 16 penny nail per manufacture. An injury could occur if not corrected. Repairs are needed.

A qualified person should repair or replace as needed.

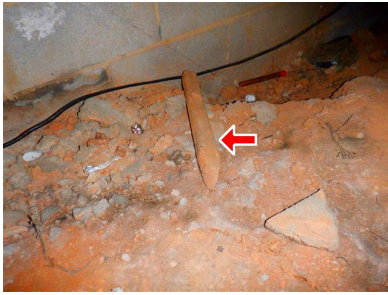
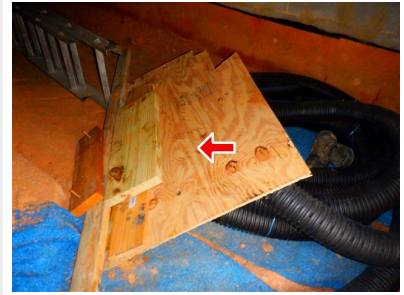
1. Wood debris is in contact with the crawl space floor in numerous areas. This can attract wood destroying organisms. Removal is needed.

A qualified contractor should inspect and repair as needed.

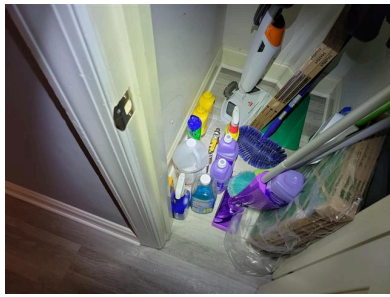
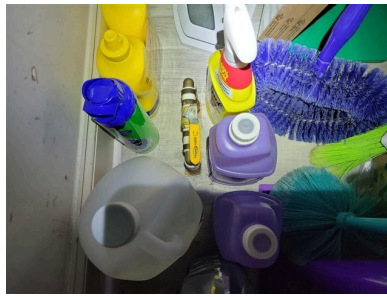
The main shut off is the yellow lever located entry code closet. This is for your information.

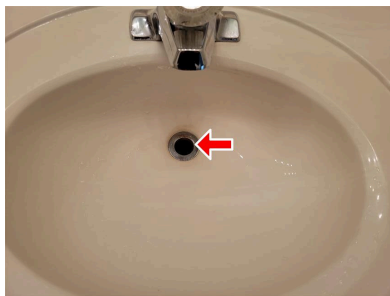
5.3 Item 1 (Picture)

1. The stop-valve strainer is missing at the Guest Bath sink. Repairs are needed. A qualified licensed plumber should repair or correct as needed.

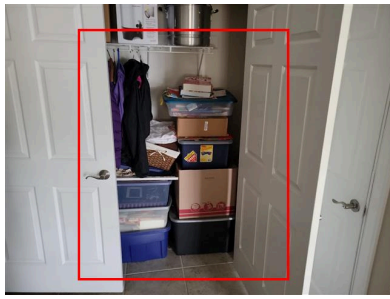
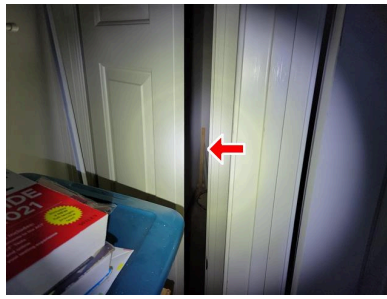
1. Could not gain access to the sump pump was blocked by personal items. This is an inspection limitation and for your information.

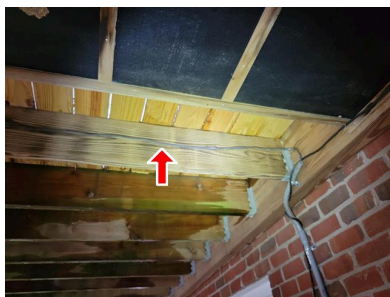
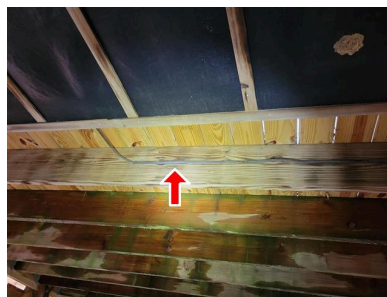
1. Exposed electrical wires were present at the exterior of the home. Even though standard NM cable has a vinyl outer jacket and waterproof insulation around the individual conducting wires, it is not intended for use in outdoor locations. Exposed or buried wiring must be listed for this application. Evidence suggests that the current wiring is not allowed for safety reasons. Further investigation and repairs are needed.

A qualified licensed electrical contractor should correct as needed.

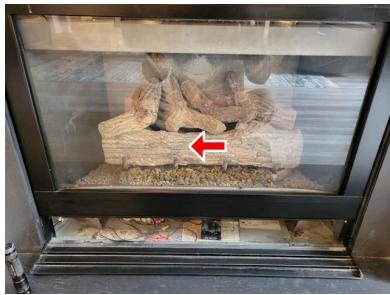
7.7 Item 1 (Picture)

1. The vented fire logs in the living room is not operable (pilot would not ignite). Repairs should be made so unit works properly. Repairs are needed.

A qualified licensed HVAC (Heat/Ventilation/Air conditioning Contractor) should inspect further and repair as needed.

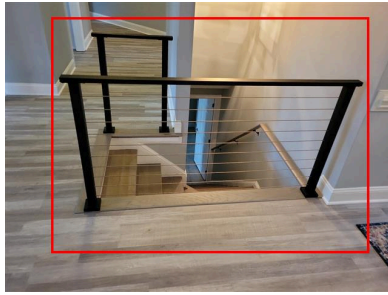
8.3 Item 1 (Picture)

1. The hand/guard rail for the upstairs are climbable. A fall or injury could occur if not corrected A repair or replacement is needed.

A qualified contractor should repair or replace as needed.

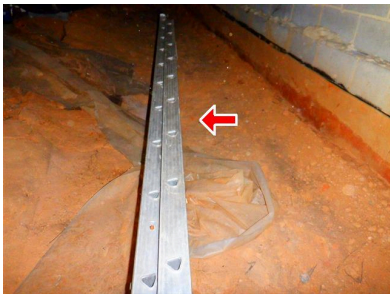
9.0 Item 1 (Picture)

1. The vapor barrier (plastic) on the crawlspace ground is missing in areas. A vapor barrier provides added protection to the floor system from moisture or dampness that can enter from ground.  
Repairs are needed.

A qualified person should repair or replace as needed.

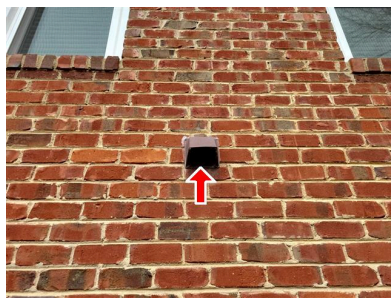
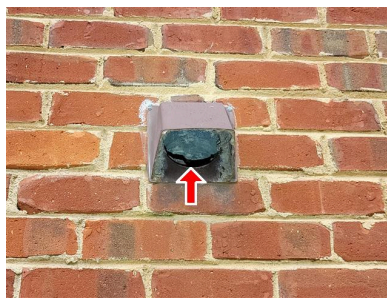
1. The dryer vent hood is damaged outside. Rodents, reptiles or insects could enter into crawlspace. I recommend repair as needed.

A qualified person should repair or replace as needed.
