INSPECTION REPORT  
825 W Stokes St  
China Grove NC 28023

INSPECTED BY  
Alex Parr 3692  
Above Parr Home  
Inspections

INSPECTION DATE  
📅 3/29/2023  
🕒 09:00:00 AM

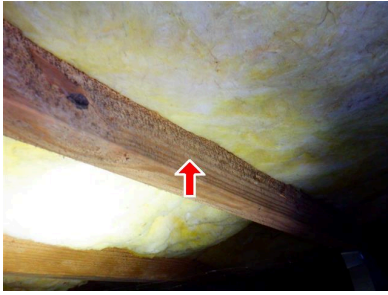
1.0 Item 1 (Picture)

1. Discoloration and some type of mold (Microbial) growth is present in the structure at several areas including but not limited to the crawl space and interior spaces. Evidence suggests that this condition is from a past or present elevated moisture conditions. We did not inspect, test or determine if this type of substance is or is not a health hazard. Further investigation is needed.

We recommend you contact a properly licensed expert for testing, investigation and or correction as deemed appropriate.

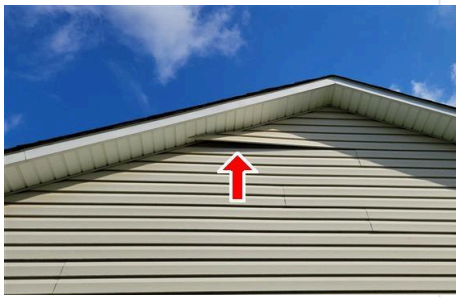
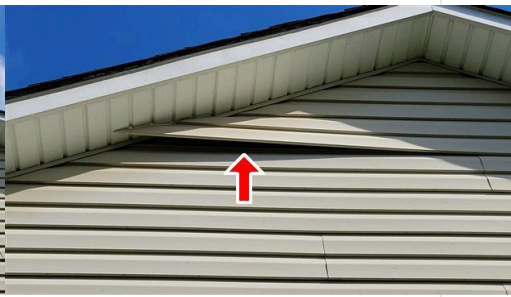
1. The Vinyl siding at the left side (facing front) is loose. Deterioration can eventually occur if not corrected. Repairs are needed.

A qualified person should repair or replace as needed.

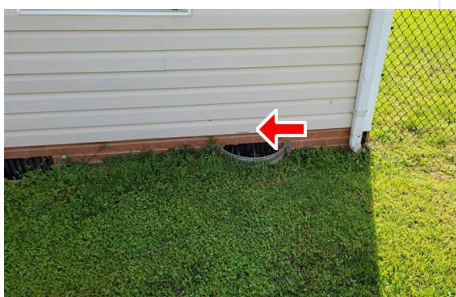
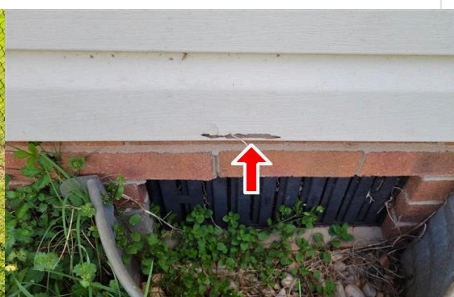
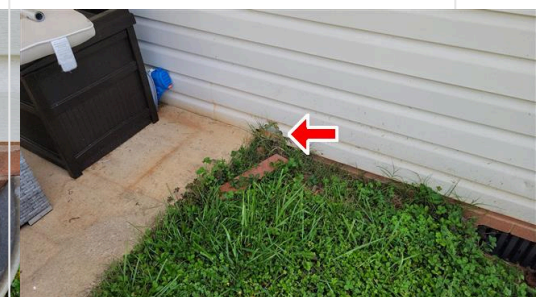
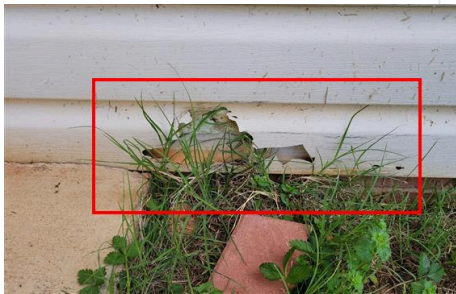
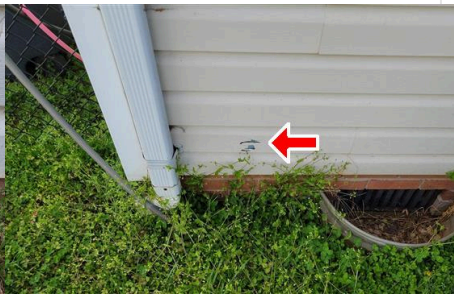
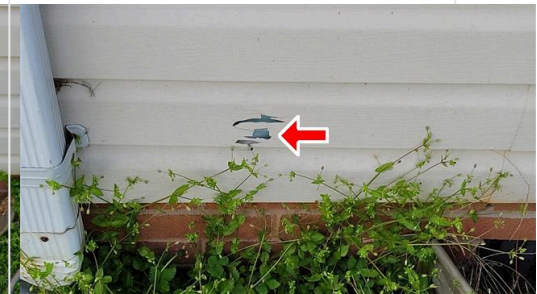
1. The Vinyl siding at the exterior in areas is damaged. This could allow water damage to occur to the home. Repairs are needed.

A qualified person should repair or replace as needed.

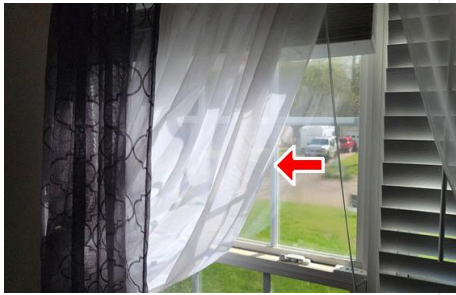
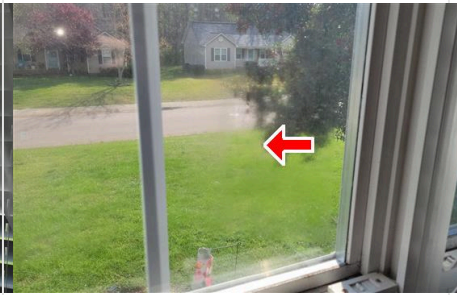
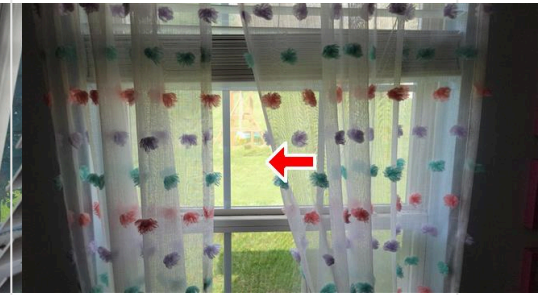
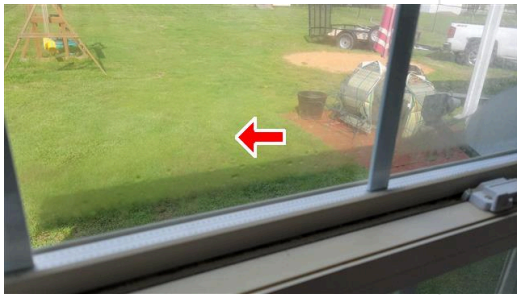
1. Several windows have failed/compromised thermal seals/fogged window panes. This is indicated by the visible moisture, discoloration, calcium deposits and or crystallization visible between the glass window panes. A certified window technician should recheck all the windows throughout the home. Due to weather conditions many times compromised/failed windows cannot be identified at the time of inspection. Further investigation and repairs are needed.

We recommend contacting a properly licensed window technician/contractor regarding these conditions and have repairs made deemed appropriate

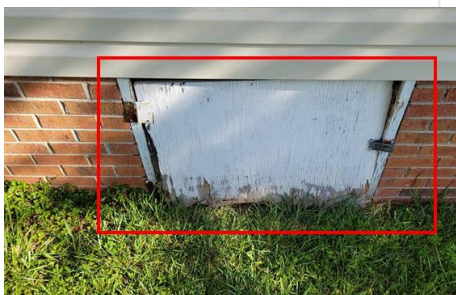
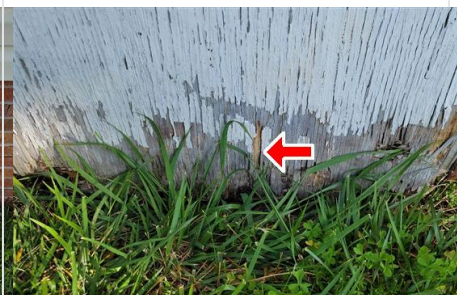
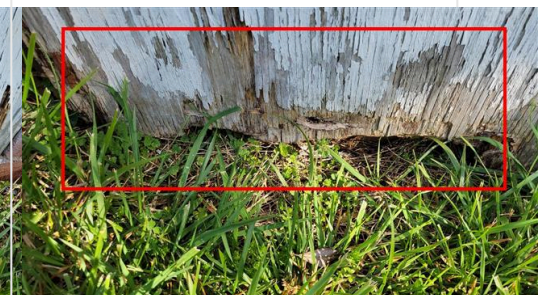
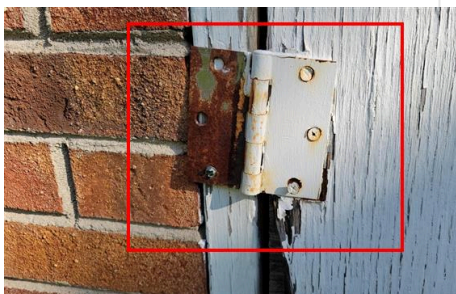
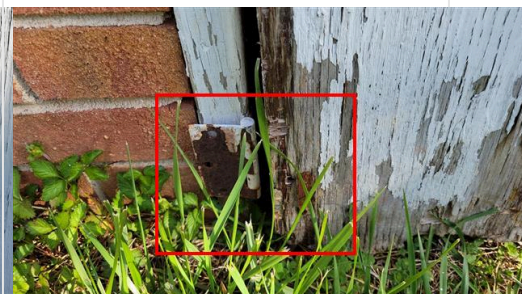
1. The access door to the crawlspace is deteriorated and has damaged hinges. Therefore the door does not function as intended. I recommend repair as needed.

A qualified person should repair or replace as needed.

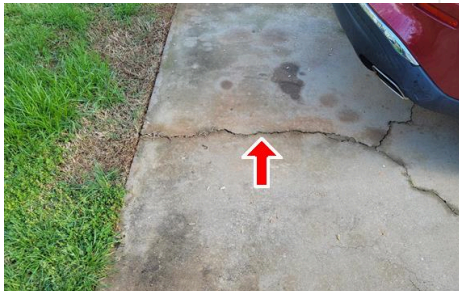
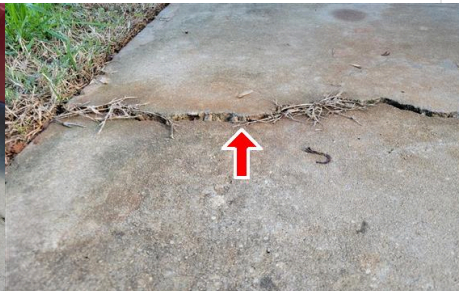
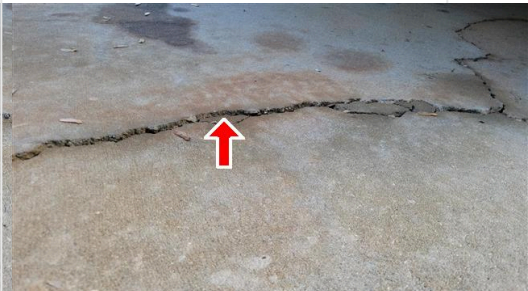
1. The concrete drive at the right side (facing front) uneven, and can be a tripping hazard. Water can cause further deterioration if not repaired and sealed properly. A fall or injury can occur if not corrected. Repairs are needed.

A qualified person should repair or replace as needed.

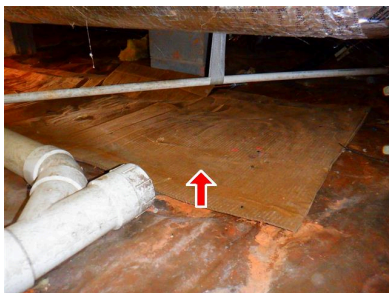
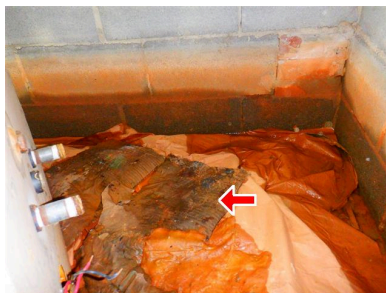
1. Wood debris is in contact with the crawl space floor in numerous areas. This can attract wood destroying organisms. Removal is needed.

A qualified contractor should inspect and repair as needed.

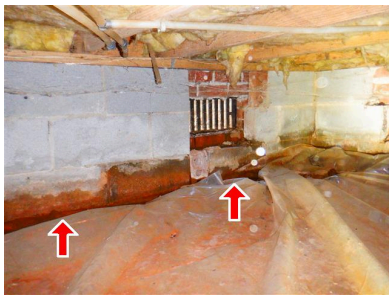
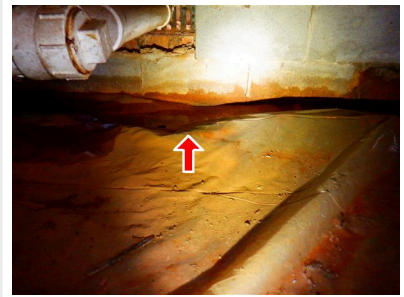
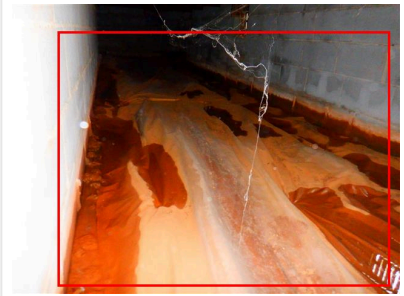
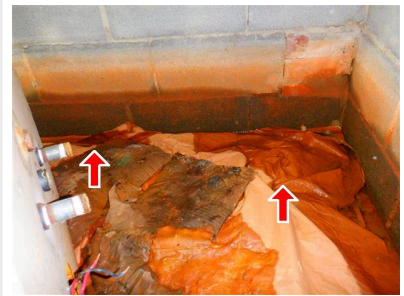
1. Visible signs of water intrusion in the crawlspace are present from standing water on plastic vapor barrier. Water intrusion can cause deterioration and excessive moisture on building components if not corrected. Further investigation and repairs are needed.

I recommend further investigation or correction by a qualified licensed contractor or water infiltration

specialist.

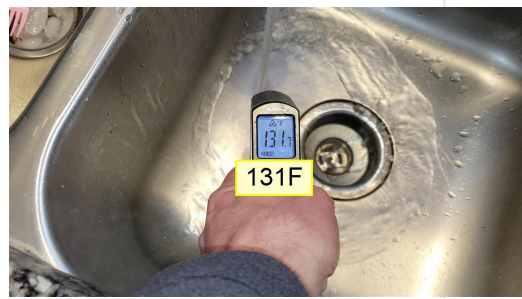
5.1 Item 1 (Picture)

1. The water heater is set over the recommended temperature. (Over 120) The risk is especially acute for infants, children, and the elderly. Water temperatures should never be set higher than 120 degrees.

This is a safety issue. Repairs are needed

A qualified contractor should inspect and repair as needed.

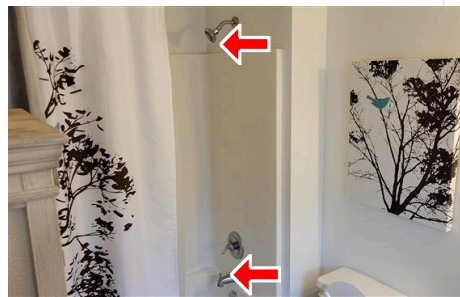
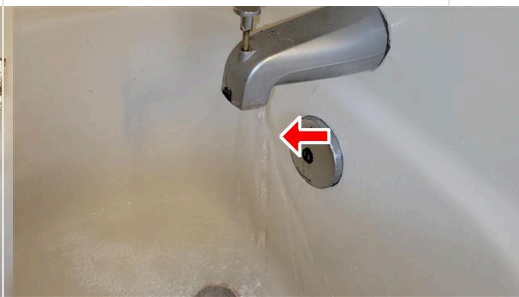
1. The tub spout diverter leaks a stream through tub spout when shower is on at the master bath.  
Repairs are needed.

A qualified licensed plumber should repair or correct as needed.

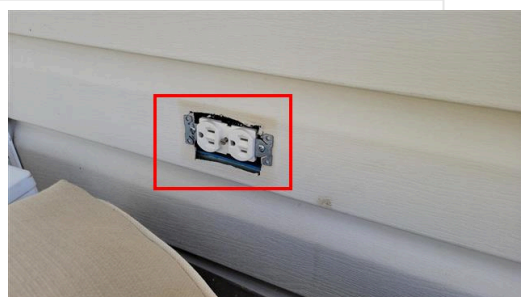
6.6 Item 1 (Picture)

1. One GFCI (Ground Fault Circuit Interrupter) outlet at the exterior is missing a cover. This may allow for water intrusion to occur. Repairs are needed..

A qualified licensed electrical contractor should correct as needed.

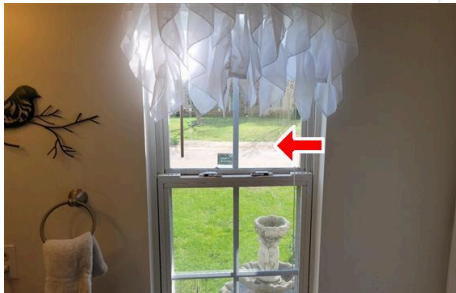
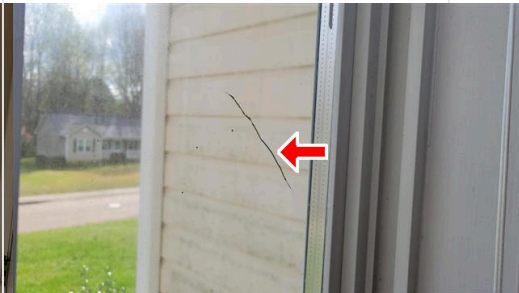
1. One window cracked at glass pane at the master bath. Cracked glass should be replaced to prevent injury or damage. Repairs are needed.

A qualified person should repair or replace as needed.

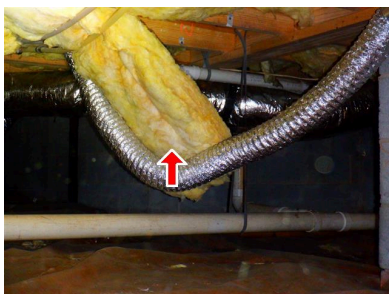
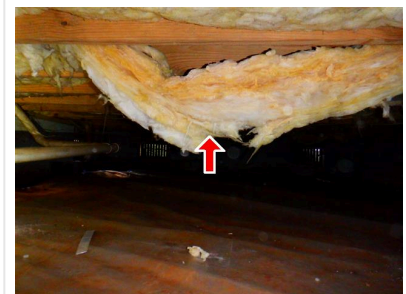
1. The insulation is loose/fallen in the crawlspace. Heat loss can occur more on this home than one that is properly insulated. Repairs are needed..

A qualified person should repair or replace as needed.

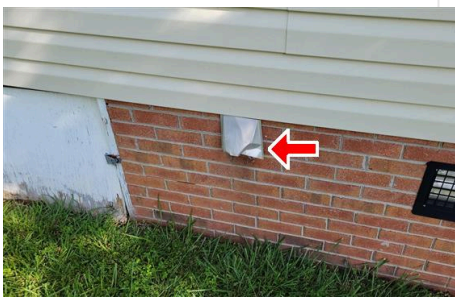
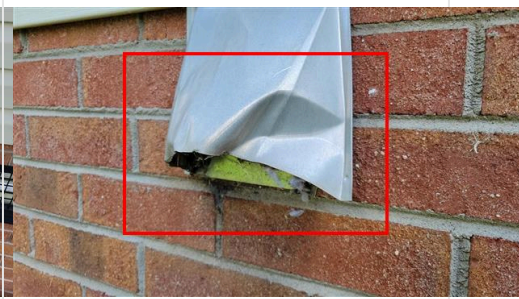
1. The dryer vent hood is damaged at the exterior of the home. Damaged piping can cause an obstruction of lint that has a possibility to create a fire hazard. I recommend repair as needed.

A qualified person should repair or replace as needed.

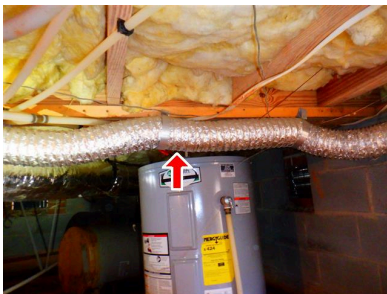
9.5 Item 3 (Picture)

1. The dryer vent piping is over 25 feet long and is flex type. Some professionals considered this type of vent pipe unsafe and recommend rigid metal pipe. Further investigation and repairs are needed.

A qualified person should repair or replace as needed.

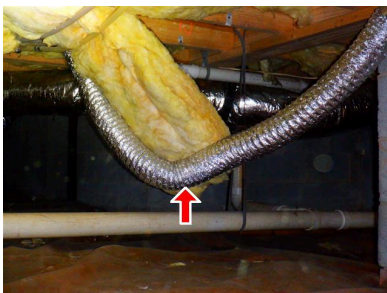
9.5 Item 6 (Picture)

1. The dryer vent piping has large sags. This can cause an obstruction of lint that has a possibility to create a fire hazard. Repairs are needed.

A qualified person should repair or replace as needed.

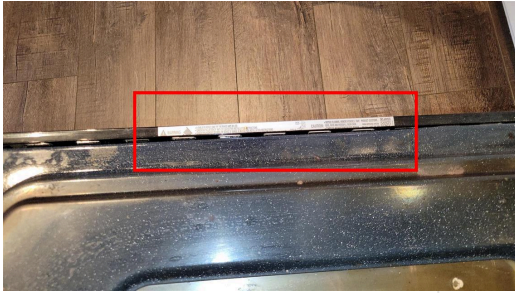
10.1 Item 1 (Picture)

1. The range/oven needs to be properly attached/anchored to the structure as to keep it from tipping over when the oven door is opened and/or oven racks are pulled out during use. This is a safety issue. Repairs are needed.

I recommend contacting appliance repair company.

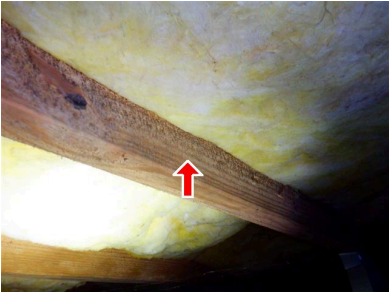
1.0 Item 1 (Picture)

1. Discoloration and some type of mold (Microbial) growth is present in the structure at several areas including but not limited to the crawl space and interior spaces. Evidence suggests that this condition is from a past or present elevated moisture conditions. We did not inspect, test or determine if this type of substance is or is not a health hazard. Further investigation is needed.

We recommend you contact a properly licensed expert for testing, investigation and or correction as deemed appropriate.

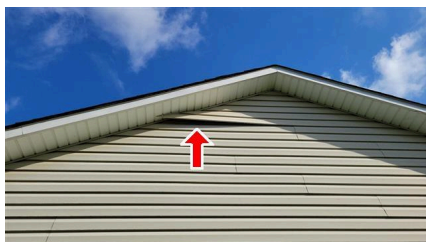
3.0 Item 1 (Picture)

1. The Vinyl siding at the left side (facing front) is loose. Deterioration can eventually occur if not corrected. Repairs are needed.

A qualified person should repair or replace as needed.

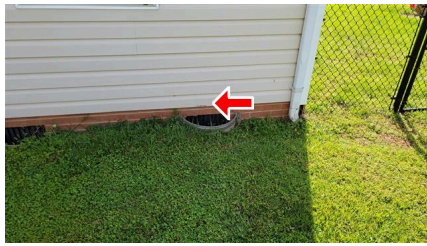
3.0 Item 3 (Picture)

1. The Vinyl siding at the exterior in areas is damaged. This could allow water damage to occur to the home. Repairs are needed.

A qualified person should repair or replace as needed.

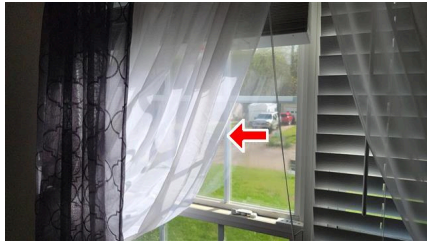
3.2 Item 1 (Picture)

1. Several windows have failed/compromised thermal seals/fogged window panes. This is indicated by the visible moisture, discoloration, calcium deposits and or crystallization visible between the glass window panes. A certified window technician should recheck all the windows throughout the home. Due to weather conditions many times compromised/failed windows cannot be identified at the time of inspection. Further investigation and repairs are needed.

We recommend contacting a properly licensed window technician/contractor regarding these conditions and have repairs made deemed appropriate

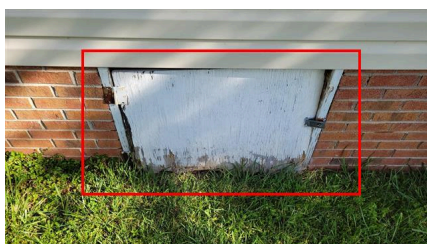
3.3 Item 1 (Picture)

1. The access door to the crawlspace is deteriorated and has damaged hinges. Therefore the door does not function as intended. I recommend repair as needed.

A qualified person should repair or replace as needed.

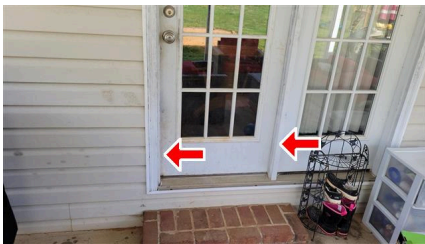
3.3 Item 6 (Picture)

1. The rear of home shows areas of peeling paint. Further deterioration may occur if not repaired.  
Repairs are needed.

A qualified person should repair or replace as needed.

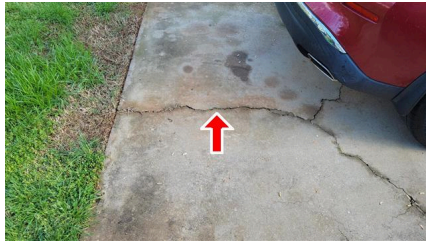
3.5 Item 1 (Picture)

1. The concrete drive at the right side (facing front) uneven, and can be a tripping hazard. Water can cause further deterioration if not repaired and sealed properly. A fall or injury can occur if not corrected. Repairs are needed.

A qualified person should repair or replace as needed.

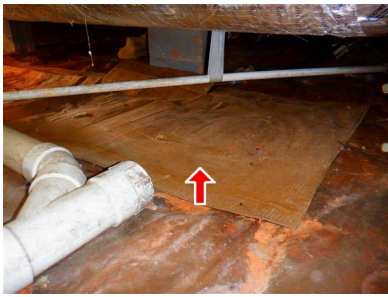
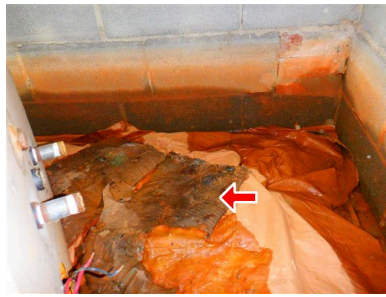
1. Wood debris is in contact with the crawl space floor in numerous areas. This can attract wood destroying organisms. Removal is needed.

A qualified contractor should inspect and repair as needed.

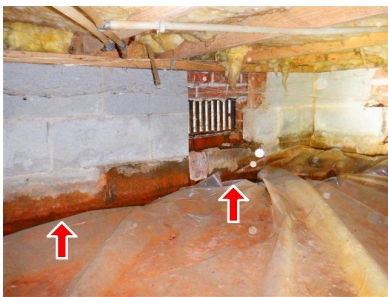
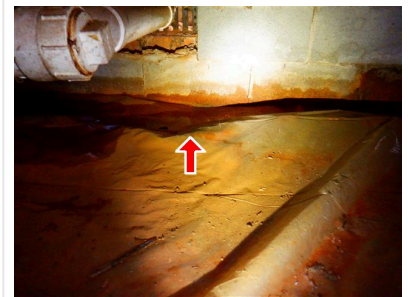
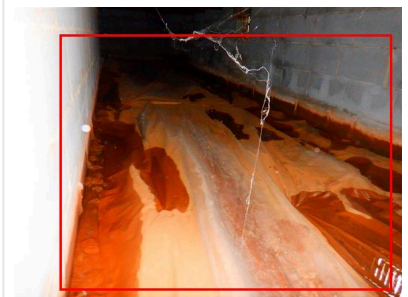
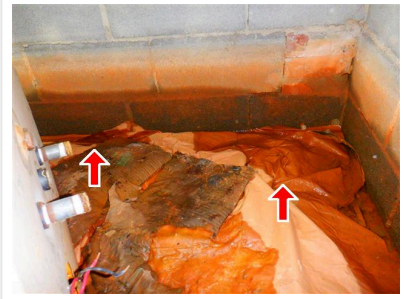
1. Visible signs of water intrusion in the crawl space are present from standing water on plastic vapor barrier. Water intrusion can cause deterioration and excessive moisture on building components if not corrected. Further investigation and repairs are needed.

I recommend further investigation or correction by a qualified licensed contractor or water infiltration specialist.

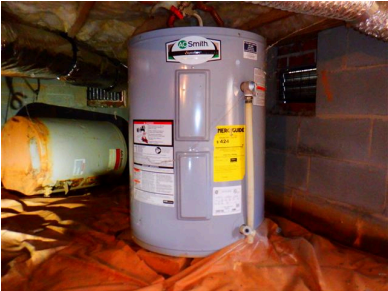
Complimentary photo of the water heater

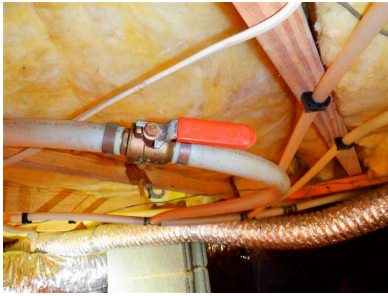
5.0 Item 1 (Picture)

The main shut off is the red lever located underneath in the crawlspace. This is for your information.

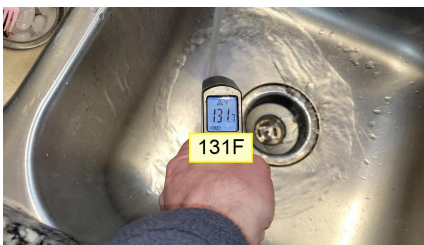
5.1 Item 1 (Picture)

1. The water heater is set over the recommended temperature. (Over 120) The risk is especially acute for infants, children, and the elderly. Water temperatures should never be set higher than 120 degrees. This is a safety issue. Repairs are needed

A qualified contractor should inspect and repair as needed.

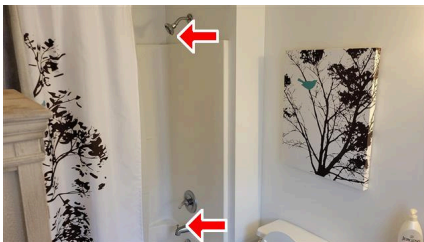
5.2 Item 1 (Picture)

1. The tub spout diverter leaks a stream through tub spout when shower is on at the master bath. Repairs are needed.

A qualified licensed plumber should repair or correct as needed.

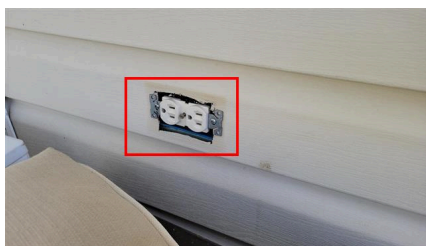
6.6 Item 1 (Picture)

1. One GFCI (Ground Fault Circuit Interrupter) outlet at the exterior is missing a cover. This may allow for water intrusion to occur. Repairs are needed..

A qualified licensed electrical contractor should correct as needed.

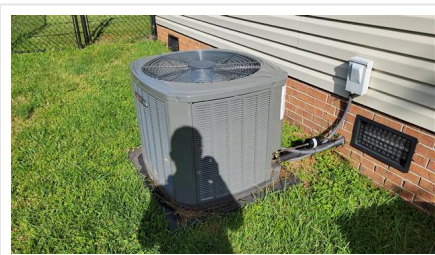
Complimentary photo of the heat pump

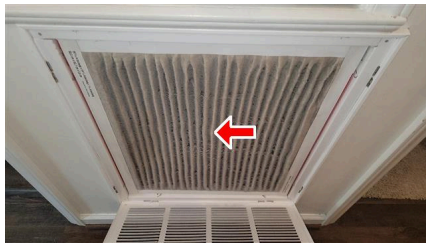
7.3 Item 1 (Picture)

1. The disposable filter is dirty. The filter needs to be replaced.

A qualified person should repair or replace as needed

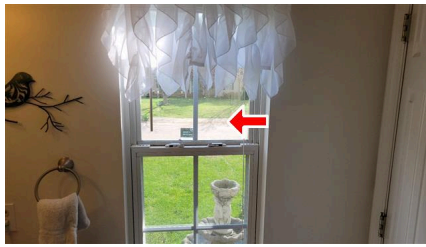
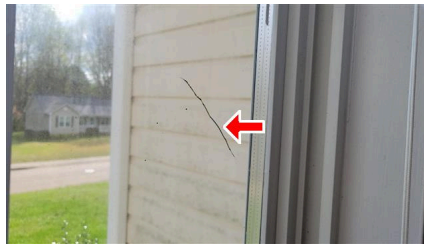
1. One window cracked at glass pane at the master bath. Cracked glass should be replaced to prevent injury or damage. Repairs are needed.

A qualified person should repair or replace as needed.

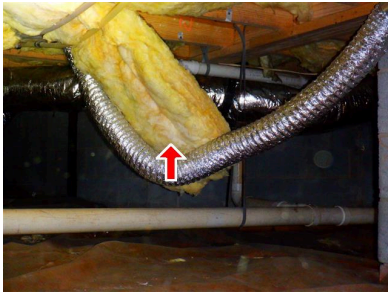
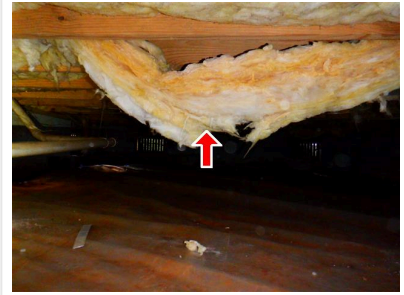
1. The insulation is loose/fallen in the crawlspace. Heat loss can occur more on this home than one that is properly insulated. Repairs are needed..

A qualified person should repair or replace as needed.

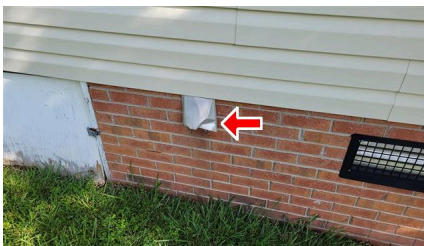
9.5 Item 1 (Picture)

1. The dryer vent hood is damaged at the exterior of the home. Damaged piping can cause an obstruction of lint that has a possibility to create a fire hazard. I recommend repair as needed.

A qualified person should repair or replace as needed.

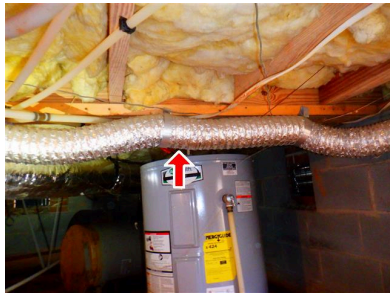
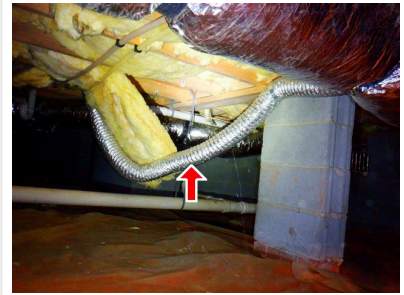
1. The dryer vent piping is over 25 feet long and is flex type. Some professionals considered this type of vent pipe unsafe and recommend rigid metal pipe. Further investigation and repairs are needed.

A qualified person should repair or replace as needed.

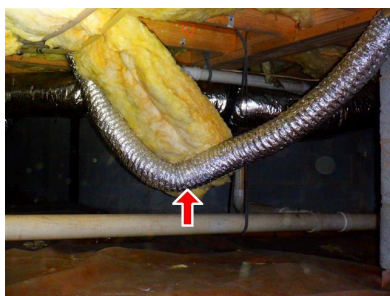
9.5 Item 6 (Picture)

1. The dryer vent piping has large sags. This can cause an obstruction of lint that has a possibility to create a fire hazard. Repairs are needed.

A qualified person should repair or replace as needed.

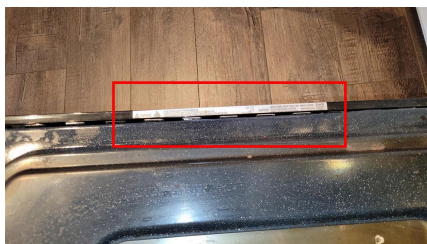
10.1 Item 1 (Picture)

1. The range/oven needs to be properly attached/anchored to the structure as to keep it from tipping over when the oven door is opened and/or oven racks are pulled out during use. This is a safety issue. Repairs are needed.

I recommend contacting appliance repair company.
