INSPECTION REPORT  
8315 Bridgegate Dr  
Huntersville NC 28078

INSPECTED BY  
Alex Parr 3692  
Above Parr Home  
Inspections

INSPECTION DATE  
📅 3/27/2025  
🕒 09:00:00 AM

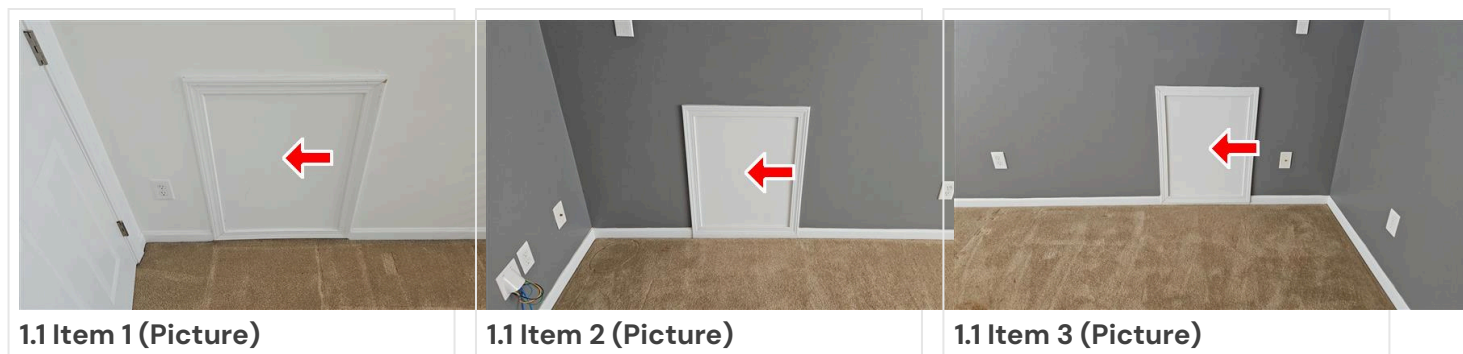
1. Several attic accesses were painted shut. As a result the areas were not inspected. Hidden damage may be present. Further investigation and repairs are needed.

We recommend having all personal items removed and these areas inspected prior to closing.

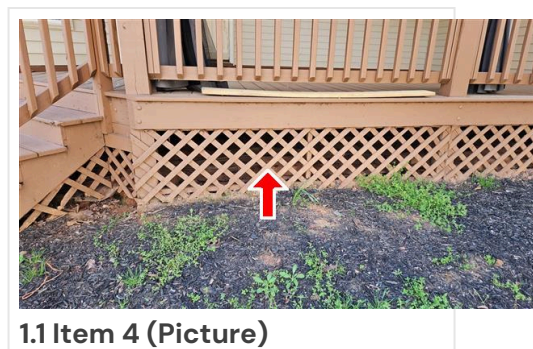
1. The framing and the foundation of the deck were not inspected as the underneath of the deck was blocked by trellis. No access panel could be located. Hidden damage may be present. Further evaluation is needed.

A qualified contractor should inspect and repair as needed.

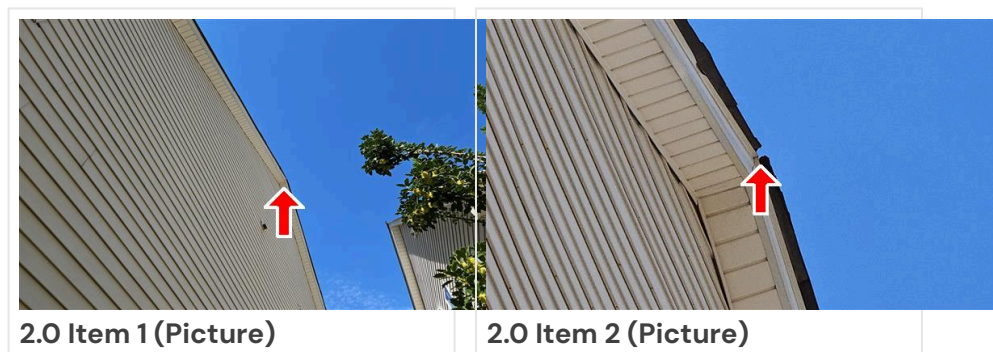
1. The roof shingles is damaged at the right side (facing front). This damage should be repaired or replaced. Due to the age and damage I recommend having the entire roof evaluated. Further investigation and repairs are needed.

A qualified contractor should inspect and repair as needed.

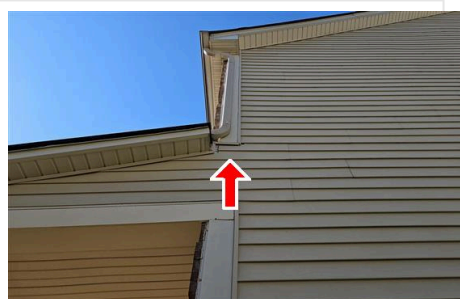
3.0 Item 1 (Picture)

1. The vinyl siding at the right side (facing front) is loose. Deterioration can eventually occur if not corrected. Further investigation and repairs are needed.

A qualified contractor should inspect and repair as needed.

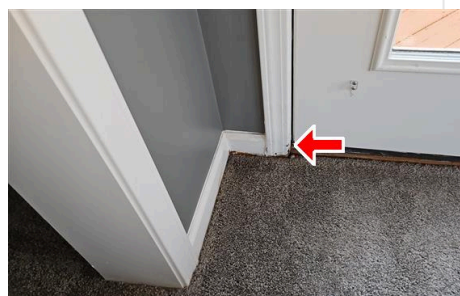
3.3 Item 1 (Picture)

1. Numerous exterior doors have evidence of past water intrusion and damaged. Using the moisture meter it did not indicate an actively at any of the locations. Further deterioration may occur. Further investigation and repairs are needed.

A qualified contractor should inspect and repair as needed.

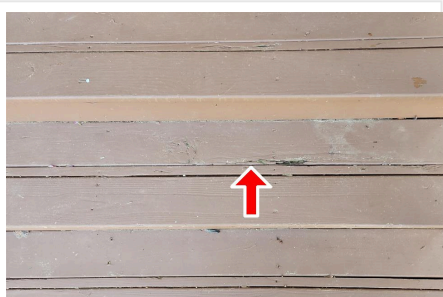
3.4 Item 1 (Picture)

1. The deck floor and steps at the rear of home are deteriorated. Further deterioration can occur if not repaired. Further investigation and repairs are needed.

A qualified contractor should repair or replace as needed.

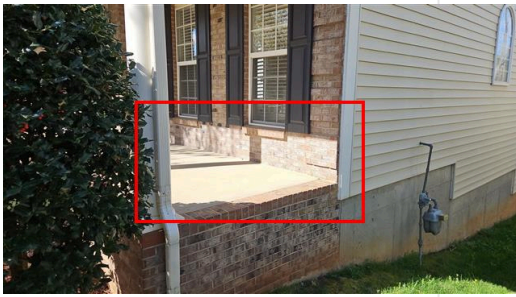
3.4 Item 8 (Picture)

1. The guardrails at covered porch at the front of home are missing. A fall or injury could occur if not corrected. Repairs are needed.

A qualified contractor should repair or replace as needed.

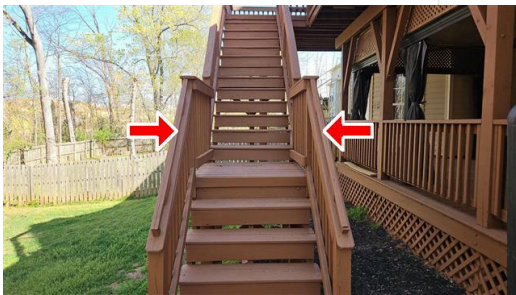
3.4 Item 9 (Picture)

1. The guardrails on steps at the rear of home are loose. A fall or injury could occur if not corrected. Repairs are needed.

A qualified contractor should repair or replace as needed.

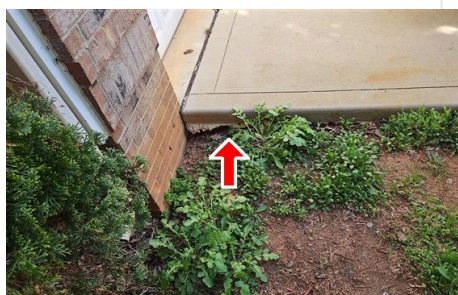
3.5 Item 1 (Picture)

1. The concrete drive at the front of home shows signs of erosion and problem needs to be addressed. Further erosion or deterioration can occur if not corrected. Further investigation and repairs are needed.

A qualified contractor should inspect and repair as needed.

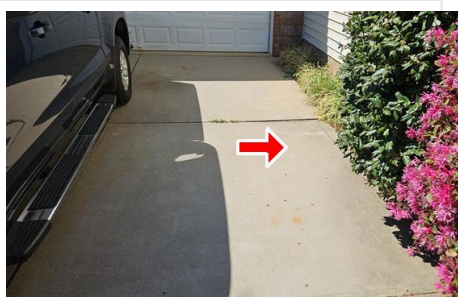
3.5 Item 3 (Picture)

Further deterioration can occur if not repaired. Further investigation and repairs are needed

A qualified contractor should inspect and repair as needed.

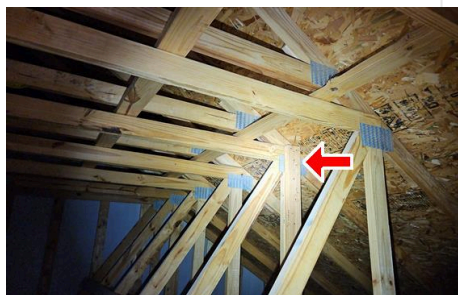
4.4 Item 1 (Picture)

1. The truss system installed in the attic have been repaired due to damage during or before installation of the truss. All truss repairs should be repaired via an approved method specified by the manufacturer and or approved and stamped by licensed structural engineer. Note: No letter was present at repair. Further evaluation and repairs are needed. A qualified licensed structural engineer/design professional is recommended to evaluate the trusses for any repairs. This should include a site specific letter from the registered design professional/engineer stating what repairs (if any) are needed approval of performed repairs, signature, state license number, and state registered stamp of the engineer.

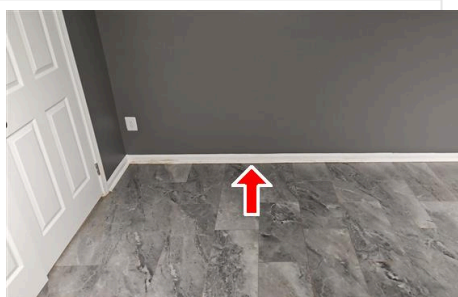
4.6 Item 1 (Picture)

1. Visible signs of water intrusion in the basement (left side of home facing front) are present from water on wall. Water intrusion can lead to more costly repairs and increase damage if not corrected. Further investigation and repairs are needed.

I recommend further investigation or correction by a qualified licensed contractor or water infiltration specialist.

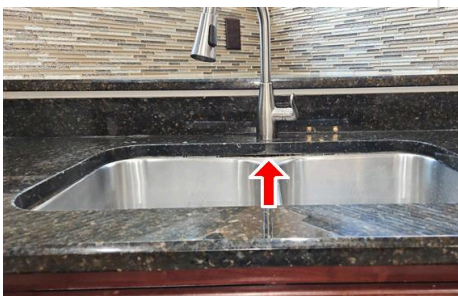
5.2 Item 1 (Picture)

1. The kitchen sink is loose/not sealed properly. Repairs are needed to prevent water damage from occurring to the home. Further investigation and repairs are needed.

A qualified licensed plumber should repair or correct as needed.

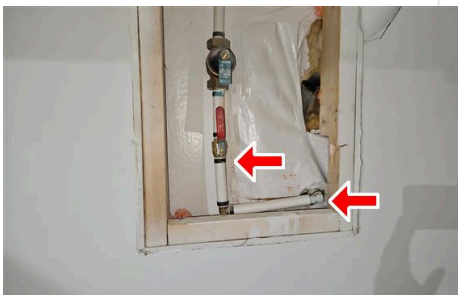
5.2 Item 4 (Picture)

1. The supply line has a corroded at connection in the basement. Repairs are needed to prevent water damage from occurring to the home. Further investigation and repairs are needed.

A qualified licensed plumber should repair or correct as needed.

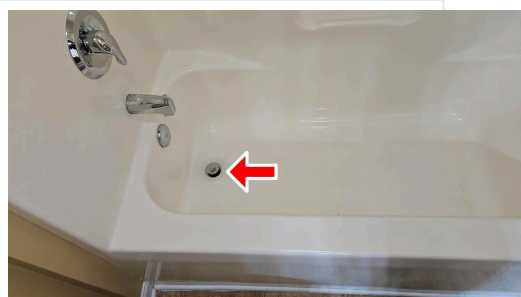
5.3 Item 1 (Picture)

I am unable to determine the cause of the slow drain. Further investigation and repairs are needed.

A qualified licensed plumber should repair or correct as needed.

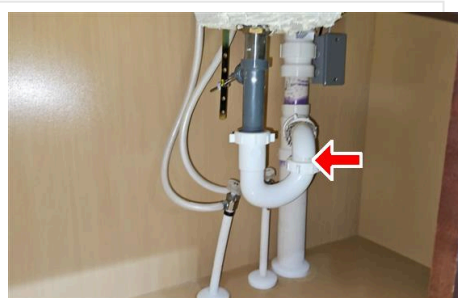
5.3 Item 2 (Picture)

1. The plumbing waste line leaks at the master bath sink. Repairs are needed to prevent water damage from occurring to the home. Further investigation and repairs are needed.

A qualified licensed plumber should repair or correct as needed.

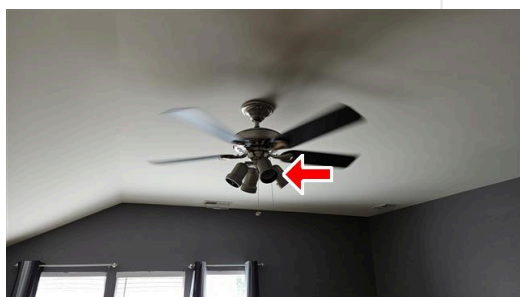
**6.4 Item 1 (Picture)**

1. The light fixture does not work (try bulb first) at the bonus room. Electrical issues are considered a hazard until repaired. Repairs are needed.

A qualified licensed electrical contractor should correct as needed.

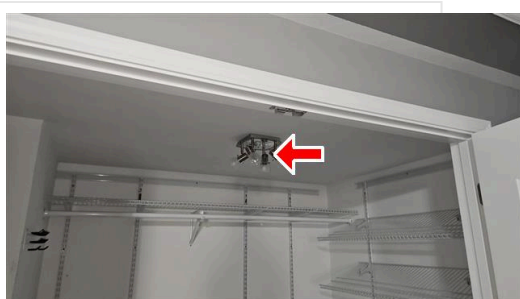
**6.4 Item 2 (Picture)**

1. The light fixture does not work at the guest bedroom closet. Electrical issues are considered a hazard until repaired. Further investigation and repairs are needed.

A qualified licensed electrical contractor should correct as needed.

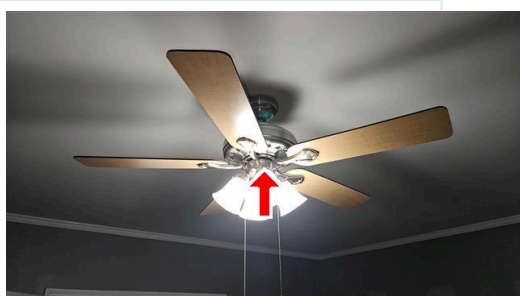
**6.4 Item 3 (Picture)**

1. The ceiling fan does not work and in the guest bedroom. Electrical issues are considered a hazard until repaired. Repairs are needed.

A qualified licensed electrical contractor should correct as needed.

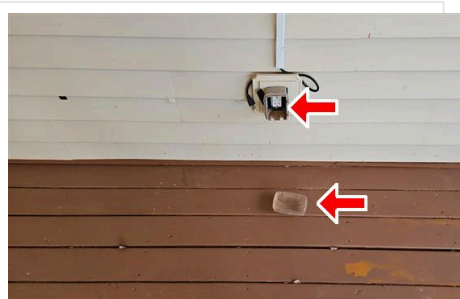
6.6 Item 1 (Picture)

1. GFCI (Ground Fault Circuit Interrupter) outlet at the exterior has a damaged cover. This may allow for water intrusion to occur. Repairs are needed.

A qualified licensed electrical contractor should correct as needed A qualified licensed electrical contractor should correct as needed.

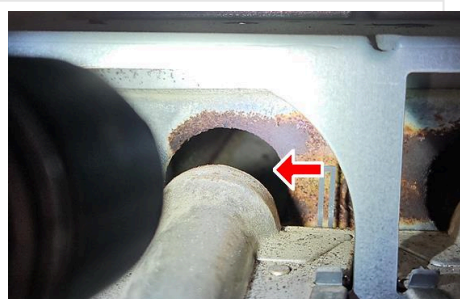
7.0 Item 1 (Picture)

1. The furnace combustion chamber has rusted with rust particles and flakes on the burners and at the bottom of the chambers. This is a typical sign of a possibly failed heating system/heat exchanger. Further investigation and repairs are needed.

I recommend contacting a licensed (HVAC) heating and air contractor for further evaluation.

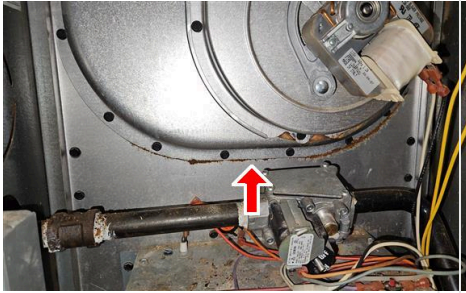
7.0 Item 3 (Picture)

1. The gas furnace has a gasket that is leaking. This can cause damage to the unit or shorten its life span. Further investigation and repairs are needed.

I recommend a qualified licensed contractor inspect further and repair as needed.

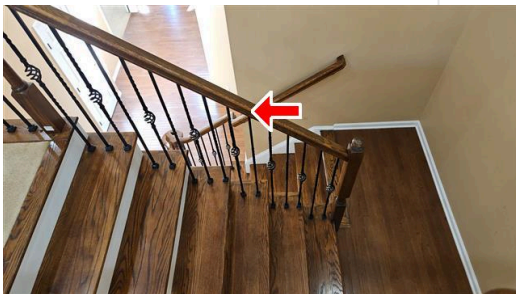
8.3 Item 1 (Picture)

1. The hand/guard rail for the upstairs is loose. A fall or injury could occur if not corrected. A repair or replacement is needed.

A qualified contractor should repair or replace as needed.

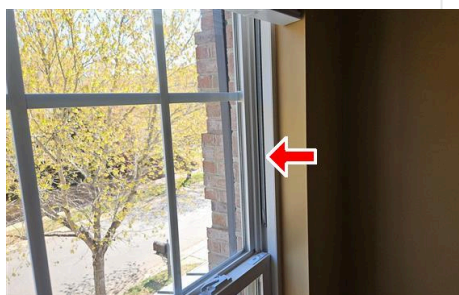
8.6 Item 1 (Picture)

1. The windows at the throughout the home have damaged sash springs. This can allow the window to come down suddenly causing glass breakage and or injury. (Safety Issue) Repairs are needed.

A qualified person should repair or replace as needed.

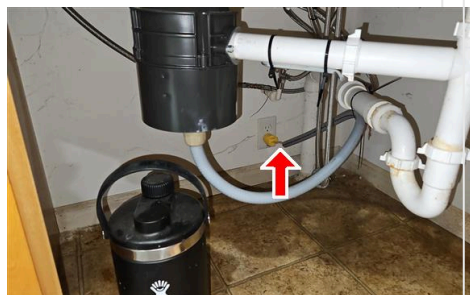
10.3 Item 1 (Picture)

1. The food disposer wiring is improper. Electrical issues are considered a hazard until repaired Further investigation and repairs are needed.

A qualified licensed electrical contractor should correct as needed.

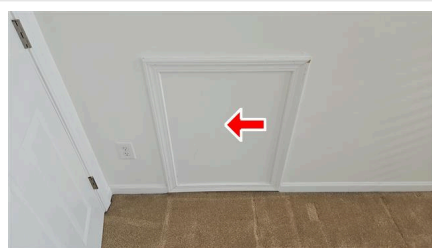
1.1 Item 1 (Picture)

1. Several attic accesses were painted shut. As a result the areas were not inspected. Hidden damage may be present. Further investigation and repairs are needed.

We recommend having all personal items removed and these areas inspected prior to closing.

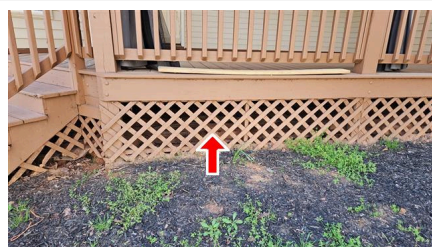
1.1 Item 4 (Picture)

1. The framing and the foundation of the deck were not inspected as the underneath of the deck was blocked by trellis. No access panel could be located. Hidden damage may be present. Further evaluation is needed.

A qualified contractor should inspect and repair as needed.

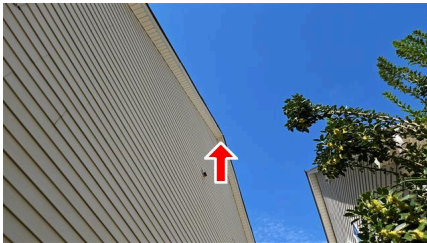
2.0 Item 1 (Picture)

1. The roof shingles is damaged at the right side (facing front). This damage should be repaired or replaced. Due to the age and damage I recommend having the entire roof evaluated. Further investigation and repairs are needed.

A qualified contractor should inspect and repair as needed.

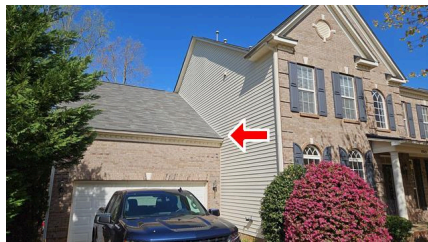
2.1 Item 1 (Picture)

1. The kick-out flashing is missing at the roof to wall intersection of the home. This is not best practice. Repairs are needed.

A qualified roofing contractor should inspect further and correct as needed.

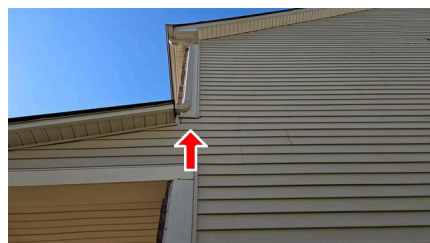
3.0 Item 1 (Picture)

1. The vinyl siding at the right side (facing front) is loose. Deterioration can eventually occur if not corrected. Further investigation and repairs are needed.

A qualified contractor should inspect and repair as needed.

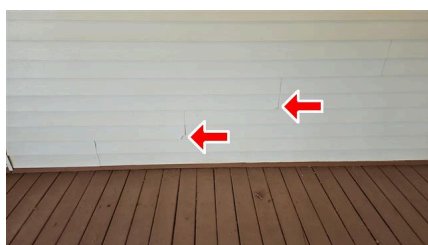
3.0 Item 4 (Picture)

1. The vinyl siding at the rear of home is damaged. Further deterioration can occur if not corrected. Repairs are needed.

A qualified person should repair or replace as needed.

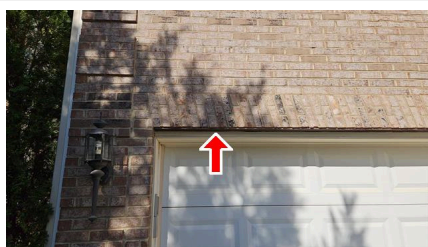
3.2 Item 1 (Picture)

1. The steel lintels around the exterior of the home are beginning to rust or have rust present. A lintel is a horizontal architectural member or steel beam support placed over a wall opening to carry the weight of the masonry placed over it. In most situation, the lintel above you windows and doors will be steel angle iron or I beam. Either due to age or improper rust proofing or weep chord and flashing placement during installation, lintels will begin to rust. Rusting lintels can expand to become much thicker than their original size. The expansive forces of rusting steel can shift entire multi-story elevations. If your lintels are currently rusting, a telltale sign of expansion is diagonal "step" pattern cracks, which can be found on either end of the window or door opening. Repairs are needed to prevent further damage to the structure. Further deterioration may occur if not repaired.

I recommend a qualified contractor inspect and repair as needed.

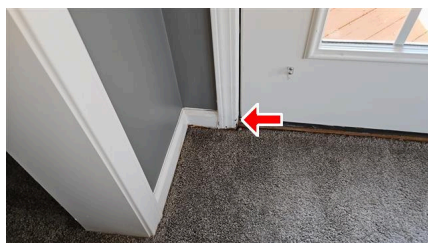
3.3 Item 1 (Picture)

1. Numerous exterior doors have evidence of past water intrusion and damaged. Using the moisture

meter it did not indicate an actively at any of the locations. Further deterioration may occur.  
Further investigation and repairs are needed.

A qualified contractor should inspect and repair as needed.

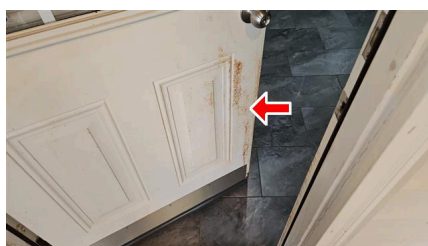
3.3 Item 5 (Picture)

1. The entry door at rear of home is deteriorated. Further deterioration may occur if not repaired.  
Repairs are needed.

A qualified person should repair or replace as needed.

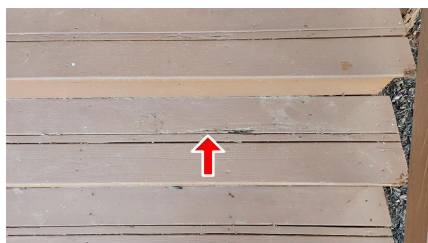
3.4 Item 1 (Picture)

1. The deck floor and steps at the rear of home are deteriorated. Further deterioration can occur if not repaired. Further investigation and repairs are needed.

A qualified contractor should repair or replace as needed.

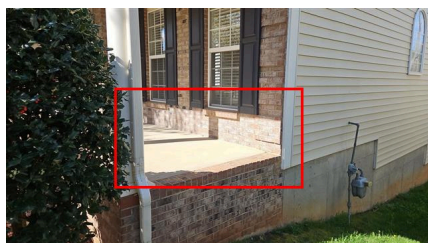
3.4 Item 8 (Picture)

1. The guardrails at covered porch at the front of home are missing. A fall or injury could occur if not corrected. Repairs are needed.

A qualified contractor should repair or replace as needed.

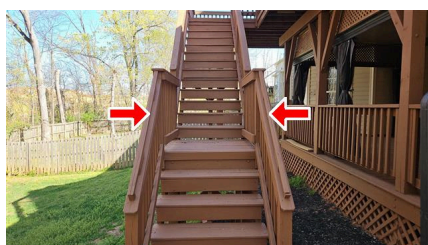
3.4 Item 9 (Picture)

1. The guardrails on steps at the rear of home are loose. A fall or injury could occur if not corrected. Repairs are needed.

A qualified contractor should repair or replace as needed.

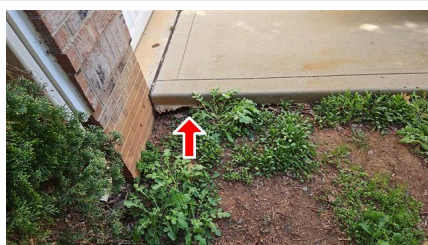
3.5 Item 1 (Picture)

1. The concrete drive at the front of home shows signs of erosion and problem needs to be addressed. Further erosion or deterioration can occur if not corrected. Further investigation and repairs are needed.

A qualified contractor should inspect and repair as needed.

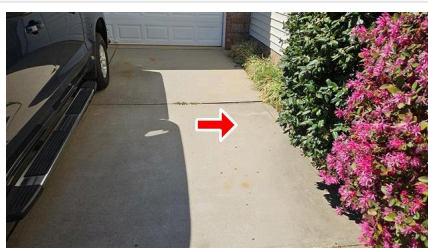
3.5 Item 3 (Picture)

1. Evidence suggests the driveway at the front of the home is diverting stormwater towards the home. Further deterioration can occur if not repaired. Further investigation and repairs are needed

A qualified contractor should inspect and repair as needed.

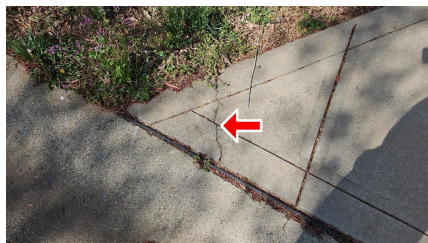
3.5 Item 5 (Picture)

1. The concrete driveway has cracks that should be sealed to prevent further damage, which is part of ongoing maintenance of a concrete driveway that will need to be performed on a regular basis. Repairs are recommended.

A qualified contractor should inspect and repair as needed.

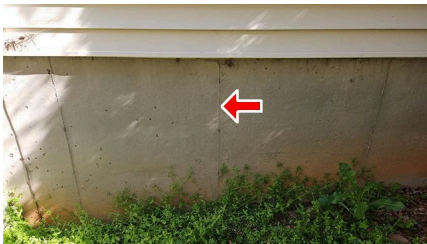
4.0 Item 1 (Picture)

1. The concrete poured foundation wall at the exterior has cracks present. This crack does not appear significant to require repairs at this time. Further investigation and repairs are needed.

A qualified licensed general contractor should inspect further and repair as needed.

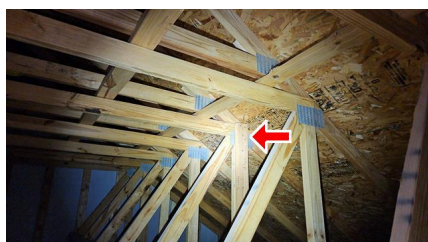
4.4 Item 1 (Picture)

1. The truss system installed in the attic have been repaired due to damage during or before installation of the truss. All truss repairs should be repaired via an approved method specified b the manufacture and or approved and stamped by licensed structural engineer. Note: No letter was present at repair. Further evaluation and repairs are needed. A qualified licensed structural engineer/design professional is recommended to evaluate the trusses for any repairs. This should include a site specific letter from the registered design professional/engineer stating what repairs (if any) are needed approval of performed repairs, signature, state license number, and state registered stamp of the engineer.

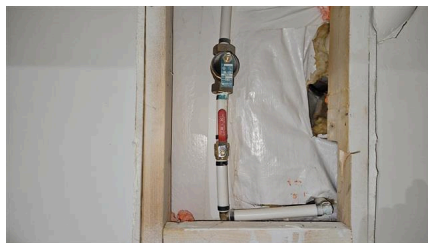
The main shut off is the red lever located in the basement. This is for your information.

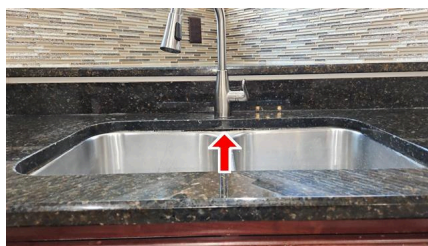
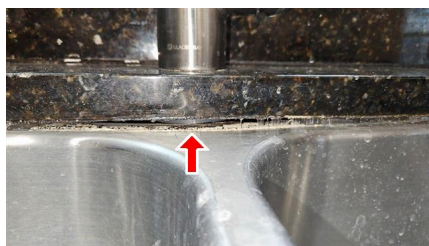
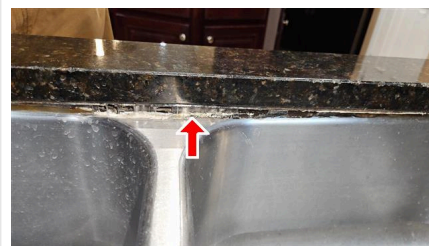
1. The kitchen sink is loose/not sealed properly. Repairs are needed to prevent water damage from occurring to the home. Further investigation and repairs are needed.

A qualified licensed plumber should repair or correct as needed.

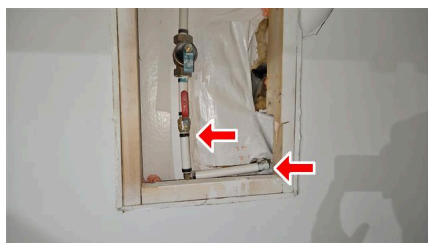
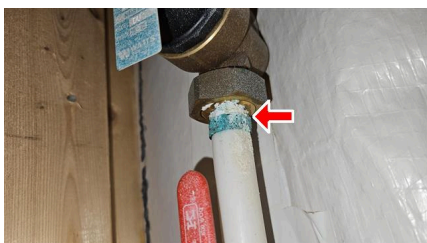
1. The supply line has a corroded at connection in the basement. Repairs are needed to prevent water damage from occurring to the home. Further investigation and repairs are needed.

A qualified licensed plumber should repair or correct as needed.

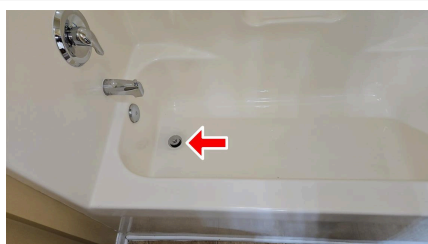
5.3 Item 1 (Picture)

1. The tub drain drains slowly at the guest bath. Sometimes the drain can be partially clogged down line. I am unable to determine the cause of the slow drain. Further investigation and repairs are needed.

A qualified licensed plumber should repair or correct as needed.

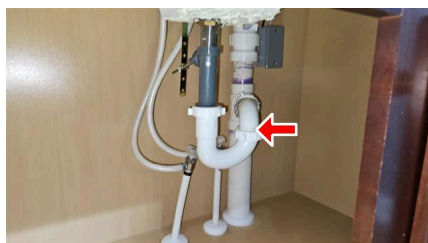
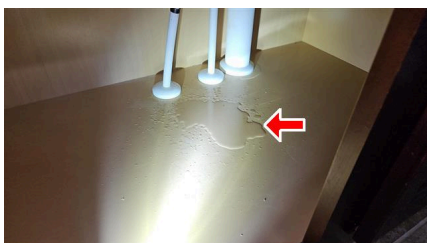
1. The plumbing waste line leaks at the master bath sink. Repairs are needed to prevent water damage from occurring to the home. Further investigation and repairs are needed.

A qualified licensed plumber should repair or correct as needed.

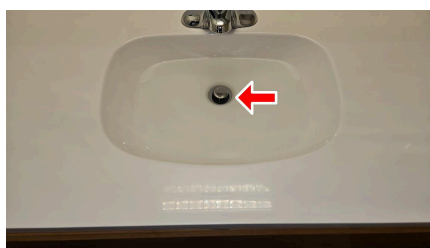
5.3 Item 4 (Picture)

1. The plumbing waste line drains slowly at the guest bath sink. A cause of a slow drain can range from a simple cleaning at stop valve or at the trap under sink. Sometimes the drain can be partially clogged down line. I am unable to determine the cause of the slow drain.

A qualified licensed plumber should repair or correct as needed.

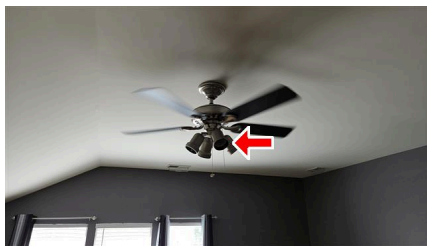
6.4 Item 1 (Picture)

1. The light fixture does not work (try bulb first) at the bonus room. Electrical issues are considered a hazard until repaired. Repairs are needed.

A qualified licensed electrical contractor should correct as needed.

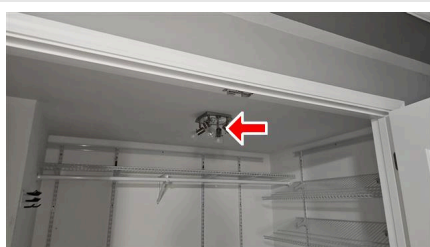
6.4 Item 2 (Picture)

1. The light fixture does not work at the guest bedroom closet. Electrical issues are considered a hazard until repaired. Further investigation and repairs are needed.

A qualified licensed electrical contractor should correct as needed.

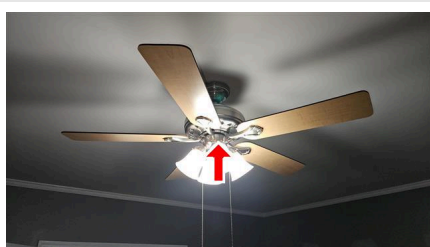
6.4 Item 3 (Picture)

1. The ceiling fan does not work and in the guest bedroom. Electrical issues are considered a hazard until repaired. Repairs are needed.

A qualified licensed electrical contractor should correct as needed.

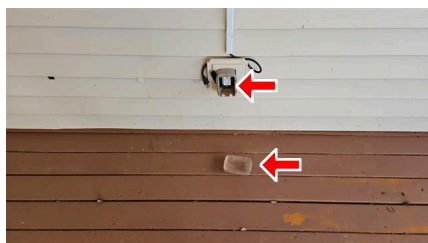
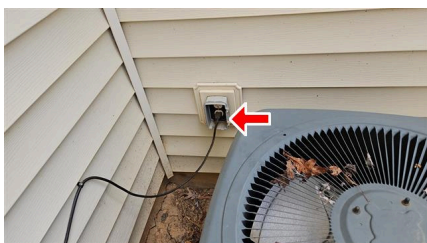
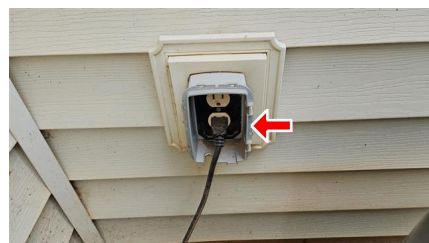
1. GFCI (Ground Fault Circuit Interrupter) outlet at the exterior has a damaged cover. This may allow for water intrusion to occur. Repairs are needed.

A qualified licensed electrical contractor should correct as needed A qualified licensed electrical contractor should correct as needed.

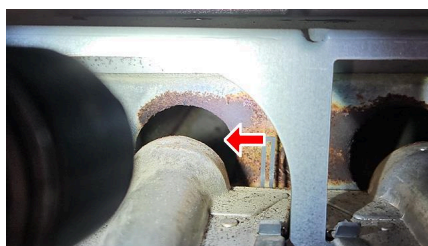
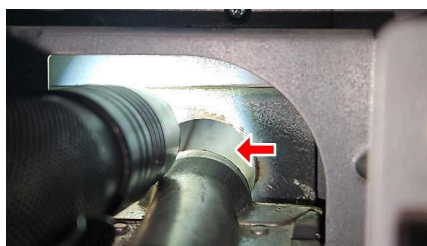
1. The furnace combustion chamber has rusted with rust particles and flakes on the burners and at the bottom of the chambers. This is a typical sign of a possibly failed heating system/heat exchanger. Further investigation and repairs are needed.

I recommend contacting a licensed (HVAC) heating and air contractor for further evaluation.

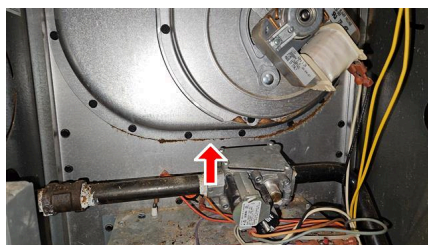
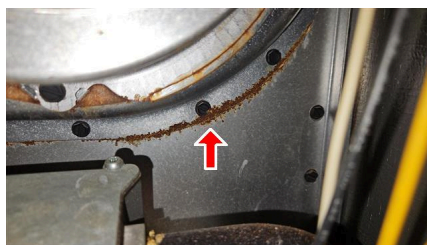
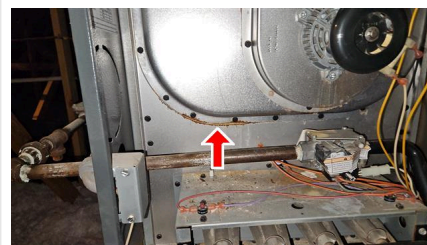
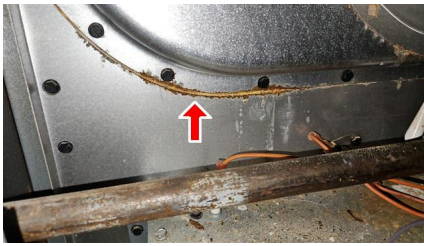
1. The gas furnace has a gasket that is leaking. This can cause damage to the unit or shorten its life span. Further investigation and repairs are needed.

I recommend a qualified licensed contractor inspect further and repair as needed.

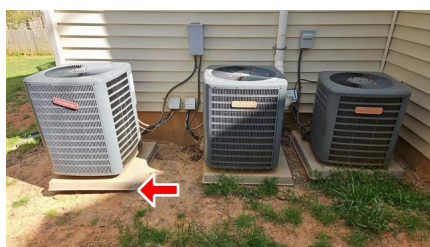
7.8 Item 1 (Picture)

1. The platform for condenser(s) has erosion occurring under it. This can cause damage to the unit or shorten its life span. Repairs are needed.

I recommend further inspection by a licensed HVAC contractor.

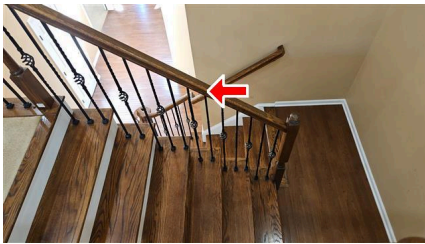
8.3 Item 1 (Picture)

1. The hand/guard rail for the upstairs is loose. A fall or injury could occur if not corrected. A repair or replacement is needed.

A qualified contractor should repair or replace as needed.

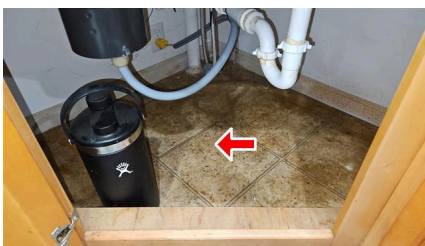
8.4 Item 1 (Picture)

1. Cabinet base is missing under sink. This is a cosmetic issue for your information. Recommend repair or replace as necessary.

A qualified person should repair or replace as needed

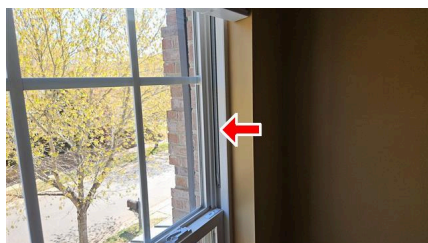
8.6 Item 1 (Picture)

1. The windows at the throughout the home have damaged sash springs. This can allow the window to come down suddenly causing glass breakage and or injury. (Safety Issue) Repairs are needed. A qualified person should repair or replace as needed.

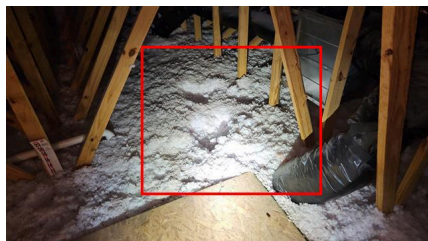
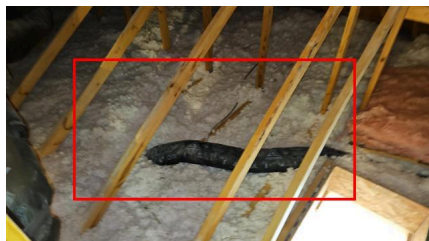
1. Fiberglass (loose-fill) insulation is is compressed in areas of the attic due to foot traffic or storage in attic. Heat loss can occur more on this home than one that is properly insulated. Repairs are recommended .

A qualified person should repair or replace as needed.

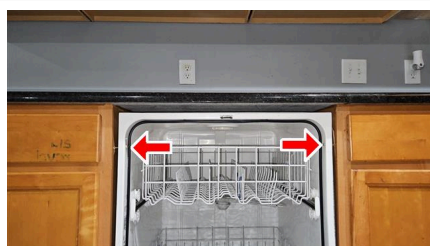
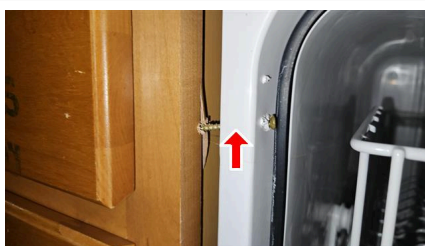
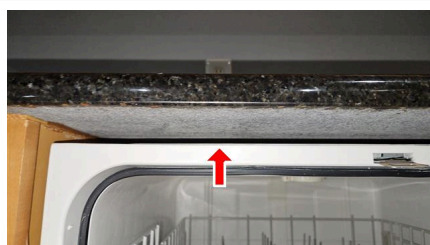
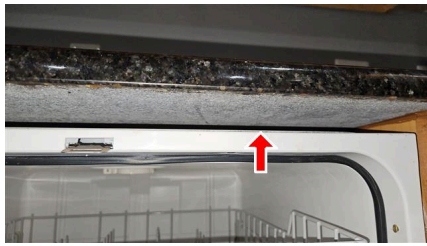
1. The dishwasher is loose and needs securing to underside of countertop (using a proper length screw). I recommend repair as necessary.

A qualified licensed plumber should repair or correct as needed.

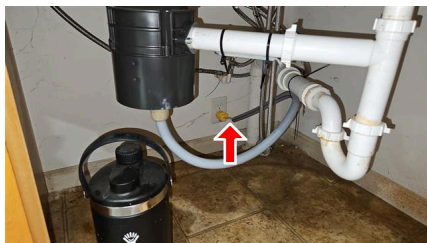
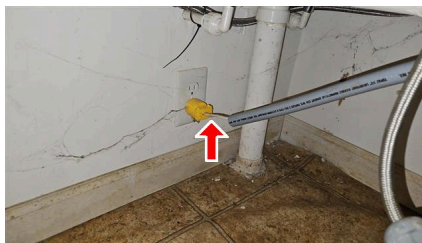
1. The food disposer wiring is improper. Electrical issues are considered a hazard until repaired. Further investigation and repairs are needed.

A qualified licensed electrical contractor should correct as needed.
