INSPECTION REPORT  
8993 Unity Church Rd  
Denver NC 28037

INSPECTED BY  
Alex Parr 3692  
Above Parr Home  
Inspections

INSPECTION DATE  
📅 3/31/2023  
🕒 09:00:00 AM

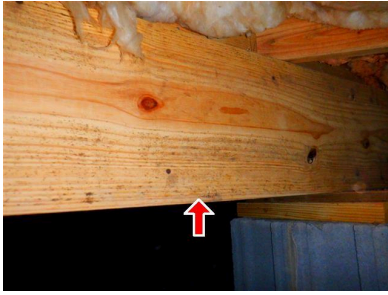
1.0 Item 1 (Picture)

1. Discoloration and some type of mold (Microbial) growth is present in the structure at several areas including but not limited to the crawl space and interior spaces. Evidence suggests that this condition is from a past or present elevated moisture conditions. We did not inspect, test or determine if this type of substance is or is not a health hazard. Further investigation is needed.

We recommend you contact a properly licensed expert for testing, investigation and or correction as deemed appropriate.

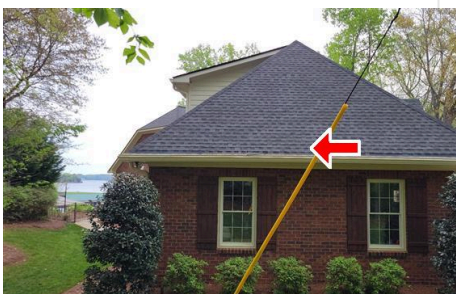
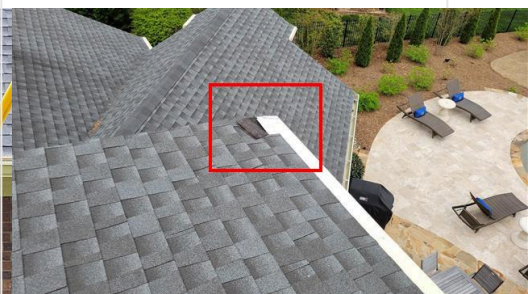
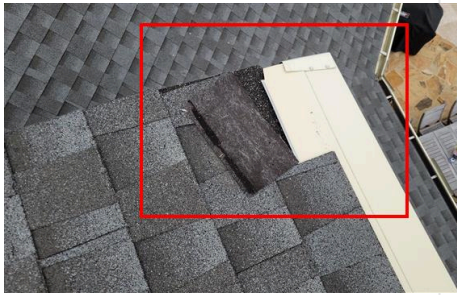
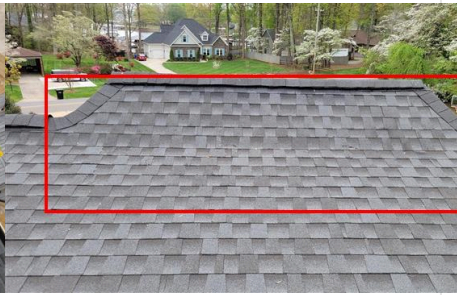
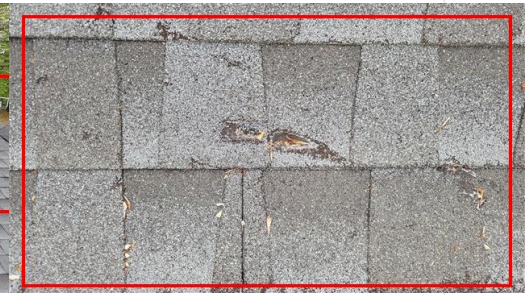
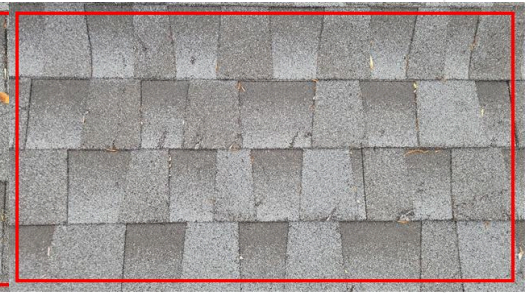
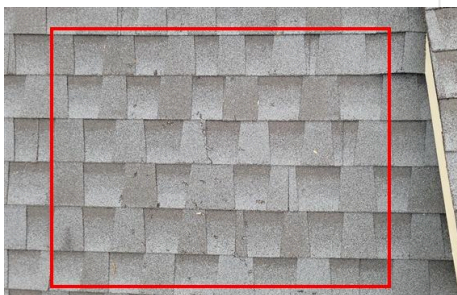
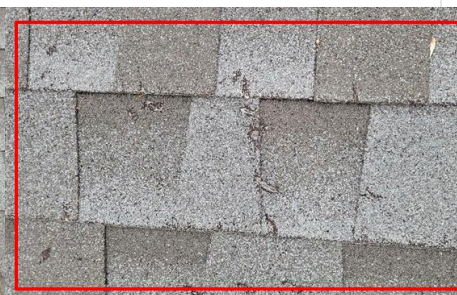
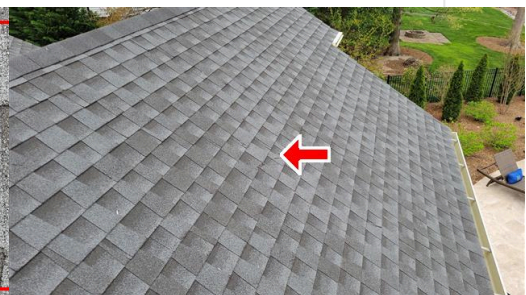
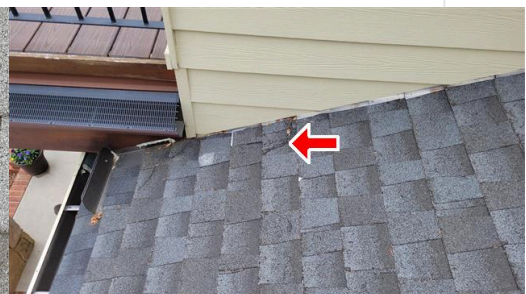
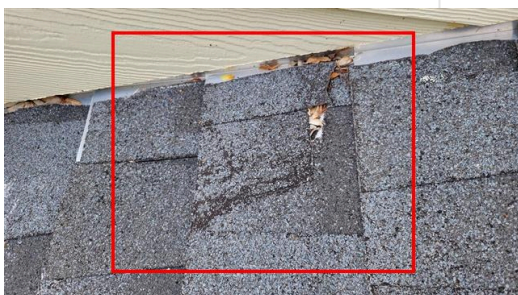
1. The roof shingles is damaged at the in areas. This damage should be repaired or replaced. Further investigation and repairs are needed.

I recommend having the entire roof evaluated by a licensed roofer.

A qualified contractor should inspect and repair as needed.

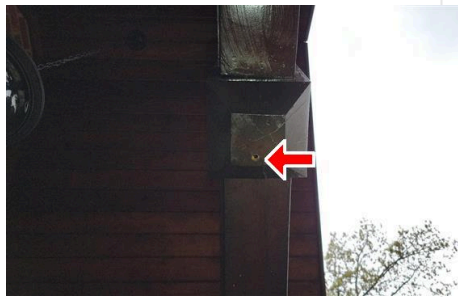
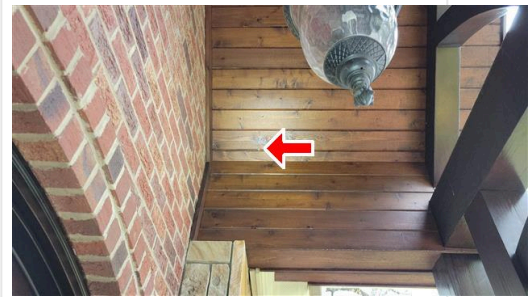
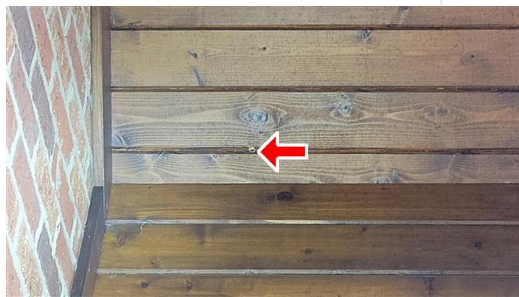
1. Active wood destroying insect activity at the front of the home. Further deterioration can occur if not corrected. Further investigation and repairs are needed.

A qualified person should repair or replace as needed.

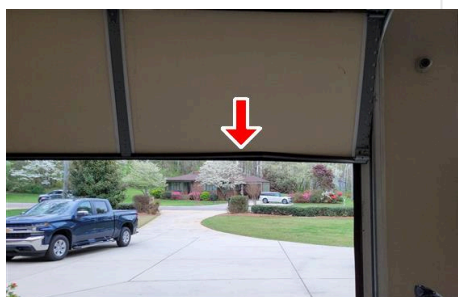
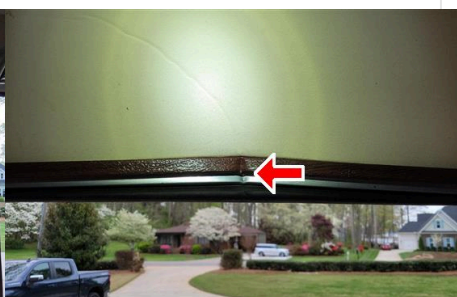
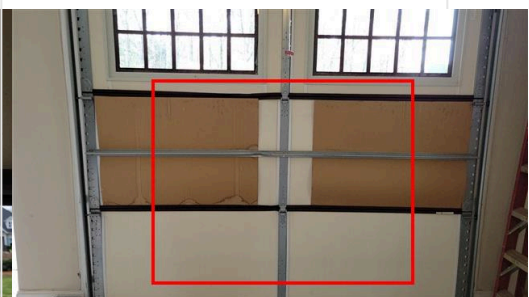
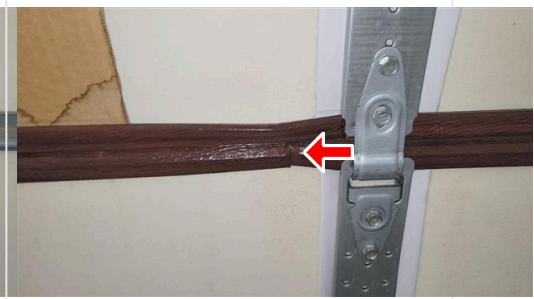
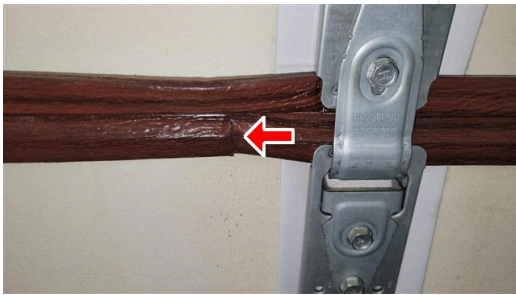
1. The two garage doors at the front of home "left" door (from outside), and "right" door (from outside), are damaged at panel. This could allow for failure of the door. Further investigation and repairs are needed.

A qualified contractor should inspect and repair as needed.

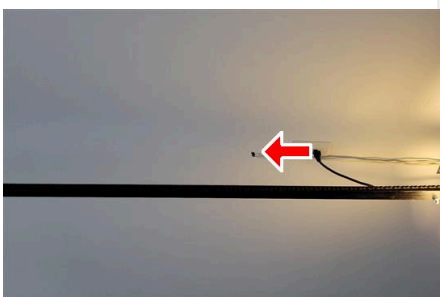
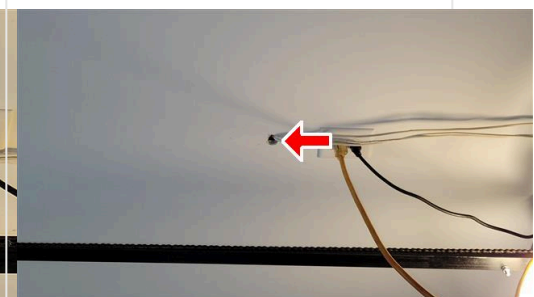
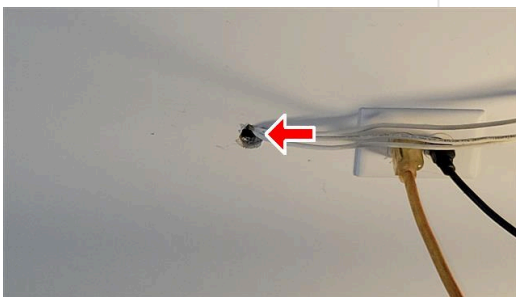
1. The fire resistance sheathing that separates garage from heated space is compromised. This is considered unsafe until corrected. Repairs are needed.

A qualified person should correct for safety.

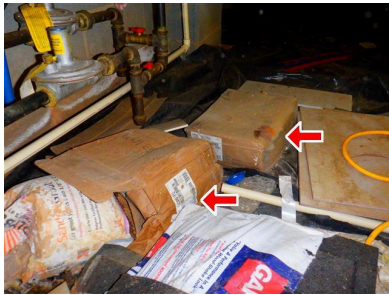
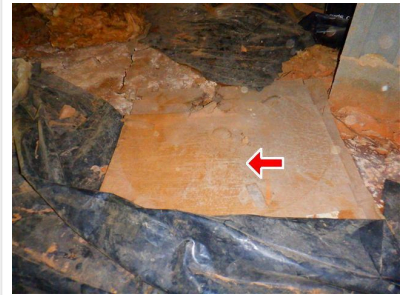
1. Wood debris is in contact with the crawl space floor in numerous areas. This can attract wood destroying organisms. Removal is needed.

A qualified contractor should inspect and repair as needed.

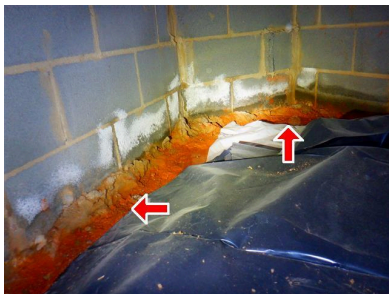
4.6 Item 1 (Picture)

1. Visible signs of water intrusion in the crawlspace (along front of home) are present from standing water on ground. Water intrusion if not corrected can lead to other problems including mold and cause excessive moisture to floor system that can lead to deterioration and increased repair cost. Further investigation and repairs are needed.

I recommend further investigation or correction by a qualified licensed contractor or water infiltration specialist.

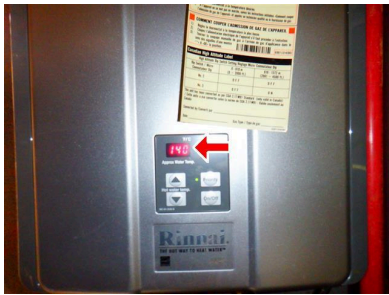
5.1 Item 1 (Picture)

1. The water heater is set over the recommended temperature. (Over 120) The risk is especially acute for infants, children, and the elderly. Water temperatures should never be set higher than 120 degrees.

This is a safety issue. Repairs are needed

A qualified contractor should inspect and repair as needed.

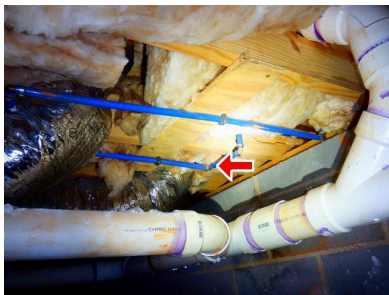
5.2 Item 1 (Picture)

1. The cold supply line is leaking in the crawlspace. Repairs are needed to prevent water damage from occurring to the home. Further investigation and repairs are needed.

A qualified licensed plumber should repair or correct as needed.

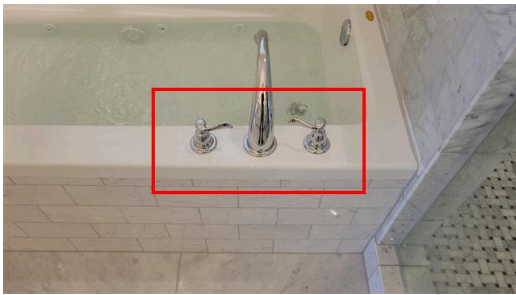
5.2 Item 9 (Picture)

1. The hot control is reversed (hot is cold, cold is hot) at the master bath. Hot should always be on the left and cold on the right for safety reasons. Scalding could occur if not corrected. Repairs are needed.

A qualified licensed plumber should repair or correct as needed.

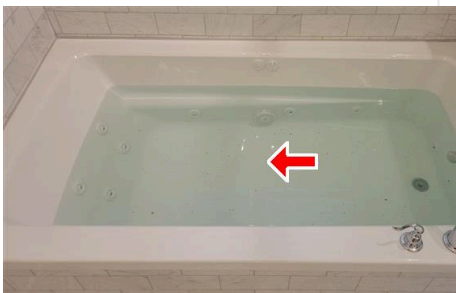
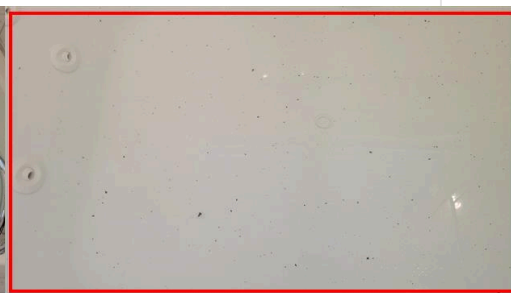
1. The jacuzzi shows signs of improper cleaning and maintenance, as a result black residue is present (likely bacteria) when the tub was operated. (Health Safety Issue) Repairs are needed.

I recommend contacting a licensed plumber.

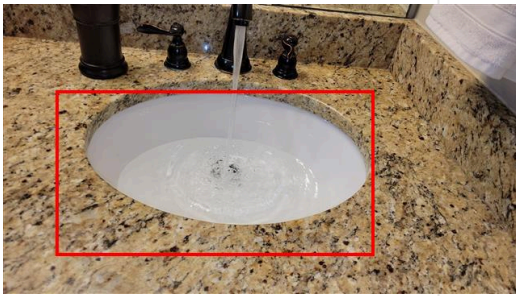
5.3 Item 1 (Picture)

1. The plumbing waste line drains slowly at the Upstairs Bath sink (right sink). A cause of a slow drain can range from a simple cleaning at stop valve or at the trap under sink. Sometimes the drain can be partially clogged down line. I am unable to determine the cause of the slow drain. Further investigation

and repairs are needed.

A qualified licensed plumber should repair or correct as needed.

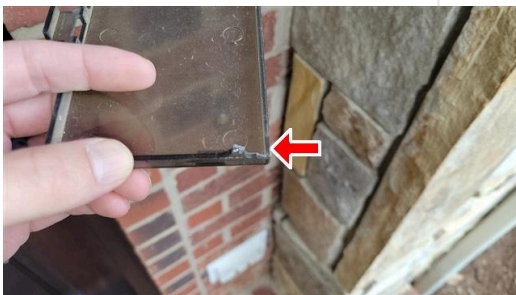
6.6 Item 1 (Picture)

1. One or more GFCI (Ground Fault Circuit Interrupter) outlet at the exterior has a damaged cover. This may allow for water intrusion to occur. Repairs are needed..

A qualified licensed electrical contractor should correct as needed.

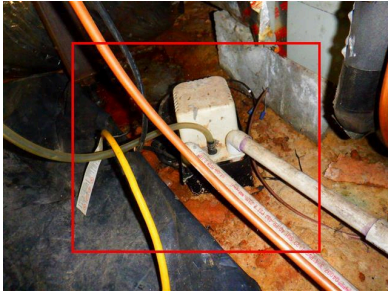
7.3 Item 1 (Picture)

1. The condensation pump is damaged and is leaking in the crawl space. Repairs are needed to prevent water damage from occurring to the home. Further investigation and repairs are needed.

A qualified licensed HVAC (Heat/Ventilation/Air conditioning Contractor) should inspect further and repair as needed.

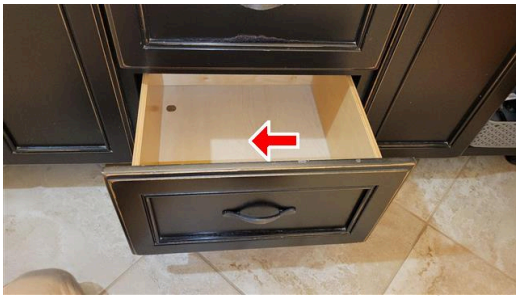
8.4 Item 1 (Picture)

1. Drawer track in upstairs bath does not work smoothly. Therefore it does not function as intended. Repairs are needed.

I recommend repair or replace as necessary.

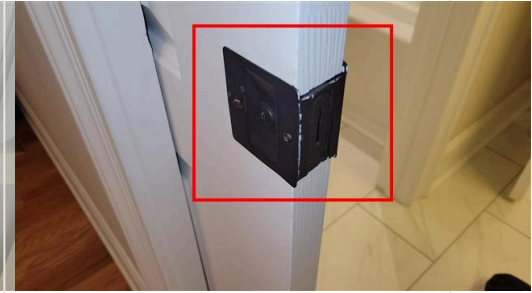
8.5 Item 3 (Picture)

1. The pocket door at the guest bathroom has a damaged latch. Therefore it does not function as intended. Repairs are needed.

A qualified person should repair or replace as needed.

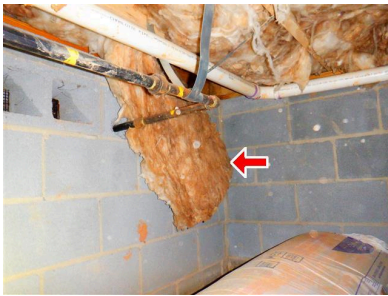
9.3 Item 1 (Picture)

1. The insulation is loose/fallen in the crawlspace. Heat loss can occur more on this home than one that is properly insulated. Repairs are needed..

A qualified person should repair or replace as needed.

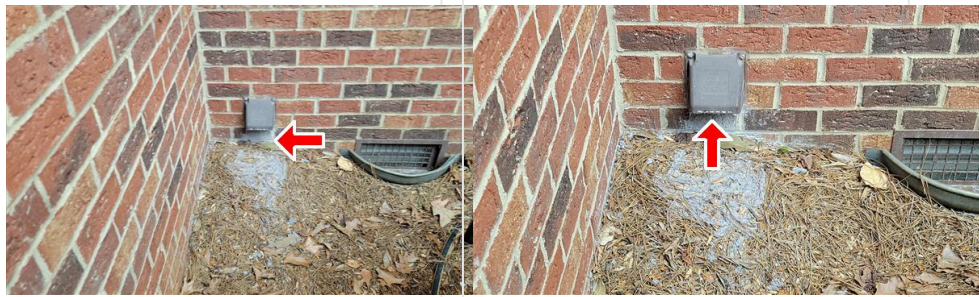
1. The dryer vent hood at the front of home does not have the proper clearance from the grade/ground to function as intended. Dryer vent exhaust shall terminate not less than 12 inches above finish grade to prevent blockages. Current conditions should be considered a fire hazard until repaired. Repairs are needed.

A qualified person should repair or replace as needed.

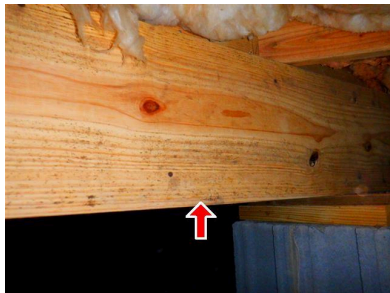
**1.0 Item 1 (Picture)**

1. Discoloration and some type of mold (Microbial) growth is present in the structure at several areas including but not limited to the crawl space and interior spaces. Evidence suggests that this condition is from a past or present elevated moisture conditions. We did not inspect, test or determine if this type of substance is or is not a health hazard. Further investigation is needed.

We recommend you contact a properly licensed expert for testing, investigation and or correction as deemed appropriate.

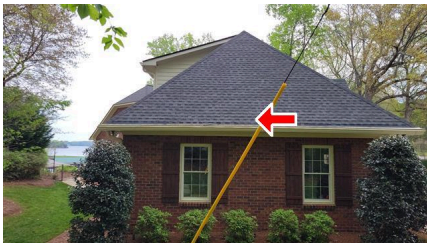
2.0 Item 1 (Picture)

1. The roof shingles is damaged at the in areas. This damage should be repaired or replaced. Further investigation and repairs are needed.

I recommend having the entire roof evaluated by a licensed roofer.

A qualified contractor should inspect and repair as needed.

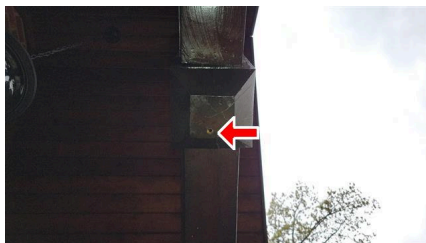
3.0 Item 1 (Picture)

1. Active word destroying insect activity at the front of the home. Further deterioration can occur if not corrected. Further investigation and repairs are needed.

A qualified person should repair or replace as needed.

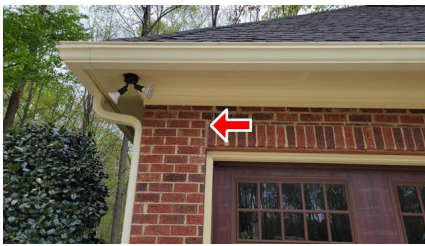
3.0 Item 5 (Picture)

1. I observed small cracks in the brick veneer at the exterior. These are typical in nature due to age and normal masonry shrinkage. Although the cracks in the brick veneer are typical, these areas should be re sealed to prevent any water penetration or damage. Further evaluation by a qualified masonry contractor is recommended for this entire condition.

I recommend repair or replace using a qualified contractor.

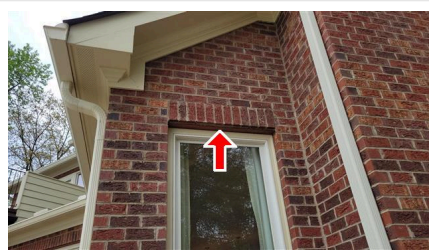
3.2 Item 1 (Picture)

1. The steel lintels around the exterior of the home are beginning to rust or have rust present. A lintel is a horizontal architectural member or steel beam support placed over a wall opening to carry the weight of the masonry placed over it. In most situation, the lintel above you windows and doors will be steel angle iron or I beam. Either due to age or improper rust proofing or weep chord and flashing placement during installation, lintels will begin to rust. Rusting lintels can expand to become much thicker then their original size. The expansive forces of rusting steel can shift entire multi-story elevations. If your lintels are currently rusting, a telltale sign of expansion is diagonal "step" pattern cracks, which can be found on either end of the window or door opening. Repairs are needed to prevent further damage to the structure. Further deterioration may occur if not repaired.

I recommend a qualified contractor inspect and repair as needed.

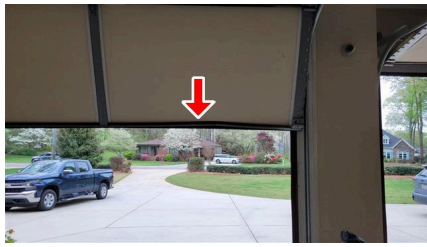
3.6 Item 1 (Picture)

1. The two garage doors at the front of home "left" door (from outside), and "right" door (from outside), are damaged at panel. This could allow for failure of the door. Further investigation and repairs are needed.

A qualified contractor should inspect and repair as needed.

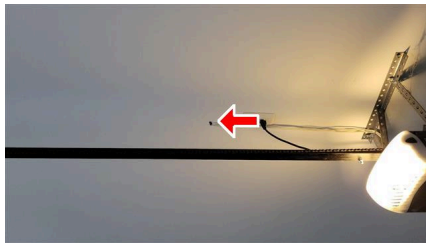
3.8 Item 1 (Picture)

1. The fire resistance sheathing that separates garage from heated space is compromised. This is considered unsafe until corrected. Repairs are needed.

A qualified person should correct for safety.

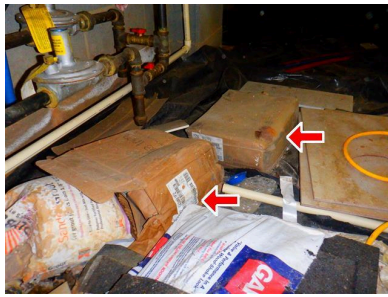
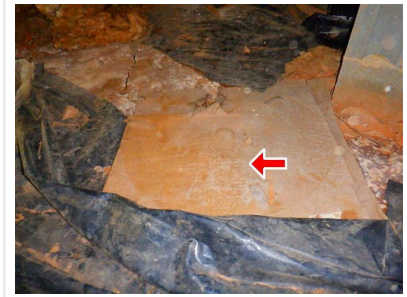
1. Wood debris is in contact with the crawl space floor in numerous areas. This can attract wood destroying organisms. Removal is needed.

A qualified contractor should inspect and repair as needed.

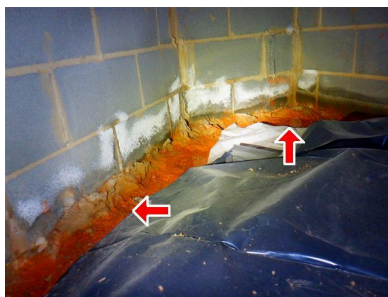
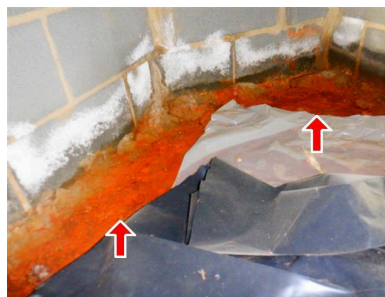
1. Visible signs of water intrusion in the crawlspace (along front of home) are present from standing water on ground. Water intrusion if not corrected can lead to other problems including mold and cause excessive moisture to floor system that can lead to deterioration and increased repair cost. Further investigation and repairs are needed.

I recommend further investigation or correction by a qualified licensed contractor or water infiltration specialist.

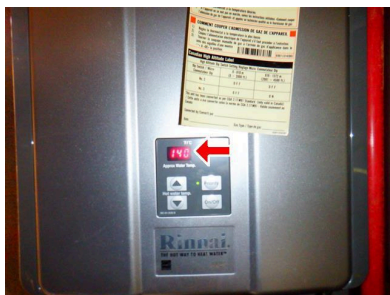
5.1 Item 1 (Picture)

1. The water heater is set over the recommended temperature. (Over 120) The risk is especially acute for infants, children, and the elderly. Water temperatures should never be set higher than 120 degrees. This is a safety issue. Repairs are needed

A qualified contractor should inspect and repair as needed.

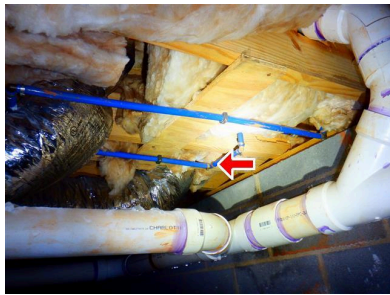
5.2 Item 1 (Picture)

1. The cold supply line is leaking in the crawlspace. Repairs are needed to prevent water damage from occurring to the home. Further investigation and repairs are needed.

A qualified licensed plumber should repair or correct as needed.

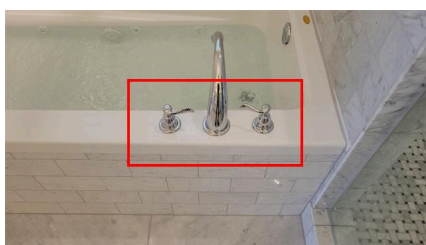
5.2 Item 9 (Picture)

1. The hot control is reversed (hot is cold, cold is hot) at the master bath. Hot should always be on the left and cold on the right for safety reasons. Scalding could occur if not corrected. Repairs are needed.

A qualified licensed plumber should repair or correct as needed.

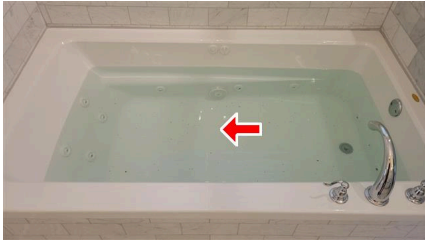
5.2 Item 10 (Picture)

1. The jacuzzi shows signs of improper cleaning and maintenance, as a result black residue is present (likely bacteria) when the tub was operated. (Health Safety Issue) Repairs are needed.

I recommend contacting a licensed plumber.

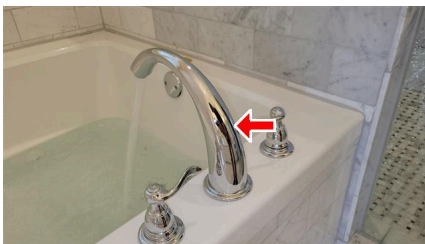
5.2 Item 12 (Picture)

1. The tub spout is loose at the master bath. Repairs are needed to prevent water damage from occurring to the home. Repairs are needed.

A qualified licensed plumber should repair or correct as needed.

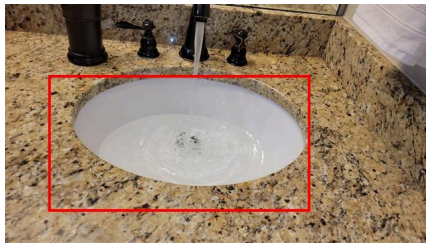
5.3 Item 1 (Picture)

1. The plumbing waste line drains slowly at the Upstairs Bath sink (right sink). A cause of a slow drain can range from a simple cleaning at stop valve or at the trap under sink. Sometimes the drain can be partially clogged down line. I am unable to determine the cause of the slow drain. Further investigation and repairs are needed.

A qualified licensed plumber should repair or correct as needed.

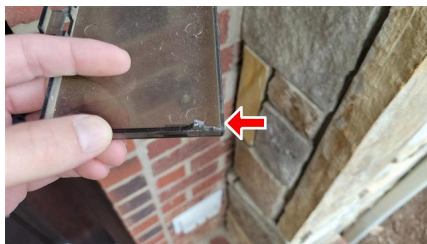
6.6 Item 1 (Picture)

1. One or more GFCI (Ground Fault Circuit Interrupter) outlet at the exterior has a damaged cover. This may allow for water intrusion to occur. Repairs are needed..

A qualified licensed electrical contractor should correct as needed.

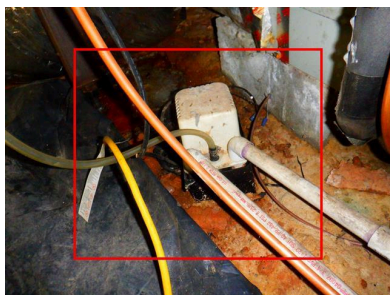
7.3 Item 1 (Picture)

1. The condensation pump is damaged and is leaking in the crawl space. Repairs are needed to prevent water damage from occurring to the home. Further investigation and repairs are needed.

A qualified licensed HVAC (Heat/Ventilation/Air conditioning Contractor) should inspect further and repair as needed.

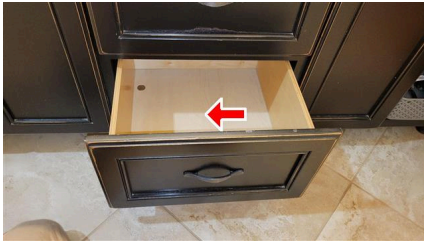
8.4 Item 1 (Picture)

1. Drawer track in upstairs bath does not work smoothly. Therefore it does not function as intended. Repairs are needed.

I recommend repair or replace as necessary.

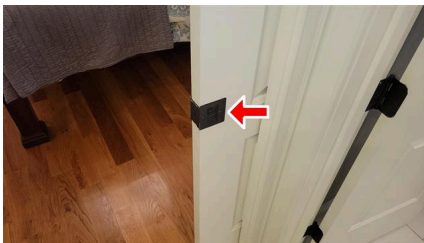
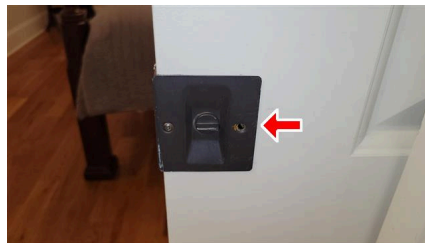
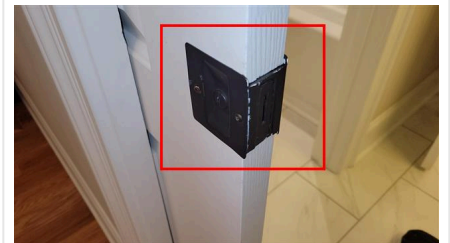
1. The pocket door at the guest bathroom has a damaged latch. Therefore it does not function as intended. Repairs are needed.

A qualified person should repair or replace as needed.

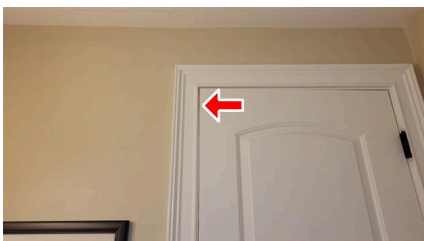
8.5 Item 4 (Picture)

1. The Privacy door rubs at jamb when closing at the Hall Bath (at top of stairs). As a result the door will not close properly. Repairs are needed.

A qualified person should repair or replace as needed.

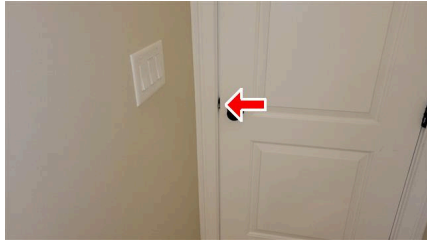
8.5 Item 5 (Picture)

1. The door at Private Bath will not latch properly. Evidence suggest that the door needs strike and latch adjustment to shut properly. This is a small repair.

A qualified person should repair or replace as needed.

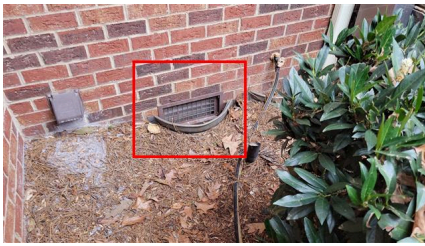
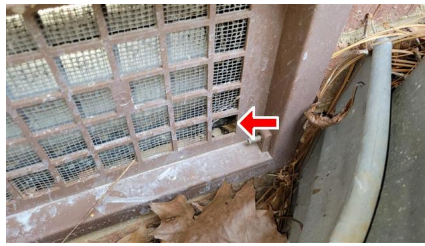
1. The screen for foundation vent(s) are damaged at the exterior. Rodents, reptiles or insects could enter into crawlspace. Repairs are needed.

A qualified person should repair or replace as needed.

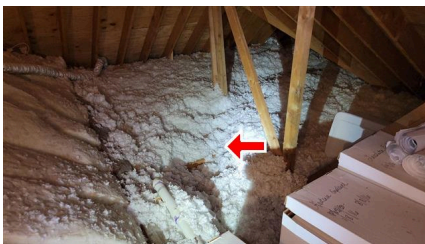
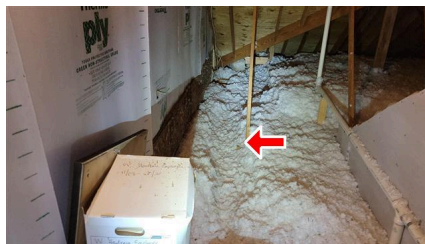
1. Fiberglass (loose-fill) insulation is is compressed in areas of the attic due to foot traffic or storage in attic. Heat loss can occur more on this home than one that is properly insulated. Repairs are recommended .

A qualified person should repair or replace as needed.

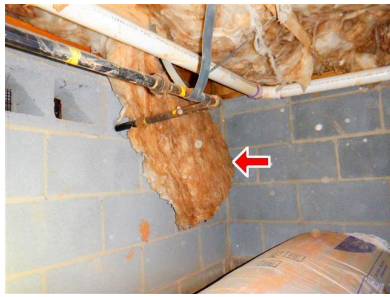
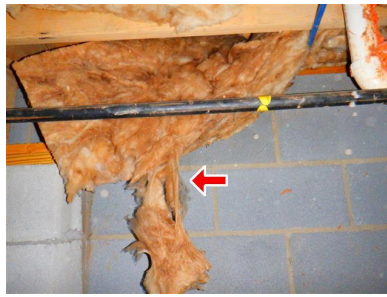
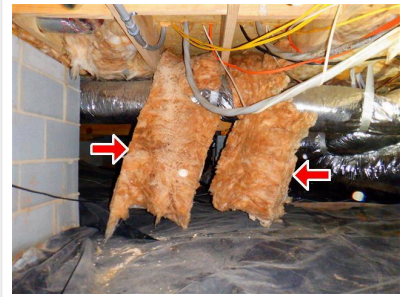
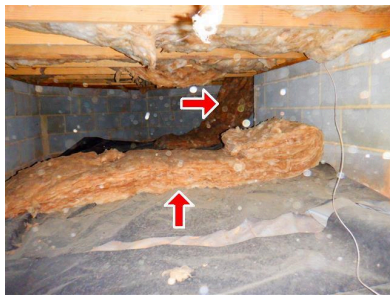
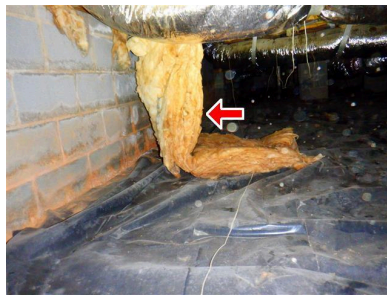
1. The insulation is loose/fallen in the crawlspace. Heat loss can occur more on this home than one that is properly insulated. Repairs are needed..

A qualified person should repair or replace as needed.

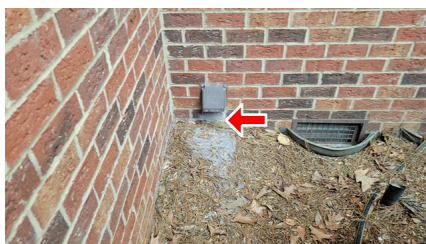
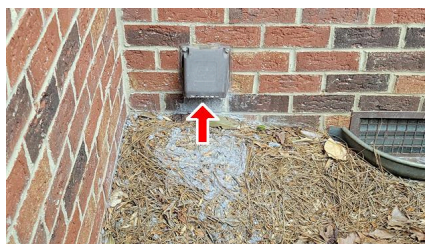
1. The dryer vent hood at the front of home does not have the proper clearance from the grade/ground to function as intended. Dryer vent exhaust shall terminate not less than 12 inches above finish grade to prevent blockages. Current conditions should be considered a fire hazard until repaired. Repairs are needed.

A qualified person should repair or replace as needed.
