INSPECTION REPORT  
9418 Wallace Pond Dr  
Huntersville NC 28078

INSPECTED BY  
Alex Parr 3692  
Above Parr Home  
Inspections

INSPECTION DATE  
📅 3/11/2026  
🕒 02:00:00 PM

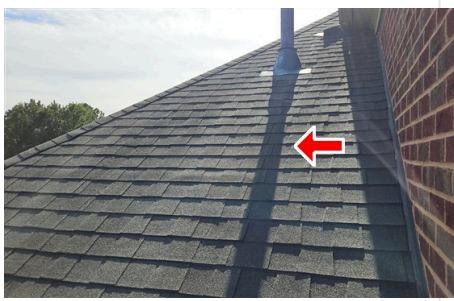
2.0 Item 1 (Picture)

The asphalt/fiberglass shingles and penetration flashings appear to be near the end of their service life. It appears that they will need replacing in the not too distant future. They show signs of heavy wear typical for

their age consisting of heavy loss of moderate to heavy wear long edges of tabs. No signs of leaks were observed at the time of inspection. Further investigation and repairs are needed. A qualified contractor should inspect and repair as needed.

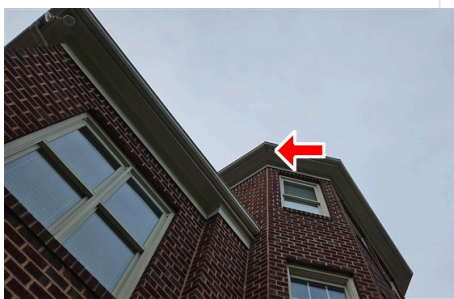
3.1 Item 1 (Picture)

The wood fascia at eave on the at rear of home deteriorated. Further deterioration may occur if not repaired. Repairs are needed.

A qualified contractor should inspect and repair as needed.

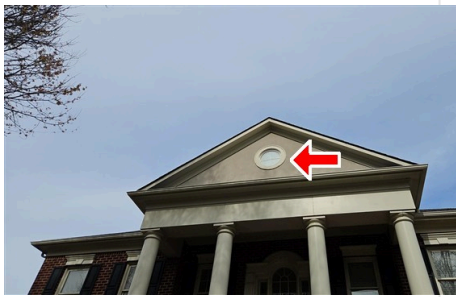
3.2 Item 1 (Picture)

The window and frame is deteriorated at most windows. Further deterioration may occur if not repaired This may allow water intrusion to occur. Further investigation and repairs are needed.

A qualified contractor should inspect and repair as needed.

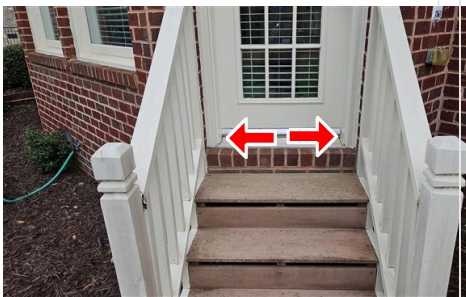
3.3 Item 1 (Picture)

The entry door at rear of home deteriorated at bottom of jamb (s). Further deterioration may occur if not repaired. Further investigation and repairs are needed.

A qualified contractor should inspect and repair as needed.

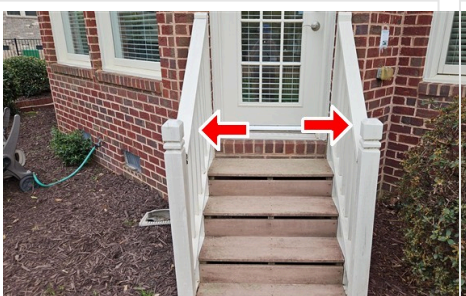
3.4 Item 1 (Picture)

The guardrails on steps at the rear of home damaged. An injury could occur if not corrected. A repair or replacement is needed.

A qualified contractor should repair or replace as needed.

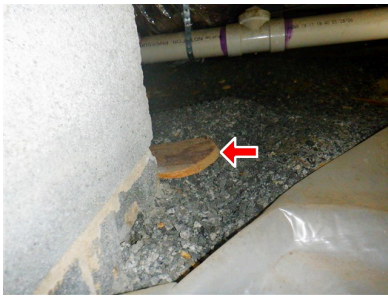
**4.5 Item 1 (Picture)**

Wood debris is in contact with the crawl space floor in numerous areas. This can attract wood destroying organisms. Removal is needed.

A qualified contractor should inspect and repair as needed.

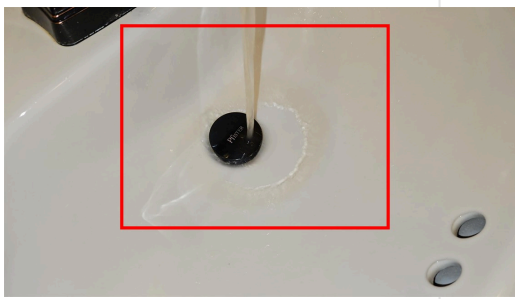
5.1 Item 1 (Picture)

The hot water in the home has a rust color to it . This may be an indication that the water heater is rusted or needs to be flushed. A more thorough inspection by a qualified contractor is needed.

A qualified licensed plumber should repair or correct as needed.

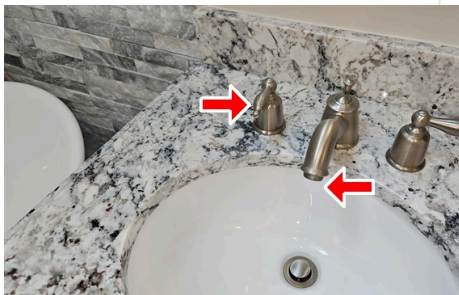
5.2 Item 1 (Picture)

(1) The shut off valve for the hot water at the left master bathroom sink is turned off. I am unable to determine the reason why. Further investigation is needed.

A qualified licensed plumber should repair or correct as needed.

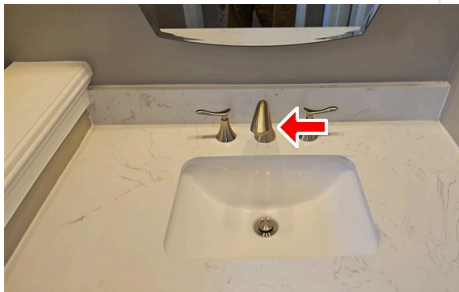
5.2 Item 3 (Picture)

(2) The sink faucet at the guest bath is loose. This can allow water damage to occur to the home. Further investigation and repairs are needed.

A qualified licensed plumber should repair or correct as needed.

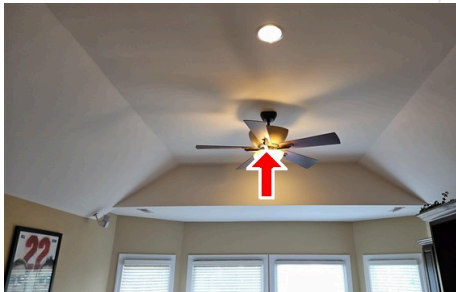
6.4 Item 1 (Picture)

(1) The remote for the 3rd story bonus room did not function at the time of inspection. Further investigation and repairs are needed.

A qualified licensed electrical contractor should correct as needed.

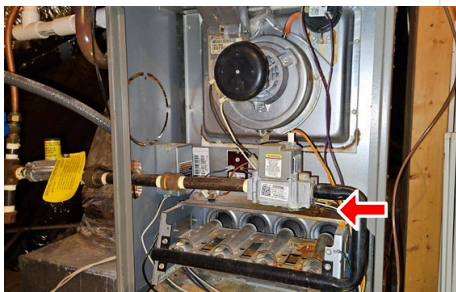
7.0 Item 1 (Picture)

The gas furnace in the attic as evidence of leaks and rust on different electrical components. Leaks can cause damage to unit or home. Further investigation and repairs are needed.

A qualified HVAC person should inspect further and repair or replace as needed.

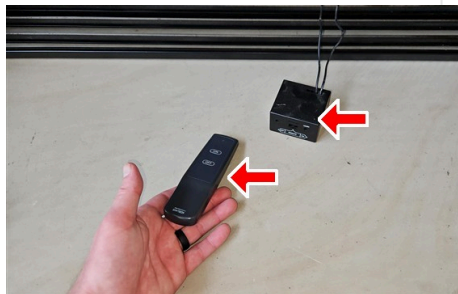
7.7 Item 1 (Picture)

The remote for the gas logs did not function at the time of the inspection in the living room. Evidence of corrosion at the batteries under the fireplace. Further investigation and repairs are needed.

A qualified licensed HVAC (Heat/Ventilation/Air conditioning Contractor) should inspect further and repair as needed.

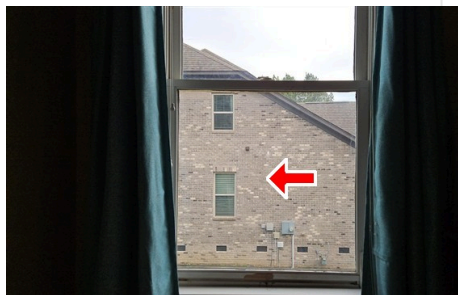
8.6 Item 1 (Picture)

One window at the master has water damage occurring. Further deterioration may occur if not repaired. Further investigation and repairs are needed.

A qualified contractor should inspect and repair as needed.

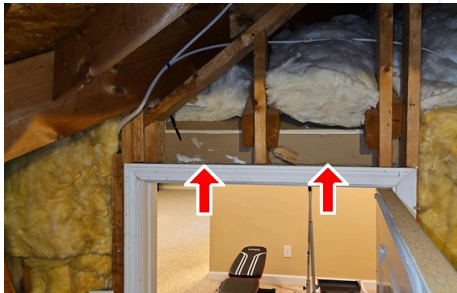
9.2 Item 1 (Picture)

Fiberglass (Batts) insulation is missing in areas in the attic. Heat loss can occur more on this home than one that is properly insulated. Repairs are needed.

A qualified person should repair or replace as needed.

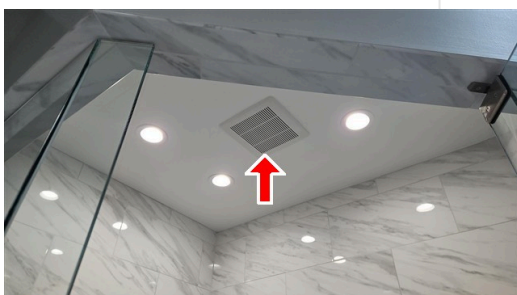
9.4 Item 1 (Picture)

The Exhaust fan did not work at the master bath. This may allow moisture damage to occur to the home. Repairs are needed.

A qualified contractor should inspect and repair as needed.

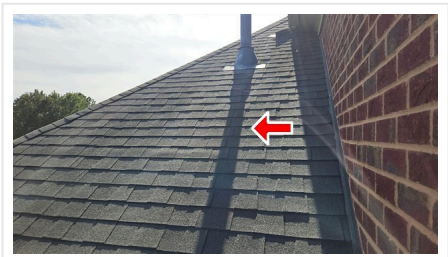
2.0 Item 1 (Picture)

The asphalt/fiberglass shingles and penetration flashings appear to be near the end of their service life. It appears that they will need replacing in the not too distant future. They show signs of heavy wear typical for their age consisting of heavy loss of moderate to heavy wear long edges of tabs. No signs of leaks were observed at the time of inspection. Further investigation and repairs are needed.  
A qualified contractor should inspect and repair as needed.

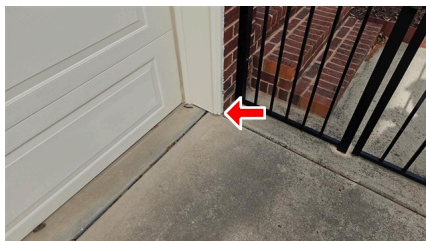
3.0 Item 1 (Picture)

The Wood trim at the exterior in areas is deteriorated. Further deterioration can occur if not corrected. Repairs are needed.

A qualified contractor should inspect and repair as needed.

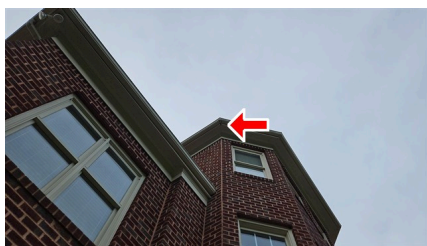
3.1 Item 1 (Picture)

The wood fascia at eave on the at rear of home deteriorated. Further deterioration may occur if not repaired. Repairs are needed.

A qualified contractor should inspect and repair as needed.

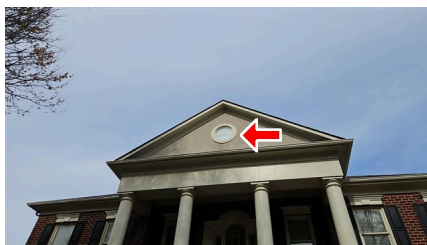
3.2 Item 1 (Picture)

The window and frame is deteriorated at most windows. Further deterioration may occur if not repaired This may allow water intrusion to occur. Further investigation and repairs are needed.

A qualified contractor should inspect and repair as needed.

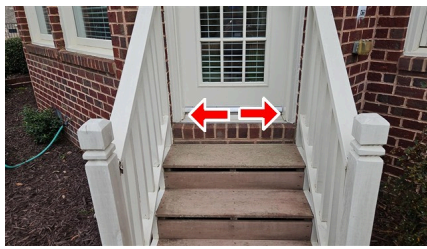
3.3 Item 1 (Picture)

The entry door at rear of home deteriorated at bottom of jamb (s). Further deterioration may occur if not repaired. Further investigation and repairs are needed.

A qualified contractor should inspect and repair as needed.

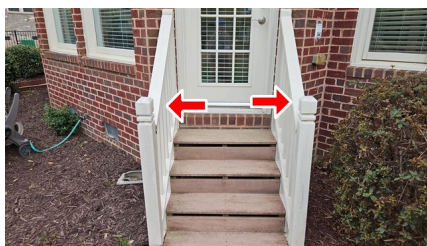
3.4 Item 1 (Picture)

The guardrails on steps at the rear of home damaged. An injury could occur if not corrected. A repair or replacement is needed.

A qualified contractor should repair or replace as needed.

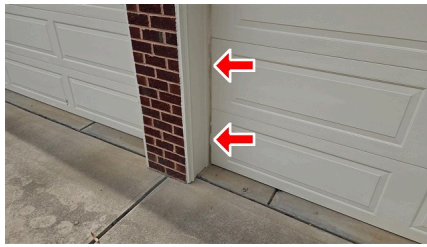
3.6 Item 1 (Picture)

The garage door at the right side (facing front) is damaged at panel missing weather-stripping. This can cause some heat loss in winter and loss of cool air in summer if not corrected. Repairs are needed. A qualified person should repair or replace as needed.

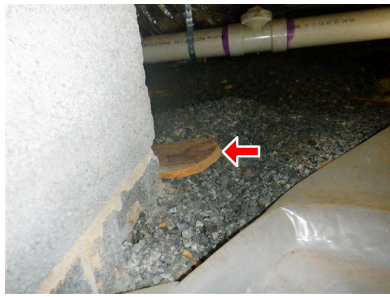
4.5 Item 1 (Picture)

Wood debris is in contact with the crawl space floor in numerous areas. This can attract wood destroying organisms. Removal is needed.

A qualified contractor should inspect and repair as needed.

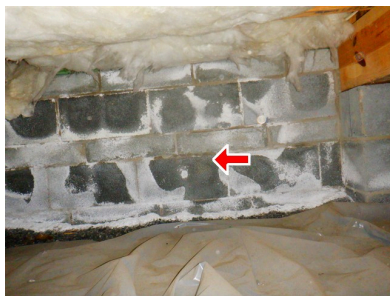
4.6 Item 1 (Picture)

White efflorescence (powder substance) on block wall indicates moisture is in contact with the masonry. This does not necessarily indicate that intrusion will occur. I recommend checking the gutters and the downspout drain lines for proper operation. Also, a water proofing paint could be applied to the interior side of the block if necessary. Efflorescence is found on many homes without water intrusion occurring inside the home. But, it should alert you to the possibility that future steps may be needed.

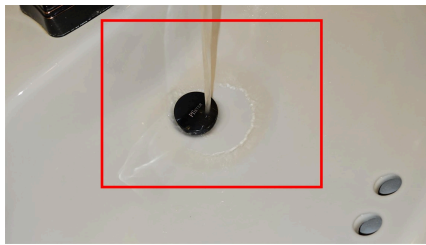
5.1 Item 1 (Picture)

The hot water in the home has a rust color to it . This may be an indication that the water heater is rusted or needs to be flushed. A more thorough inspection by a qualified contractor is needed.

A qualified licensed plumber should repair or correct as needed.

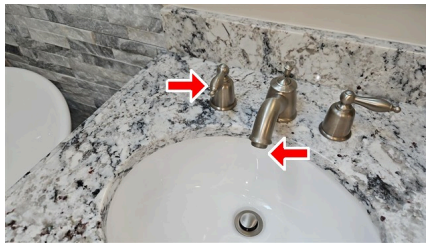
5.2 Item 1 (Picture)

(1) The shut off valve for the hot water at the left master bathroom sink is turned off. I am unable to determine the reason why. Further investigation is needed.

A qualified licensed plumber should repair or correct as needed.

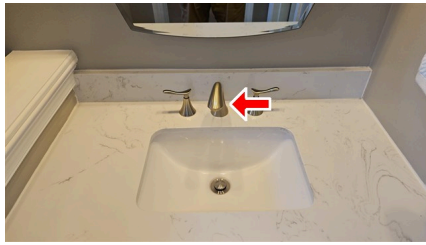
5.2 Item 3 (Picture)

(2) The sink faucet at the guest bath is loose. This can allow water damage to occur to the home. Further investigation and repairs are needed.

A qualified licensed plumber should repair or correct as needed.

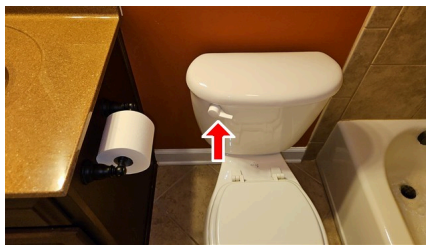
5.2 Item 5 (Picture)

(3) The handle 3rd story toilet is installed upside down. This does not appear to affect the function. Repairs are recommended.

A qualified licensed plumber should repair or correct as needed.

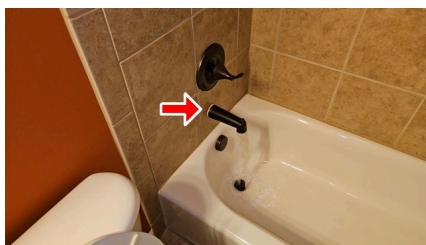
5.2 Item 7 (Picture)

(4) The tub faucet in the upstairs guest bath is not sealed to the wall properly. This may allow water damage to occur to the home. Further investigation and repairs are needed.

A qualified licensed plumber should repair or correct as needed.

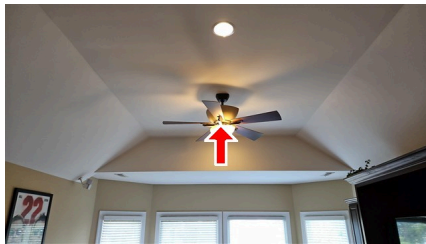
6.4 Item 1 (Picture)

(1) The remote for the 3rd story bonus room did not function at the time of inspection. Further investigation and repairs are needed.

A qualified licensed electrical contractor should correct as needed.

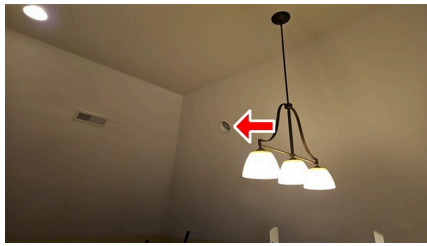
6.4 Item 3 (Picture)

(2) The light fixture does not work (try bulb first) at the throughout the home. Electrical issues are considered a hazard until repaired. Further investigation and repairs are needed.  
A qualified licensed electrical contractor should correct as needed.

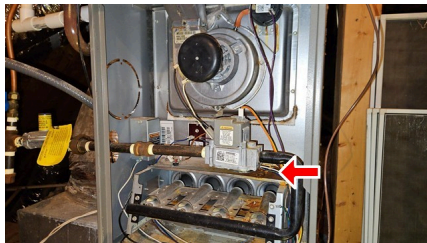
7.0 Item 1 (Picture)

The gas furnace in the attic as evidence of leaks and rust on different electrical components. Leaks can cause damage to unit or home. Further investigation and repairs are needed.

A qualified HVAC person should inspect further and repair or replace as needed.

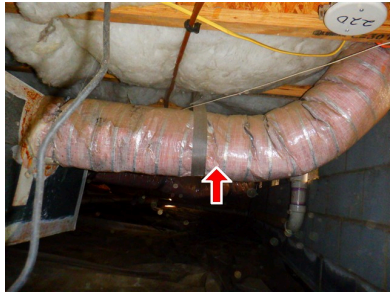
7.3 Item 1 (Picture)

The supply duct pipe in the crawlspace is deteriorated . Energy loss is occurring Further investigation and

repairs are needed.

A licensed HVAC contractor should service or repair unit.

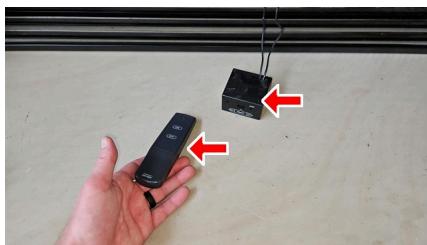
7.7 Item 1 (Picture)

The remote for the gas logs did not function at the time of the inspection in the living room. Evidence of corrosion at the batteries under the fireplace. Further investigation and repairs are needed.

A qualified licensed HVAC (Heat/Ventilation/Air conditioning Contractor) should inspect further and repair as needed.

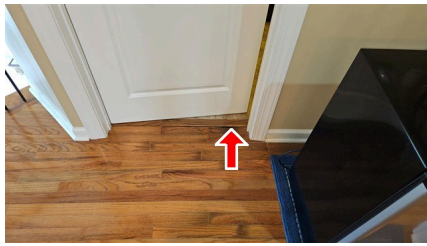
8.5 Item 1 (Picture)

(1) The door at the washer/dryer room hits the threshold. As a result the door will not close properly. Repairs

are needed.

A qualified person should repair or replace as needed.

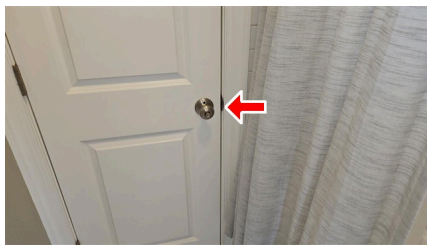
8.5 Item 3 (Picture)

1. The door at Guest bath will not latch properly. Evidence suggest that the door needs strike and latch adjustment to shut properly. This is a small repair.

A qualified person should repair or replace as needed.

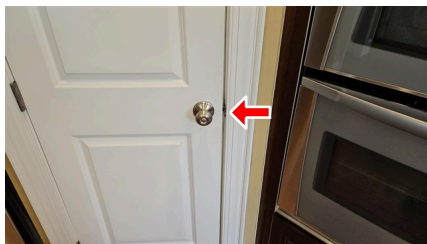
8.5 Item 4 (Picture)

1. The door at pantry will not latch properly. Evidence suggest that the door needs strike and latch adjustment to shut properly. This is a small repair.

A qualified person should repair or replace as needed.

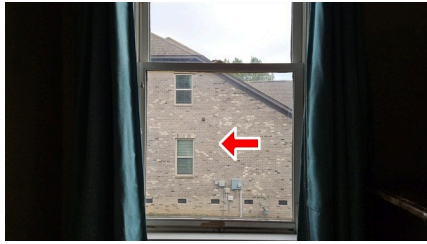
8.6 Item 1 (Picture)

One window at the master has water damage occurring. Further deterioration may occur if not repaired. Further investigation and repairs are needed. A qualified contractor should inspect and repair as needed.

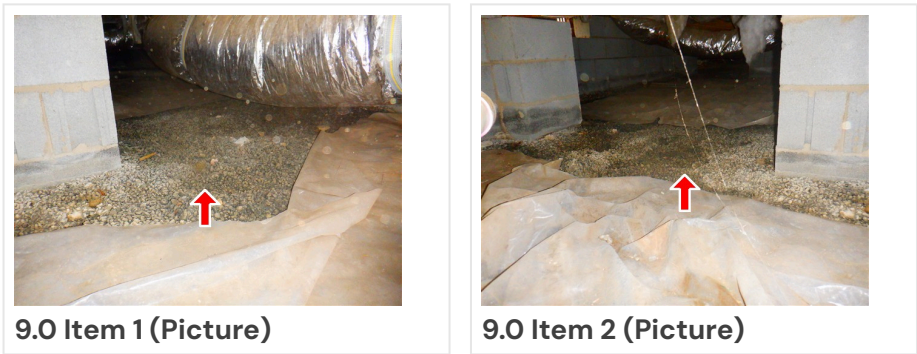
The vapor barrier (plastic) on the crawlspace ground is missing in areas. A vapor barrier provides added protection to the floor system from moisture or dampness that can enter from ground. Repairs are needed. A qualified person should repair or replace as needed.

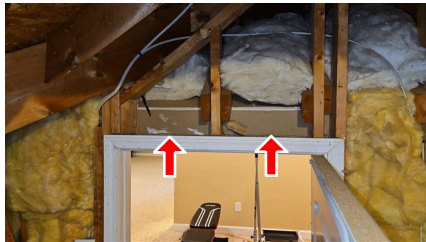
9.2 Item 1 (Picture)

Fiberglass (Batts) insulation is missing in areas in the attic. Heat loss can occur more on this home than one that is properly insulated. Repairs are needed.

A qualified person should repair or replace as needed.
