# Inspection Report

**Carolinas Home Inspections, LLC**

Mark Powers

1022 Kenilworth Ct NW

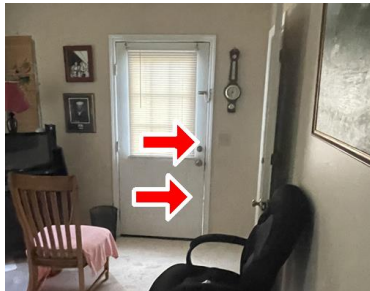
2.1 Item 1 (Picture)

At rear basement exterior door, daylight was visible at the weatherstripping on the side of the door. This can produce drafts. The weatherstripping needs to be "enlarged" at this side of the door to prevent drafts. Recommend repair.

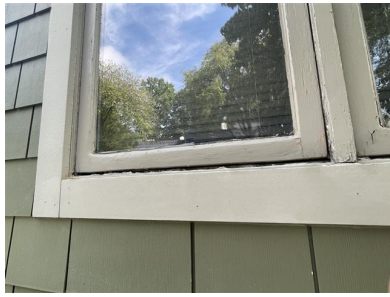
2.2 Item 1 (Picture)

Many of exterior casement window bottom stiles are in need of repair or are near to rotting. Some have been repaired with wood hardener, many have not. I operated some of the windows from the inside, but there were some I did not operate due to fear that operating them may further damage the bottom stiles. Repair or replacement of windows is needed.

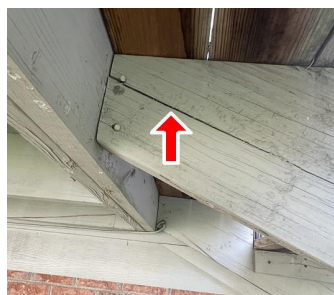
B) - the middle stair stringer is cracked near where it connects to the side of the deck. A joist hanger (mentioned above) will help to prevent this from further cracking)

**2.3 Item 3 (Picture)**  
middle stair stringer cracked

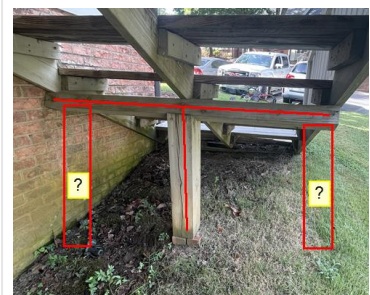
**2.3 Item 4 (Picture)**

(2) At the side deck structure, the deck structure was built using methods approved at the time of the build. It is likely that most all condo units have the same building method to each deck. I noted no rotten boards or structure issues which require "immediate" attention. However, there are some safety features which could be added to ensure long-term structural stability for occupant safety.

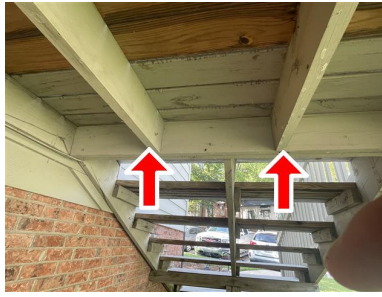
**2.3 Item 5 (Picture)**  
end of lateral 4x4 not touching the stringer (no support)

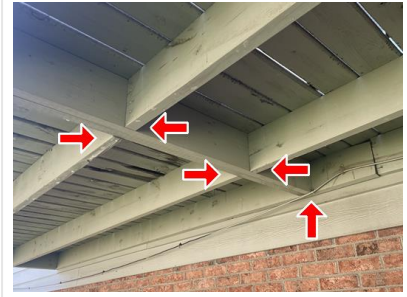
D) - all deck joists should have joist hangers applied for safety

**2.3 Item 7 (Picture)**  
joist hangers would help to provide a higher level of structural safety

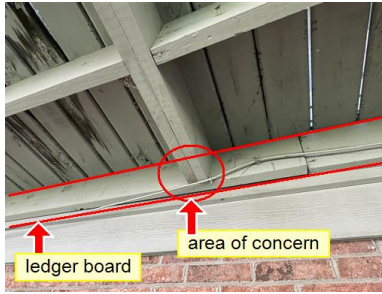
**2.3 Item 9 (Picture)**

E) - at the deck ledger board which runs parallel to the exterior wall of unit, the ledger board was applied over the siding, and there is no indication that this ledger board was properly fastened to the exterior frame of the wall using bolts. Due to this, the area of the ledger board where the double joists are located (shown in picture 9) may not be fully supported. Even if joists hangers are applied at the double joists (at red circle in picture), the ledger board which "carries the weight" of the double joists does not appear to be bolted to the house (only nailed). Further evaluation should be done at this area

You will need to address this with the HOA, which may (or may not) agree with my safety suggestions. ..

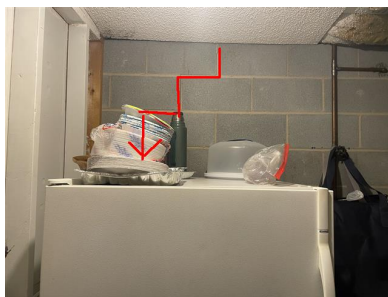
4.0 Item 1 (Picture)

In basement utility room there is a small hairline stair-step crack in the foundation block above the refrigerator (to the left of the vertical copper water pipe). This crack is approx 1/16" or less and does not appear to pose a structural concern at the moment. It should be monitored to ensure the crack does not get larger. If crack begins to exceed 1/4" or if water intrusion is noted at this crack in the future, the HOA should be contacted. This is FYI

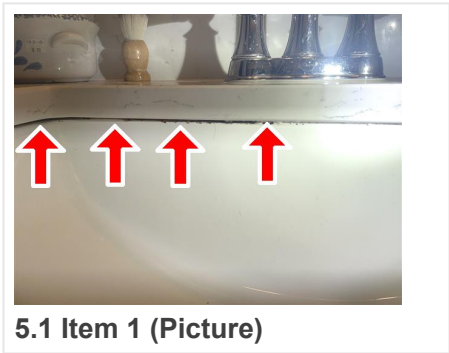
(1) At master bath sink, the sink bowl needs to have caulking applied in certain areas where the sink bowl intersects the underside of the countertop. There appears to be "void" (gap) in various areas.

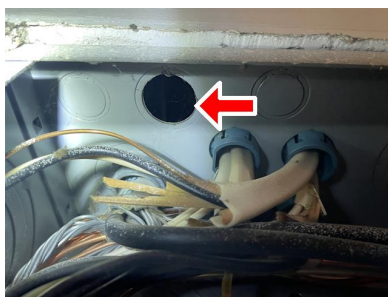
Inside the electrical panel, the knock-out hole at the top of the panel needs to be covered with knock-out plate, and at the bottom of the panel, the service entrance cables from the meter need to have a bushing installed (the bushing is meant to protect the electrical cable insulation from chaffing against the metal of the box). Recommend repair by electrician if/when they are on site for other issues noted in this section.

**6.1 Item 1 (Picture)**  
hole at top

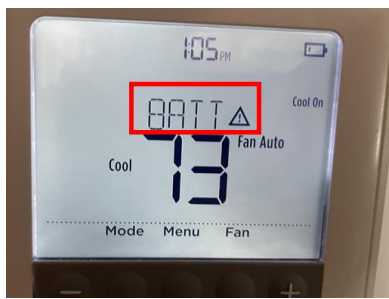
**7.3 Item 3 (Picture)**

(2) Battery needs to be replaced in the digital thermostat.

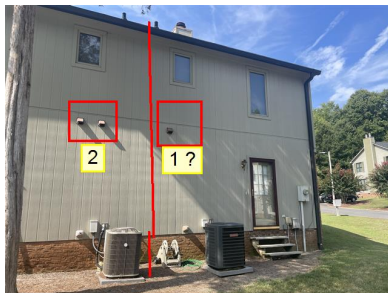
**8.3 Item 1 (Picture)**

At basement bathroom, it is an interior bathroom (no window) and does not have an exhaust fan installed. This is unusual, as bathrooms which include a shower (but no window) typically have been required to have fans for decades. There could be several reasons for this. 1) This issue may go back to the original build, and it was just never installed. 2) There may be a fan pipe in the ceiling, but the light in the bathroom did not have a fan installed. If this is the case, the light can simply be switched out for a fan/light, BUT there was only 1 vent termination noted at the rear of home, and the adjacent unit appears to have 2 vents at the exterior. The vent termination at the exterior rear wall may have been covered up with newer siding, and the termination vent at the rear wall would need to be relocated to properly vent to the exterior. (Seller stated that there was no fan when they bought it)

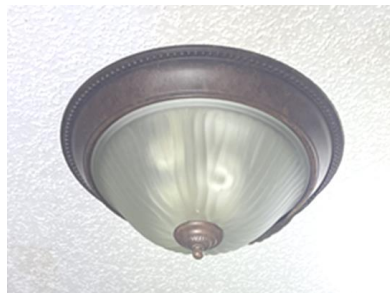
**8.3 Item 2 (Picture)**  
light in basement bath - no fan noted

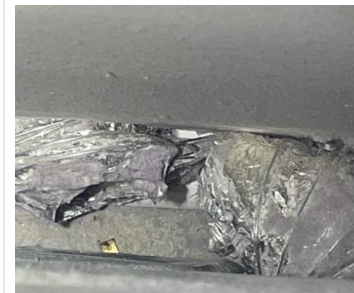
Additionally regarding the laundry dryer vent - When looking behind the dryer, there was an excessive amount of lint. I then noted that the flexible vent pipe behind the dryer has a significant hole in it. This flexible dryer hose can obviously be replaced, BUT my concern is this: Due to this hole in the dryer vent, I could not test the dryer vent to determine if the singular vent termination at the rear exterior wall is for the dryer or the bath fan. Further verification will be needed to determine if the singular vent pipe at the rear is for the dryer or the bath vent (unit next door appears to have 2 vents instead of 1, assuming the adjacent unit has the same floor plan) The repair method for the basement bathroom vent and dryer vent will be determined upon further verification of both of these areas. Repair of the dryer vent and operation of the dryer may be the easiest way to determine what this singular vent is connected to (assuming the dryer vent is not clogged inside the wall or ceiling) NOTE: the laundry room and basement bath are aligned back to back, so it should be relatively easy to find out what steps need to be taken by opening up the bathroom ceiling. The laundry vent pipe should run above the bathroom ceiling as well.

**8.3 Item 3 (Picture)**  
hole in vent flex pipe behind the dryer

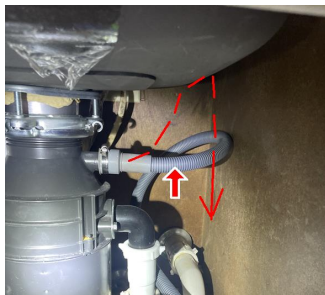
9.0 Item 1 (Picture)

The dishwasher drain hose under the sink which attaches to the disposal needs to be elevated to a height just above the bottom of the sink and attached to the backside cabinet wall with a metal strap. This is called a "high loop" and it prevents water from the disposal from draining back into the dishwasher basin. This is a minor repair.

The dishwasher drain hose was not installed as to create a trap under sink.(known as a "high loop" ) The high loop prevents grey water and debris from disposal from running back to he dishwasher drain basin. Grey water which sits in the dishwasher basin can create mildew and foul smells inside the dishwasher. Repair recommended.

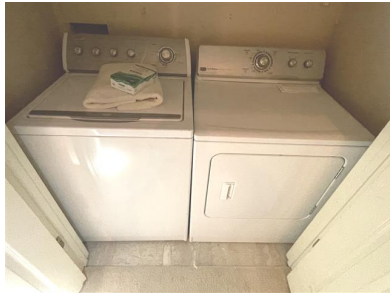
9.6 Item 1 (Picture)

Partial inspection - I did not operate the clothes washer or dryer. These are not considered built-in appliances and typically do not convey (seller stated they are not transferring). I DID view the washer connections behind these units. No water leak stains were noted
