## INSPECTION Template

## INSPECTION CHECKLIST

| Property Address | 8803 Peninsula DR Terrell NC 28682. |

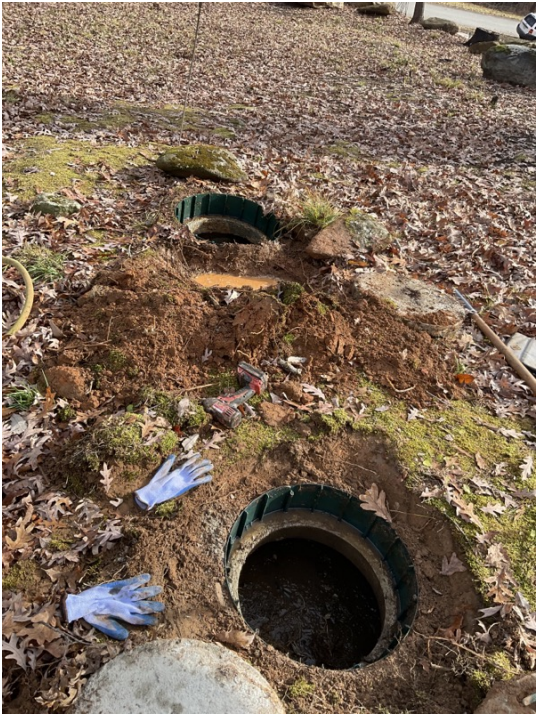
Riser/Lid Photo

| Tank Lids INTACT | Yes |

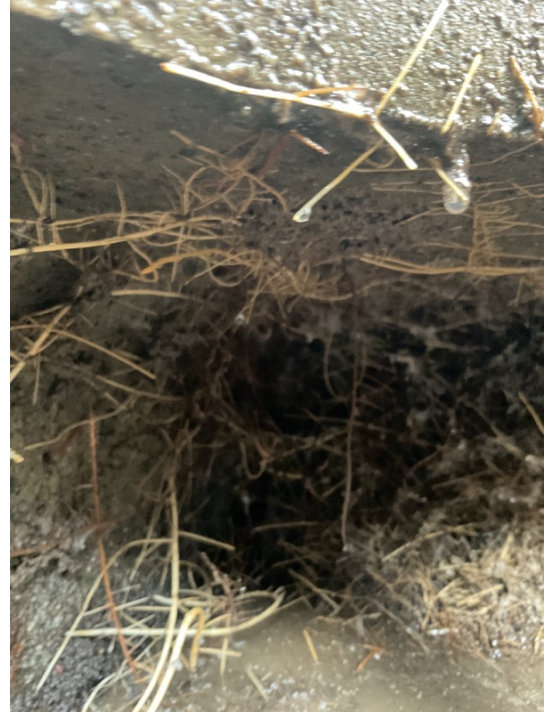
Photo of Roots/Leakage

| NO ROOTS present in tank | Yes roots are intruding around the incoming pipe. |
| Describe extent of roots if present in tank | Roots are intruding around the incoming pipe. |

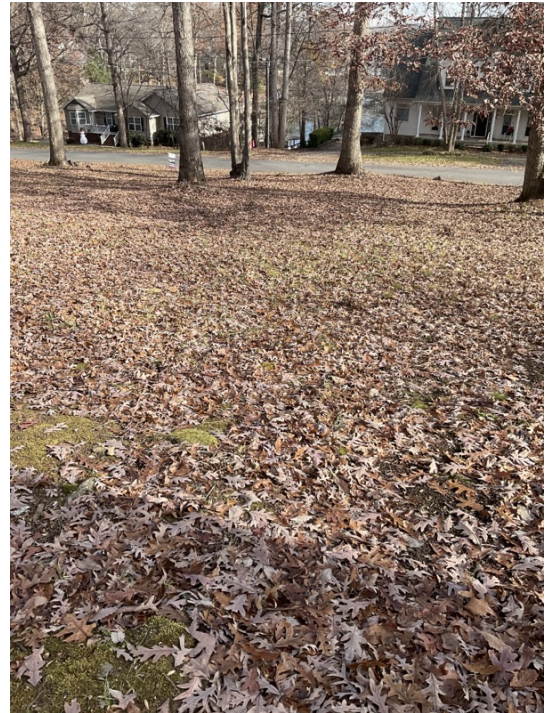
25 percent reduction system installed on contour

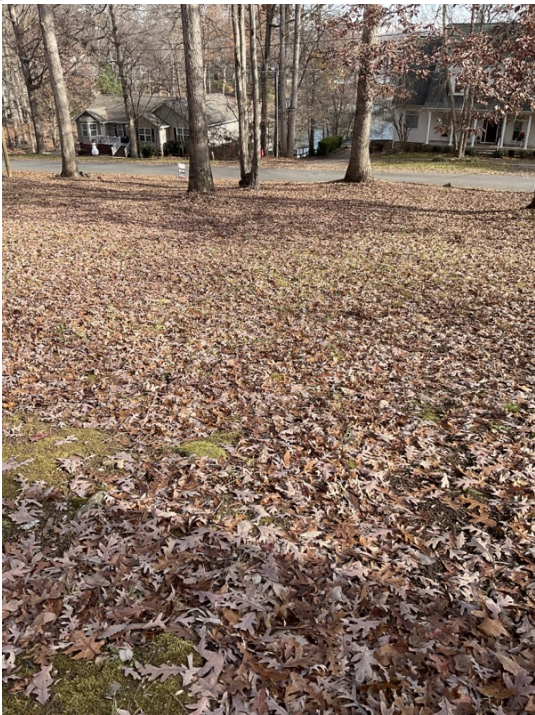
| Photo #2 of Dispersal Field | |

| Evidence of past or current SURFACING at time of Inspection | No |

| Effluent is reaching the Dispersal Field | Yes |

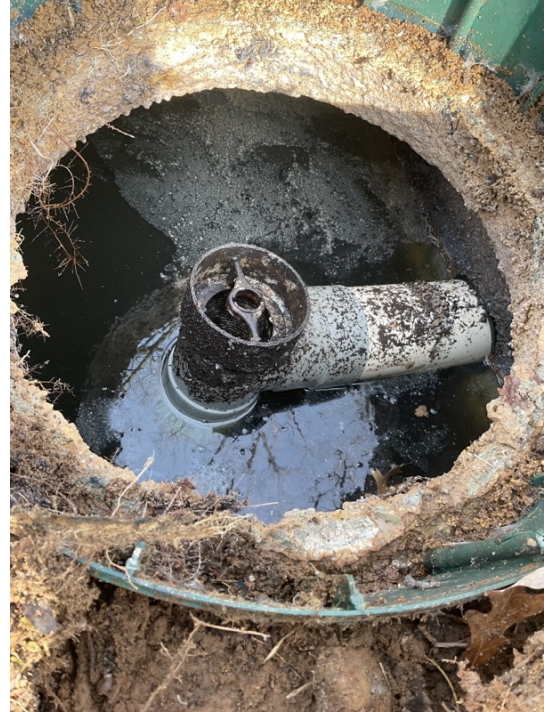
Photo 1 of Needed Repair

| Yes. Filter is not level. Roots are intruding around the incoming pipe. | |

Consequences of the adverse condition/s Filter is not level

Client should contact the Environmental Health Dept  
and/or a Certified on-site wastewater contractor in this  
County
