RE: Inspection Report for 113 Ivy Hollow Ln Mooresville NC 28117

TCW Wastewater Management, Inc.  
5600 Lakeview Road  
Charlotte, NC 28269

System Type: LCPM-2/8

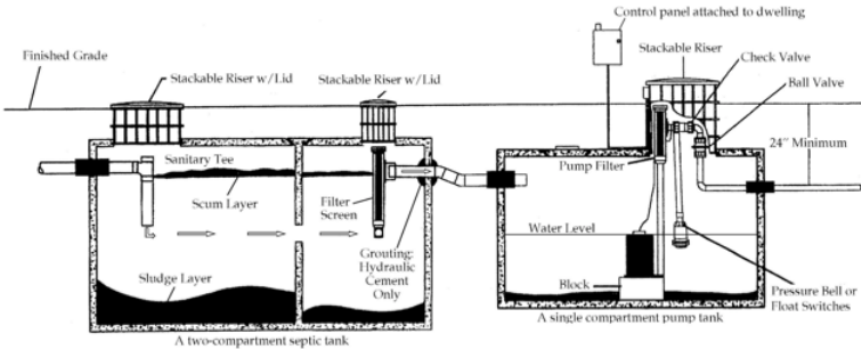
Notes:  
Homeowner has repaired riser and lid. He has fiberglassed the lid and reinforced the riser with metal and brackets so lids will seal correctly. Tanks have also been pumped. Also a brush filter has been added. Inlet pipe is marginal and we will monitor for now.

Inlet Sludge Level and Clean Filter
