Akoya Zinna(Damac Hills 2)  
Townhouse ABC

TECHNICAL SNAGGING REPORT

3-BEDROOM TOWNHOUSE

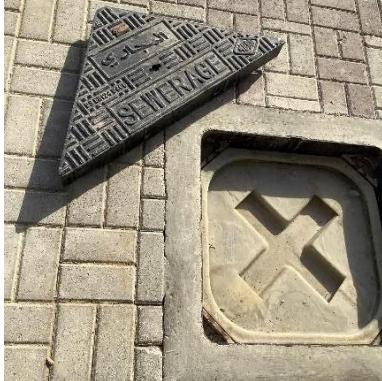
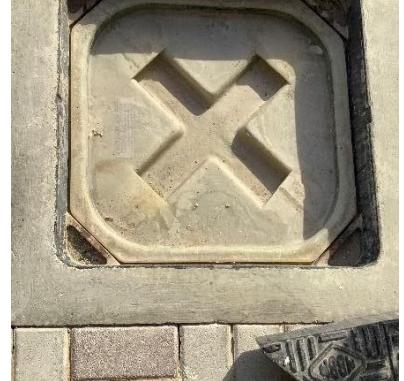
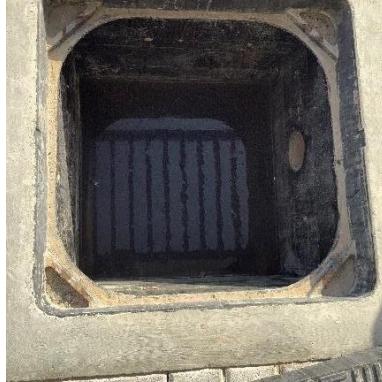
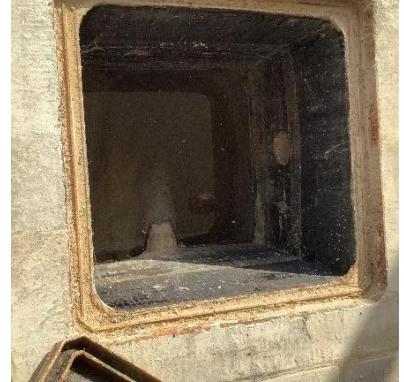
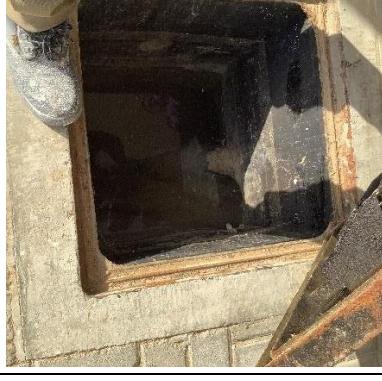
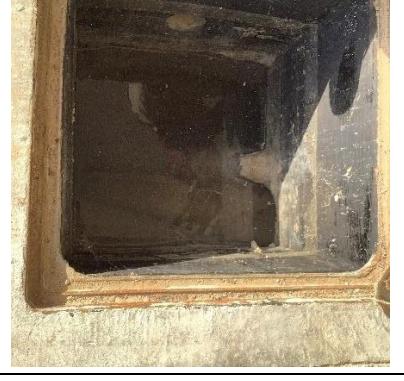
SN	Room	Item	Snag Description	Snag Images
001	Exterior	Floor – Sewage	<ul style="list-style-type: none"> <li>• Sewage blocked. Filled and not cleaned whole system must be cleaned and flushed.</li> <li>• No proper sand filling around the interlocks in all area</li> <li>• Sewage cover needs cleaning and painting.</li> </ul>

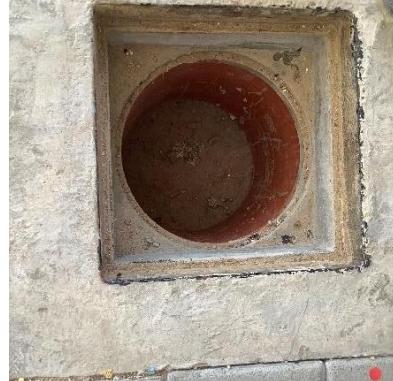
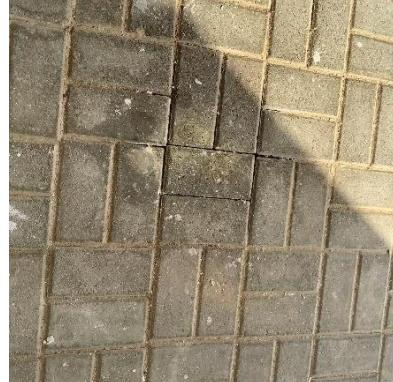
SN	Room	Item	Snag Description	Snag Images
002	Exterior	Floor	<ul style="list-style-type: none"> <li>• Gully trap needs to be cleaned properly.</li> <li>• No proper sand filling between the interlock.</li> <li>• No correct paint marking on the interlock.</li> <li>• Dirt all over the surface and needs to be cleaned.</li> <li>• No proper finish around the floor drain.</li> <li>• No cutout for gas cylinder pipe in the gas cylinder cabinet.</li> </ul>

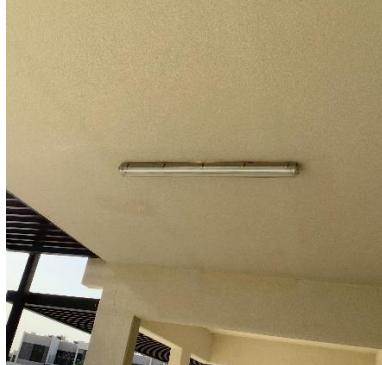
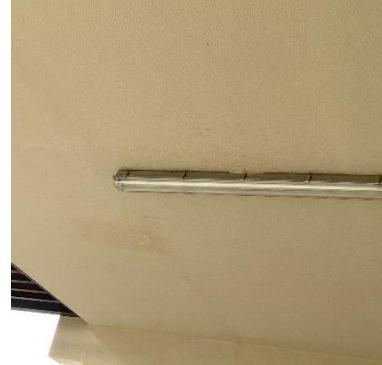
SN	Room	Item	Snag Description	Snag Images	
003	Exterior	Ceiling	<ul style="list-style-type: none"> <li>Leakage observed from the ceiling.</li> <li>Patches observed on the ceiling.</li> </ul>

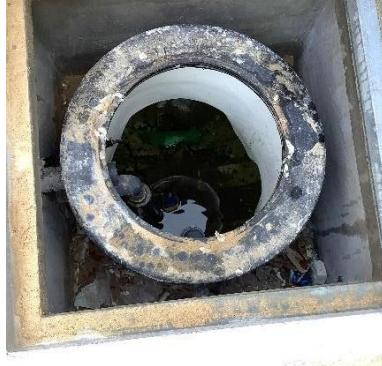
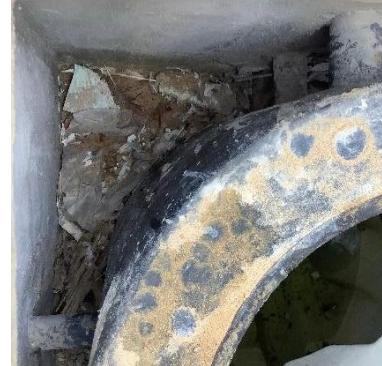
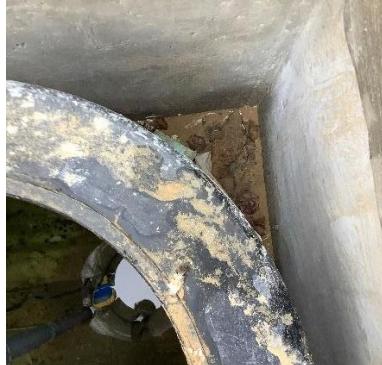
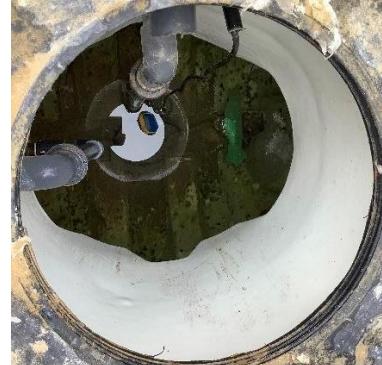
004	Backyard	Water tank	<ul style="list-style-type: none"> <li>Uncleaned area around the water tank.</li> <li>Molds observed in the water tank; must be deep cleaned and sanitized.</li> </ul>

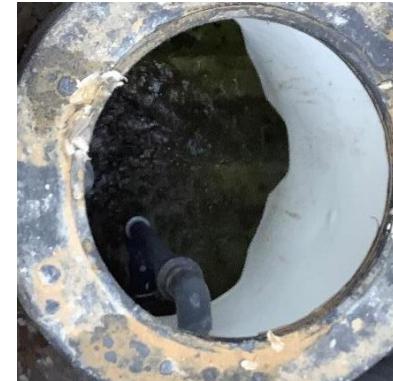
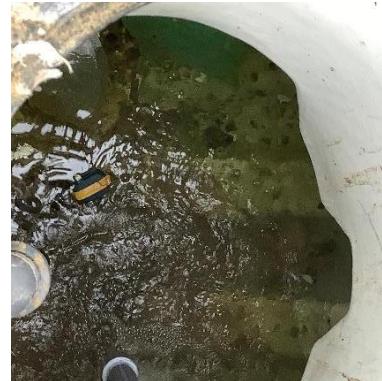
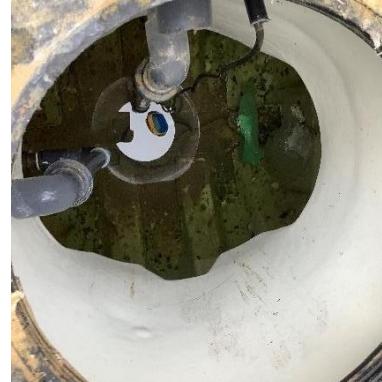
SN	Room	Item	Snag Description	Snag Images
005	Backyard	Water tank	<ul style="list-style-type: none"><li>• Float Valve faulty, does not open and close properly.</li><li>• Molds observed in the water tank; must be deep cleaned and sanitized.</li></ul>

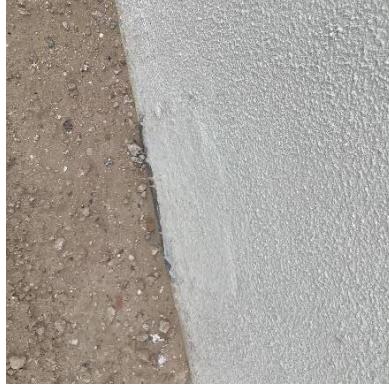
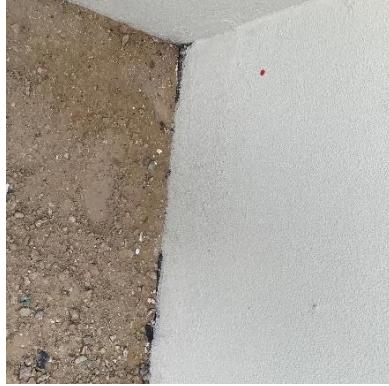
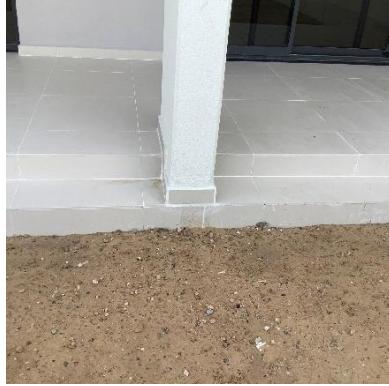
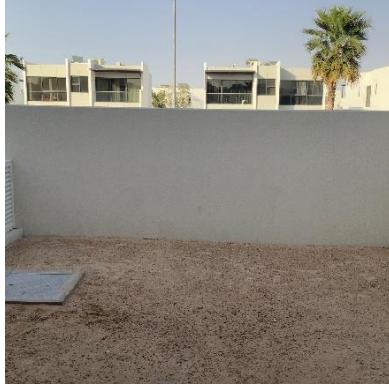
SN	Room	Item	Snag Description	Snag Images
006	Backyard	Flooring	<ul style="list-style-type: none"><li>• No proper soil compaction.</li><li>• Area requires proper cleaning.</li></ul>

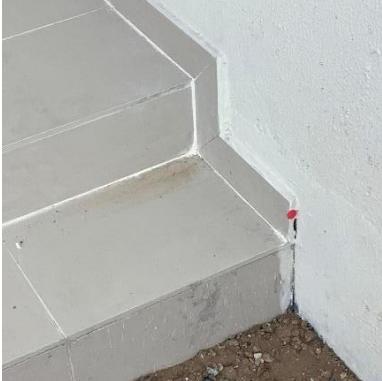
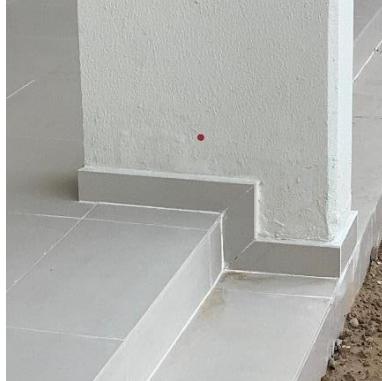
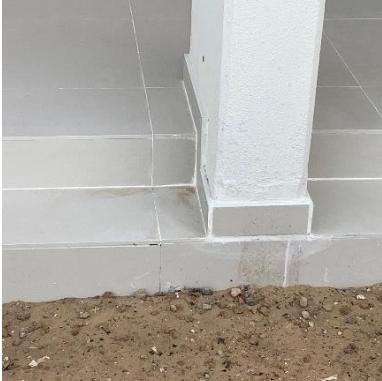
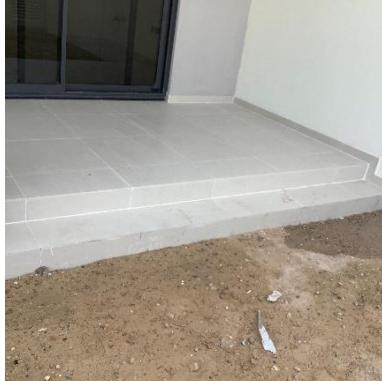
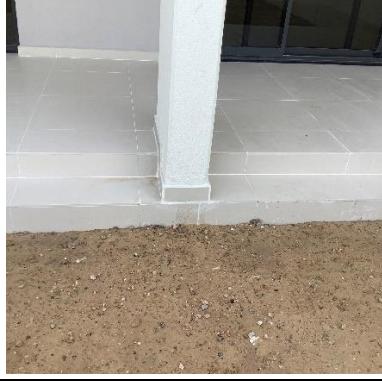
SN	Room	Item	Snag Description	Snag Images
007	Backyard	Flooring	<ul style="list-style-type: none"> <li>• No proper finish around the floor skirting.</li> <li>• Area needs proper cleaning.</li> <li>• No proper grouting between the floor tiles.</li> <li>• Blackish stains on the grout.</li> <li>• Stains and scratches on the floor.</li> </ul>

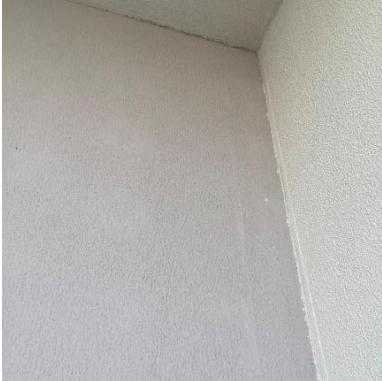
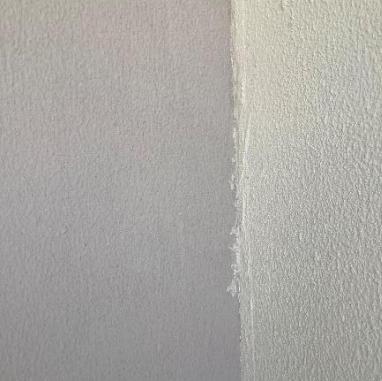
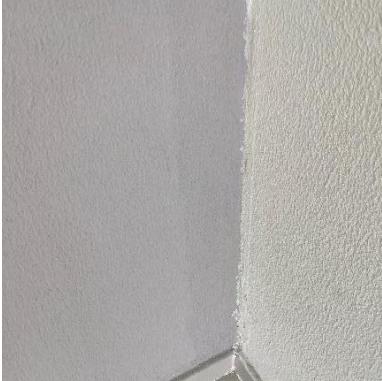
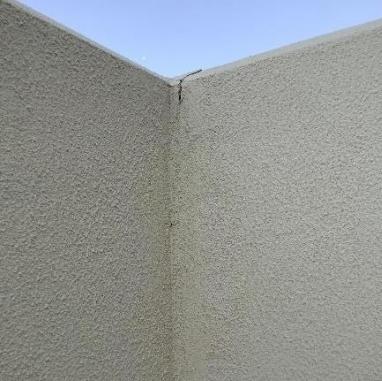
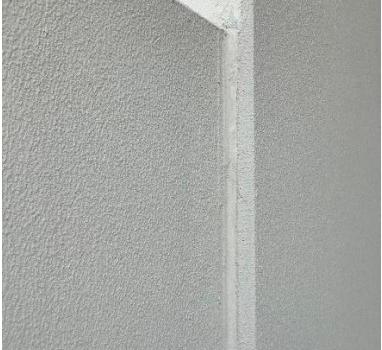
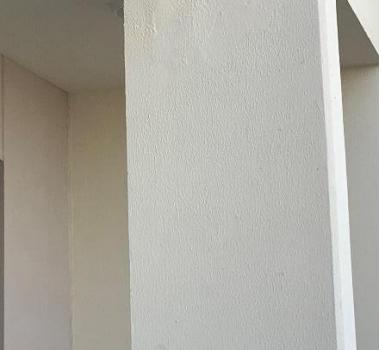
SN	Room	Item	Snag Description	Snag Images
008	Backyard – Entrance	Wall	<ul style="list-style-type: none"><li>• No proper finish around the at the wall junction.</li><li>• Rough surface of the wall.</li><li>• Cracked wall.</li><li>• Stains and scratches on the wall.</li></ul>

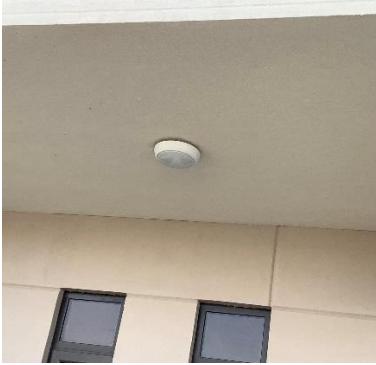
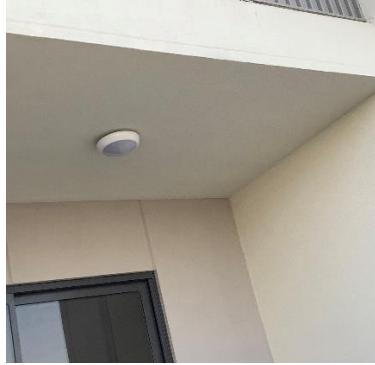
Villa #				
SN	Room	Item	Snag Description	Snag Images
009	Backyard – Entrance	Ceiling	<ul style="list-style-type: none"> <li>• Ceiling lamp is not working.</li> <li>• No proper finish on the ceiling.</li> <li>• No proper paint on the ceiling.</li> </ul>

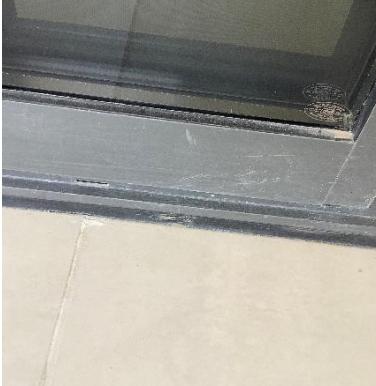
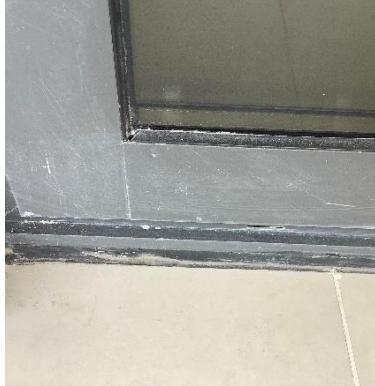
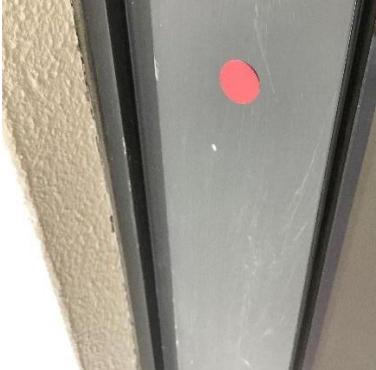
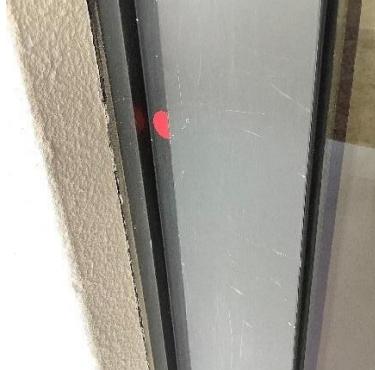
010	Backyard – Entrance	Window	<ul style="list-style-type: none"> <li>• Stains and scratches on the window frame.</li> <li>• No proper finish around the window frame.</li> </ul>

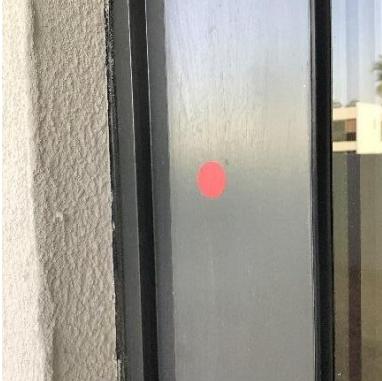
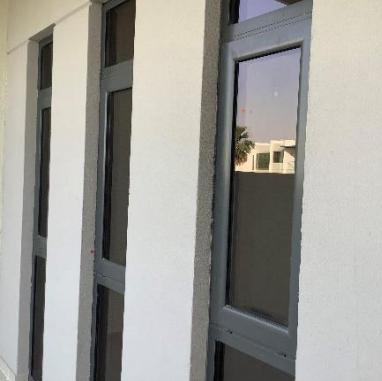
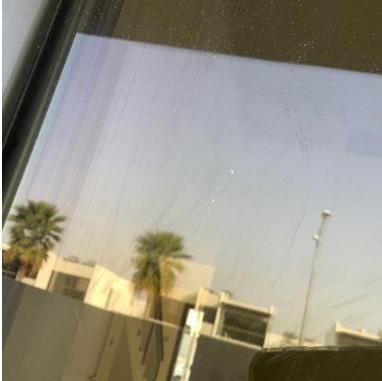
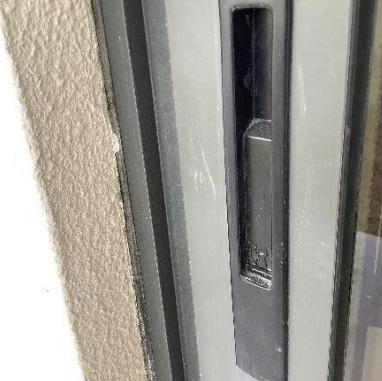
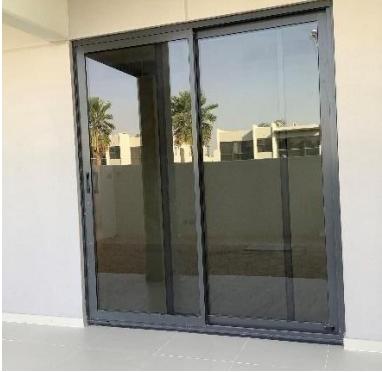
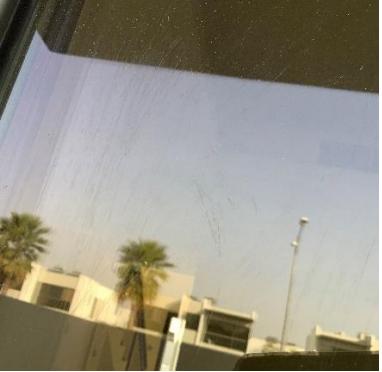
Villa #				
SN	Room	Item	Snag Description	Snag Images
011	Backyard – Entrance	Window	<ul style="list-style-type: none"> <li>• Stains and scratches on and around the window frame.</li> <li>• Rough surface around the window frame.</li> <li>• Scratches on the window glass.</li> </ul>

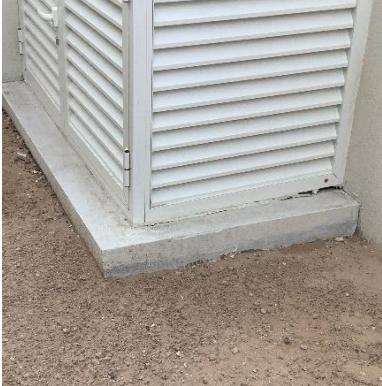
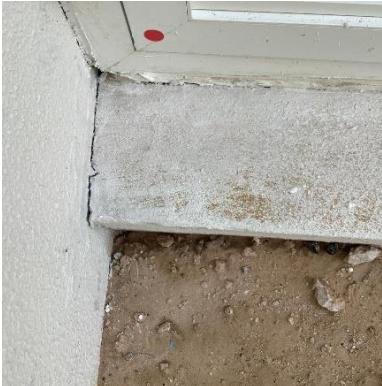
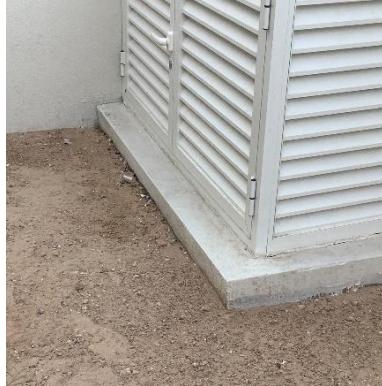
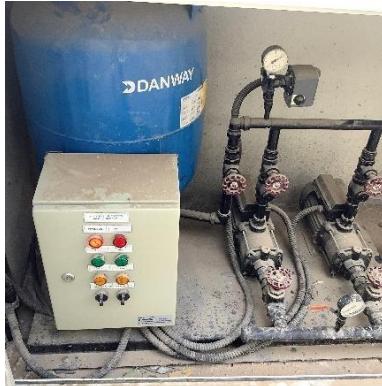
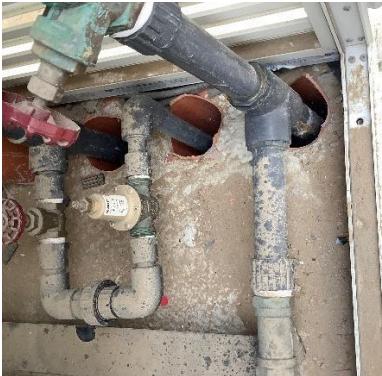
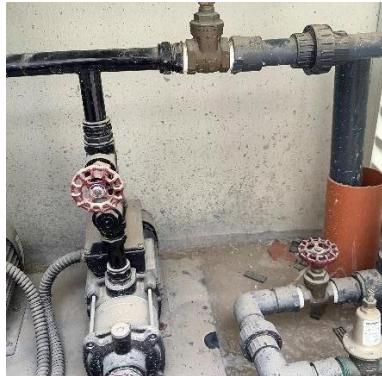
SN	Room	Item	Snag Description	Snag Images
012	Backyard	Pump Room	<ul style="list-style-type: none"> <li>Pump room cabinet is damaged.</li> <li>No proper finish around the pump room cabinet.</li> <li>No proper cutout for pipes on the cabinet.</li> <li>No proper sealant around the pipes.</li> <li>Heavy dirt around the pressure gauge and other electrical devices.</li> <li>Area needs proper cleaning.</li> </ul>

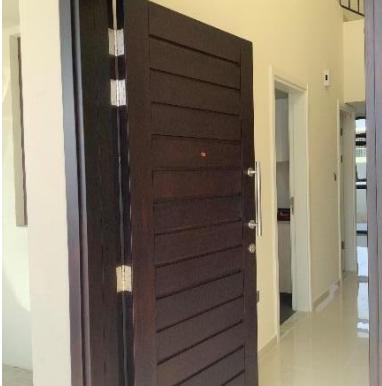
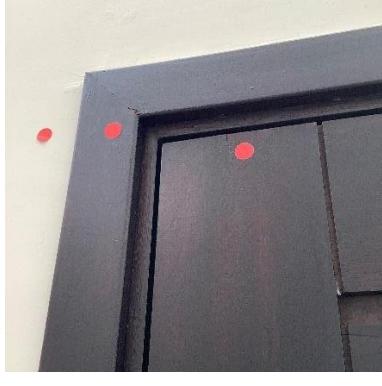
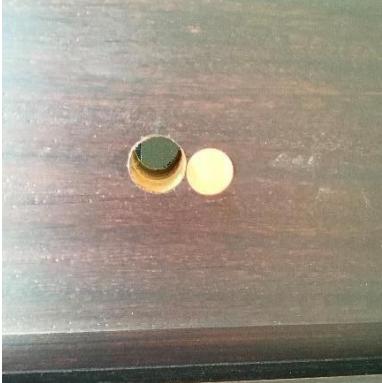
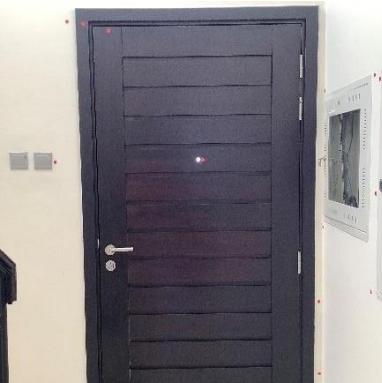
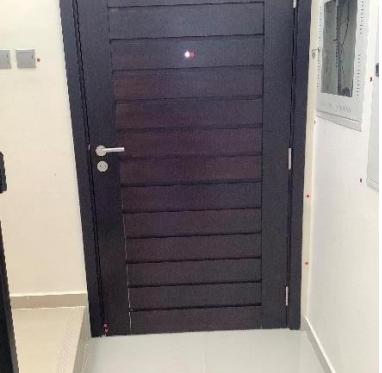
SN	Room	Item	Snag Description	Snag Images
013	Main Entrance	Main door	<ul style="list-style-type: none"> <li>Whitish stains at the edges of the door.</li> <li>No proper finish around the door lock system.</li> <li>No proper finish on and around the door and the frame.</li> <li>No proper finish around the number plate.</li> <li>Eye view magnifier is not installed.</li> <li>Door is swelled at the left Bottom and door does not open and close correctly</li> </ul>

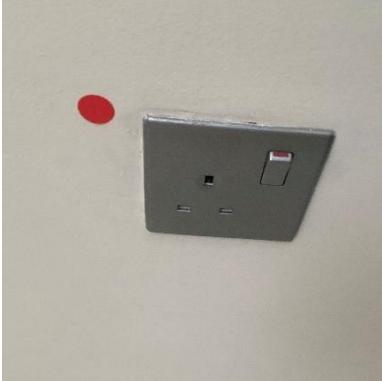
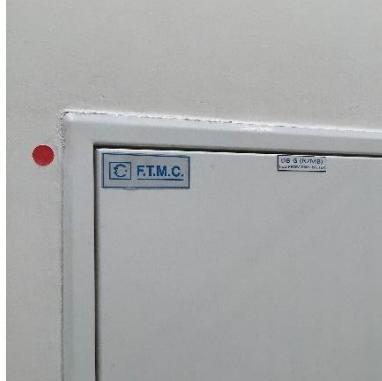
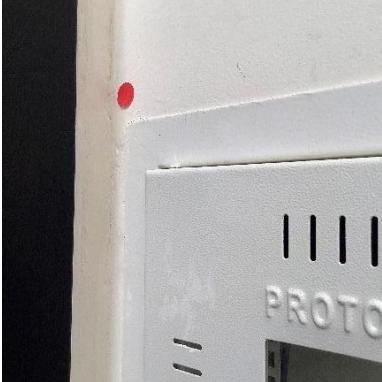
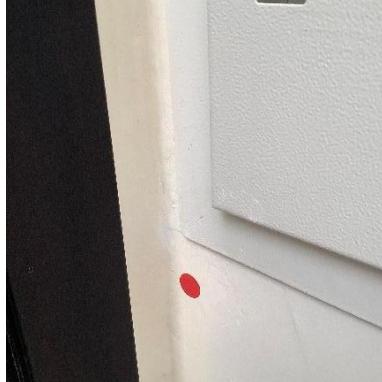
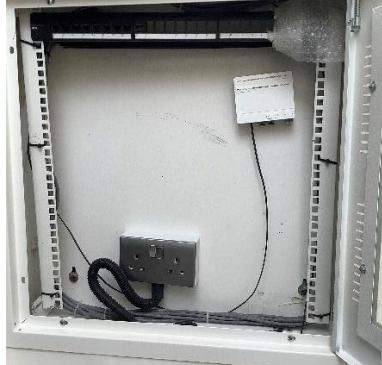
Villa #				
SN	Room	Item	Snag Description	Snag Images
014	Foyer	Electrical	<ul style="list-style-type: none"> <li>• No proper finish around the electrical fitting.</li> <li>• No proper finish around the Load Distribution Box.</li> <li>• Stains and scratches on and around the DB and IT box.</li> <li>• IT Box key is broken and needs to be replaced.</li> <li>• Blackish stain on the IT box.</li> </ul>

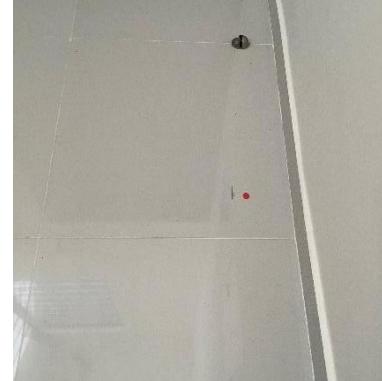
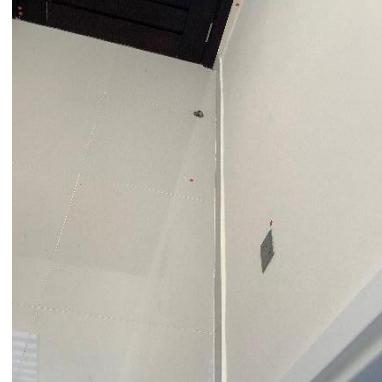
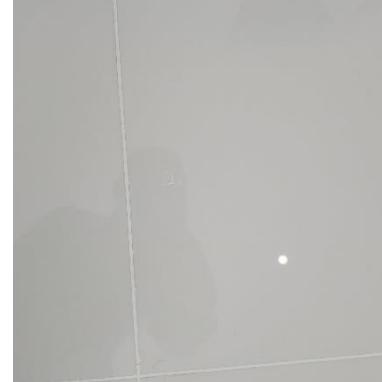
Villa #			
SN	Room	Item	Snag Description
015	Foyer	Flooring & floor skirting	<ul style="list-style-type: none"><li>• No proper finished grout between the tiles.</li><li>• Chipping of the floor tiles.</li><li>• No proper finish around the floor skirting.</li><li>• No proper grouting on the floor skirting.</li></ul>

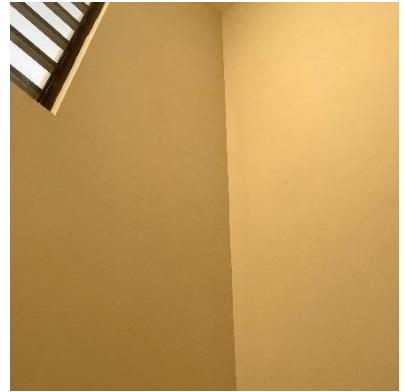
Villa #				
SN	Room	Item	Snag Description	Snag Images
016	Foyer	Wall	<ul style="list-style-type: none"><li>Major crack on the wall.</li></ul>

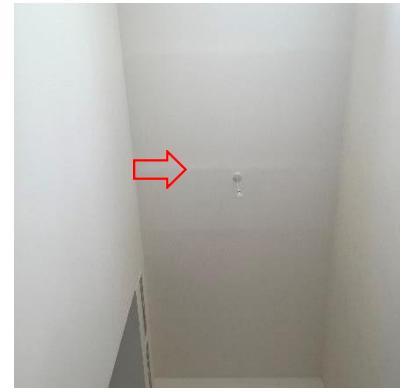
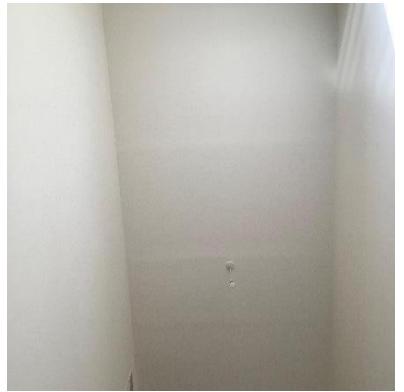
017	Foyer	Ceiling	<ul style="list-style-type: none"><li>Ceiling paint undulations.</li><li>No proper finished ceiling.</li><li>Ceiling lamp is not working.</li></ul>

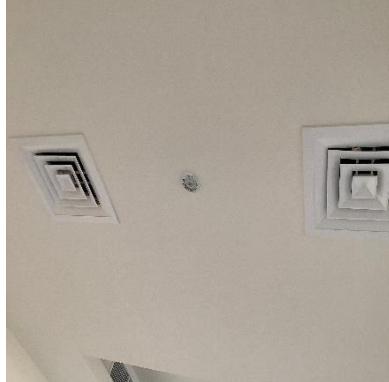
Villa #					
SN	Room	Item	Snag Description	Snag Images	
019	Living	Ceiling	<ul style="list-style-type: none"> <li>• Panels are not aligned properly.</li> <li>• Poor termination at the wall ceiling junction.</li> <li>• Poor paint finish around the termination.</li> </ul>

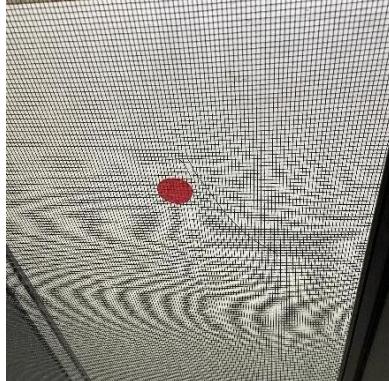
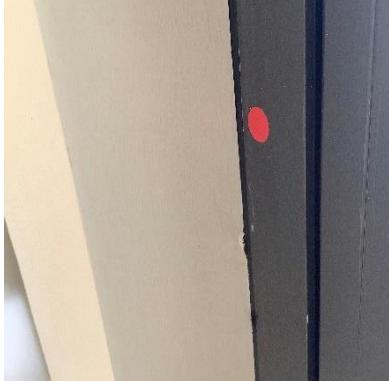
020	Living	Window	<ul style="list-style-type: none"> <li>• Damaged window fly net.</li> <li>• No proper finish around the window frame.</li> <li>• Stains on the window frame.</li> </ul>

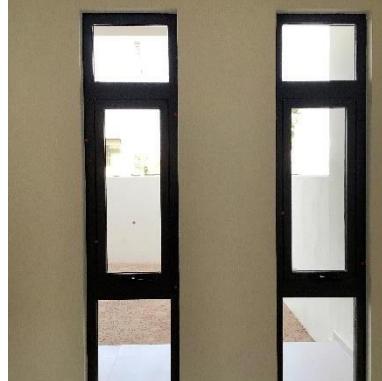
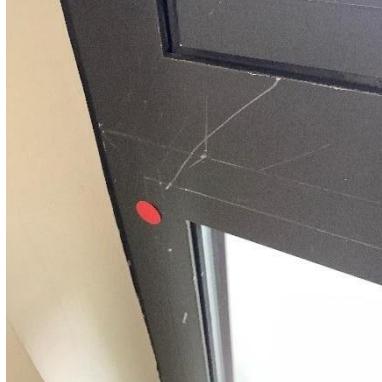
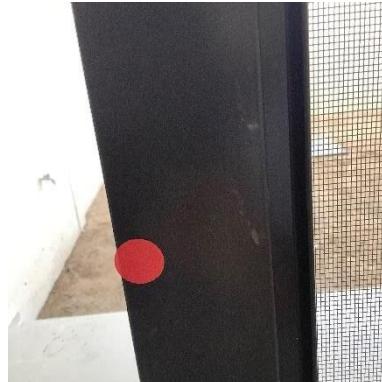
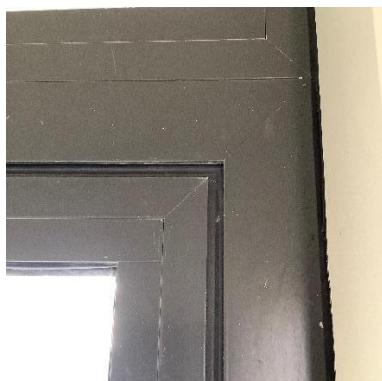
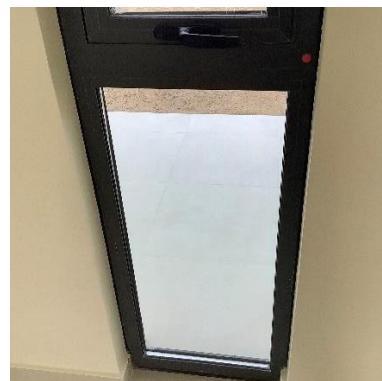
Villa #				
SN	Room	Item	Snag Description	Snag Images
021	Living	Window	<ul style="list-style-type: none"><li>• Not well insulated and slight opening on the left side of both window.</li><li>• Stains and scratches on and around the window frame.</li><li>• No proper finish around the window frame.</li><li>• Stains on the fly net.</li><li>• Damaged flynet.</li></ul>

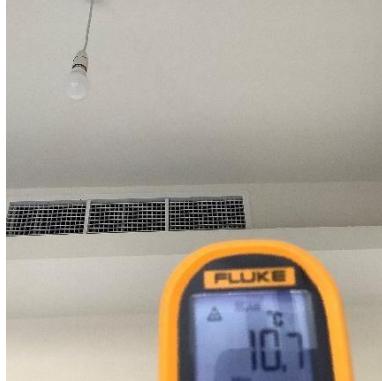
Villa #				
SN	Room	Item	Snag Description	Snag Images
022	Living	Electrical - A/C	<ul style="list-style-type: none"> <li>• Air condition is in working condition.</li> <li>• Grills and ducts needs to be cleaned and sanitized.</li> </ul>

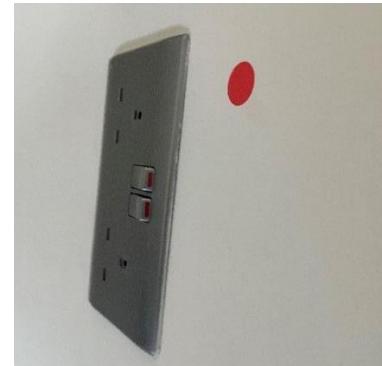
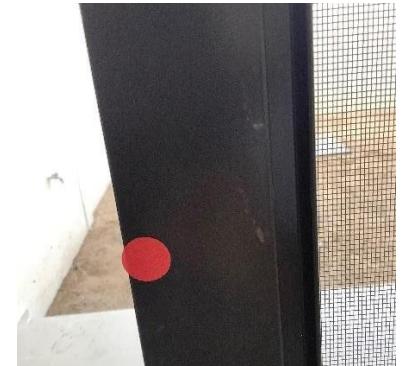
023	Living	Electrical	<ul style="list-style-type: none"> <li>• Poor finish around the electrical fittings.</li> <li>• Stains and scratches on the electrical sockets and switches.</li> </ul>

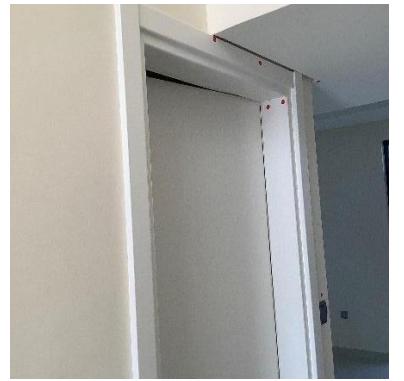
Villa #				
SN	Room	Item	Snag Description	Snag Images
024	Living	Corridor – Ceiling	<ul style="list-style-type: none"> <li>Poor termination between ceiling wall junction.</li> <li>Poor finish around the junction.</li> </ul>

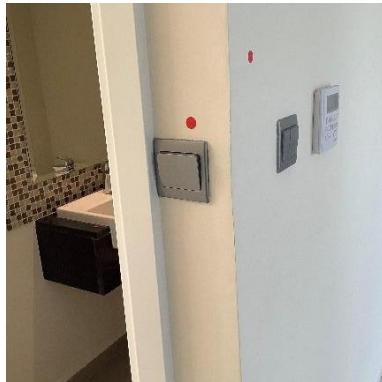
025	Living	Corridor – Electrical	<ul style="list-style-type: none"> <li>No proper finish around the electrical fittings.</li> </ul>

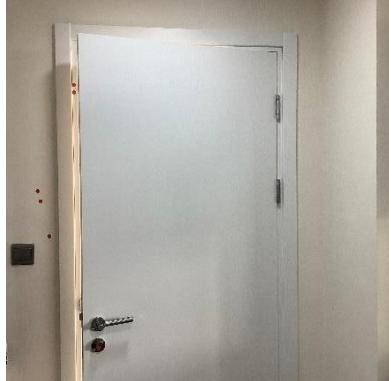
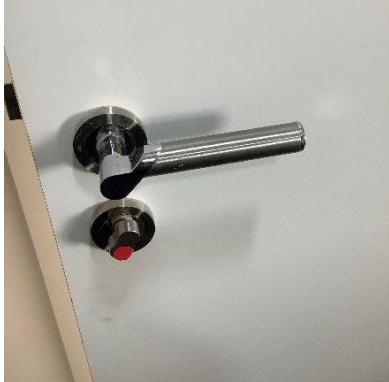
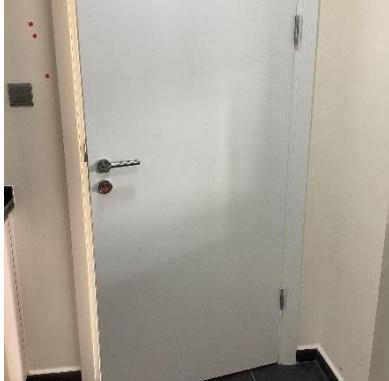
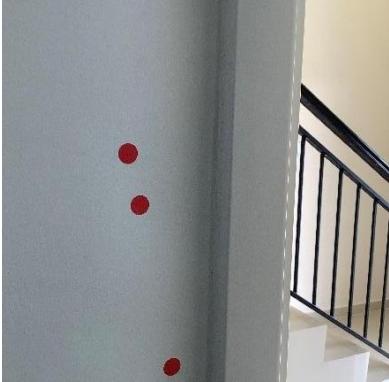
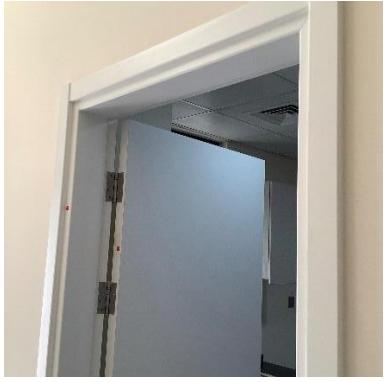
Villa #				
SN	Room	Item	Snag Description	Snag Images
026	Kitchen	Door	<ul style="list-style-type: none"> <li>• No proper finish on the door and the door frame.</li> <li>• Stains on the door lock system.</li> <li>• Door does not open and shuts properly.</li> <li>• No proper finish around the door lock system.</li> <li>• Stains and scratches on the door and the door frame.</li> <li>• Paint stains on the door hinges.</li> </ul>

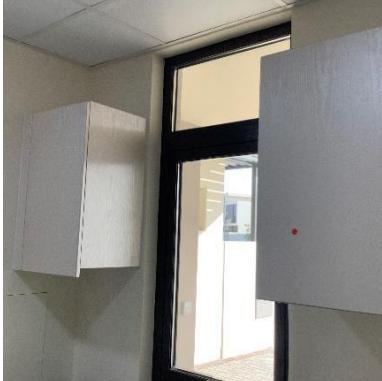
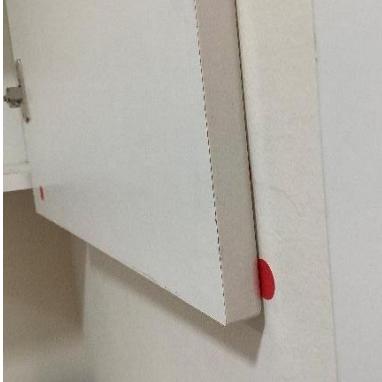
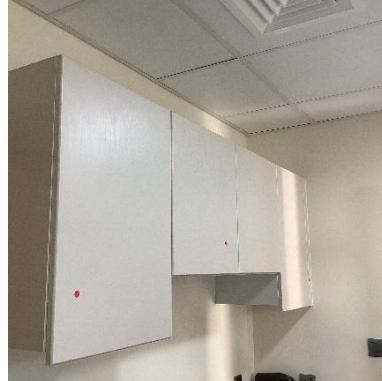
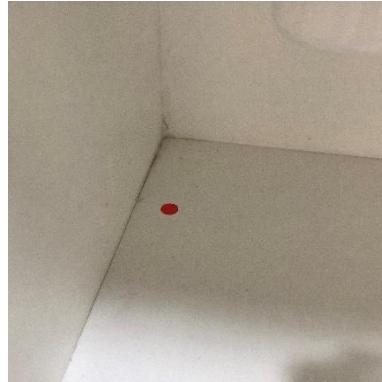
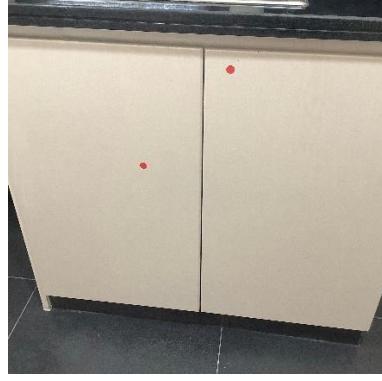
Villa #				
SN	Room	Item	Snag Description	Snag Images
027	Kitchen	Cabinets	<ul style="list-style-type: none"><li>• Stains and scratches in the cabinets.</li><li>• Blackish stains on the drawers.</li><li>• No proper finish around the cabinet edges.</li><li>• Dirt stains around the planks.</li></ul>

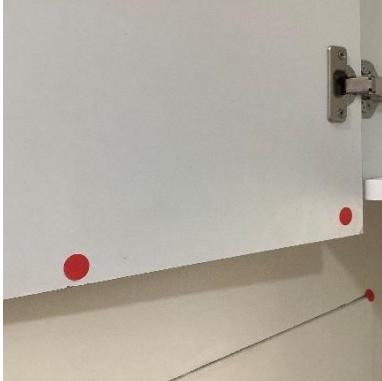
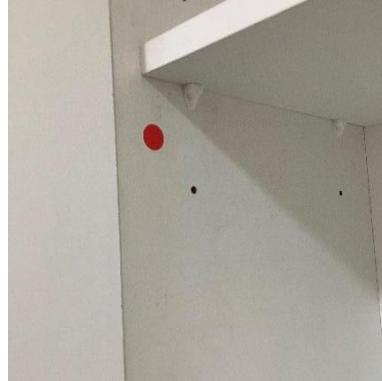
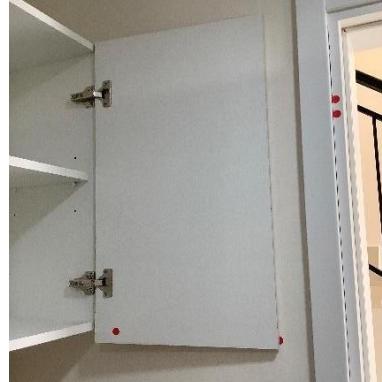
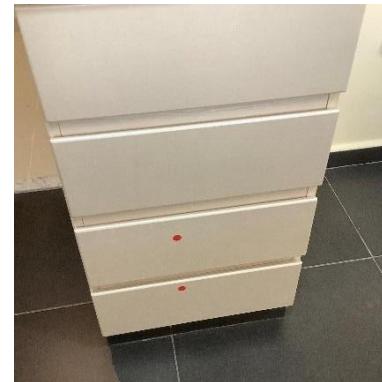
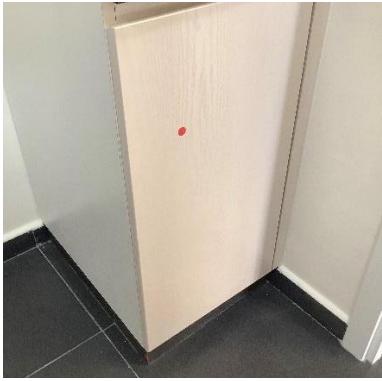
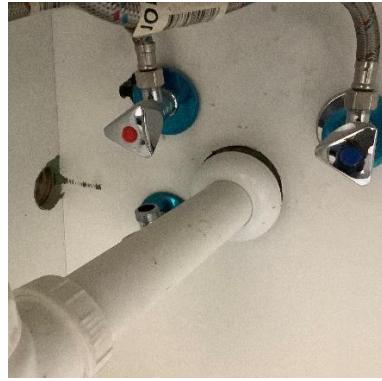
Villa #				
SN	Room	Item	Snag Description	Snag Images
028	Kitchen	Cabinet	<ul style="list-style-type: none"><li>• No cover caps for holes on the cabinet.</li><li>• No proper finish around the cabinet door.</li><li>• Stains on the drawers.</li><li>• Drawers does not open and shut smoothly.</li><li>• No proper sealant around the bottle trap.</li><li>• No proper finish around the cabinet.</li></ul>

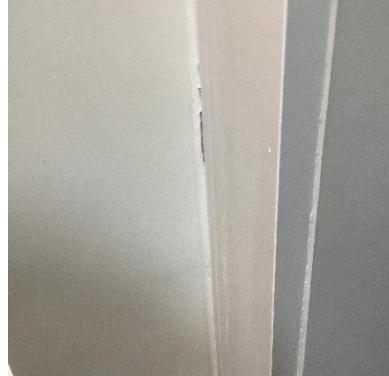
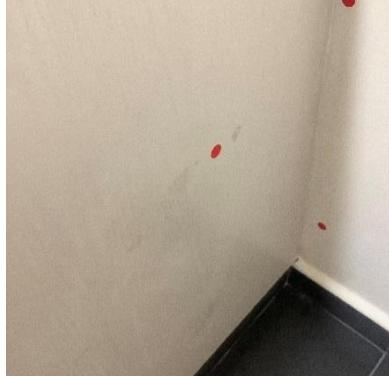
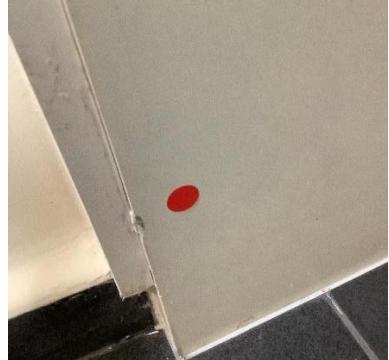
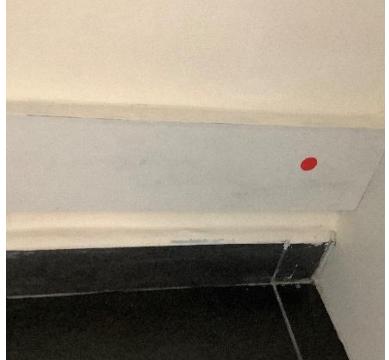
Villa #				
SN	Room	Item	Snag Description	Snag Images
029	Kitchen	Wall	<ul style="list-style-type: none"><li>Poor finish around the wall edges.</li><li>Blackish stains on the wall.</li><li>No proper finish around the access panel.</li><li>No proper finish around the laundry area.</li><li>Silicon traces on the wall edges.</li><li>Poor finish around the laundry area.</li></ul>

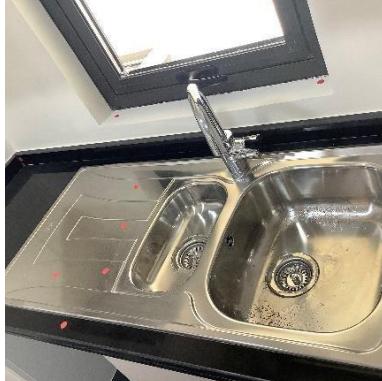
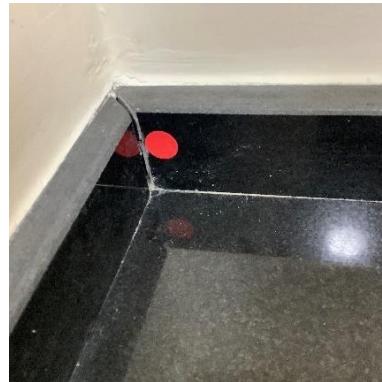
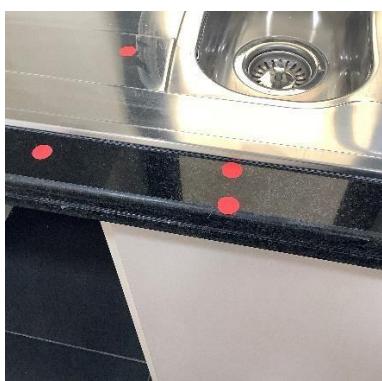
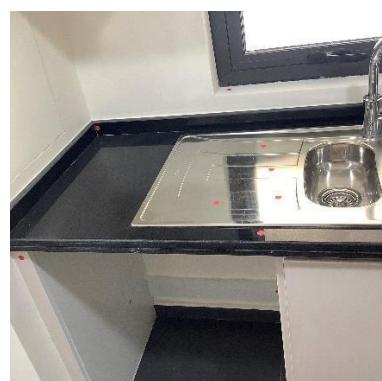
Villa #				
SN	Room	Item	Snag Description	Snag Images
030	Kitchen	Sink & counter top	<ul style="list-style-type: none"><li>• Scratches on the sink and needs to be replaced.</li><li>• No proper sealant around the countertop.</li><li>• Stains and scratches on the countertop.</li></ul>

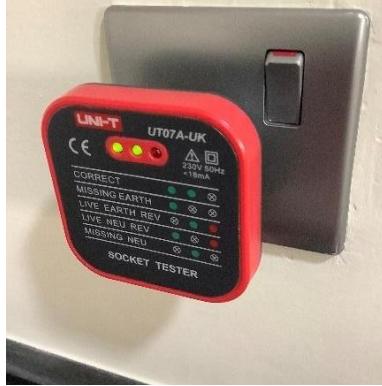
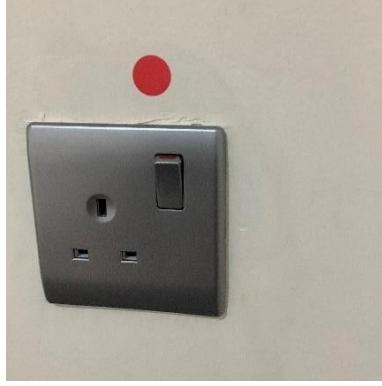
Villa #				
SN	Room	Item	Snag Description	Snag Images
031	Kitchen	Electrical	<ul style="list-style-type: none"> <li>• Power sockets are in working condition.</li> <li>• No proper finish around the electrical fittings.</li> <li>• Stains and scratches on and around the electrical fittings.</li> </ul>

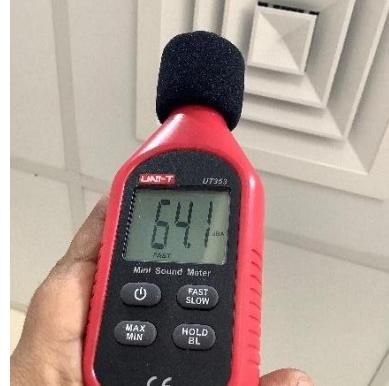
Villa #				
SN	Room	Item	Snag Description	Snag Images
032	Kitchen	Electrical	<ul style="list-style-type: none"><li>Loud sound from the exhaust.</li></ul>

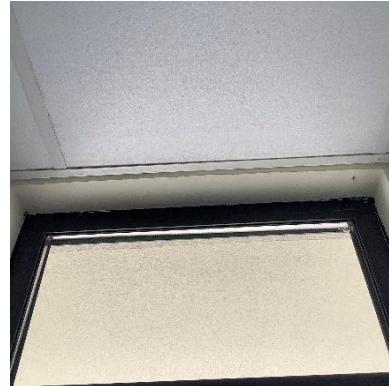
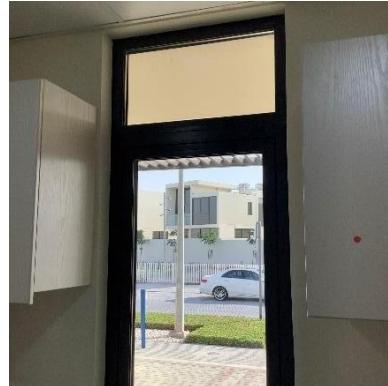
033	Kitchen	Window	<ul style="list-style-type: none"><li>Untidy window pane and glass.</li><li>Stains and scratches on the window.</li></ul>

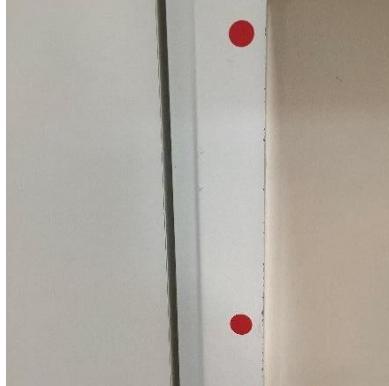
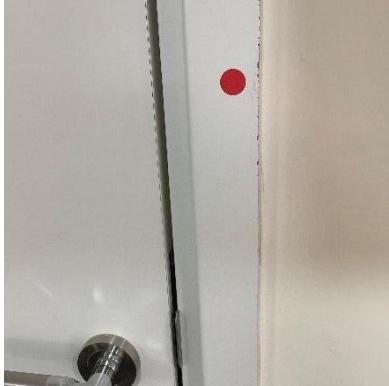
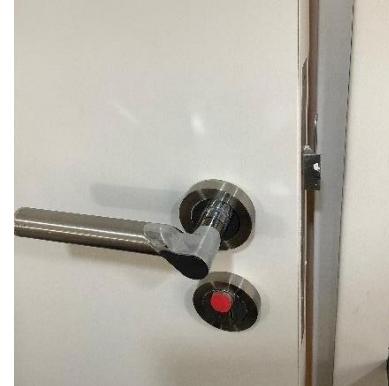
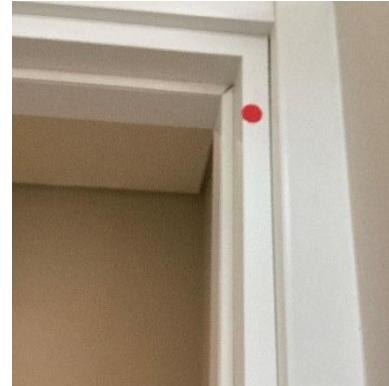
Villa #				
SN	Room	Item	Snag Description	Snag Images
034	Kitchen	Utility Room – Door	<ul style="list-style-type: none"><li>• No proper finish on the door frame.</li><li>• Stains and scratches on the door and the door frame.</li><li>• Door does not open and shut smoothly.</li></ul>

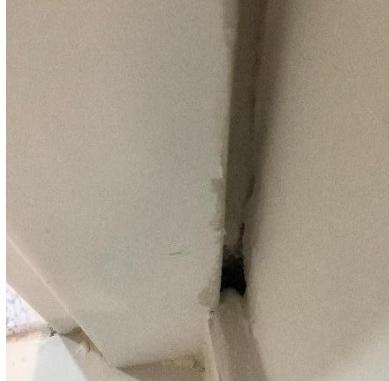
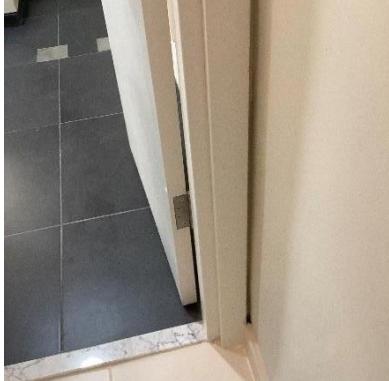
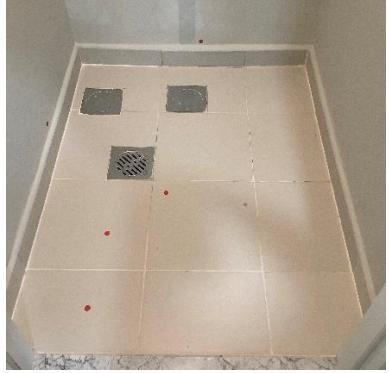
Villa #				
SN	Room	Item	Snag Description	Snag Images
035	Kitchen	Utility Room – Floor & Skirting	<ul style="list-style-type: none"><li>• Poor finish around the floor skirting.</li><li>• Rough edge of the floor skirting.</li><li>• No proper grouting on the floor tile.</li><li>• Paint stains and scratches on the floor drain.</li></ul>

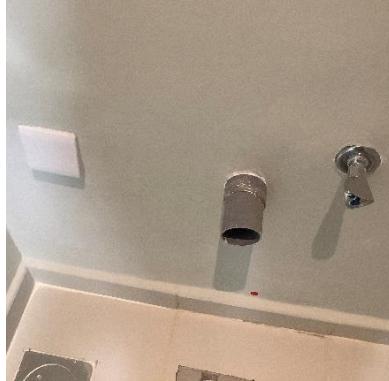
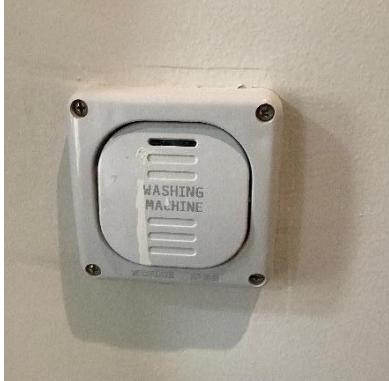
Villa #				
SN	Room	Item	Snag Description	Snag Images
036	Kitchen	Utility Room – Wall	<ul style="list-style-type: none"><li>Poor finish around the plumbing fixtures.</li><li>Paint stains and scratches on the electric fittings.</li></ul>

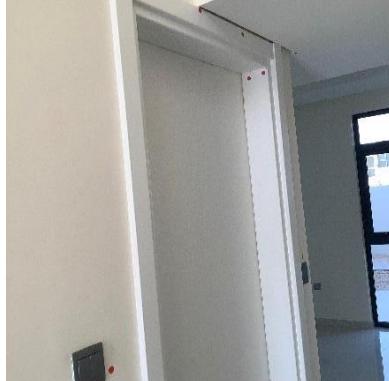
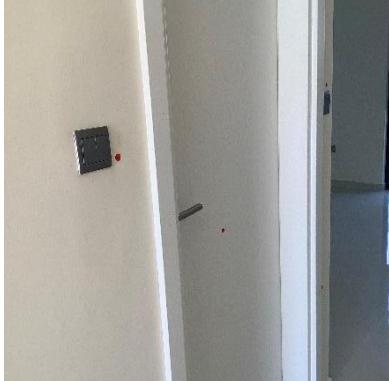
037	Guest's Washroom	Door	<ul style="list-style-type: none"><li>Stains and scratches on the door.</li><li>Poor finish around the door frame.</li></ul>

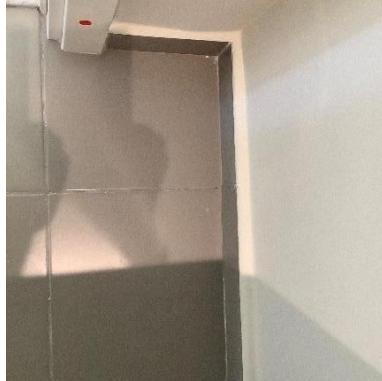
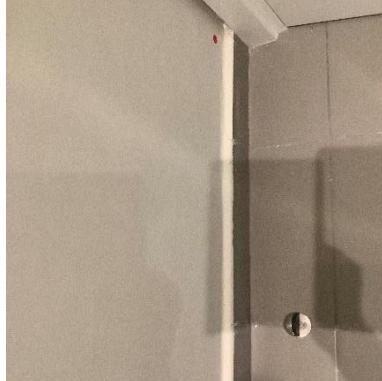
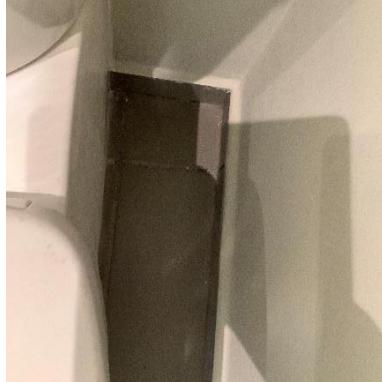
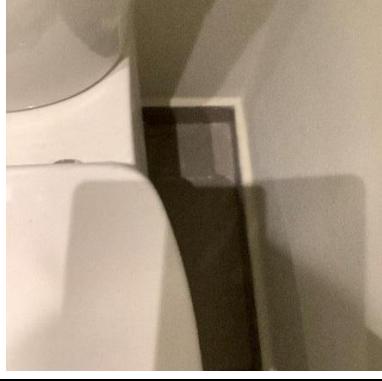
Villa #				
SN	Room	Item	Snag Description	Snag Images
038	Guest's Washroom	Flooring	<ul style="list-style-type: none"><li>• No proper finished grout.</li><li>• No proper finish around the floor skirting.</li><li>• Untidy corners of the washroom.</li><li>• Stains on the floor tiles.</li><li>• No proper grouting on the floor skirting.</li><li>• No proper finish around the floor drain.</li><li>• Stains on the floor drain.</li></ul>

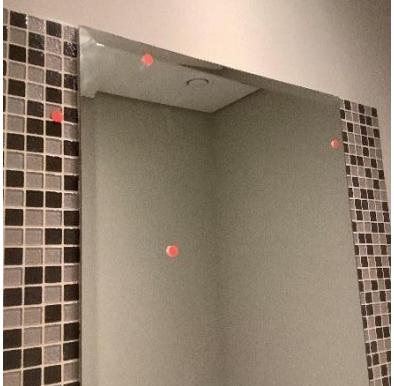
Villa #				
SN	Room	Item	Snag Description	Snag Images
039	Guest's Washroom	Sanitary & Accessories	<ul style="list-style-type: none"><li>• Stains and scratches on the mirror.</li><li>• No proper finish around the mirror.</li></ul>

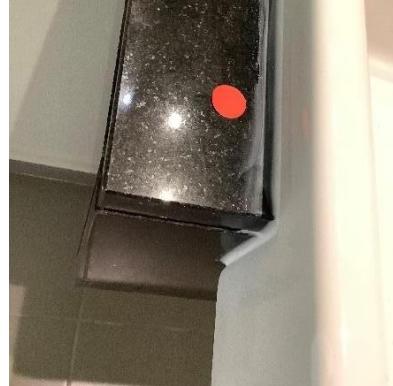
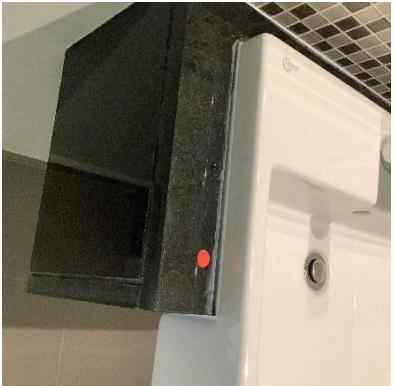
040	Guest's Washroom	Sanitary & Accessories	<ul style="list-style-type: none"><li>• Paint stains and scratches on the wash basin counter.</li><li>• Silicon traces around the wash basin.</li></ul>

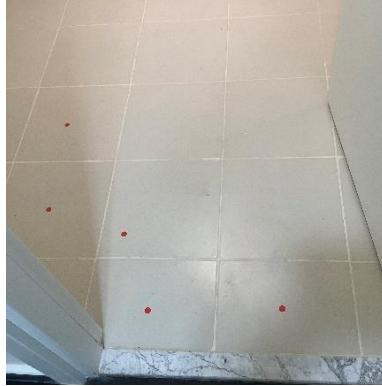
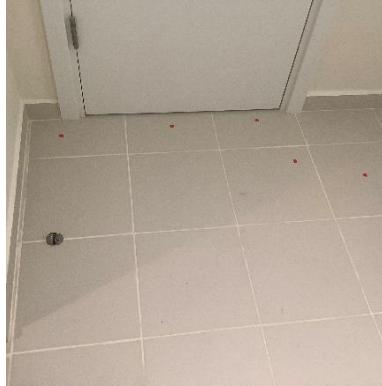
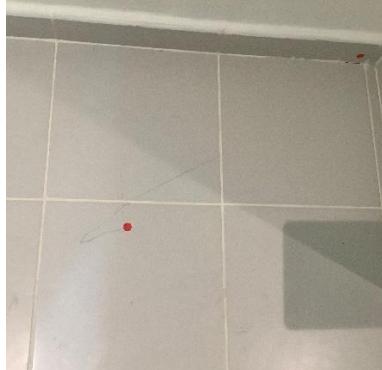
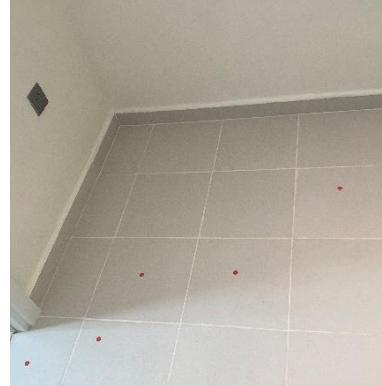
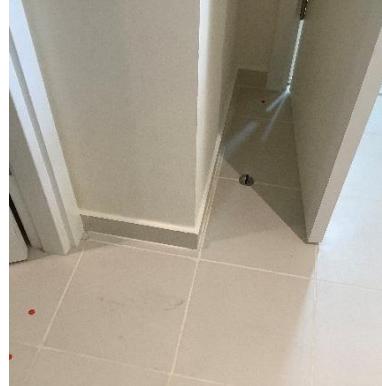
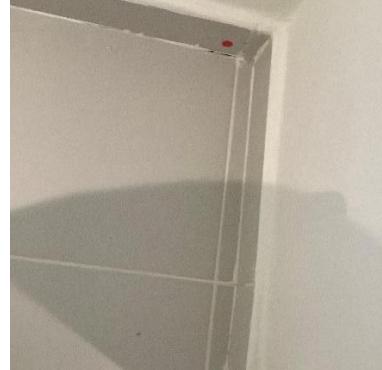
Villa #				
SN	Room	Item	Snag Description	Snag Images
041	Maid's Room	Flooring	<ul style="list-style-type: none"><li>• No proper grouting between the floor tiles.</li><li>• No proper finish around the floor skirt.</li><li>• Untidy corners of the floor.</li><li>• Blackish stains and scratches on the floor tiles.</li><li>• Hollow tiles observed, void below the tiles - tiles to be removed &amp; filled with binding material &amp; laid again ( marked with red dots )</li></ul>

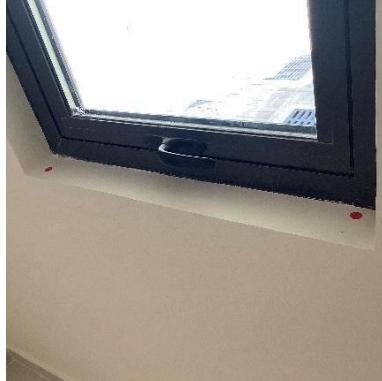
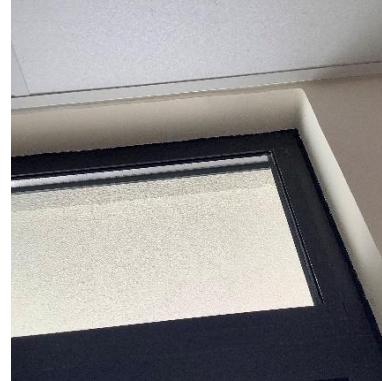
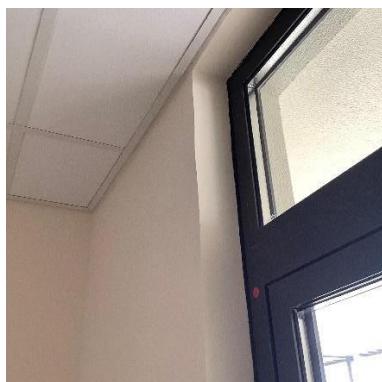
Villa #				
SN	Room	Item	Snag Description	Snag Images
042	Maid's Room	Window	<ul style="list-style-type: none"><li>• No proper finish around the window frame.</li><li>• Stains on the window glass.</li></ul>
