Akoya Zinna(Damac Hills 2)  
Townhouse ABC

TECHNICAL SNAGGING REPORT

3-BEDROOM TOWNHOUSE

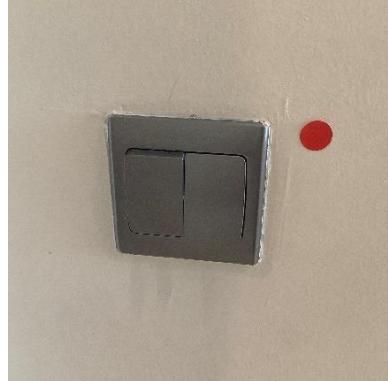
Villa #				
SN	Room	Item	Snag Description	Snag Images
043	Maid's Room	Electrical	<ul style="list-style-type: none"><li>Poor finish around the electrical fittings.</li><li>Scratches on the electrical switch.</li></ul>

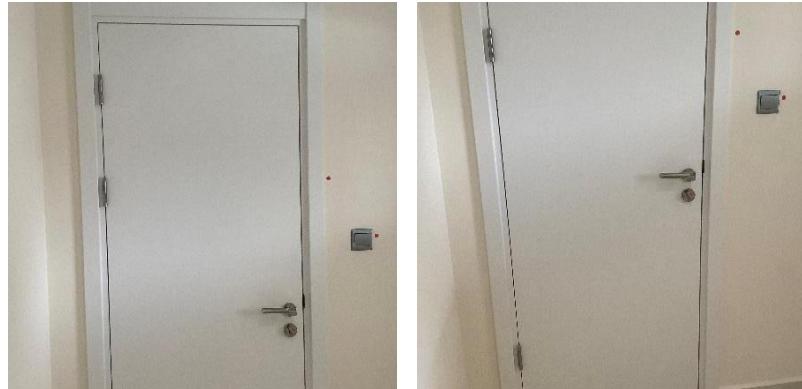
044	Maid's Washroom	Door	<ul style="list-style-type: none"><li>No proper finish around the door frame.</li></ul>

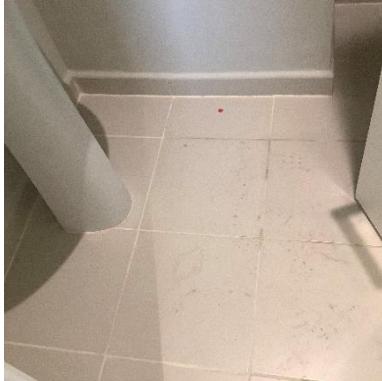
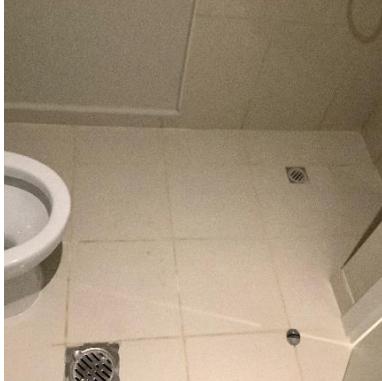
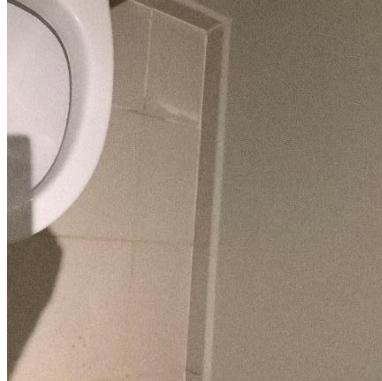
Villa #				
SN	Room	Item	Snag Description	Snag Images
045	Maid's Washroom	Flooring	<ul style="list-style-type: none"> <li>• No proper finish around the floor skirting.</li> <li>• No proper finished grout on the floor tiles.</li> <li>• Blackish stains on the floor.</li> <li>• Hollow tiles observed, void below the tiles - tiles to be removed &amp; filled with binding material &amp; laid again ( marked with red dots )</li> </ul>

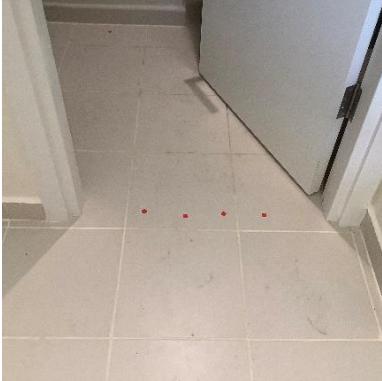
Villa #				
SN	Room	Item	Snag Description	Snag Images
046	Maid's Washroom	Threshold	<ul style="list-style-type: none"><li>• Washroom threshold is not installed.</li></ul>

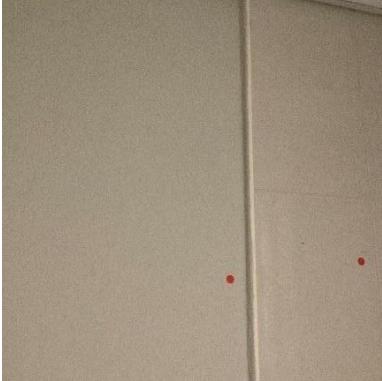
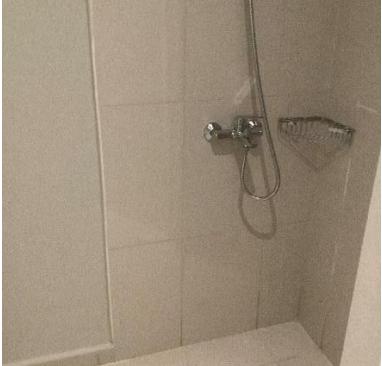
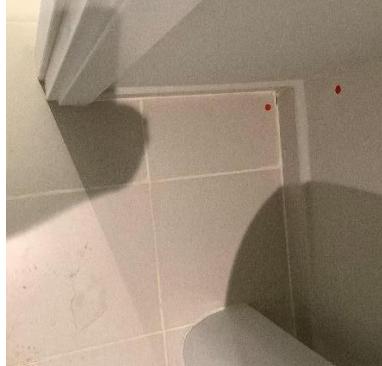
047	Maid's Washroom	Wall	<ul style="list-style-type: none"><li>• No proper finish around the wall junction.</li><li>• Stains and scratches on the wall tiles.</li></ul>

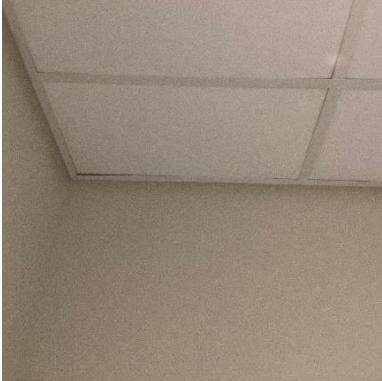
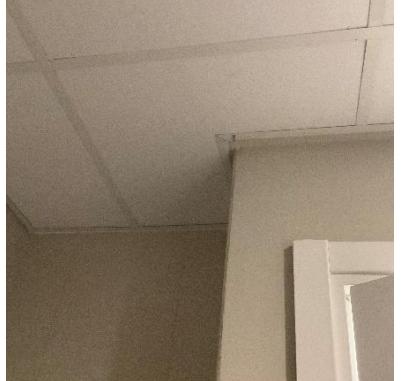
Villa #			
SN	Room	Item	Snag Description
048	Maid's Washroom	Ceiling	<ul style="list-style-type: none"><li>• Poor paint finish all around the ceiling.</li><li>• Poor finish around the ceiling corners.</li><li>• Access panels are not fixed properly.</li></ul>

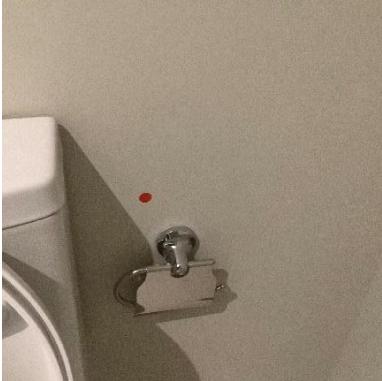
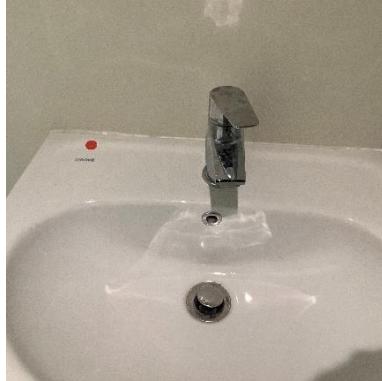
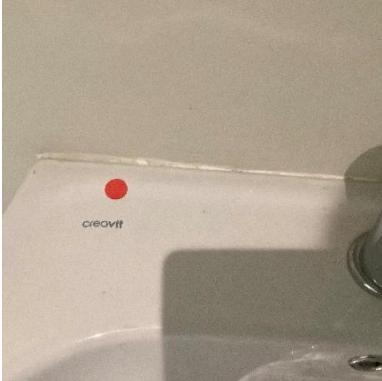
Villa #				
SN	Room	Item	Snag Description	Snag Images
049	Maid's Washroom	Sanitary	<ul style="list-style-type: none"><li>• No proper finish around the tissue holder.</li><li>• Poor finish around the wash basin.</li><li>• No proper sealant around the wash basin.</li></ul>

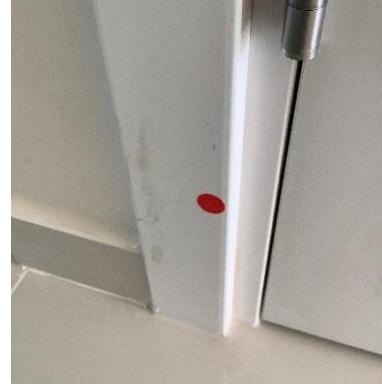
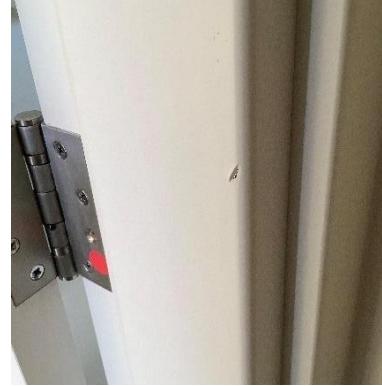
Villa #			
SN	Room	Item	Snag Description
050	Store Room	Door	<ul style="list-style-type: none"><li>• No proper finish around door frame.</li><li>• Blackish stains on the door frame.</li><li>• Stains on the door hinge.</li></ul>

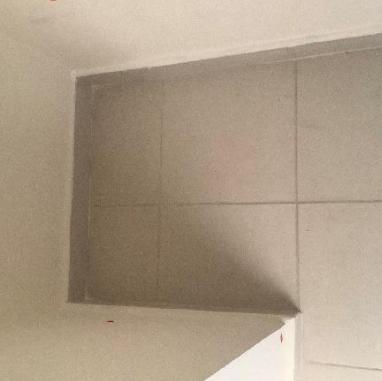
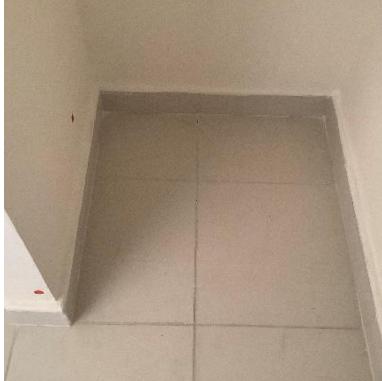
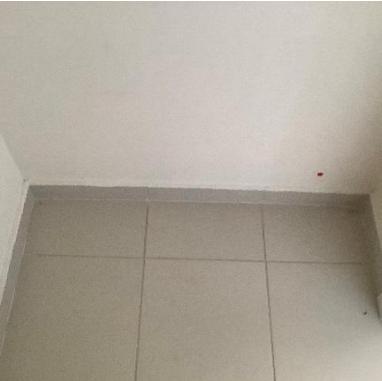
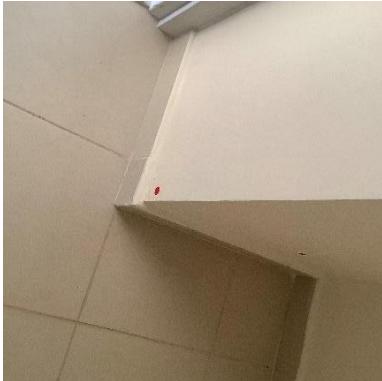
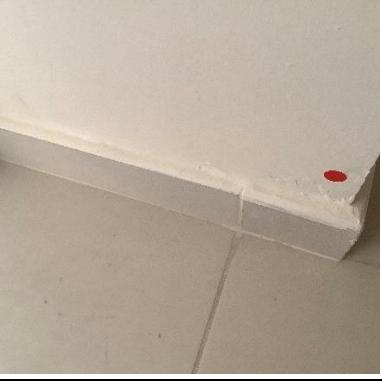
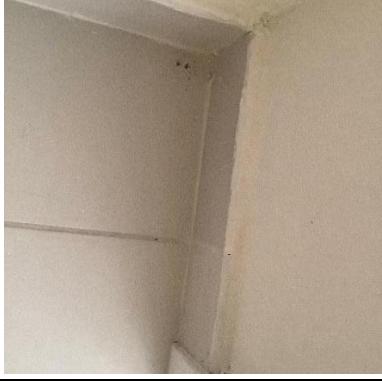
Villa #				
SN	Room	Item	Snag Description	Snag Images
051	Store Room	Floor	<ul style="list-style-type: none"><li>Poor finish around the floor skirting.</li><li>No proper finished grouting.</li><li>Blackish stains on the grout.</li></ul>

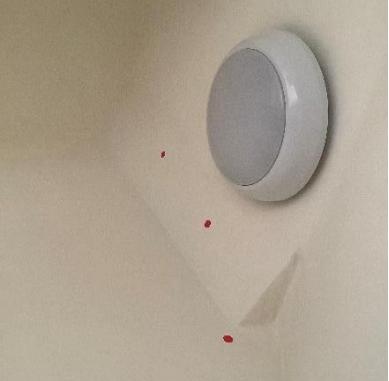
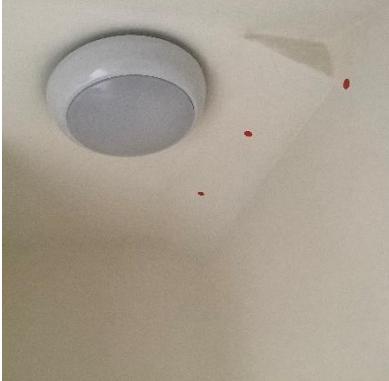
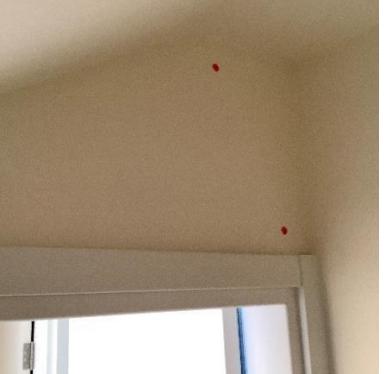
Villa #			
SN	Room	Item	Snag Description
052	Store Room	Ceiling	<ul style="list-style-type: none"><li>• Poor paint at termination all over the ceiling.</li><li>• Access panels are not fixed properly.</li><li>• No proper finish around the ceiling corners.</li></ul>

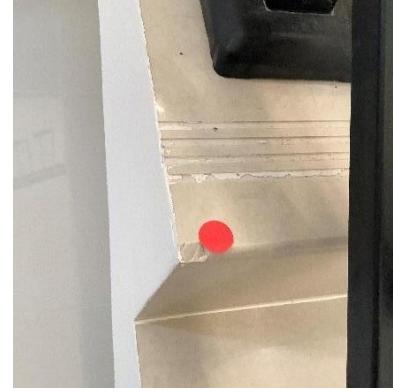
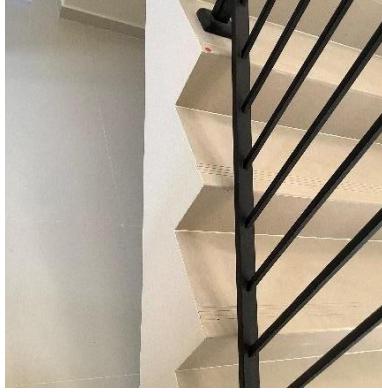
Villa #			
SN	Room	Item	Snag Description
053	Staircase	Steps	<ul style="list-style-type: none"><li>• No proper grouting throughout the staircase.</li><li>• No proper grout around the floor skirt.</li><li>• Blackish stains on the step floor tile.</li><li>• Chipping of the tile.</li><li>• No proper finished grout between the tiles.</li></ul>

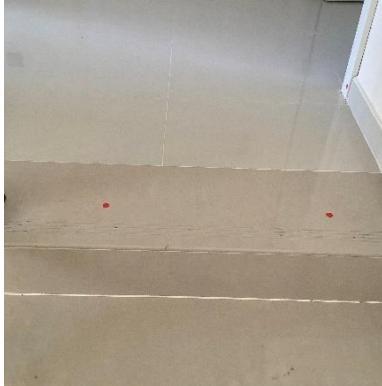
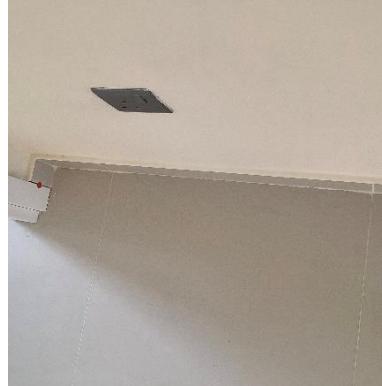
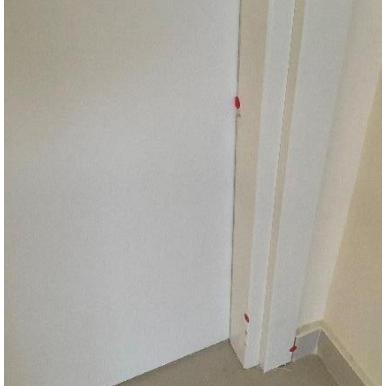
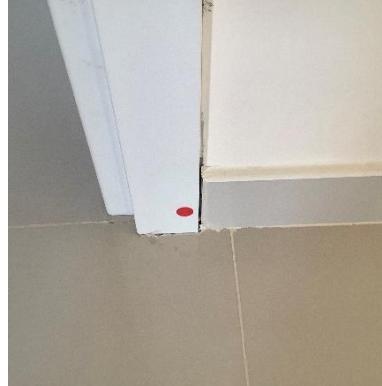
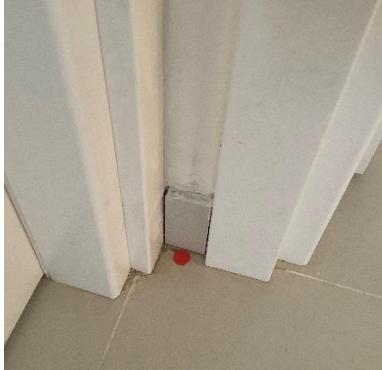
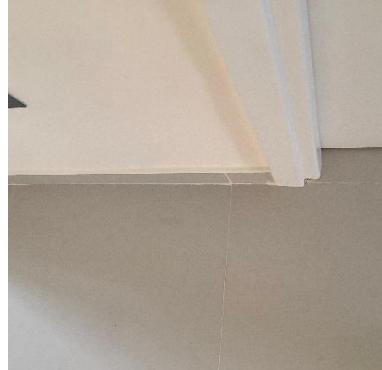
Villa #				
SN	Room	Item	Snag Description	Snag Images
054	1 <sup>st</sup> Floor Corridor	Floor	<ul style="list-style-type: none"> <li>Hollow tiles observed, void below the tiles - tiles to be removed &amp; filled with binding material &amp; laid again ( marked with red dots )</li> <li>Poor finish around the floor skirting.</li> <li>Stains on and around the floor skirting.</li> <li>No proper grout termination around the floor skirting.</li> </ul>

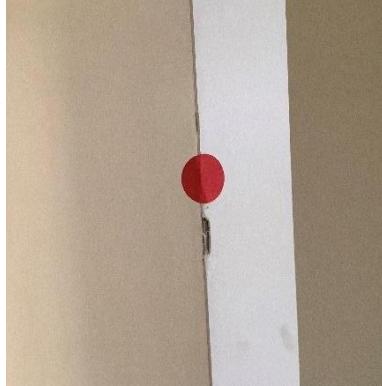
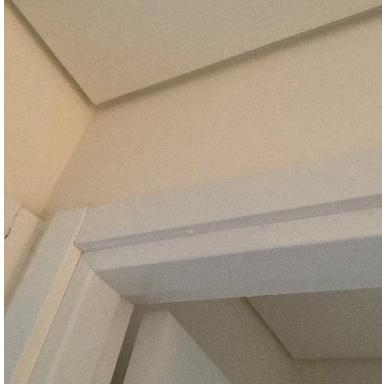
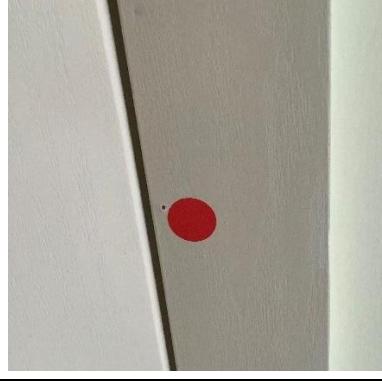
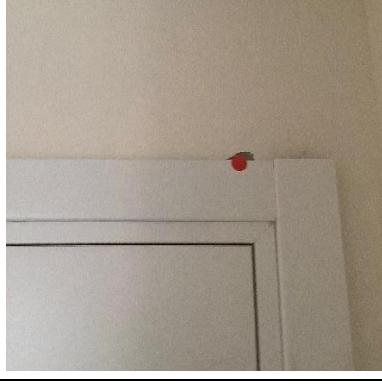
Villa #				
SN	Room	Item	Snag Description	Snag Images
055	Bedroom – 1	Door	<ul style="list-style-type: none"> <li>• No proper finish around the door lock system.</li> <li>• Chipped door frame.</li> <li>• No proper finish around the door hinges.</li> <li>• No proper finish on and around the door and the door frame.</li> <li>• Stains and scratches on the door and the door frame.</li> </ul>

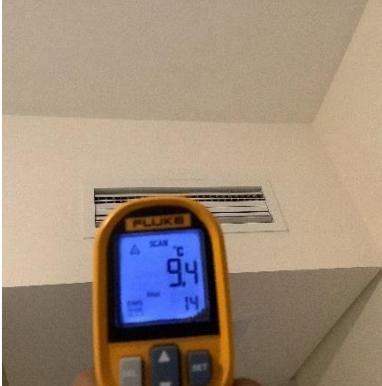
Villa #				
SN	Room	Item	Snag Description	Snag Images
056	Bedroom - 1	Electrical – A/C	<ul style="list-style-type: none"> <li>• Air Condition is in working condition and cools enough</li> <li>• A/C grills and ducts needs to be cleaned.</li> </ul>

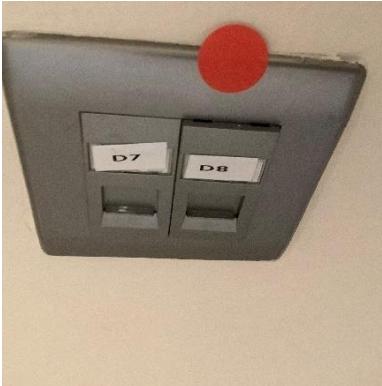
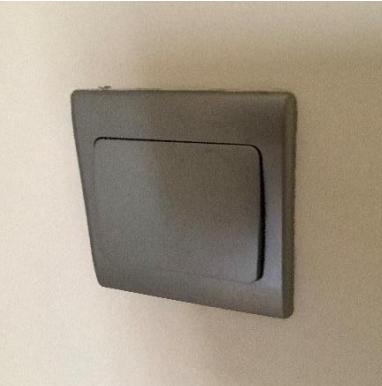
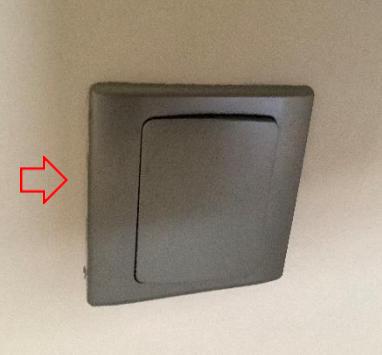
057	Bedroom – 1	Electrical	<ul style="list-style-type: none"> <li>• Poor finish around the electrical fittings.</li> <li>• Switches are fixed properly.</li> <li>• Stains and scratches on the electrical fittings.</li> </ul>

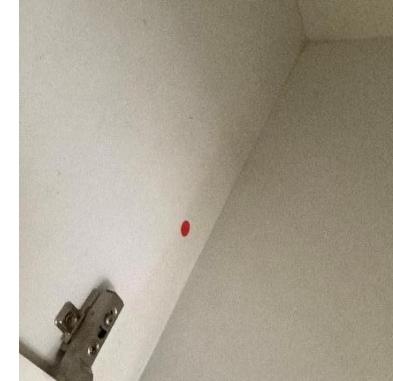
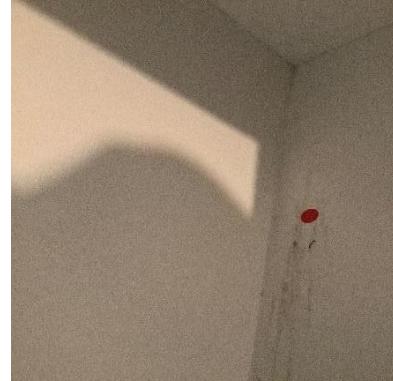
Villa #				
SN	Room	Item	Snag Description	Snag Images
058	Bedroom – 1	Wardrobe	<ul style="list-style-type: none"><li>• Rusty wardrobe door hinges.</li><li>• Scratches on the hanger rod.</li><li>• Dirt and stains in the wardrobe cabinets.</li></ul>

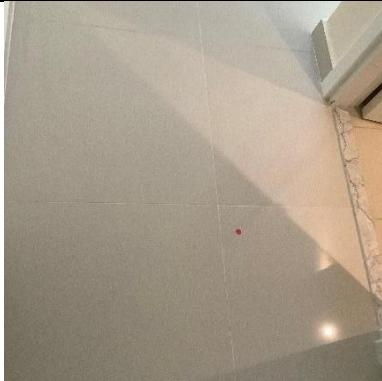
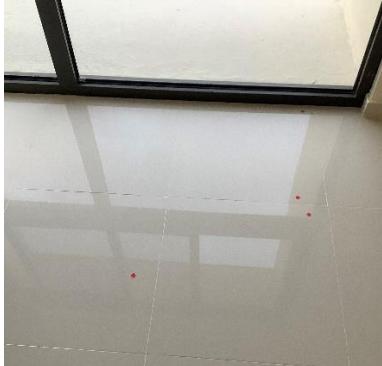
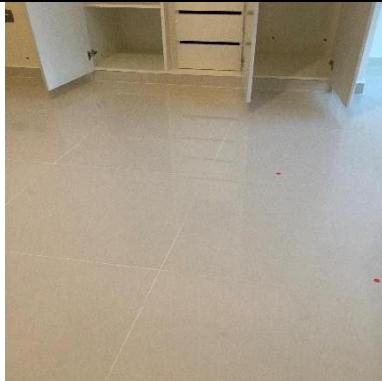
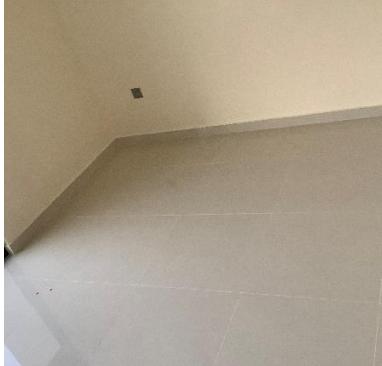
060	Bedroom – 1	Floor	<ul style="list-style-type: none"> <li>• No proper grouting between the tiles.</li> <li>• Hollow tiles observed, void below the tiles - tiles to be removed &amp; filled with binding material &amp; laid again ( marked with red dots )</li> <li>• Blackish stains on the floor.</li> </ul>

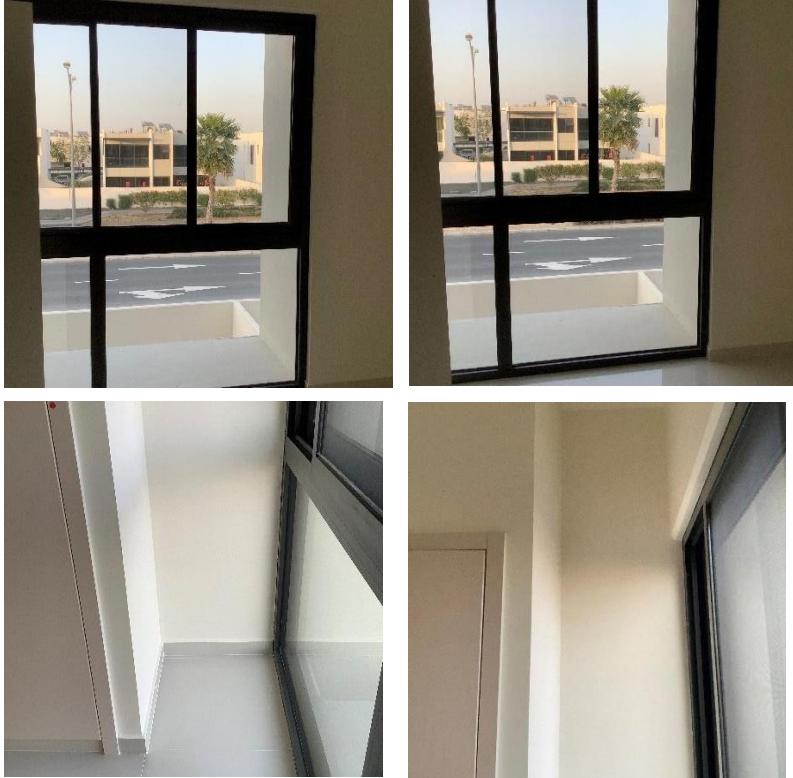
Villa #			
SN	Room	Item	Snag Description
			Snag Images
061	Bedroom – 1	Window	<ul style="list-style-type: none"><li>• Stains and scratches on and around the window frame.</li><li>• No proper finish around the window frame.</li></ul>

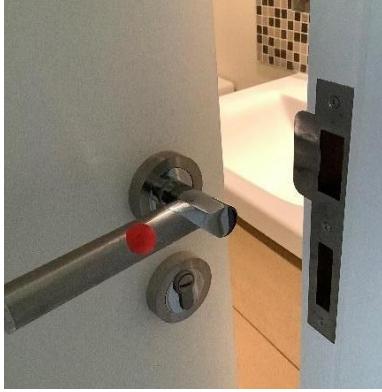
Villa #				
SN	Room	Item	Snag Description	Snag Images
062	Washroom - 1	Door	<ul style="list-style-type: none"><li>• Door does not open and shut smoothly.</li><li>• No proper finish around the door frame.</li><li>• No proper finish around the edges of the door.</li><li>• No proper sealant around the door frame.</li><li>• No proper finish around the door hinges.</li><li>• Stains and scratches on the door and the door frame.</li></ul>

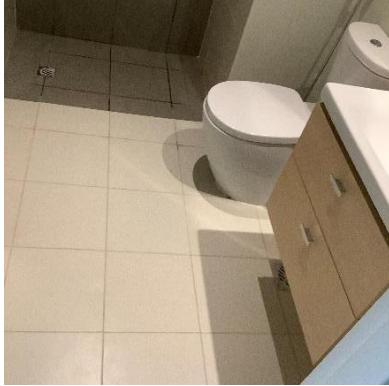
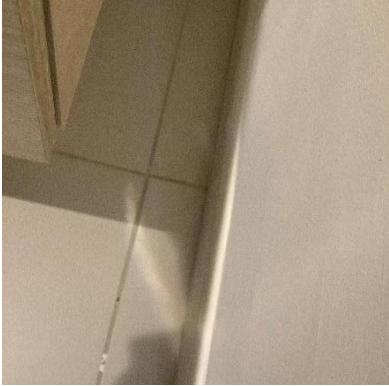
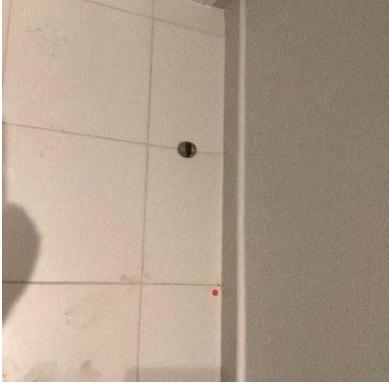
Villa #				
SN	Room	Item	Snag Description	Snag Images
063	Washroom -	Flooring	<ul style="list-style-type: none"><li>• Stains and scratches on the floor tiles.</li><li>• No proper finished grouting between the tiles.</li><li>• No proper grouting on and around the floor skirting.</li><li>• Blackish stains on the grout.</li></ul>

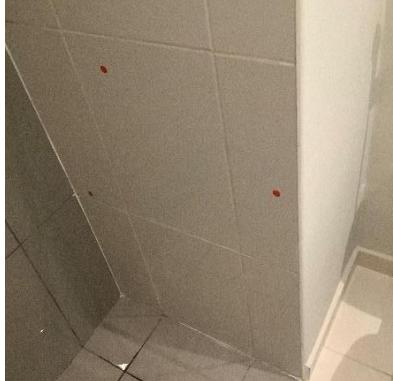
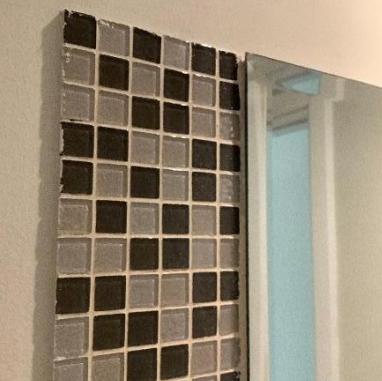
Villa #				
SN	Room	Item	Snag Description	Snag Images
064	Washroom - 1	Wall	<ul style="list-style-type: none"> <li>No proper finished grouting between the wall tiles.</li> <li>Stain and scratches on the wall.</li> <li>Blackish stains on the grout.</li> <li>Paint stains on the wall tiles.</li> </ul>

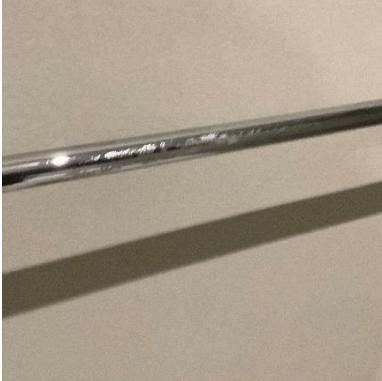
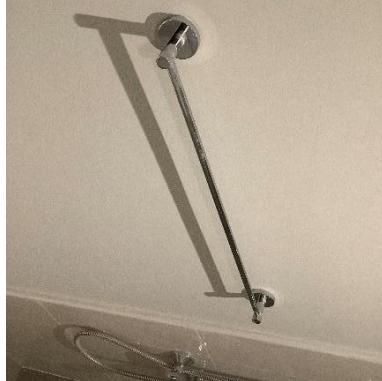
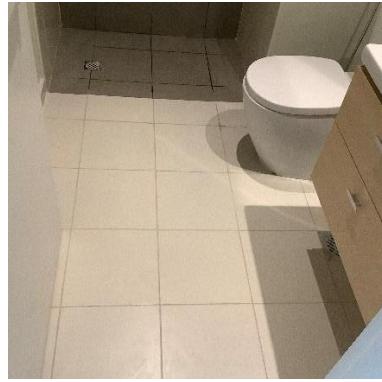
Villa #				
SN	Room	Item	Snag Description	Snag Images
066	Washroom - 1	Sanitary	<ul style="list-style-type: none"> <li>• No proper finish around the sanitary fittings.</li> <li>• Stains and scratches on the towel holder.</li> <li>• No proper sealant around the commode.</li> <li>• Blackish stains around the commode.</li> </ul>

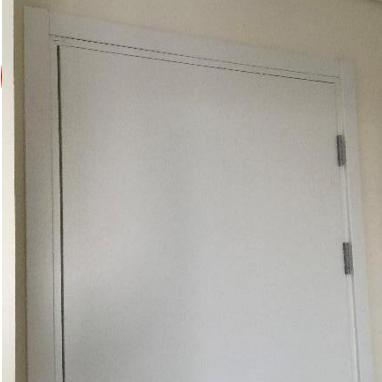
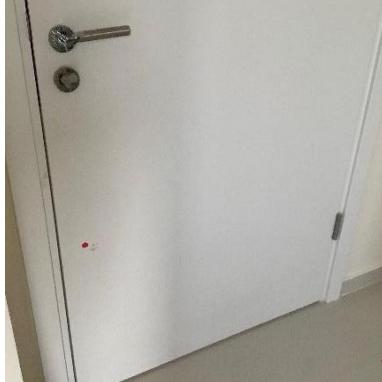
067	Bedroom – 2	Door	<ul style="list-style-type: none"> <li>• Stains on the door and the door frame.</li> <li>• No proper finish around the door frame.</li> </ul>

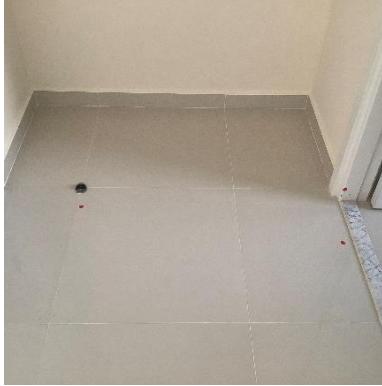
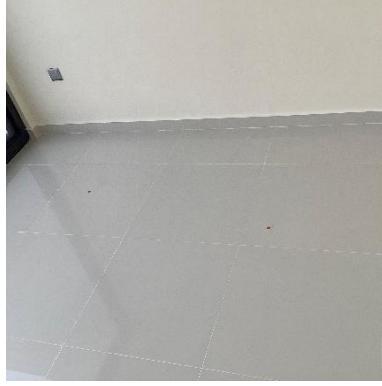
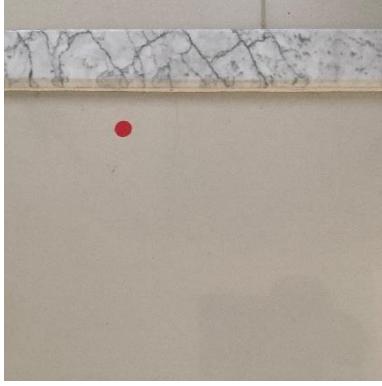
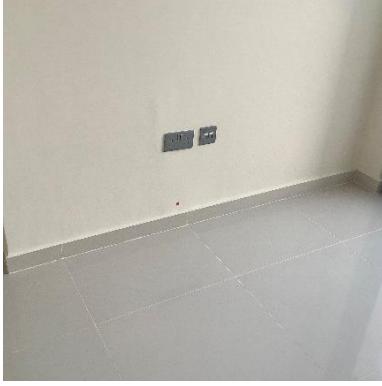
Villa #				
SN	Room	Item	Snag Description	
			Snag Images	
068	Bedroom – 2	Flooring	<ul style="list-style-type: none"><li>• No proper finished grout between the tiles.</li><li>• Chipped floor tile.</li><li>• Cracked tile near the threshold.</li><li>• Blackish stains on the grout.</li><li>• No proper finish around floor skirting.</li></ul>

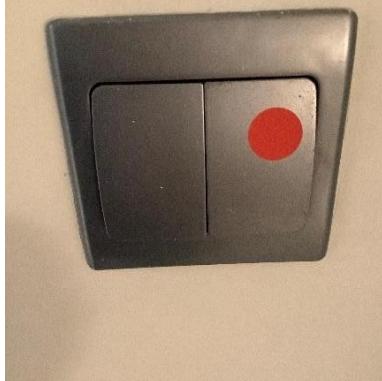
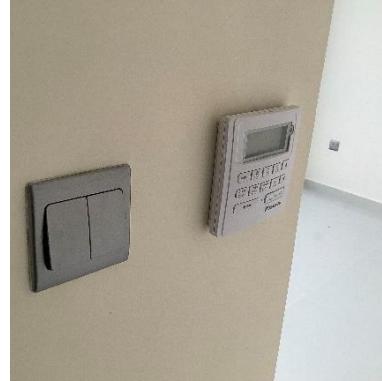
Villa #				
SN	Room	Item	Snag Description	Snag Images
069	Bedroom – 2	Electrical.	<ul style="list-style-type: none"> <li>• No proper finish around the electrical fittings.</li> <li>• Stains and scratches on and around the electrical fittings.</li> </ul>

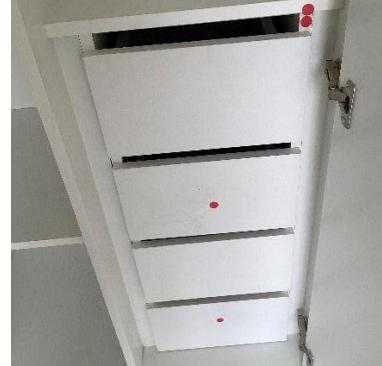
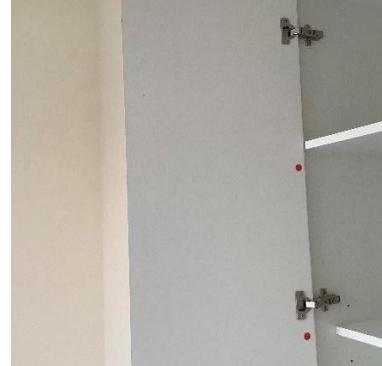
070	Bedroom – 2	Wardrobe	<ul style="list-style-type: none"> <li>• No proper finish around the wardrobe frame.</li> <li>• Wardrobe drawers does not open and close smoothly.</li> <li>• Blackish stains around the drawer corners.</li> <li>• No proper hinge setting.</li> </ul>

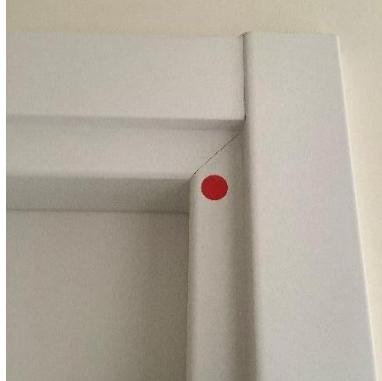
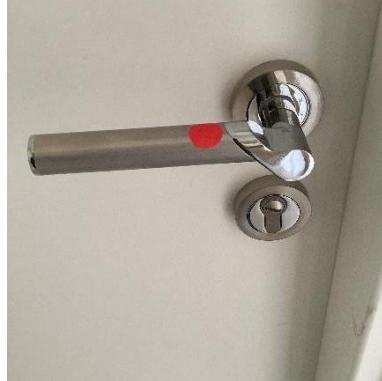
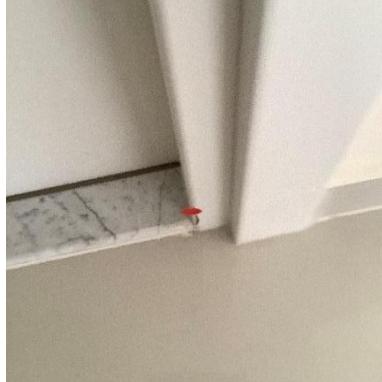
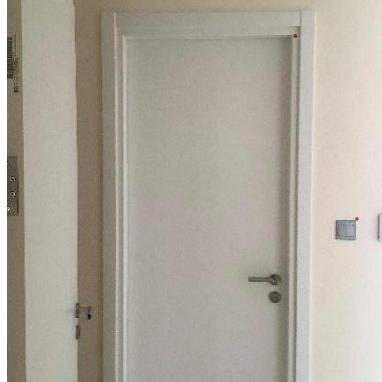
<b>Villa #</b>			
<b>SN</b>	<b>Room</b>	<b>Item</b>	<b>Snag Description</b>
072	Washroom – 2	Door	<ul style="list-style-type: none"><li>• No proper finish around the door frame.</li><li>• Chipped corner of the door frame.</li><li>• Door does not open and close properly.</li><li>• Blackish stains on the door and the frame.</li></ul>

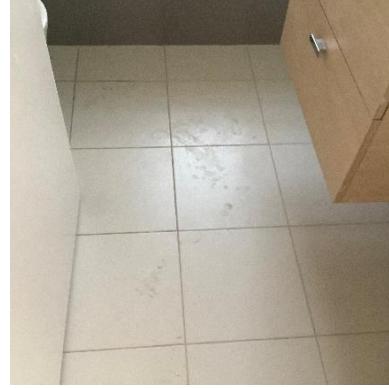
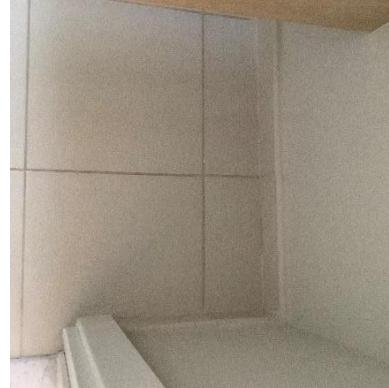
Villa #				
SN	Room	Item	Snag Description	
Snag Images				
073	Washroom - 2	Floor	<ul style="list-style-type: none"><li>• Untidy floor surface and needs deep cleaning.</li><li>• Poor grout finish between the floor tiles.</li><li>• Blackish stains on the grout and tiles.</li><li>• No proper finish around the floor skirting.</li></ul>

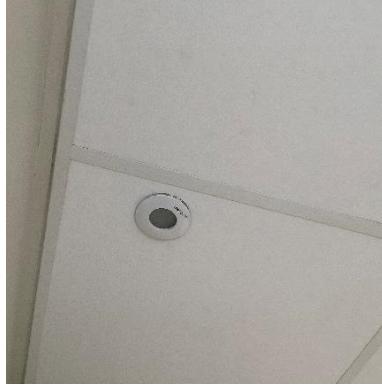
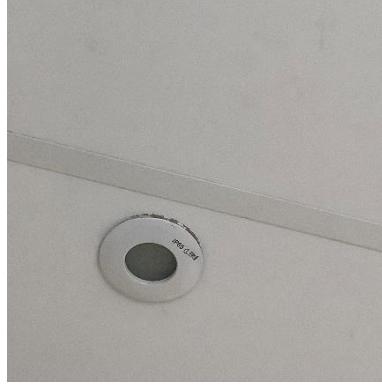
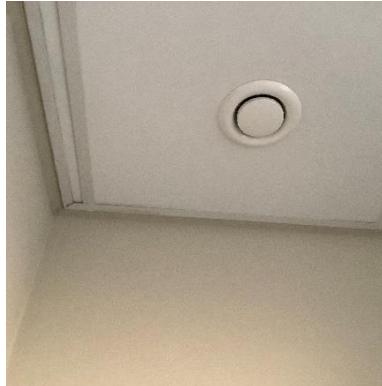
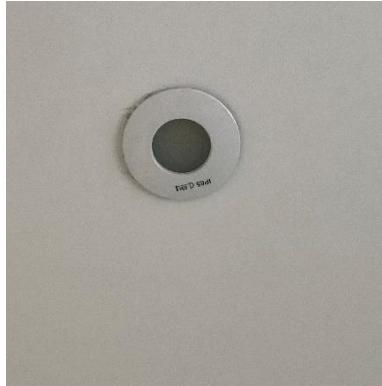
Villa #				
SN	Room	Item	Snag Description	Snag Images
075	Washroom - 2	Ceiling	<ul style="list-style-type: none"><li>• No proper finish around the ceiling.</li><li>• No proper sealant around the ceiling corners.</li><li>• Poor finish around the ceiling fixtures.</li><li>• Ceiling surface is untidy and requires cleaning.</li></ul>

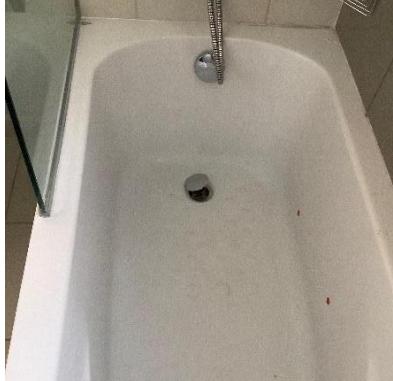
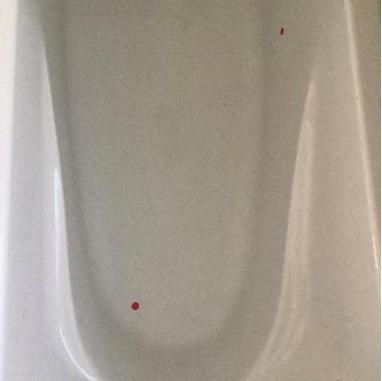
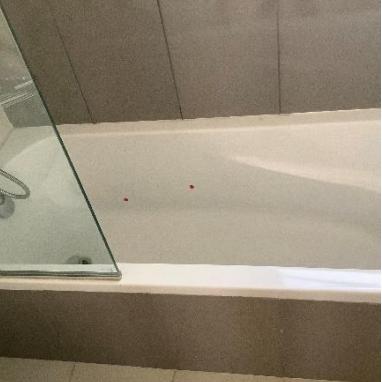
Villa #				
SN	Room	Item	Snag Description	Snag Images
076	Washroom – 2	Sanitary	<ul style="list-style-type: none"><li>• Poor finish around the bathtub.</li><li>• Stains and scratches on the bathtub.</li><li>• Blackish stains on the grout around the bathtub.</li><li>• Bathtub water outlet needs to be cleaned.</li></ul>

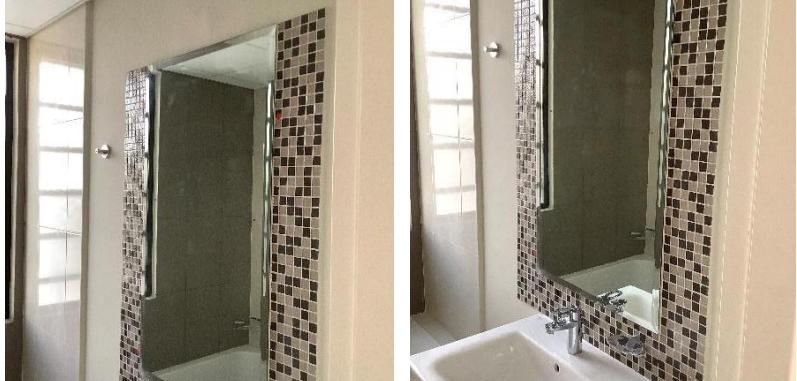
Villa #				
SN	Room	Item	Snag Description	Snag Images
077	Washroom - 2	Mirror	<ul style="list-style-type: none"><li>• Stains on the mirror and require cleaning.</li><li>• No proper finish around the mirror.</li></ul>

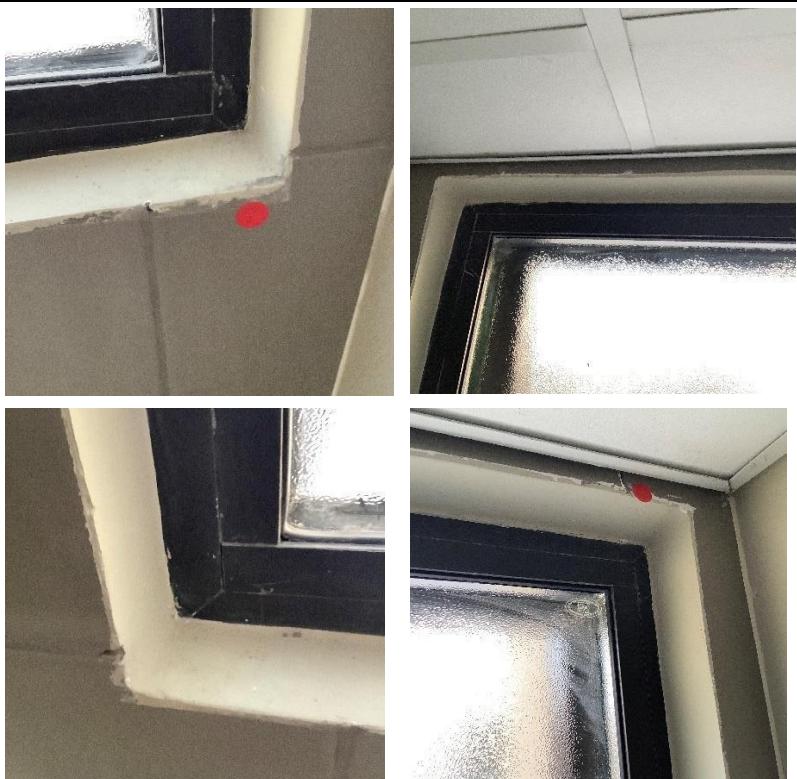
078	Washroom - 2	Window	<ul style="list-style-type: none"><li>• Poor finish around the window frame.</li><li>• Poor sealant around the window and requires proper sealant application.</li><li>• Paint stains and scratches on and around the window and the frame.</li><li>• Untidy glass surface and needs to be cleaned properly.</li></ul>

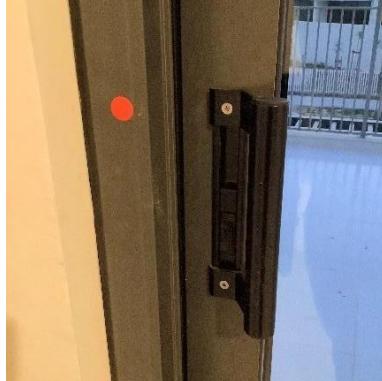
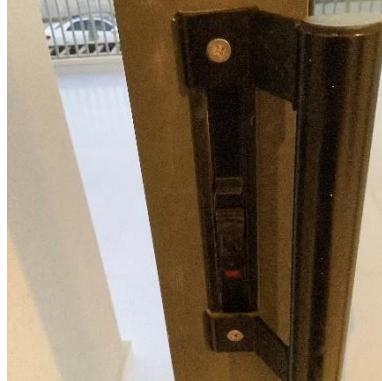
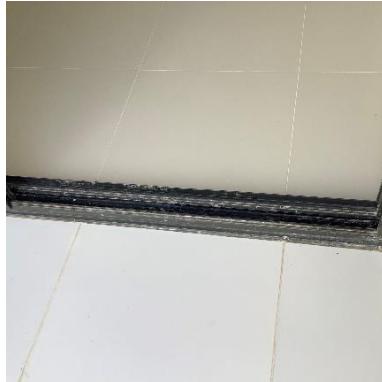
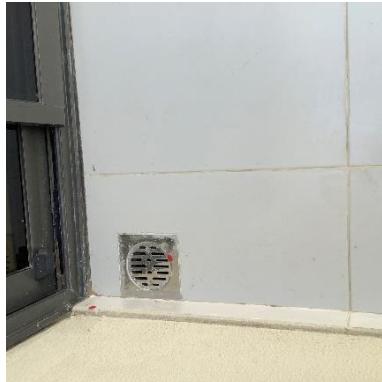
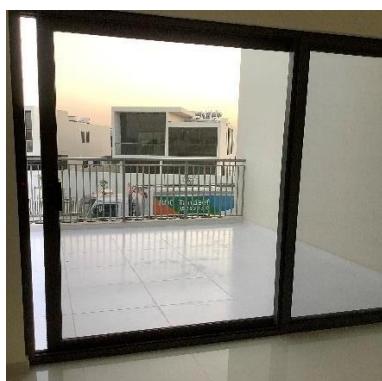
Villa #				
SN	Room	Item	Snag Description	Snag Images
079	Balcony	Door	<ul style="list-style-type: none"><li>• Poor finish around the door frame.</li><li>• Balcony door does not open and close smoothly.</li><li>• Paint stains and scratches on the door frame.</li><li>• Untidy door glass and requires cleaning.</li></ul>

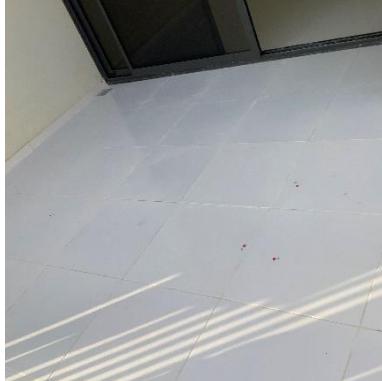
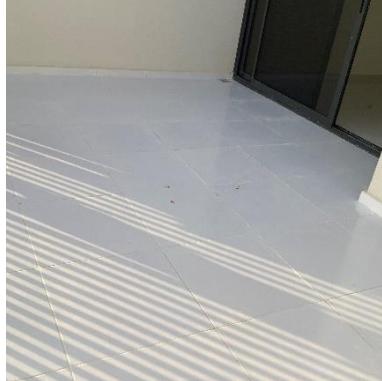
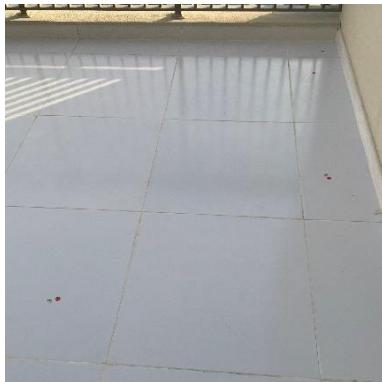
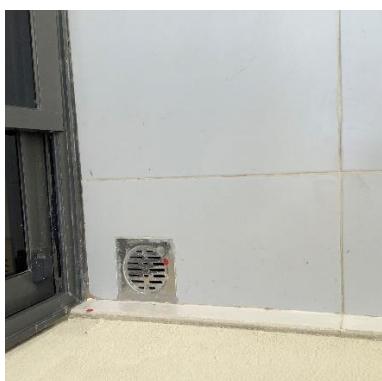
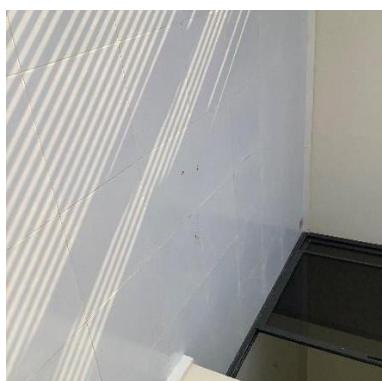
Villa #				
SN	Room	Item	Snag Description	Snag Images
080	Balcony	Floor	<ul style="list-style-type: none"> <li>Poor grout between the floor tiles.</li> <li>Blackish stains on the grout.</li> <li>Untidy floor surface and requires deep cleaning.</li> <li>No proper finish around the floor skirting.</li> <li>Poor finish around the rain water outlet.</li> <li>Rain water outlet needs to be cleaned prior to handover.</li> </ul>

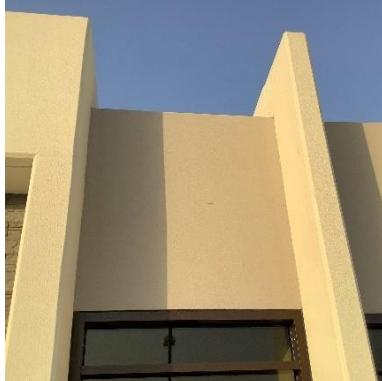
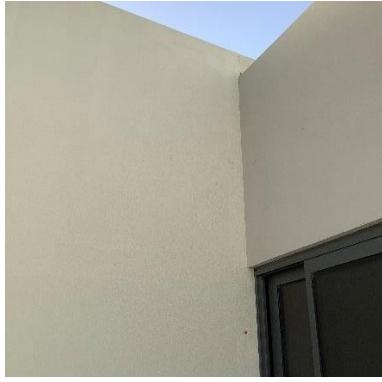
Villa #				
SN	Room	Item	Snag Description	Snag Images
081	Balcony	Wall	<ul style="list-style-type: none"><li>• Dust on the wall and needs cleaning prior to handover.</li><li>• Cracks on the wall.</li><li>• Patches, &amp; stains on the wall.</li></ul>

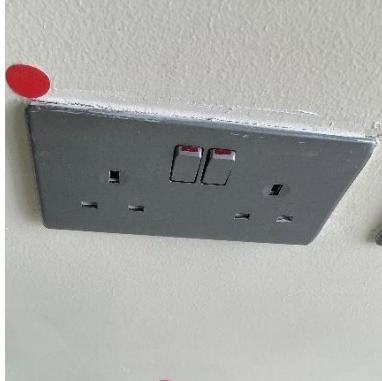
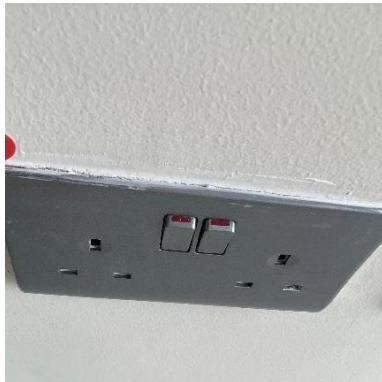
Villa #			
SN	Room	Item	Snag Description
082	Balcony	Electrical	<ul style="list-style-type: none"><li>Poor finish around the electrical fittings.</li><li>Paint stains and scratches on and around the switch boards.</li></ul>

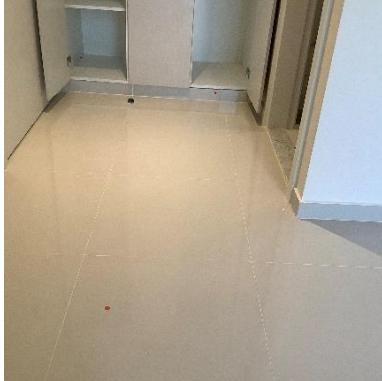
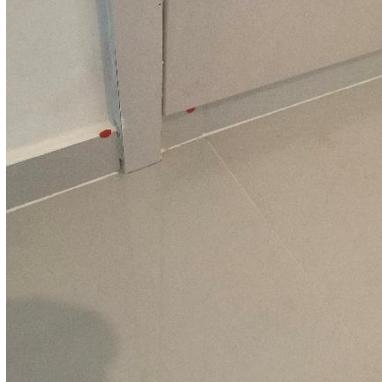
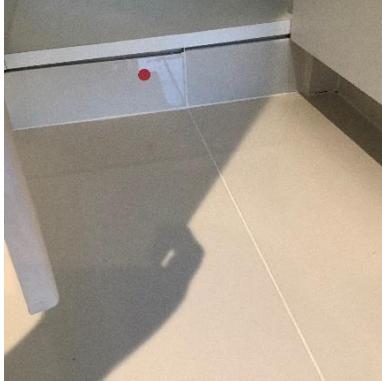
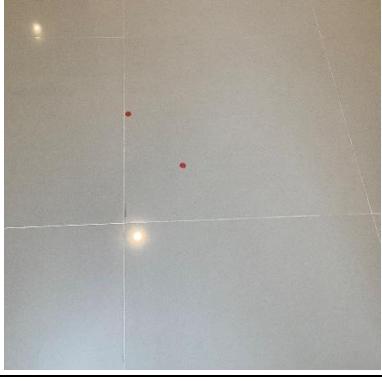
Villa #				
SN	Room	Item	Snag Description	Snag Images
084	Master's Bedroom	Flooring	<ul style="list-style-type: none"><li>• No proper finished grout between the tiles.</li><li>• Blackish stains on the grout.</li><li>• Poor finish around floor skirting.</li><li>• Chipped floor tiles.</li></ul>

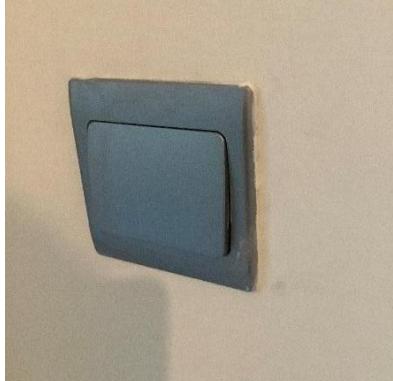
Villa #				
SN	Room	Item	Snag Description	Snag Images
085	Master's Bedroom	Electrical.	<ul style="list-style-type: none"> <li>• No proper finish around the electrical fittings.</li> <li>• Stains and scratches on and around the electrical fittings.</li> </ul>

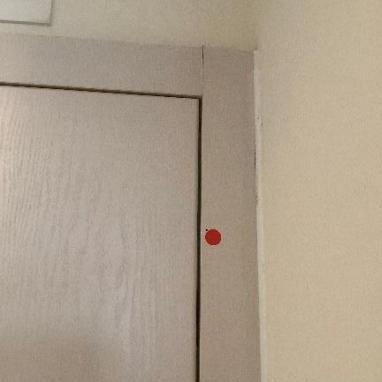
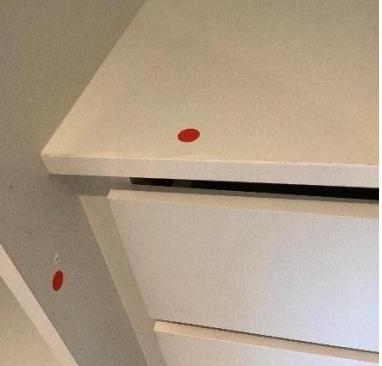
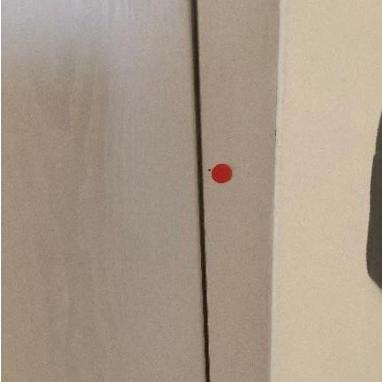
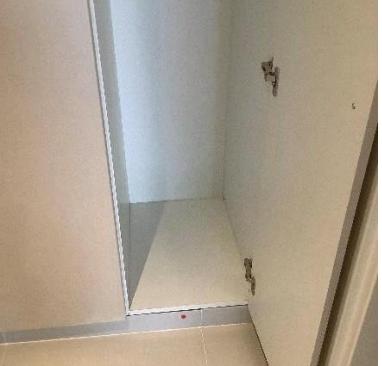
086	Master's Bedroom	Wardrobe	<ul style="list-style-type: none"> <li>• No proper finish around the wardrobe frame.</li> <li>• Wardrobe drawers does not open and close smoothly.</li> <li>• Blackish stains around the drawer corners.</li> <li>• No proper hinge setting.</li> </ul>

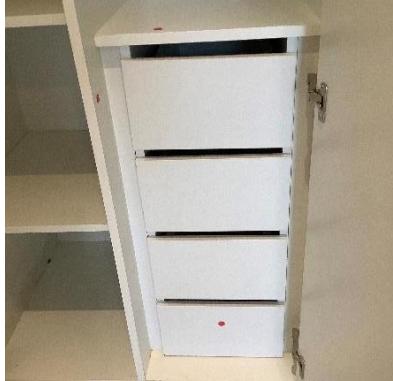
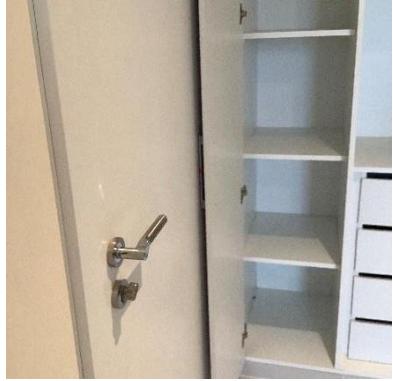
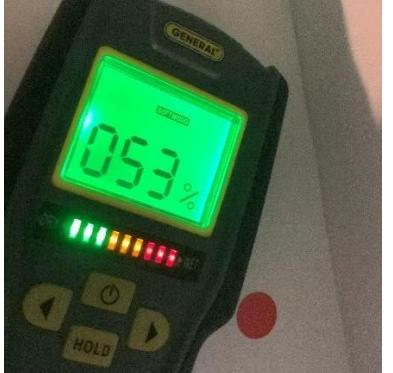
Villa #				
SN	Room	Item	Snag Description	Snag Images
087	Master's Bedroom	Wardrobe	<ul style="list-style-type: none"><li>• Stains and scratches on and around the drawer corners.</li><li>• Poor finish around the drawer corners.</li><li>• Stains around the wardrobe cabinets.</li><li>• High moisture content observed in the wardrobe.</li></ul>

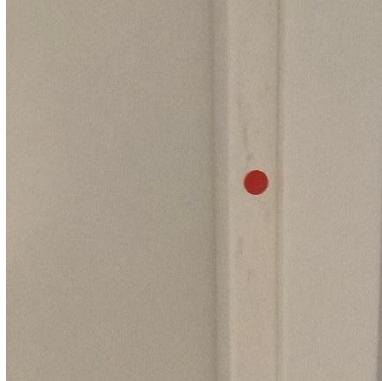
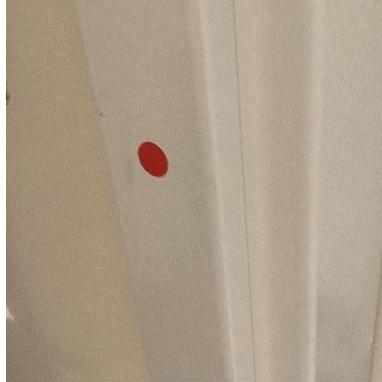
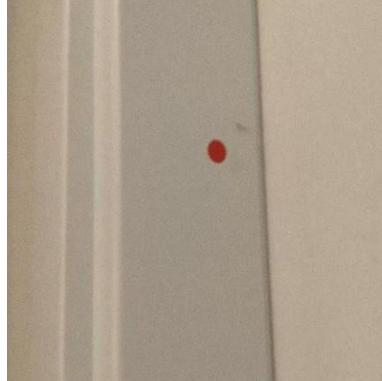
Villa #				
SN	Room	Item	Snag Description	Snag Images
088	Master's Washroom	Door	<ul style="list-style-type: none"><li>• No proper finish around the door frame.</li><li>• Chipped corner of the door frame.</li><li>• Blackish stains on the door and the frame.</li></ul>

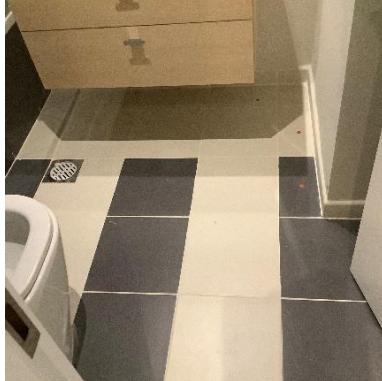
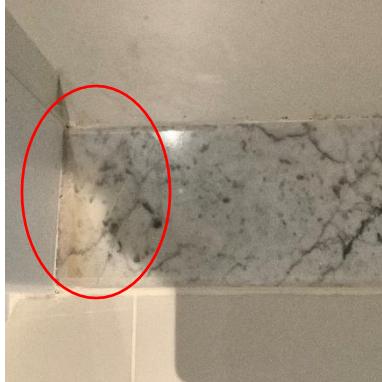
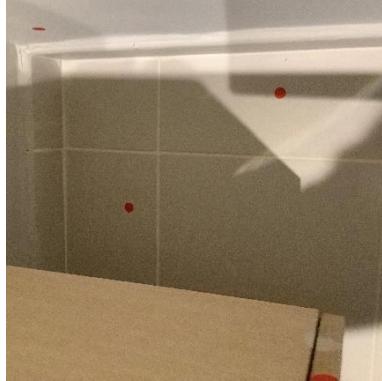
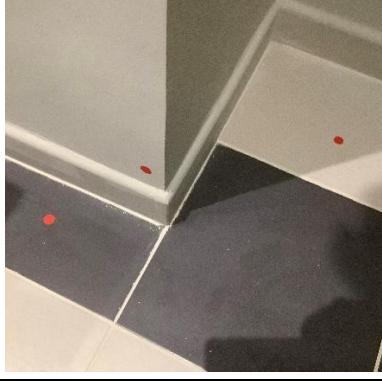
Villa #				
SN	Room	Item	Snag Description	
			Snag Images	
089	Master's Washroom	Floor	<ul style="list-style-type: none"><li>• Untidy floor surface and requires cleaning.</li><li>• Poor grout finish between the floor tiles.</li><li>• Blackish stains on the grout and tiles.</li><li>• No proper finish around the floor skirting.</li><li>• Poor finish around the threshold.</li></ul>

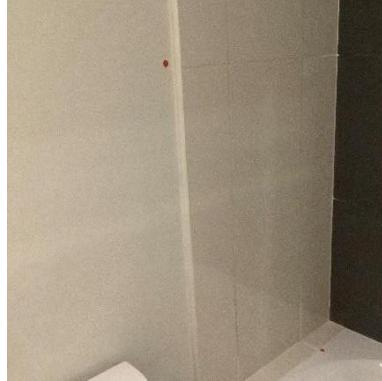
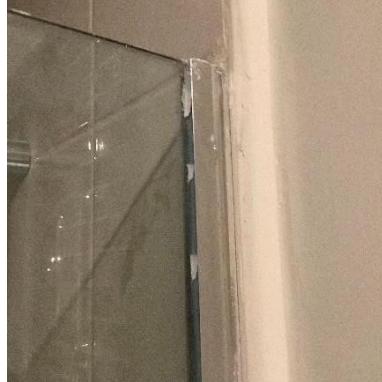
Villa #				
SN	Room	Item	Snag Description	Snag Images
090	Master's Washroom	Wall	<ul style="list-style-type: none"><li>• Poor grout between the wall tiles.</li><li>• Blackish stains on the grout.</li><li>• No proper finish around the wall termination.</li></ul>

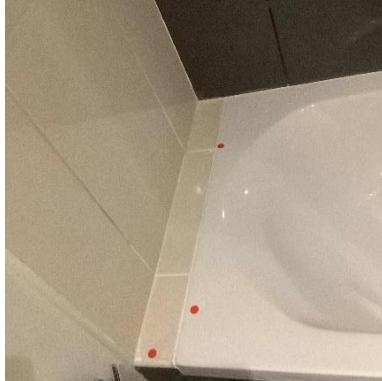
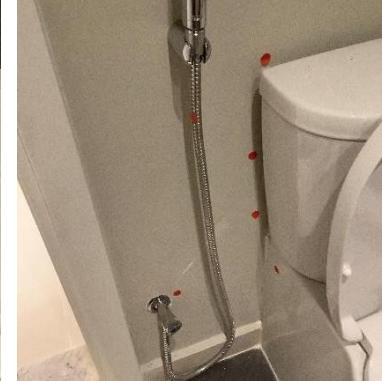
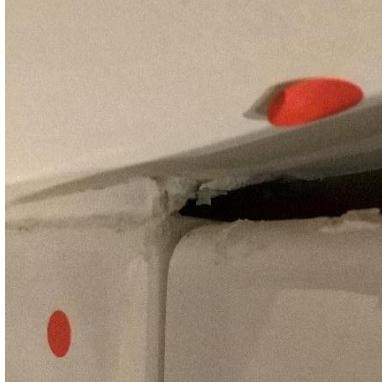
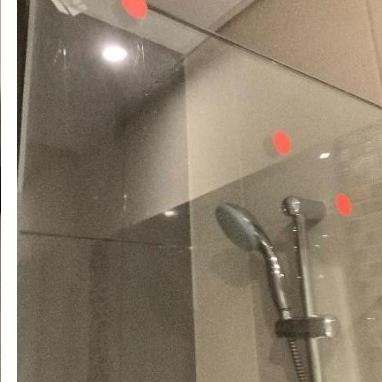
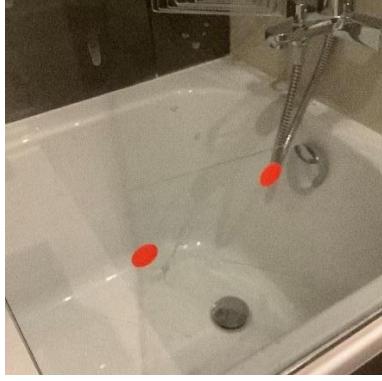
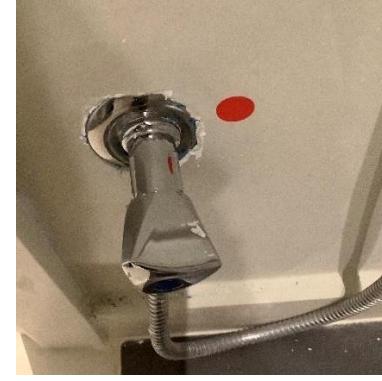
Villa #				
SN	Room	Item	Snag Description	Snag Images
091	Master's Washroom	Sanitary	<ul style="list-style-type: none"><li>• Poor finish around the bathtub.</li><li>• Stains and scratches on the bathtub.</li><li>• Blackish stains on the grout around the bathtub.</li><li>• No proper sealant around the commode.</li><li>• Paint stains on the shut off hose.</li><li>• Stains &amp; scratches on the glass divider.</li><li>• Poor finish around the glass divider.</li><li>• Poor finish around the angle valve.</li><li>• Paint stains on and around the angle valve.</li></ul>
