Akoya Zinna(Damac Hills 2)  
Townhouse ABC

TECHNICAL SNAGGING REPORT

3-BEDROOM TOWNHOUSE

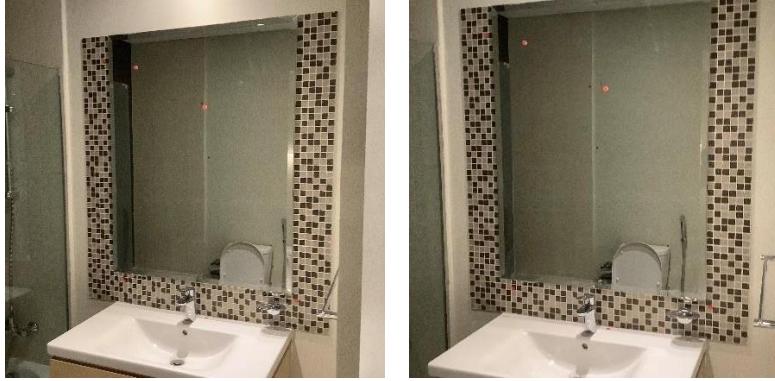
Villa #				
SN	Room	Item	Snag Description	Snag Images
092	Master's Washroom	Mirror	<ul style="list-style-type: none"><li>• Stains on the mirror and require cleaning.</li><li>• No proper finish around the mirror.</li></ul>

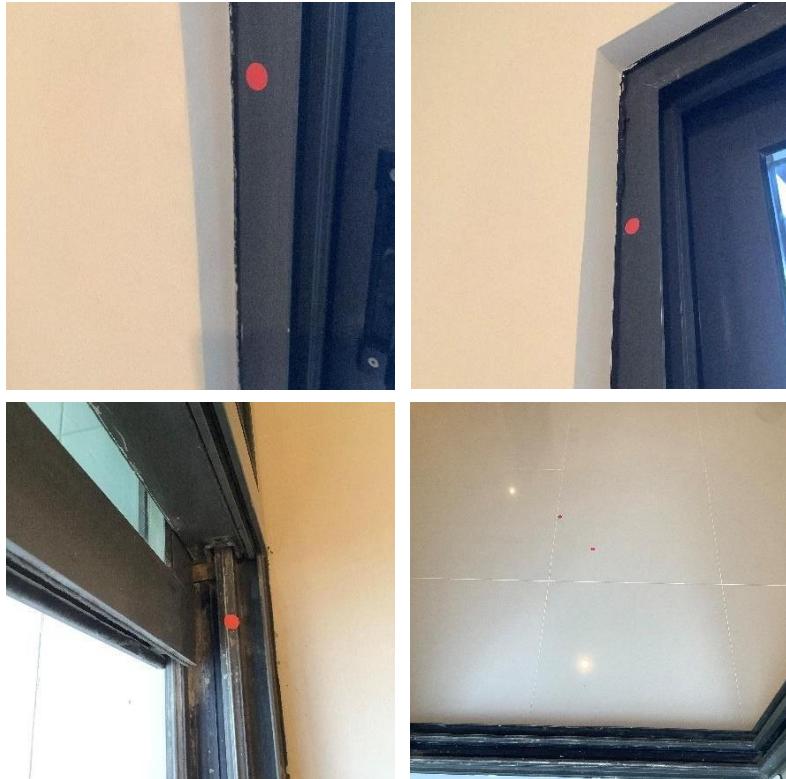
093	Balcony	Door	<ul style="list-style-type: none"><li>• Poor finish around the door frame.</li><li>• Balcony door does not open and close smoothly.</li><li>• Paint stains and scratches on the door frame.</li><li>• Untidy door glass and requires cleaning.</li></ul>

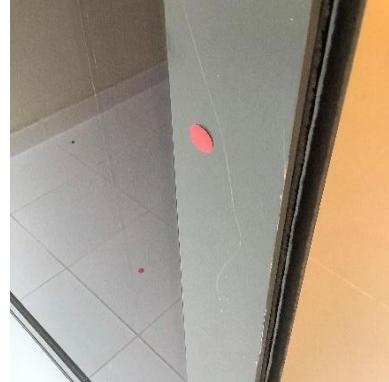
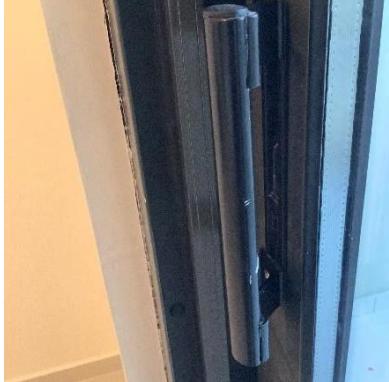
Villa #				
SN	Room	Item	Snag Description	
Snag Images				
094	Balcony	Door	<ul style="list-style-type: none"><li>• Scratches and stains on the door glass.</li><li>• Paint stains on the door glass.</li><li>• Dust on the glass surface and requires cleaning.</li></ul>

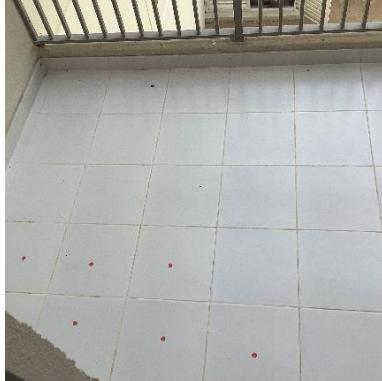
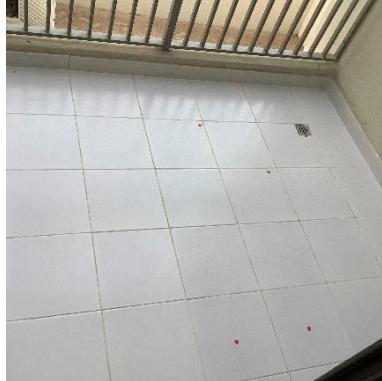
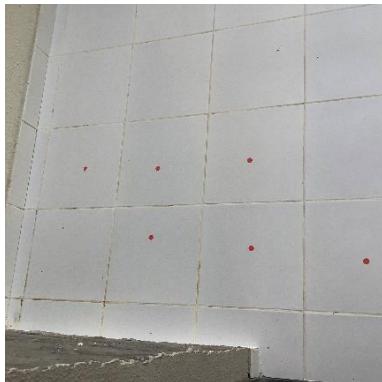
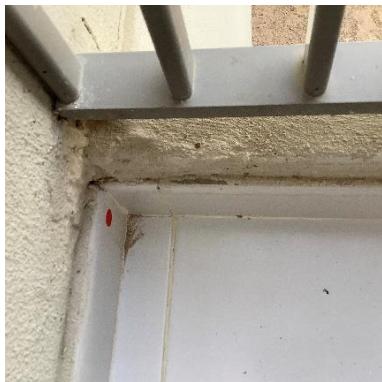
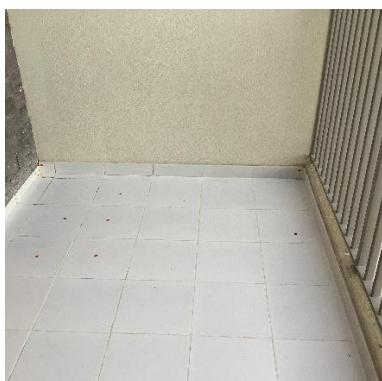
Villa #				
SN	Room	Item	Snag Description	Snag Images
095	Balcony	Floor	<ul style="list-style-type: none"><li>• Poor grout between the floor tiles.</li><li>• Blackish stains on the grout.</li><li>• Untidy floor surface and requires deep cleaning.</li><li>• No proper finish around the floor skirting.</li><li>• Poor finish around the rain water outlet.</li><li>• Rain water outlet needs to be cleaned prior to handover.</li><li>• Dust on the railing ad requires deep cleaning prior to handover.</li></ul>

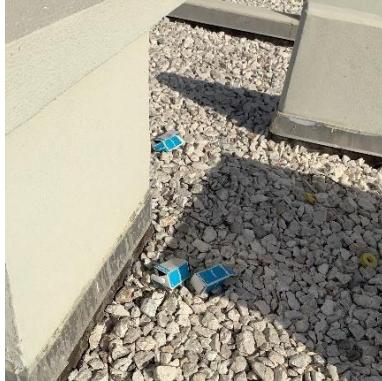
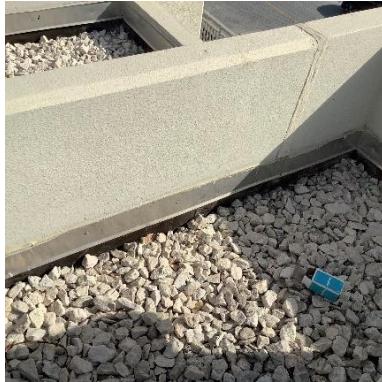
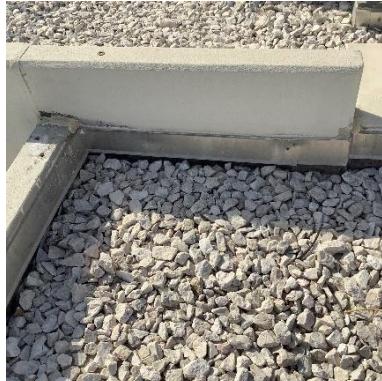
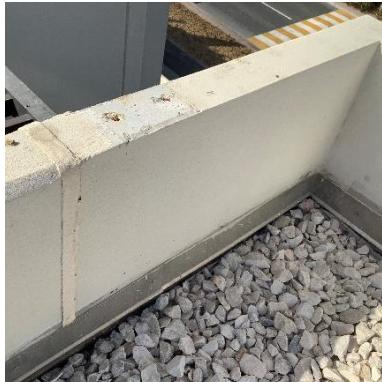
Villa #			
SN	Room	Item	Snag Description
096	Rooftop	Floor	<ul style="list-style-type: none"><li>• Trash to be cleaned.</li><li>• Surfaces to be cleaned properly.</li></ul>

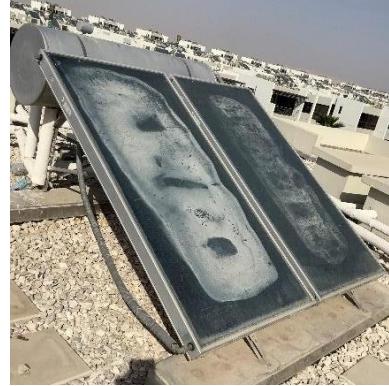
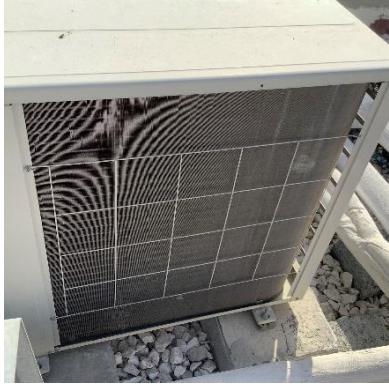
Villa #				
SN	Room	Item	Snag Description	Snag Images
097	Rooftop	Devices	<ul style="list-style-type: none"> <li>• Stains on the panels and needs to be replaced.</li> <li>• Dust on the electrical devices and requires cleaning.</li> <li>• Poor finish around the electrical fittings.</li> </ul>

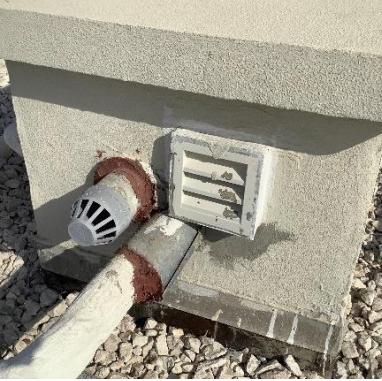
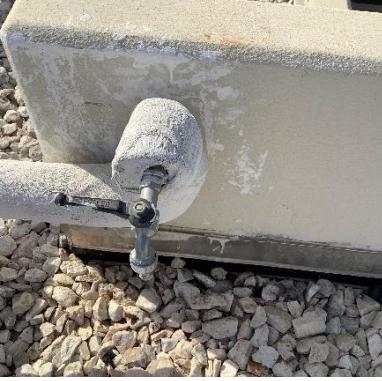
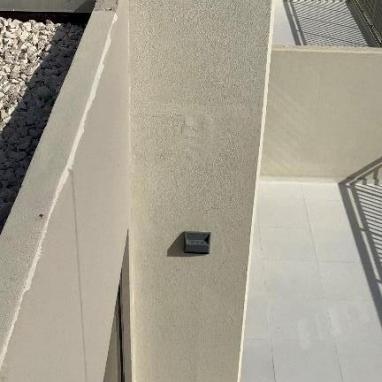
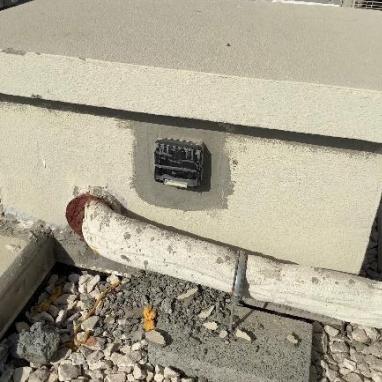
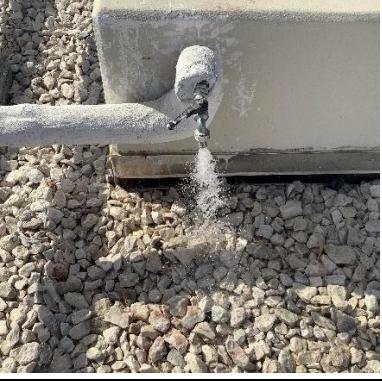
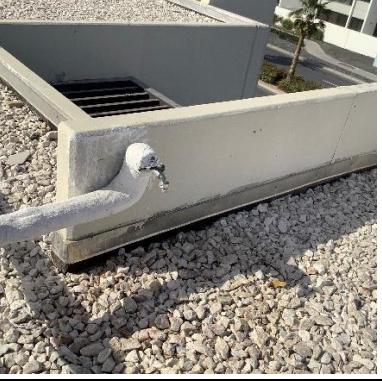
Villa #				
SN	Room	Item	Snag Description	Snag Images
098	Rooftop	Plumbing	<ul style="list-style-type: none"><li>• No proper finish around the plumbing structures.</li><li>• Paint stains around the pipes.</li></ul>

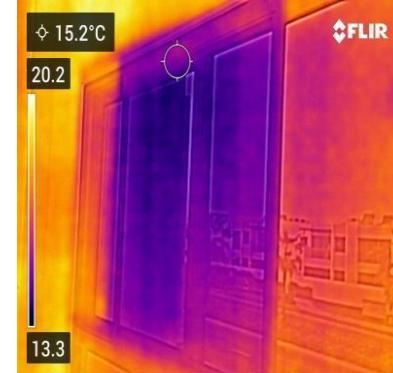
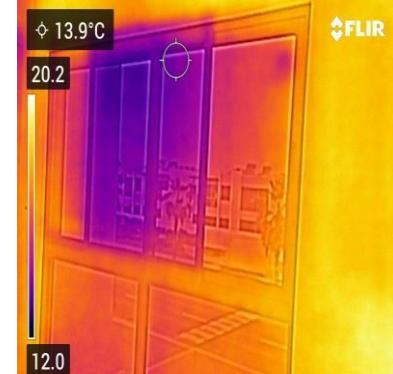
Villa #				
SN	Room	Item	Snag Description	
			Snag Images	
102	Balcony	Door frame	<ul style="list-style-type: none"><li>Insulation around the sliding door and window frames are in good condition.</li></ul>
