## **Manufacturability Analysis Report**

- QC113270005
- 08/02/2024 V1

Part Name: 309805.STL

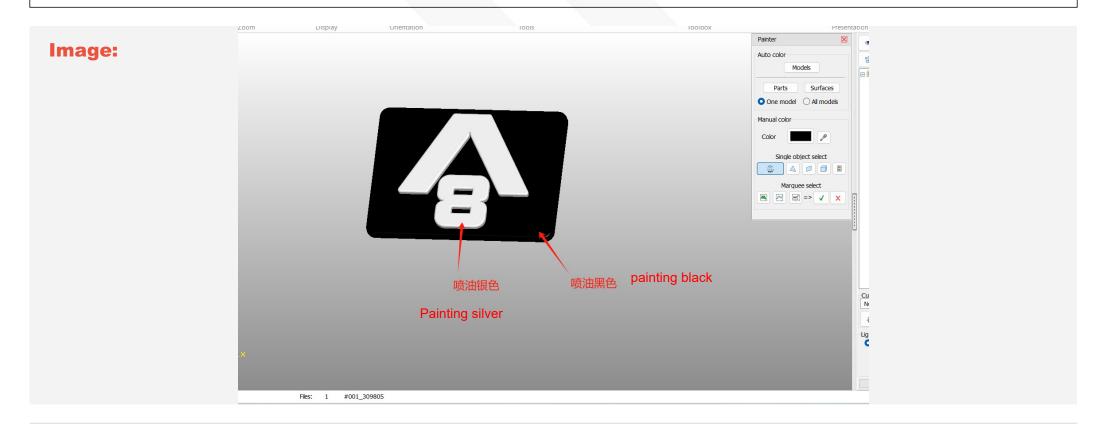
**Detail:** Do you need to paint for your parts? If the parts need to be beautiful, it is recommended to be grind and then painted as shown in the attachment. If you only paint the font, the surface will be ugly. Because the black ABS material will be a little white after grinding, which will be not attractive. May I know your idea?

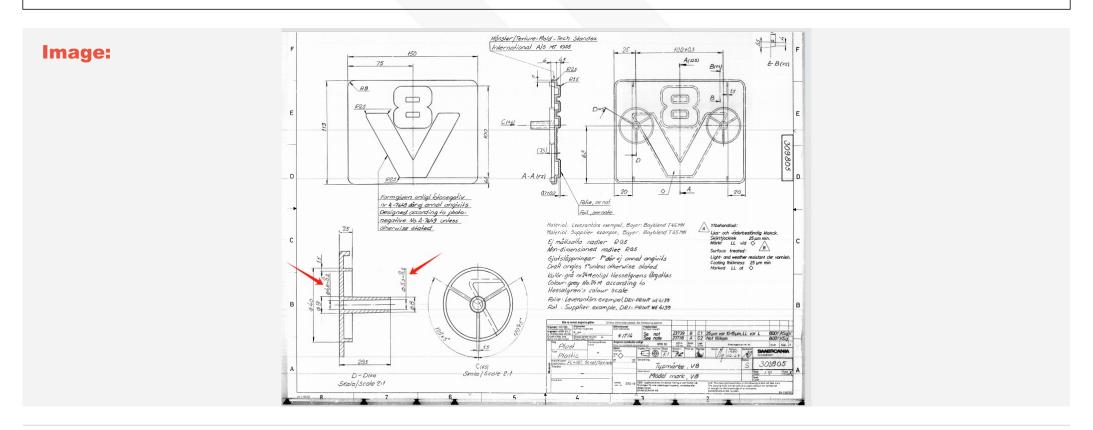
**Detail:** The tolerance of the area indicated by the arrow is not achievable by 3D printing and needs to be relaxed to + 0.30/+0 mm.
