# Safety Investigation Report

## Boeing 737-800 PK-GMP struck by an unattended lavatory service truck at parking stand W29, Kualanamu (WIMM)

| Report | ARAP-ORLIO-KNKT.24.10.22.04 |
| Project | DEMO-07 — Case study: KNKT.24.10.22.04 |

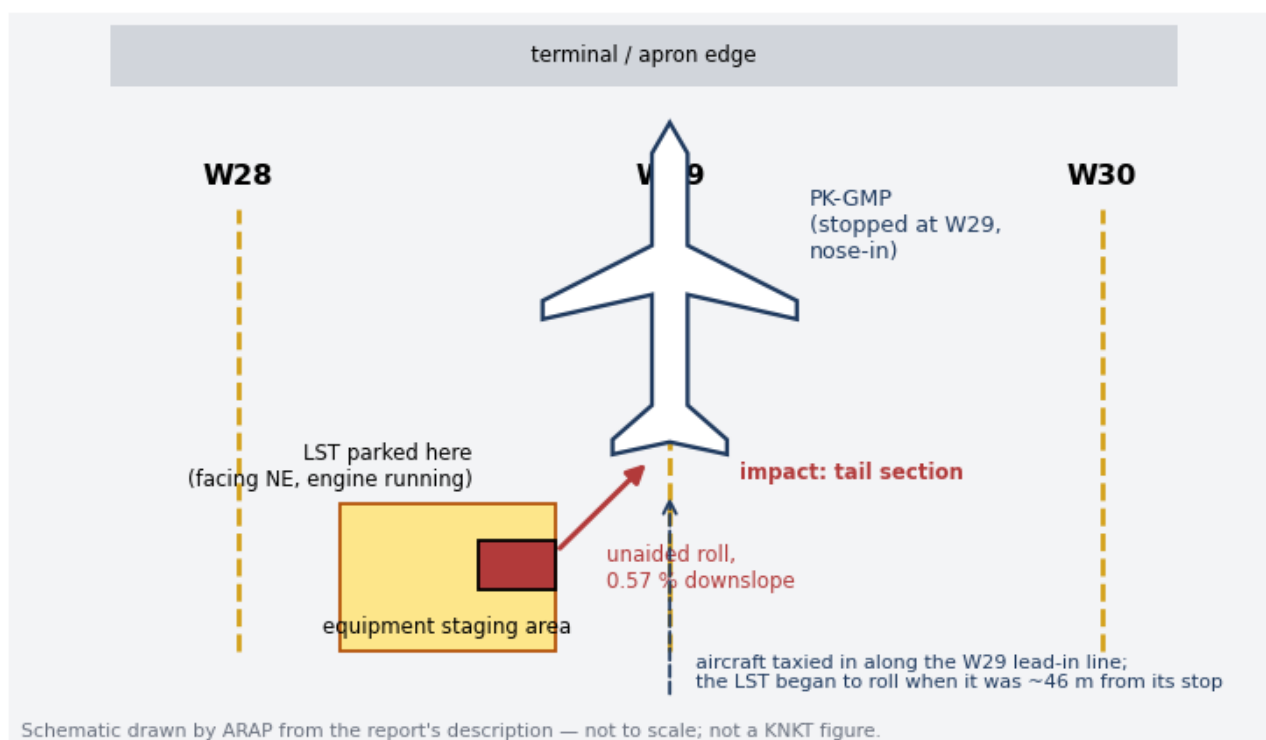
Figure A1. Schematic of the occurrence site at Apron W, parking stand W29 (not to scale)

- 7 Contributing factor 7 — Local condition: The equipment staging area between W28 and W29 sloped down 0.57 % toward the impact point. Chain: F3 (Local condition) → F1 (Occurrence event) → the occurrence.

| ORLIO layer | Identified deficiency | Corrective action required | Action owner | Target date |
|---|---|---|---|---|
| Local conditions | F3 The equipment staging area between W28 and W29 sloped down 0.57 % toward the impact point | [Engineering controls] Mark level GSE parking positions in staging areas and require GSE to park perpendicular to, or facing away from, the aircraft path (proposed (ARAP example); Proposed) | PT Angkasa Pura Aviasi | [Date] |

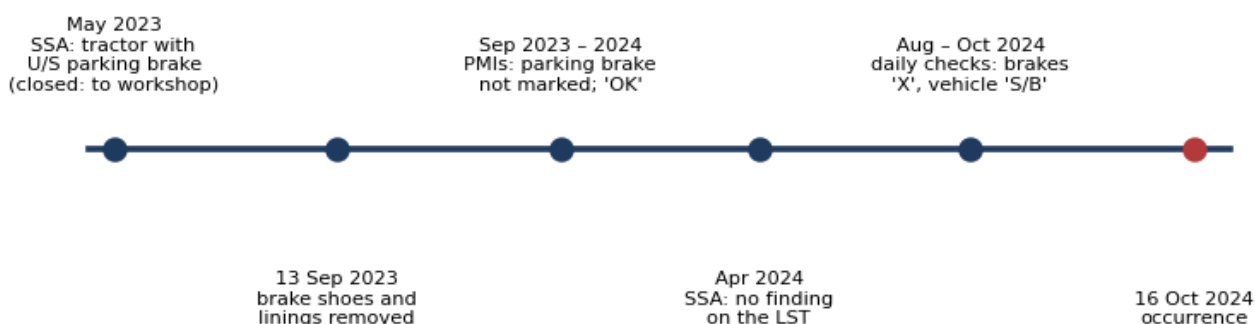
Figure A3. How the unserviceable parking brake stayed in service, September 2023 – October 2024

| Time | Event | Source |
|---|---|---|
| 2023-09-13 | Maintenance removed the LST parking brake shoes and linings for an unrecorded reason; they were not reinstalled because parts were unavailable | LST maintenance report |
| 2024-10-16 06:00 | The morning-shift GSE operator marked the LST service and parking brakes 'X' but recorded the vehicle serviceable (S/B) | Daily Check Sheet, October 2024 |

| <b>Morning-shift GSE operator</b> | Found the parking brake unserviceable during the daily check and marked it 'X'; marked the vehicle serviceable on the understanding that wheel chocks could replace the parking brake. |

| ORLIO layer | Identified deficiency | Corrective action required | Action owner | Target date |
|---|---|---|---|---|
| Risk controls | F10 Ground handler practice assessed GSE with an unserviceable parking brake as serviceable, on the assumption that wheel chocks could replace the parking brake | [Administrative controls] Amended the Daily Check Sheet so that parking brake and service brake results are recorded separately (safety action taken (KNKT report §4); Closed) | PT Gapura Angkasa | Completed |
