Restoration of the Hinderer House, Kudeti, Ibadan

¹Cordelia O. Osasona and ²Oluseyi A. Olagoke

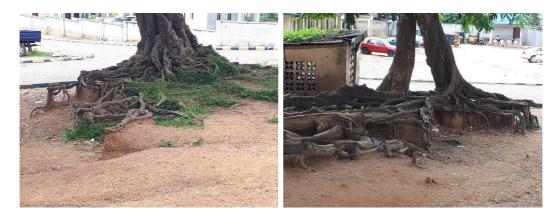
As at the time of taking possession of the Hinderer House site, the building was in a highly derelict condition. Obvious (and of great concern) was the extent of the soil erosion that had taken place in the immediate environment – and which had started to threaten the continued existence of the building. In many parts of the building, the plinth on which the whole structure rested was greatly undermined. (See the pictures below). Of similar structural concern were the deep cracks that were observed in some masonry walls – particularly external ones.

Plate 2 (a & b): Tree roots in the neighbourhood (2022).

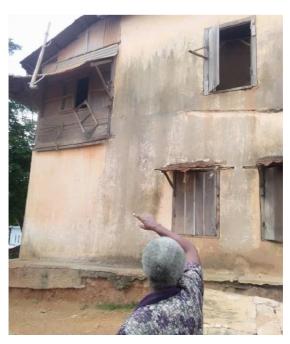
Generally, woodwork too was in bad condition; this ranged from doors and windows (and their hoods), through floor-boarding, to wall-panelling. Apart from the internal flooring and partitioning in timber, there was a lot of timberwork on the two verandas (ranging from timber- post structural support, through balustrading and floor-boarding, to flank-panelling).

Plate 3 (a & b): Hinderer House – different wings, showing eroded building plinth & dilapidated windows.

The major focus in this regard was the plinth – the base of the building in touch with the ground. As earlier mentioned, this had suffered severe damage, over the years, and needed a drastic, long-term solution. It was decided to consolidate all foundation works around the building by creating another plinth, this time of 225mm (9in) sandcrete blocks and concrete, and to further reinforce the immediate building surroundings by a retaining wall, composed of two juxtaposed sandcrete blocks, filled with concrete. The pictures below indicate the process.

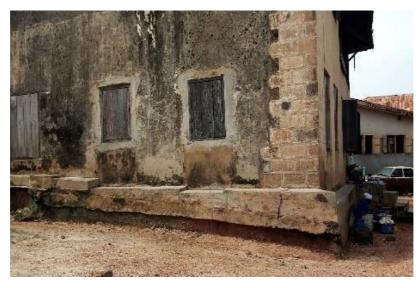
Plate 4: Building corner done in stone, accentuated by pointing in cement-plaster. Notice the eroded plinth, as well.

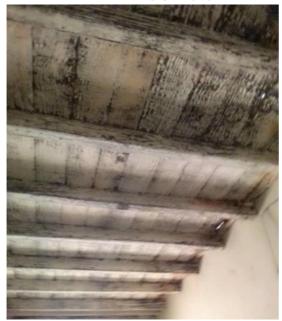
Plate 5: Timber-flooring from ground floor.

Plate 6: First floor veranda timber-flooring.

Timber-work that suffered the most damage, understandably, was with respect to floor-boarding in exposed areas (like the two verandas); the internal timber-panelled wall was in remarkably good condition. Other areas that could not be overlooked were with respect to missing (or defective) members of the overall roof structure, and also side-panelling and balustrading that enclosed the verandas.

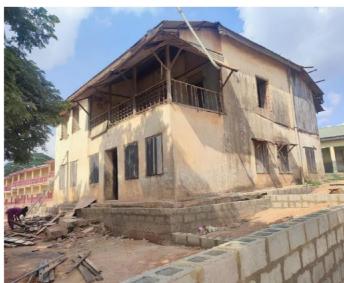
Plate 7 (a-d): External works – foundation consolidation: plinth/ retaining wall.

Other masonry repair-work undertaken includes the consolidation of wall-cracks; making up of defective plasterwork (on wall surfaces, particularly at the base), and pitted floor-screeding.

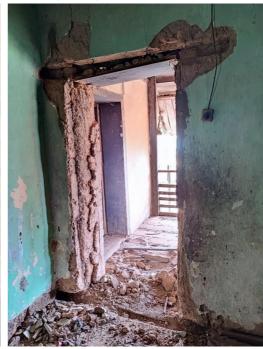
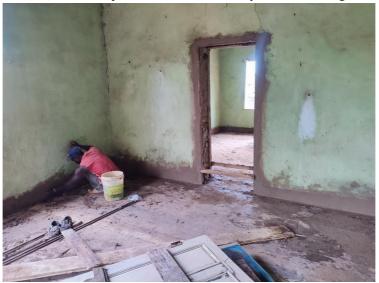
Plate 8 (a-c): Plaster-replacement around doorways and on walls, generally.

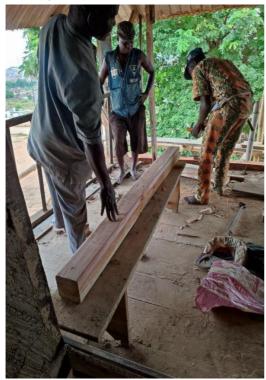
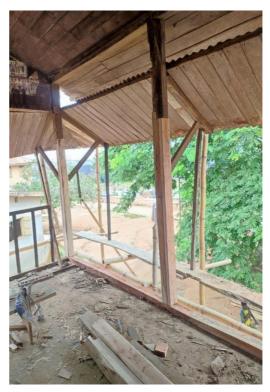
Plate 9 (a-b): Removal of defective timber posts & railings.

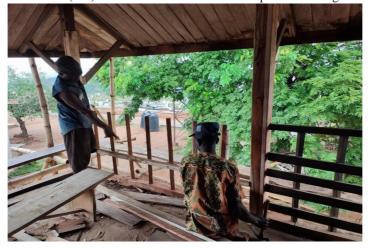
Plate 10: Replacement of defective timber posts and railings.

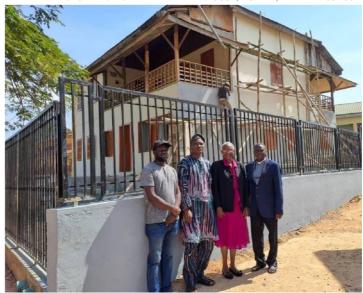
On November 24, the Team (together with a representative of the Cathedral) met on site to appraise progress made so far, and chart a path for the speedy completion of yetoutstanding works. Satisfaction on pace (and quality) of work was generally expressed; so was confidence that the project would be delivered at the end of the month, and to the agreed scope and quality of intervention.

Plate 11: Hinderer House restoration, nearing completion. Olagoke, Aderounmu, Osasona & Venerable Ogunrinde in the foreground (November 24, 2022).

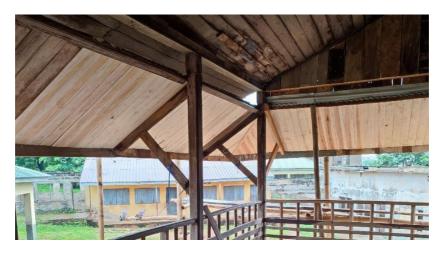
Plate 12: Veranda roof-extension ceiling repairs.
