### **TOTAL LOSS REPORT**

**RE: Road traffic Accident: Samantha Wilson : 28/04/2026**

**Our Ref:** dfd26088

**Date:** 06/05/2026

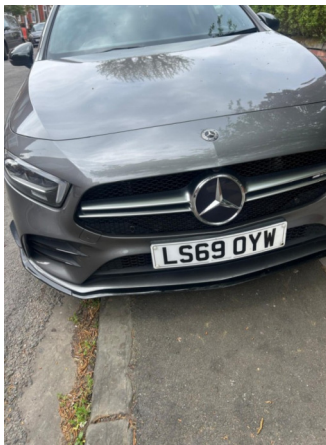
Impact Area

The vehicle has suffered heavy collision/impact damage to the right hand side, and moderate collision/impact to the left hand side.

Please note the vehicle is unroadworthy due to the extent of panel distortion sustained to the offside and impacted wheel/tyre and suspension.
