### **REPAIRABLE REPORT**

**RE: Road traffic Accident: Mrs Karin Solomons: 25/04/2026**

| Make | <b>TESLA</b> | Registration | <b>LD710GY</b> |
| Model | <b>MODEL 3 LONG RANGE</b> | Status | <b>Repair</b> |

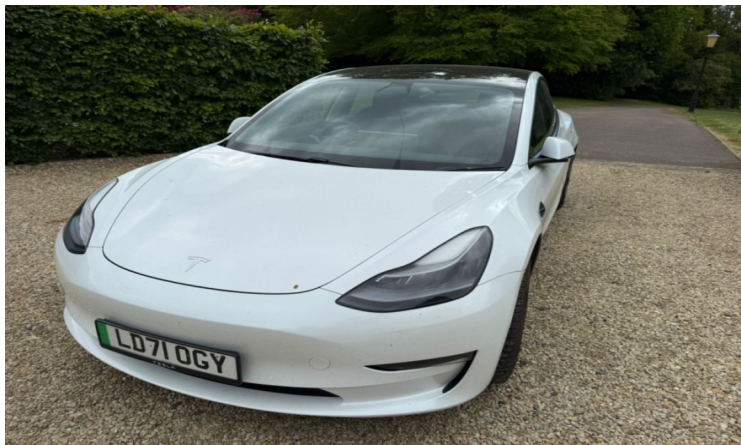
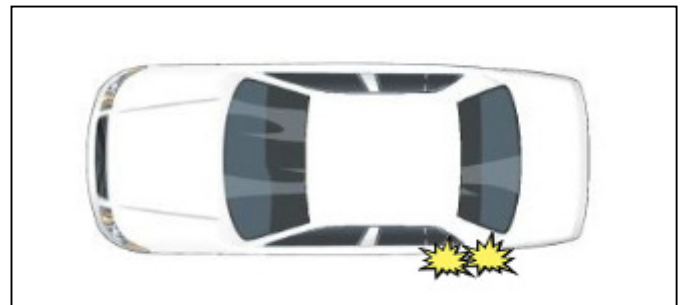
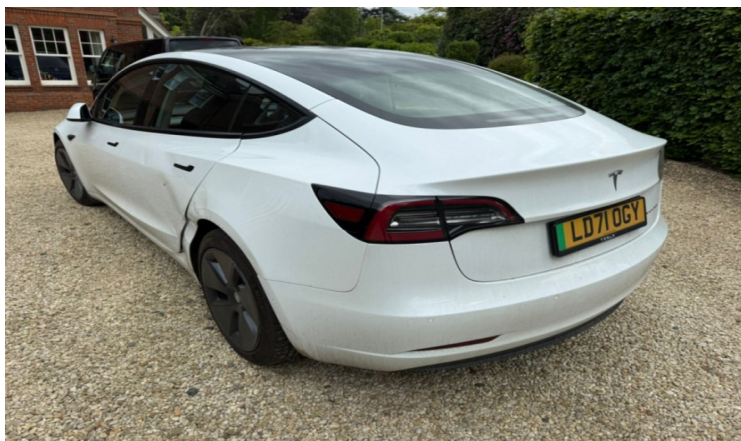
Impact Area

The vehicle has suffered moderate collision/impact damage to the left hand side.

Please note the vehicle is unroadworthy due to the possible wheel, suspension and tyre damage and the NSR door is compromised and not sealing.
