### REPAIRABLE REPORT

**RE: Road traffic Accident: Mrs Karin Solomons: 25/04/2026**

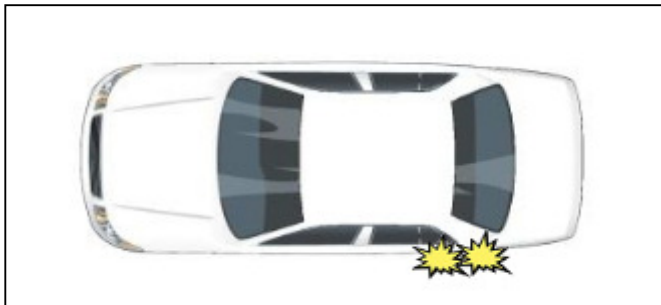
Impact Area

The vehicle has suffered moderate collision/impact damage to the left hand side.

Please note the vehicle is unroadworthy due to the possible wheel, suspension and tyre damage and the NSR door is compromised and not sealing.
