## To the Court REPAIRABLE REPORT

| Vehicle: <b>SUZUKI VITARA SZ-T BOOSTERJET MH</b> | | Colour: <b>White</b> | Speedo: <input type="text"/> | Miles <input type="text"/> |
| Reg No: <b>VU22RZH</b> | Registered: <b>Mar 2022</b> | Type: <b>5 Door Hatchback</b> | Trans: <b>Manual</b> | |
| Damage: <b>Light to Moderate Collision/Impact LH Side</b> | Incident: <b>19/07/2026</b> | L/H/F Tyre <b>Not Kno</b> | L/H/R Tyre <b>Not Kno</b> | |

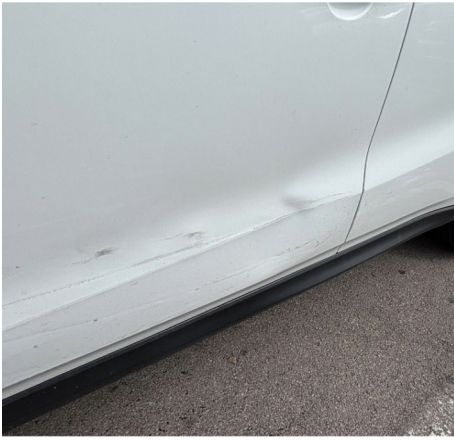
CLVOSdamage-V1.jpeg

The vehicle has suffered light to moderate collision/impact damage to the left hand side.
