## REPAIRABLE REPORT

**RE: Road traffic Accident: Miss Poonam Patel: 15/01/2026**

| Make | <b>MERCEDES-BENZ</b> | Registration | <b>BU72MPO</b> |
| Model | <b>A 180 AMG LINE ED EX</b> | Status | <b>Repair</b> |

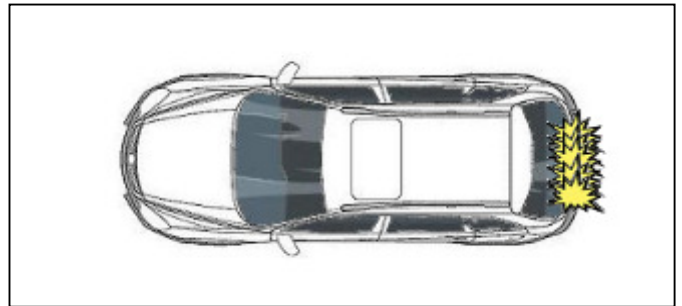
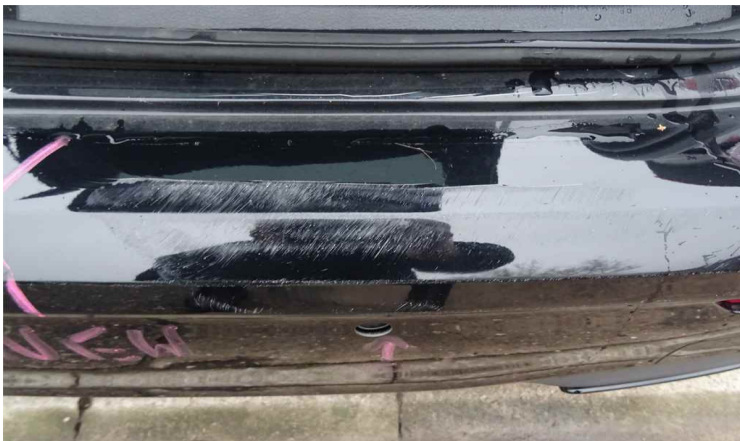
Impact Area

The vehicle has suffered moderate collision/impact damage to the rear.
