### REPAIRABLE REPORT

**RE: Road traffic Accident: Mrs Karin Solomons: 25/04/2026**

| Make | <b>TESLA</b> | Registration | <b>LD710GY</b> |
| Model | <b>MODEL 3 LONG RANGE</b> | Status | <b>Repair</b> |

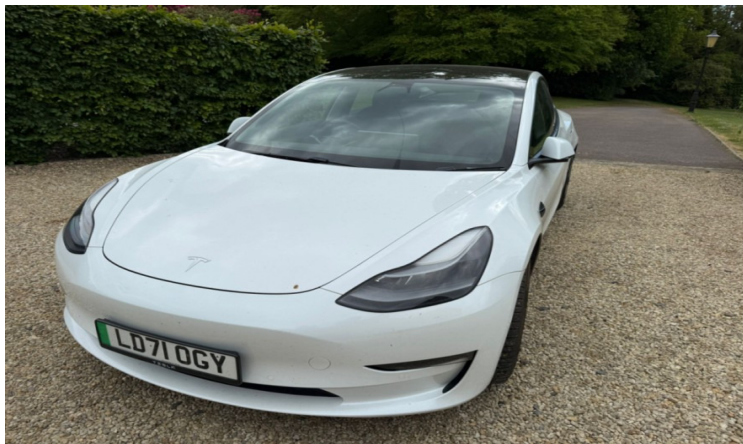
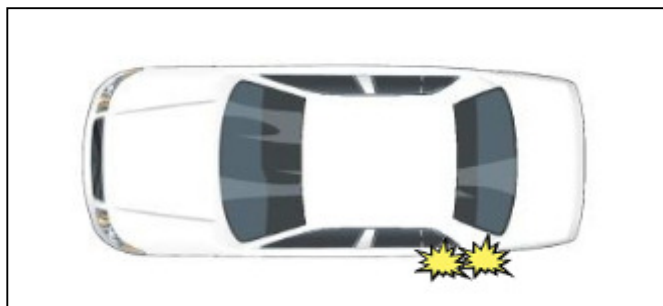
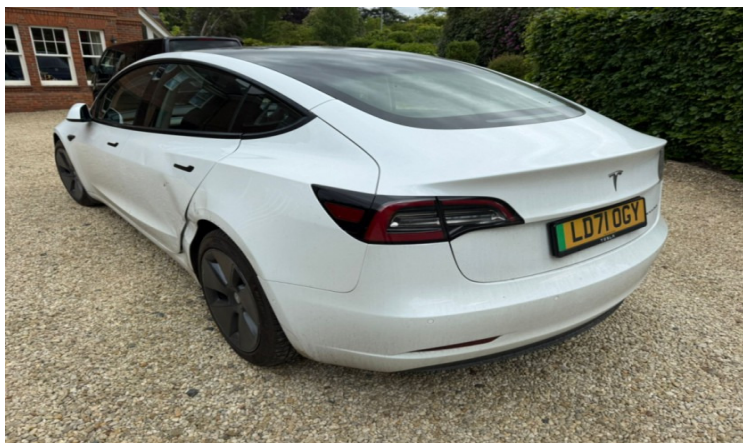
Impact Area

The vehicle has suffered moderate collision/impact damage to the left hand side.

Please note the vehicle is unroadworthy due to the possible wheel, suspension and tyre damage and the NSR door is compromised and not sealing.
