## To the Court REPAIRABLE REPORT

| Vehicle: <b>AUDI A3 SE TFSI</b> | Colour: <b>Red</b> | Speedo: <b>80134</b> | <b>Miles</b> |
| Reg No: <b>L21CSR</b> | Registered: <b>Jan 2015</b> | Type: <b>5 Door Hatchback</b> | Trans: <b>Manual</b> |
| Damage: <b>Light to Moderate Collision/Impact RH Rear Bumper</b> | Incident: <b>10/05/2026</b> | L/H/F Tyre <b>Not Kno</b> | L/H/R Tyre <b>Not Kno</b> |

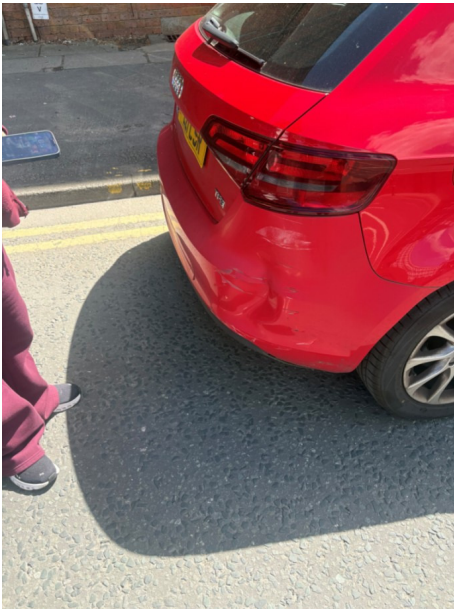
Imageofclientdamage1jpg-V1.jpg

The vehicle has suffered light to moderate collision/impact damage to the right hand rear bumper.

**New parts required:-**Rear Cover Bumper, L/R Bumper Reinf, R/R Bumper Reinf, Rear Bumper Support, Rr Bumper Clamp Kit, L/R Badge, R/R Badge, Rear Badge, L/S Window Bond Kit, R/S Window Bond Kit, Side Window Primer, Cutting Filament, Cleaning Solution, Applicator, Sundry Parts
