## To the Court REPAIRABLE REPORT

| Vehicle: <b>SKODA FABIA COLOUR EDITION TSI</b> | | Colour: <b>BLACK</b> | Speedo: <input type="text"/> | Miles: <input type="text"/> |
| Reg No: <b>KY69KJV</b> | Registered: <b>Sep 2019</b> | Type: <b>5 Door Hatchback</b> | Trans: <b>Manual</b> | |

### DESKTOP ASSESSMENT

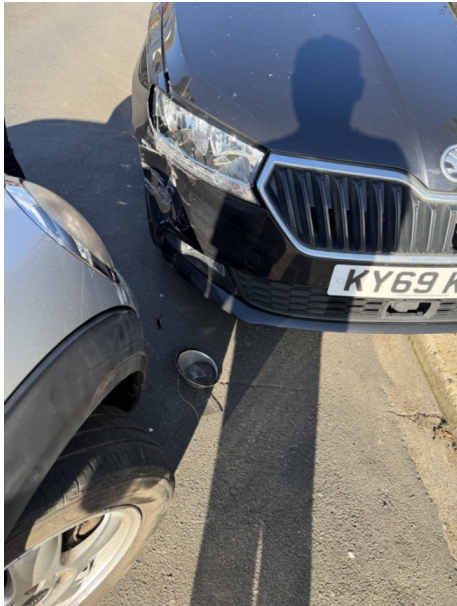
Clientvehicledamages-V1.jpeg

The vehicle has suffered moderate collision/impact damage to the right hand front complete vehicle.

In our opinion this vehicle was not roadworthy at the time of our inspection as a result of the damage sustained due to sharp edges, broken headlight. We understand that the vehicle is not currently being used by the owner.

**New parts required:-**Front Bumper Cover, R/Headlamp Cpl, Panel Sundries, Car Care Kit, Glass Lifting Tape, Sundry Parts

**Remove And Refit parts:-**Description, Front Bumper Cover, Renew Front Bumper Cover, Right Headlamp, Renew R/F Headlamp (Removed), Adjust Headlamps, Right Front Wing, Corrosion Prote To 1St Panel
