**Our Ref:** qdos221401

### CONTRACT REPAIR REPORT

**RE: Road traffic Accident: Dr Sarah Daley: 20/07/2022**

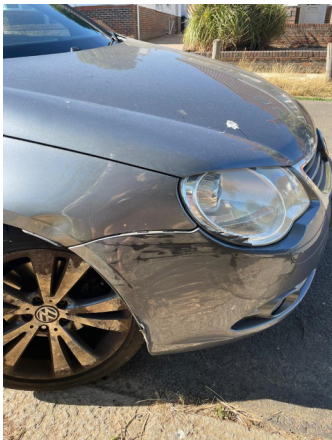
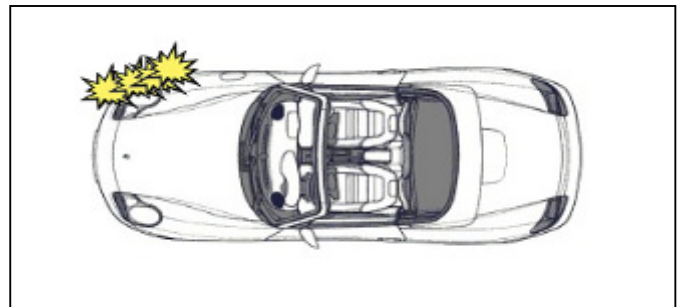
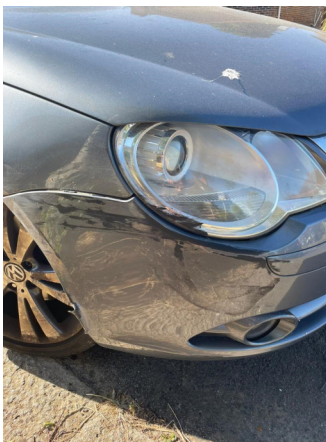
Impact Area

The vehicle has suffered moderate collision/impact damage to the right hand front.

24/08/2022 - Vehicle is unroadworthy due to the damaged/insecure front bumper.

Front Bumper  
Front Bumper Beam

Os Headlamp  
Sundries/clips/fixings

Os Wing
