## REPAIRABLE REPORT

### **RE: Road traffic Accident: Dr Rachael Lowton: 17/08/2022**

| Make | <b>FORD</b> | Registration | <b>M12DBL</b> |
| Model | <b>KUGA ZETEC TDCI</b> | Status | <b>Repair</b> |

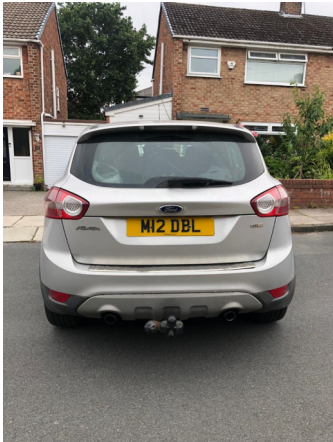
Impact Area

The vehicle has suffered light to moderate collision/impact damage to the rear.
