### **REPAIRABLE REPORT**

#### **RE: Road traffic Accident: Ian Lloyd: 10/06/2022**

| Make | <b>JAGUAR</b> | Registration | <b>OE67MYF</b> |
| Model | <b>XE S V6 AUTO</b> | Status | <b>Repair</b> |

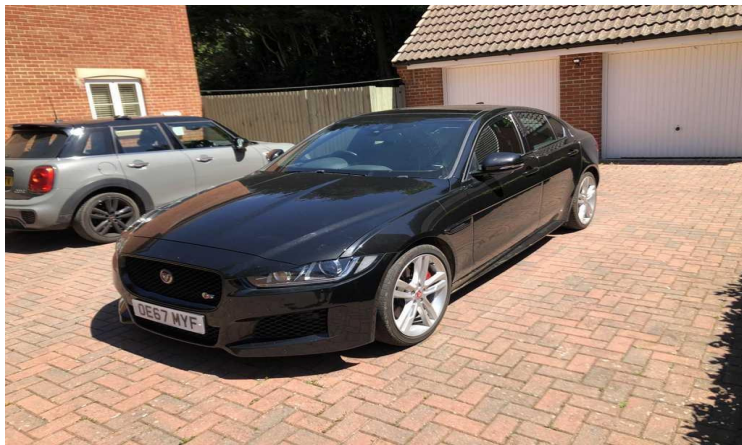
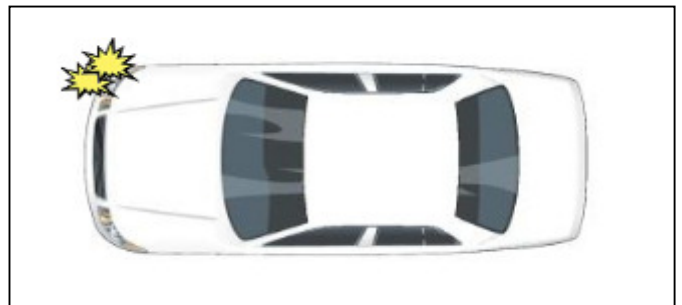
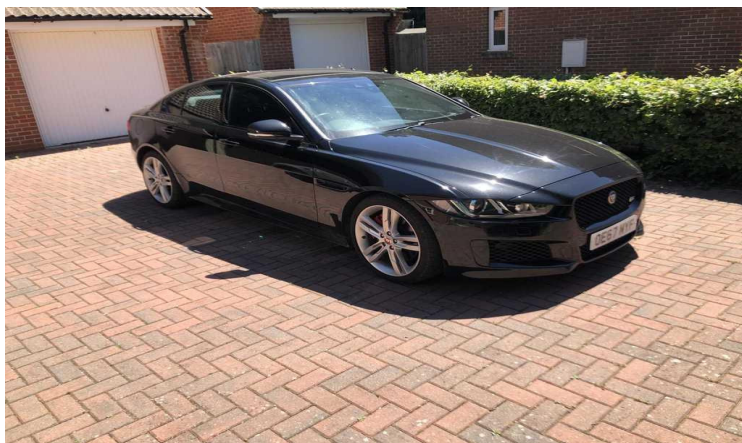
Impact Area

The vehicle has suffered moderate collision/impact damage to the right hand front.
