**Our Ref:** ap.qdos251820

### **TOTAL LOSS REPORT**

**RE: Road traffic Accident: Mr Saifuddin Rustami: 14/10/2025**

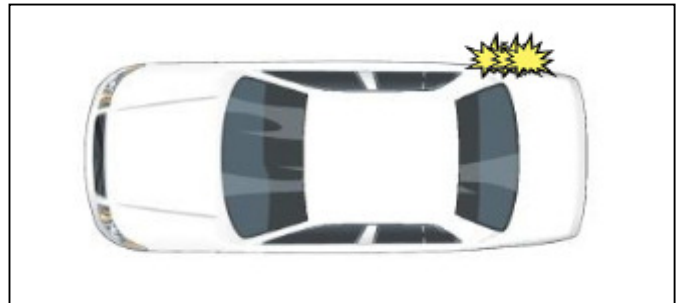
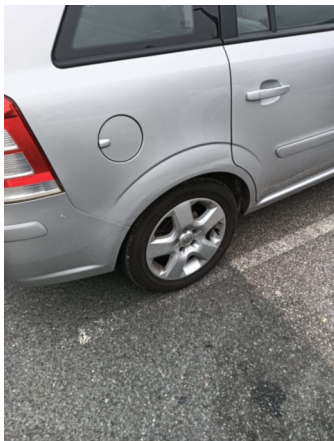
Impact Area

The vehicle has suffered light to moderate collision/impact damage to the right hand side.

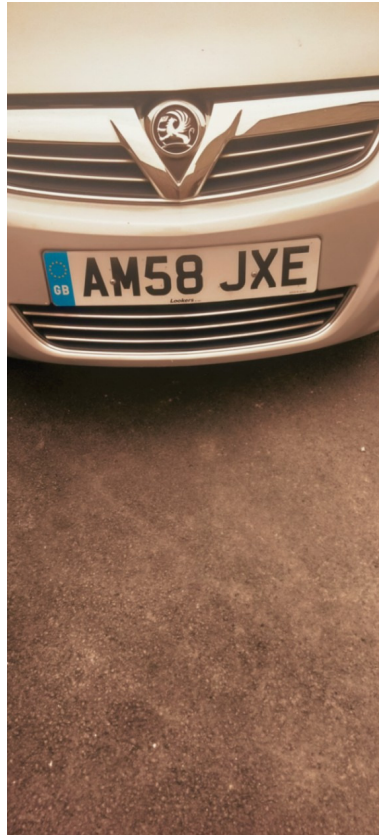
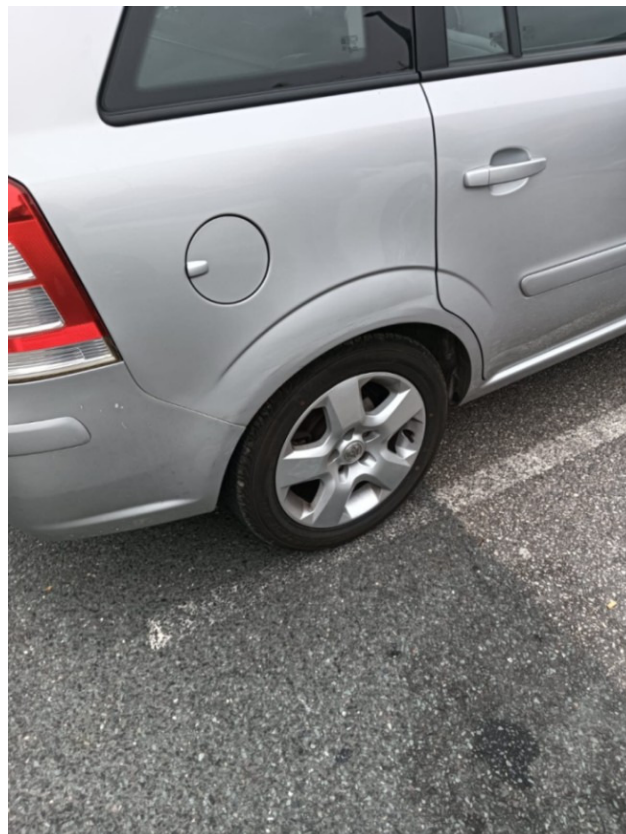
Main new parts required

Right Rear Door Protective Moulding

Right Rear Wheel Cover

Repairs required

Right Rear Side Panel
