### TOTAL LOSS REPORT

**RE: Road traffic Accident: Abdur Hosain: 15/12/2024**

| Make | <b>TOYOTA</b> | Registration | <b>BH17MWG</b> |
| Model | <b>PRIUS HYBRID</b> | Status | <b>T/Loss</b> |

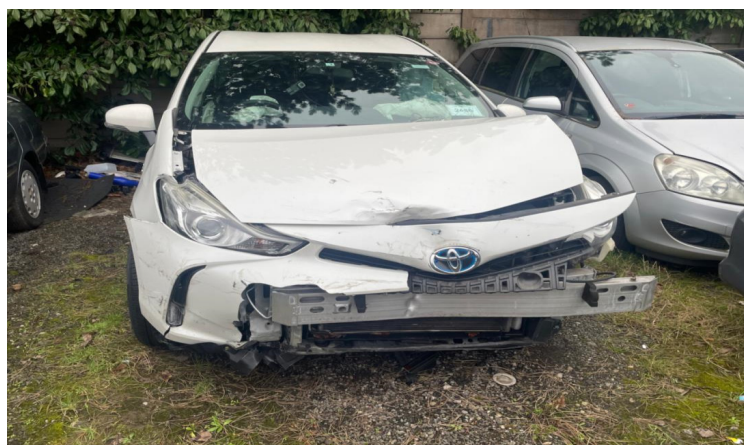
The vehicle has suffered heavy collision/impact damage to the front.

20/01/2025 - Please note the vehicle is unroadworthy due to the extent of panel distortion sustained to the front end.
