**Our Ref:** acsp26006

### TOTAL LOSS REPORT

**RE: Road traffic Accident: Tuk Tuk Pan Asian: 19/01/2026**

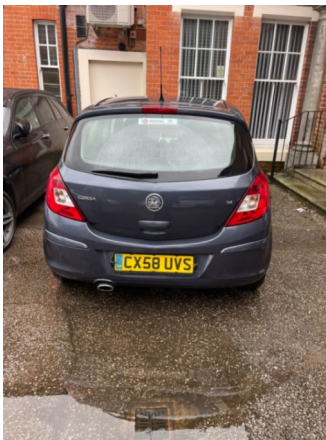
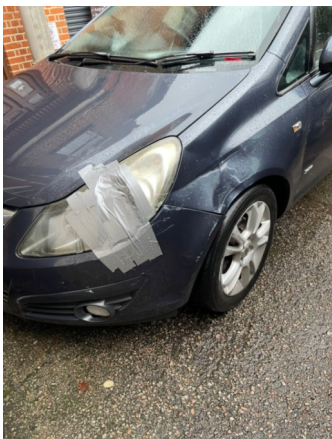
Impact Area

The vehicle has suffered moderate collision/impact damage to the left hand front.
