### **TOTAL LOSS REPORT**

**RE: Road traffic Accident: Mr Ala Aldameiry: 01/10/2024**

### **DESKTOP ASSESSMENT**

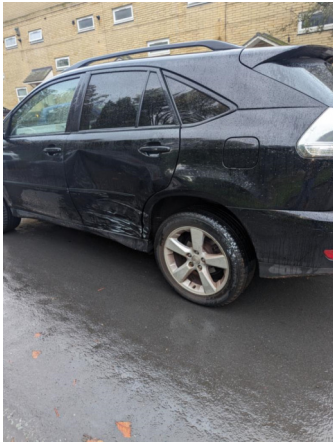
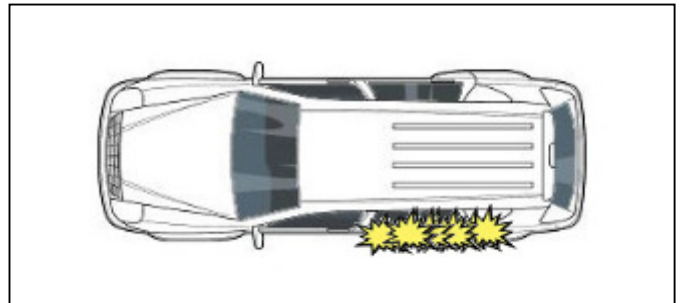
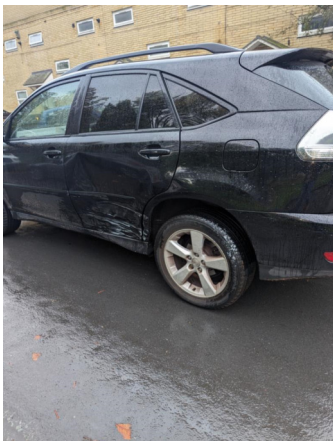
Impact Area

The vehicle has suffered moderate collision/impact damage to the left hand rear.

04/10/2024 - Please note the vehicle is unroadworthy due to the extent of panel distortion sustained to the nearside.

Left Front Door Covering Sheet (Skin)  
Left Rear Door Covering Sheet (Skin)  
Left Sill Panel Cover (Plastic)  
Left Side Glass Repair/Bonding Kit

Left Rear Door Shell  
Left Rear Door Protective Moulding  
Left Rear Side Panel

Left Rear Wheelarch, Outer
